ACCELERATED CORROSION TESTING OF ASTM A1010 STAINLESS STEEL

SUMMARY

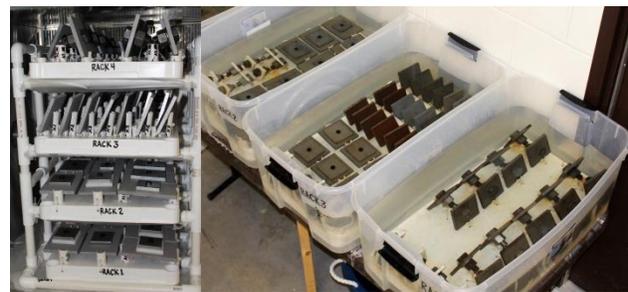
The modified SAE J2334 procedure consists of a repeated 3-stage cycle: 1) humid stage at 50°C and 100% relative humidity (RH) for 6.00 hours, 2) salt application stage with full immersion in salt solution at ambient temperatures for 0.25 hours, and 3) dry stage at 60°C and 50% relative humidity (RH) for 17.75 hours (3)(6)(8). The humid and dry stage environments were created through the use of an automated environmental chamber, while the salt application stage was implemented by manually placing the specimens in soaking tubs filled with the solution. The salt solution was modified from the original SAE J2334 specification to have 5.0 percentage weight of sodium chloride instead of 0.5 percentage weight, based on previous FHWA findings (3). Plastic racks and shelving were used to orient specimens during testing and facilitate movement between environmental chamber and soaking tub, as shown in Figure 1.

Figure 1: Test specimen configuration in environmental chamber and salt solution

The specimen orientation was selected to produce conditions suitable for each type of corrosion of interest. Corrosion is known to accelerate with increasing time of wetness (TOW), or exposure of the metal to the electrolyte. This was controlled by orienting the specimens at position which allowed electrolytes to remain on the specimen surface for a longer time prior to drying.

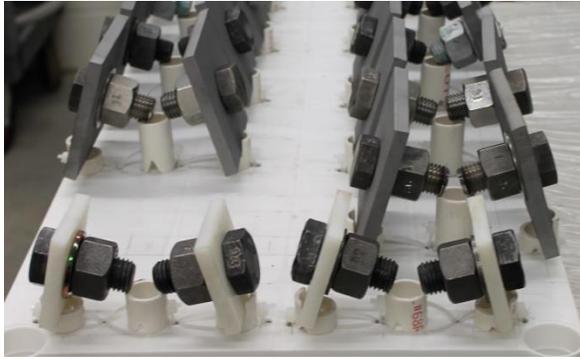
3. Galvanic Corrosion Fastener Assemblies. In a similar concept to the plate assemblies, the fastener assemblies included A1010 plates connected to conventional fastener assemblies. The fastener types were also connected to separate nylon plates to provide a comparison of assemblies allowing galvanic corrosion and those that do not allow galvanic corrosion. Six fasteners types were included from three categories: uncoated carbon and weathering steel, HDG carbon steel, and stainless steel. For a complete list, see Table 1. A1010 plates were 4 in. squares with a thickness of 3/8 in. and bolts were 3/4 in. in diameter and 2 in. long. Triplicates were provided for each assembly type to reduce sampling error. The plates were placed in a near-vertical orientation, at 15° from vertical, as shown in Figure 4.

Figure 4: Galvanic corrosion fastener assemblies in plastic racks prior to the initiation of testing

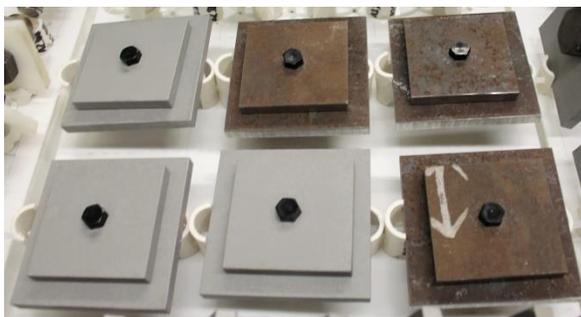
4. Crevice Corrosion Plate Assemblies. A1010 base plates were directly connected to A1010 top plates in order to investigate the crevice corrosion behavior of A1010 stainless steel when not involved in bimetallic connections. Base plates were 4 in. squares and top plates were 3 in. squares, with both types of plates having a thickness of 3/8 in. It was hypothesized that the surface preparation which the specimens received may have a significant impact on crevice corrosion. Therefore, specimen assemblies were included in which both the top and bottom plates received aluminum oxide abrasive blasting, in addition to assemblies in which neither the top nor bottom plate received any abrasive blasting. The two types of assemblies are shown in Figure 5. Specimen assemblies were placed in a near-horizontal orientation, at 85° from vertical.

Figure 5: Crevice corrosion fastener assemblies in plastic racks prior to the initiation of testing

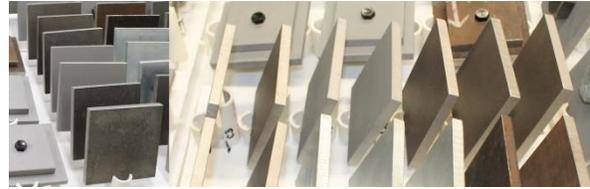
5. Surface Preparation Plate Specimens. Three different abrasive media were used in order to evaluate the effect of surface preparation on the corrosion behavior of A1010: #280 steel shot, #80 aluminum oxide grit, and #80 garnet grit. Additional control specimens received no

blasting. Specimen assemblies were placed in a near-horizontal orientation, at 85° from vertical, as shown in Figure 6. Triplicates were provided for each specimen type to reduce sampling error.

Figure 6: Surface preparation plate specimens in plastic racks prior to the initiation of testing

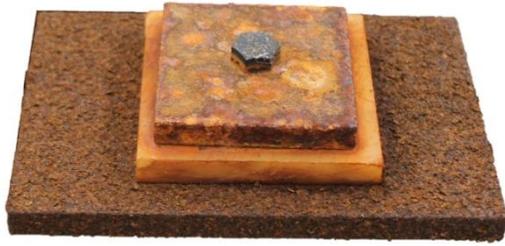
In general, the increase in magnitude was attributed to the near-horizontal orientation of the specimens which caused a higher TOW and longer exposure to corrosive substances. Unstable corrosion was observed, as the plates were unable to properly form a passive surface layer, as seen in Figure 8. This behavior was nearly equivalent for assemblies with each of the three sizes of top plate.

Figure 8: Unstable corrosion occurring on A1010 base plate connected to uncoated A709 top plate

The increase in thickness loss rates over time was attributed to crevice and pitting corrosion occurring in between the faying surfaces of the connected plates; as the depth of the crevices increased, the crevice corrosion rate also increased.

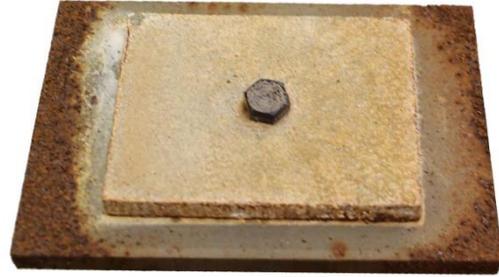
The decrease in thickness loss, compared to the uncoated carbon and weathering steel assemblies, was attributed to the sacrificial protection provided by the top plate zinc coating. The coating provided immediate protection on the faying surface between the plates within approximately 1 inch from the top plate connection, as seen in Figure 9. This protection was evident when comparing base plates connected to the varying top plate sizes; A1010 base plates connected to the largest A709 GR50 HDG top plates received the greatest protection and experienced the lowest thickness loss rates, while the assemblies with the smallest top plates received the least protection and experienced the greatest thickness loss rates.

Figure 9: Galvanic protection occurring on A1010 base plate connected to HDG coated A709 top plate

A1010 (A709 GR50CR) base plates connected to coated A709 GR50 HDG plates experienced thickness loss rates between 1.5 to 3 times greater than the A1010 control plates. The base plates experienced near-linear thickness loss rates up to 60 cycles of testing, at which point the HDG sacrificial surface layer on the top plates was fully depleted.

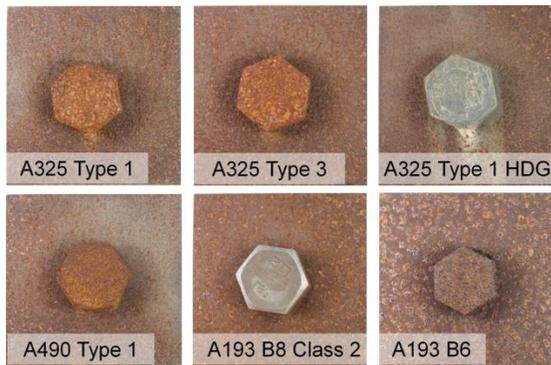
A1010 plates. Overall, thickness loss rates experienced by the A1010 plates within the galvanic corrosion fastener assemblies were approximately equivalent to the losses exhibited by the A1010 control plate specimens, at 0.02 mils/cycle. A1010 plates connected to all fastener types exhibited nearly linear thickness loss rates over the duration of testing. The A1010 plates in uncoated carbon and weathering steel bolt assemblies experienced thickness loss rates of approximately 0.02 mils/cycle, those connected to HDG bolt assemblies experienced approximately 0.01 mils/cycle, and those connected to B8 Class 2 and B6 stainless steel bolt assemblies experienced approximately 0.03 mils/cycle.

Figure 14: Galvanic corrosion fastener assemblies after 20 cycles of testing.

In general, these differences in thickness loss rates among A1010 plates connected to dissimilar metal bolt assemblies were relatively small in magnitude, even while the percentage increase or decrease appears to be significant. This was due to the passive surface layer formation on the A1010 surface for each of these specimen assemblies and the relatively small portion of surface area on the A1010 plates participating in galvanic corrosion. This behavior would likely increase in an environment in which the electrolyte connecting the plates was thicker or connected the two components for a longer period of time. Given that the use of A1010 in bridge applications would involve atmospheric environments without constant immersion in an electrolyte solution, the effect of galvanic

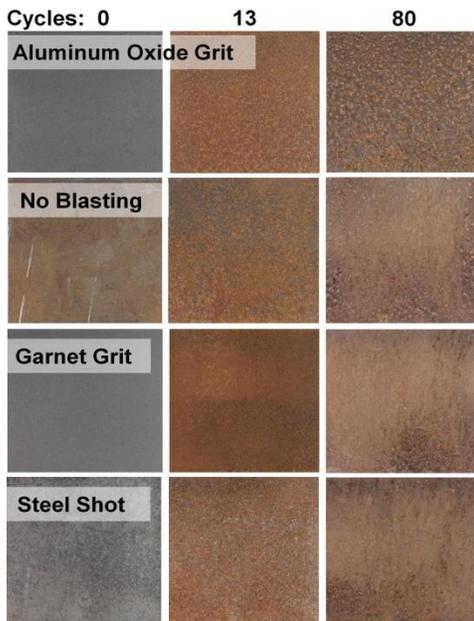
The difference in early corrosion behavior is likely the result of the difference in surface profiles produced by the different blasting media; the use of shot media produces a microscopic surface profile which is rounded and wavy, with “hills” and “valleys” randomly spaced on the surface. In addition, the collisions of shot media with the A1010 steel produce minor work hardening of the surface. This profile type is not prone to trap moisture and facilitate localized corrosion. Therefore, the corrosion products do not appear as readily and may appear less uniform. In contrast, the use of grit media produces a microscopic surface profile with jagged peaks which facilitates moisture and traps corrosive substances. This microenvironment produces corrosion products on the A1010 surface at earlier stages of exposure which are likely to be more evenly distributed on the surface. A visual comparison of the specimens is shown in Figure 20.

Figure 20: Comparison of A1010 surface preparation plate specimens at early and late stages of testing

Visual observations of the A1010 specimens indicated that the main difference in corrosion behavior of the various specimens was the appearance of corrosion products on plates blasted with grit media at earlier stages of testing. Conversely, specimens blasted with steel shot

specimens did not experience the same appearance of corrosion products at early stages of testing. By later stages of testing, all specimens had uniform distribution of corrosion products and appeared approximately visually equivalent.
