# EVALUATION AND RETROFIT FOR THE SECOND WIDENING OF THE P.R. OLGIATI BRIDGE

## SUMMARY

The P.R. Olgiati Bridge is a steel multi-girder bridge that carries US 27 over the Tennessee River in Chattanooga, Tennessee. In 1998, the bridge was widened, and pairs of steel cap beams were added to the faces of the four existing concrete river piers which extended transversely beyond the edges of the piers and supported the new girders. Each pair of cap beams was supported by six saddle beams which spanned between the cap beams and rested on the top of the piers. The cap beams were long enough to support an additional girder line for a future second widening.

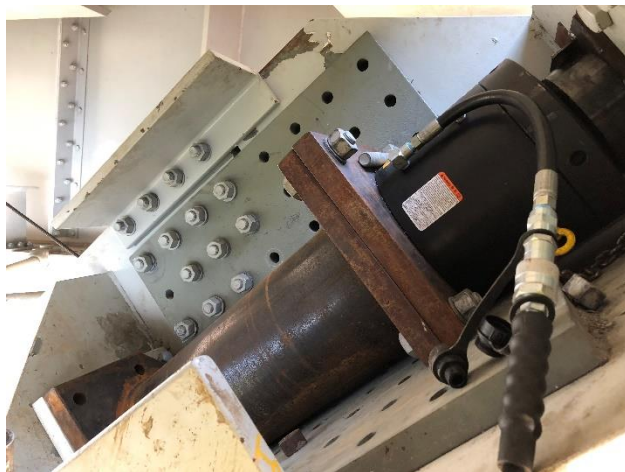
**Figure 12 – Splice plate and jack in one quadrant of the cruciform**

After both the strut and load beam were in place, the cruciform splice plates were installed and bolted to the strut portion of the cruciform. The load beam cruciform did not contain any holes, as there was no method to predict the upwards deflection of the cap beams accurately enough to pre-locate the holes. Therefore, the splice plates, which had pre-drilled holes in their top portions, were used as a template for field drilling the cruciform holes once jacking had been completed. After the splice plates were in place, jacks were placed in the four quadrants of the cruciform and connected to a single hydraulic system to ensure even loading across all four jacks. The installed splice plate and jacks in one of the four quadrants are shown in Figure 12. Also shown in this figure is a mini-CFST designed by the contractor to be used as pedestals for each of the jacks.

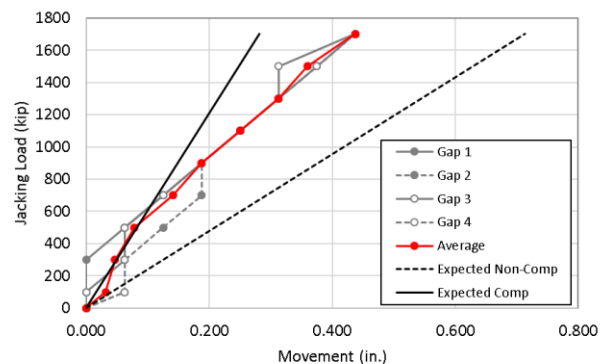
**Figure 13 – Typical plot of movements during jacking of strut**

Prior to jacking, the gaps at each leg of the cruciform between the top and bottom portions were measured, and measurements were also taken after each increment in the jacking process. The initial gap was to be set at approximately 5/8 inches, and 3/8 inches of movement was expected based on the results of a weighted average of LUSAS analysis results, where 75% of the average was based on the fully composite results and 25% of the average was based on completely non-composite behavior, i.e. completely neglecting the existence of the concrete fill. However, the real behavior of the cap beam-concrete fill system was unknown, so the envelope of allowable movements was between fully composite behavior and completely non-composite behavior. The gaps were plotted in real time by an onsite M&M engineer, and the jacking process was permitted to continue only if the gaps were within the expected envelope. An example of one of these plots is shown in Figure 13. While the first few measurements at each of the piers were generally not within the envelope, later measurements and the average increase of the gap across the four legs of the cruciform generally matched the predicted behavior. Jacking was allowed to proceed to the specified value at all four piers, and the final elongations of all struts were in reasonable compliance with the expected outcome. The pair of completed struts at pier 10 are shown in Figure 14.

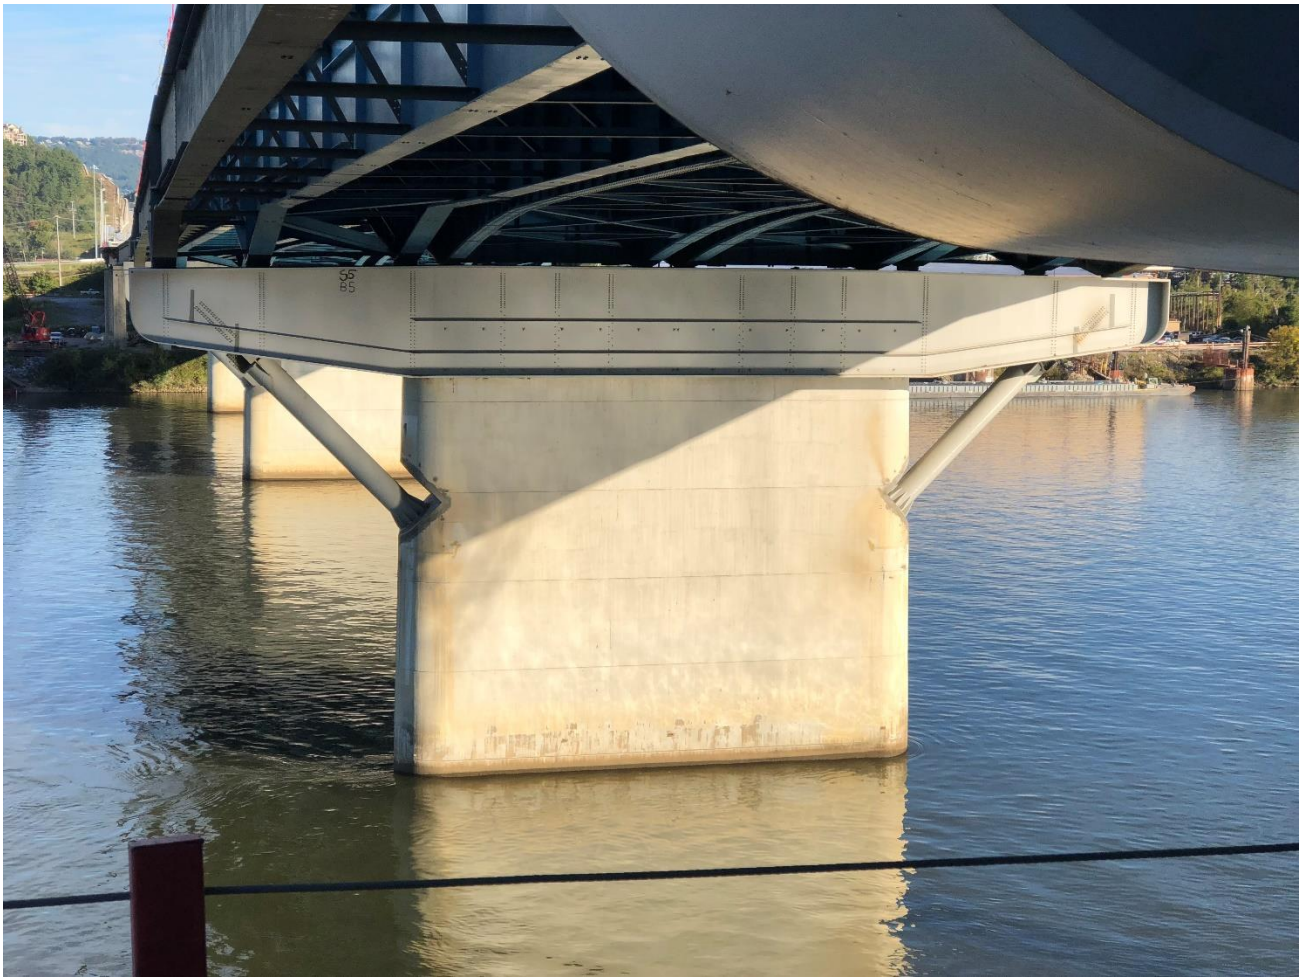
**Figure 14 – Completed struts at pier 10**
