DEVELOPMENT OF AN ANALYTICAL FRAMEWORK FOR STRENGTH ASSESSMENT OF CORRODED STEEL BRIDGES

SUMMARY

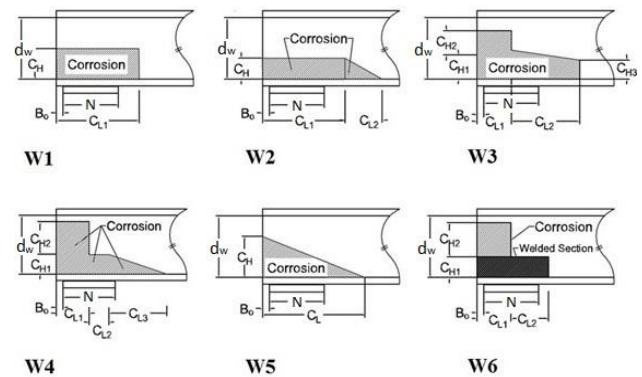
Figure 1: Raw data-based section loss patterns.

The current deterioration condition of 93 steel bridges throughout the state of Massachusetts is explicitly studied [2]. In order to manage the large amount of data included in these reports the first stage of processing involves the development of raw data-based patterns for web corrosion (Figure 1) as well as patterns of web holes (Figure 2) that describe the 95% of the reported cases. Each one of the 808 studied corroded beam ends is classified according to raw data based patterns and parameters such as thickness loss, corrosion area size, corrosion location, hole size, and hole location were clearly defined and recorded from the reports.

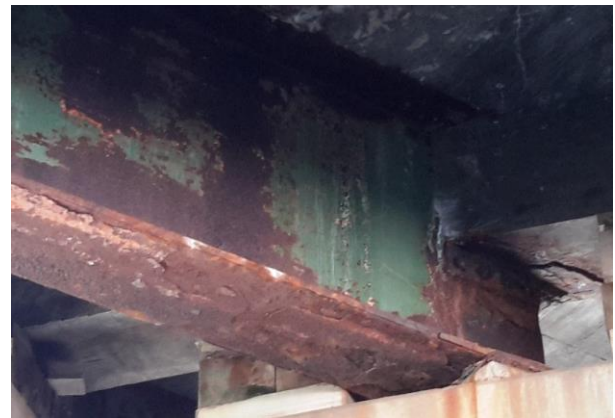
Figure 4: In-service configuration of Bridge A.

While Bridge A was in service, concrete diaphragms were located at the upper part of the web ends (Figure 4). Concrete removal revealed three artificial holes at each specimen as well as a skew cut of the upper web end and flange. Part of the steel angle sections utilized to support the diaphragms remained bolted at web mid-height.

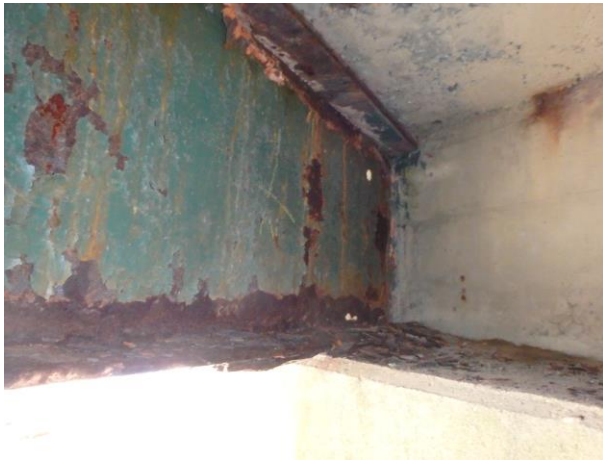
Figure 5: In-service condition of a girder in Bridge B.

The design of Bridge B consisted of beams with their ends fully embedded in concrete along their depths (Figure 5). Concrete removal also revealed holes at the web end of specimens 4 to 6.

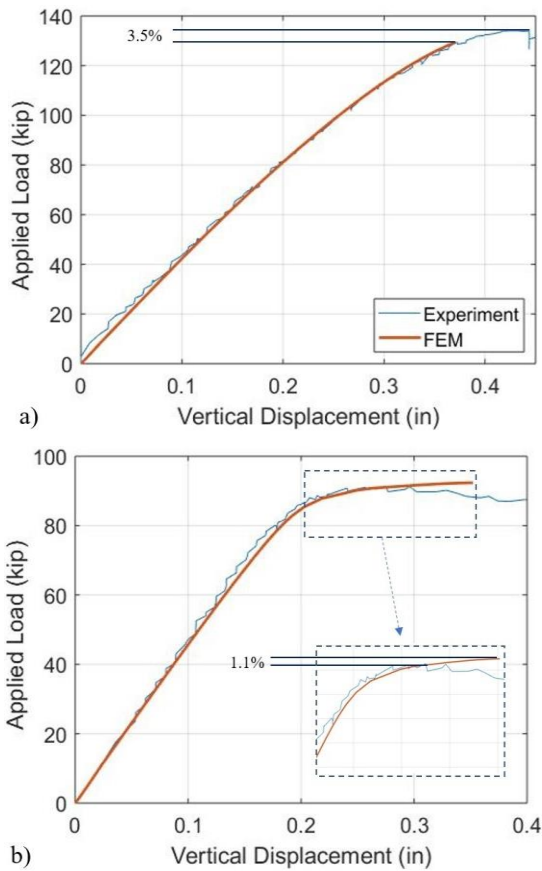
Figure 10: Comparison between experimental and numerical results for a) specimen 1 and b) specimen 2.

The only parameter which requires calibration is the “k” value, that has been set equal to 12 using the experimental data from specimen 1. The developed model is able to capture the failure mode of specimen 1 with accuracy of 3.5% (Figure 10a).

Following the procedure previously described specimen 2 was also simulated and analyzed using “k” equals 12. Both the stiffness and the peak load depict an excellent agreement between the experimental and numerical results. The numerically captured applied failure load overestimates the actual one by only 1.1% (Figure 10b).

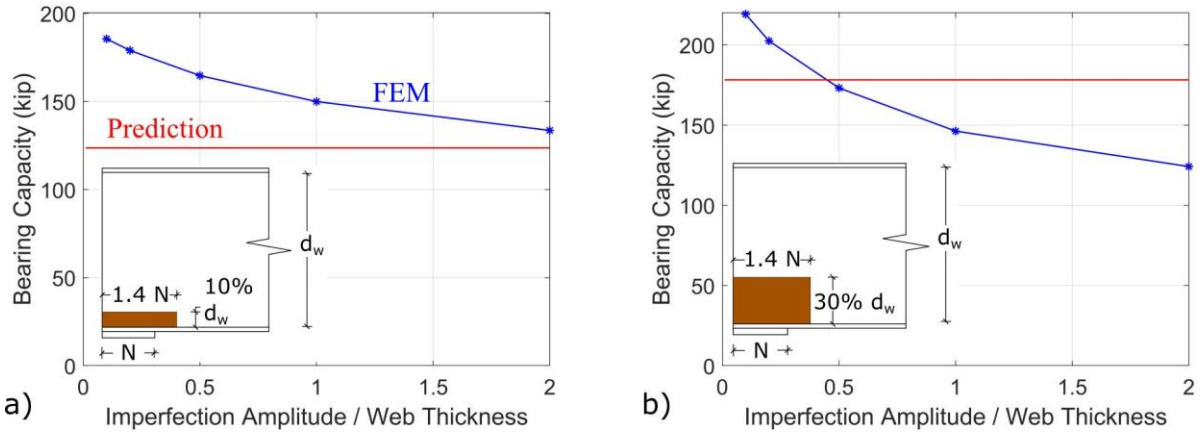
Figure 11: Effect of initial imperfection amplitude on the residual bearing capacity for section loss a) 45% and b) 25% of intact web thickness. Corrosion domain is illustrated with brown color.

Figure 11 shows the relationship of the initial imperfection amplitude (or maximum web deviation from straightness) and the bearing capacity for a 36WF150 beam with a corroded end. The nominal capacity based on [6] is also included for a comparison between the numerical results and the current Bridge Manual procedures. For the presented scenarios the bearing failure load is reduced up to 43% for imperfection amplitude equal to two times the intact web thickness.
