Steel Bridge Design Handbook

**CHAPTER 19**

# Corrosion Protection of Steel Bridges

February 2022

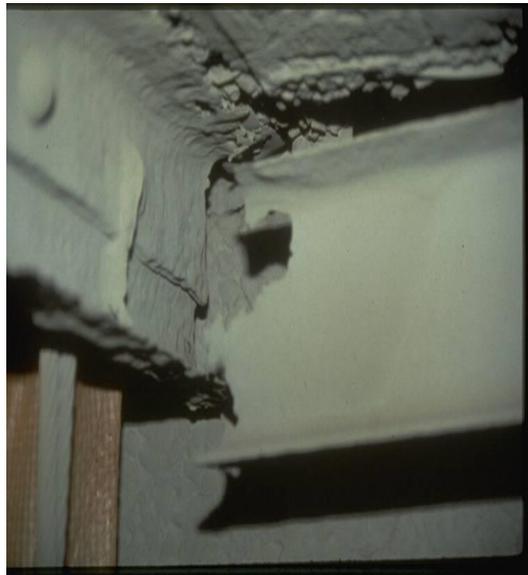
Figure 1. Photo. Photograph of a severed connection due to corrosion.

Two prominent bridge collapses were the Silver Bridge (Point Pleasant, WV) in 1967 and the Mianus River Bridge (Greenwich, CT) in 1983.<sup>(1,2)</sup> While corrosion was a player in these two failures, it was not the sole reason either. The Silver Bridge collapsed due to fracture of a non-redundant eyebar where a stress-corrosion crack led to fatigue growth and ultimately fracture. The Mianus River bridge failed when pack rust almost pushed a hanger bar off its pin, but ultimate failure occurred when the tip of the pin fractured. In either case, the collapse would have been prevented with a different structural design, more judicious materials selection, or closer attention to in-service inspection. Regardless, corrosion was a player in the collapses and it demonstrates that corrosion mitigation also needs to be a design consideration. Corrosion has been cited as a contributing factor in bridge failures of varying severity, including several failures and many load postings due to section loss in primary members. An example of bridge corrosion is exhibited in Figure 1 that shows a broken connection due to corrosion. Therefore, corrosion is not an issue to be taken lightly by the designer.

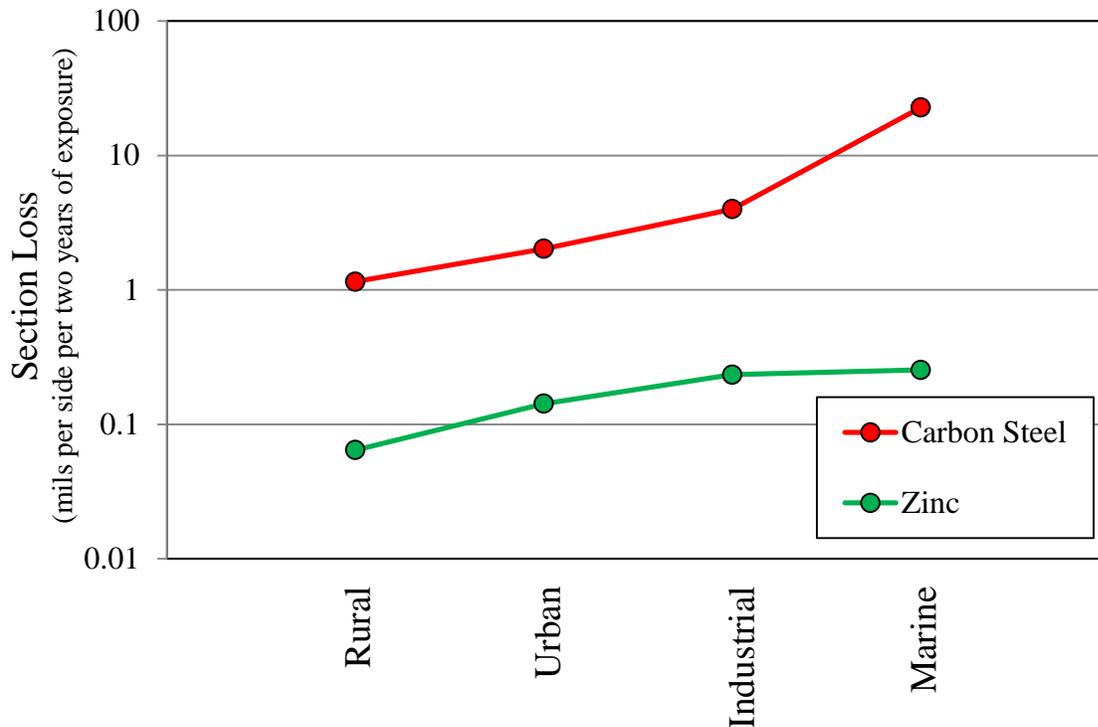
Figure 2. Graph. North America corrosion rates for carbon steel and zinc in various exposure environments.

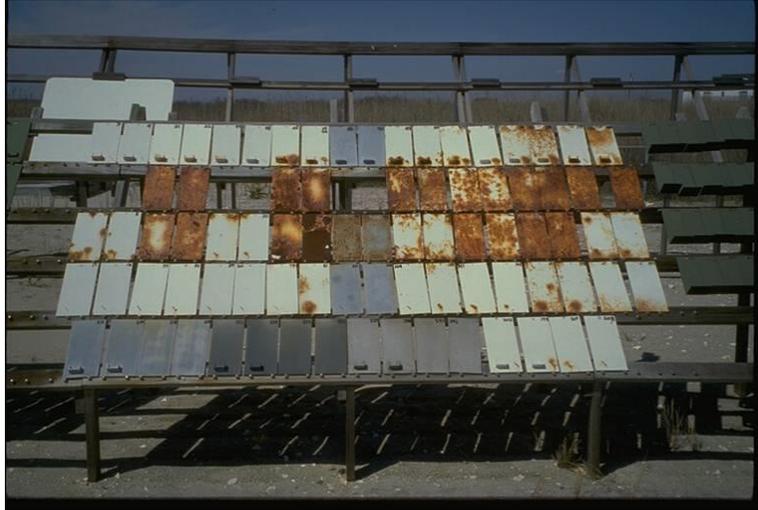
Figure 3. Photo. Testing of various generically similar paint systems shows wide variations in performance.

Zinc-rich primers are almost always topcoated for added corrosion resistance and additional functionality (color and gloss). Testing of zinc coating systems is required by most states to confirm the acceptability of individual paint systems. Testing via natural marine exposure, as seen in Figure 3, is a direct method of paint performance evaluation; however, this method requires a long time to discriminate between high performance systems. For practicality, natural exposure testing must be complemented with accelerated laboratory testing to rank the durability of paint formulations. Of important note, paints must be tested and specified as *systems*, designed and supplied by a single manufacturer to be used together; paints supplied by separate manufacturers are not always compatible. Specification of coatings by generic type or using an “or equal” approach can lead to disappointing performance results.

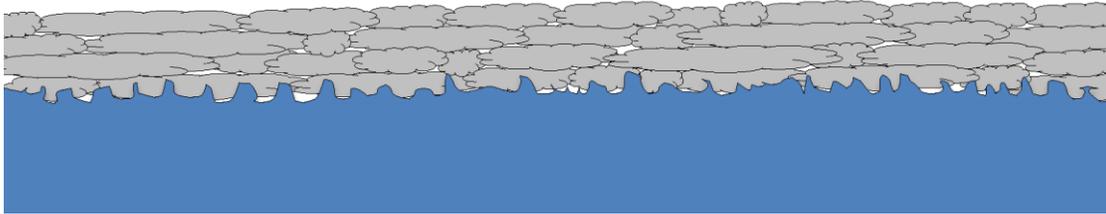
Figure 4. Illustration. Metalized coating formed on top of blast-cleaned steel surface in the form of overlapping “splats”.

far the dominant choices for bridge steel are pure zinc, 85 percent zinc/15 percent aluminum alloy, and pure aluminum. Metalized coatings are applied using a heat source to melt a metal feedstock (typically in a wire or powder form) at the tip of a spray gun that uses compressed air to propel the molten metal onto the target steel. The heat source can be either flame or electric arc, similar to the heat sources for welding equipment. Once the molten metal hits the steel surface, it immediately re-solidifies into a solid sacrificial coating. The coating is built up with a series of overlapping “splats” of metal. Achieving proper specified thickness is important to mitigate the possibility of porosity through the coating.<sup>(23)</sup> Figure 4 shows a depiction of this application. Figure 5 illustrates a typical field metalizing application.

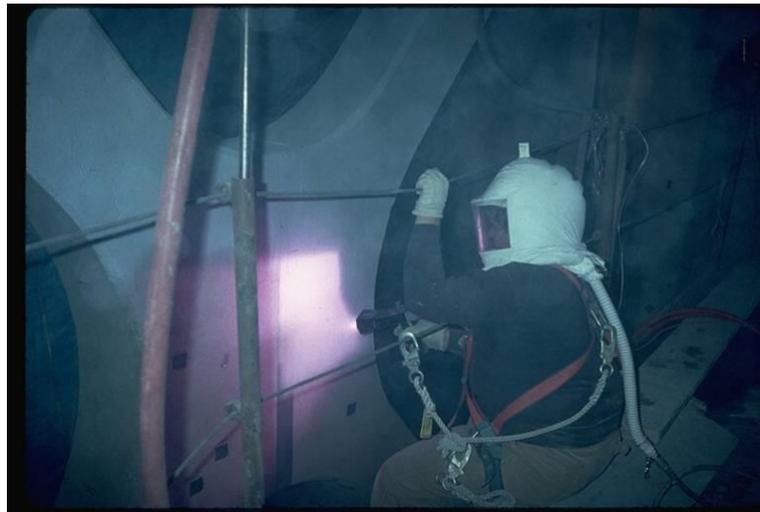
Figure 5. Photo. Metalizing of a bridge member in the field (photo courtesy of R. Kogler).

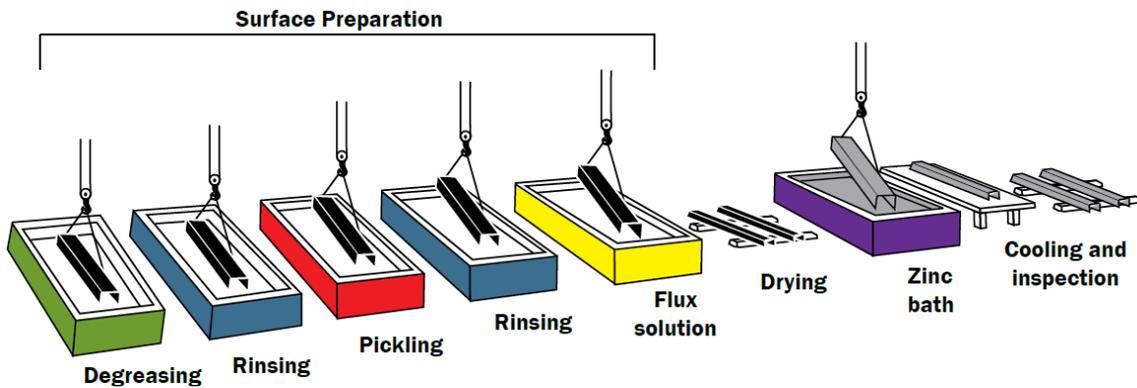
Figure 6. Illustration. Stages of the hot-dip galvanizing process. Taken from reference 28.

or kettles (as seen in Figures 6 and 7). The final dip in the process is immersing the component into molten kettle of pure zinc, typically at temperatures between 820 and 900 °F. These kettles are typically around 40 feet long, but kettles up to 60 feet long exist. The heat from this zinc dip creates a metallurgical bond between the zinc and steel, and creates a layer of sacrificial zinc. The composition of zinc layer depends on the chemistry of the steel and largely plays into the thickness of the coating, therefore a designer cannot specify a desired coating thickness for a hot-dipped galvanized component. When the silicon level in the steel is between 0.04 and 0.15 percent or above 0.22 percent the steel is considered “reactive”.<sup>(26)</sup> For reactive steels, the entire galvanized layer is zinc/iron intermetallics that can be excessively thick (generally thicker than 10 mils) and also brittle. The other problem with reactive steels is the intermetallic layer can continue to grow, and overall galvanized thickness is controlled by dwell time in the tank, but this can be mitigated by abrasive blasting in lieu of acid pickling. For non-reactive steels, the intermetallics form with a gradient in the zinc/iron ratio being more iron bearing near the steel and decreasing through the thickness to the outer layer that is pure zinc. The nonreactive steels develop a thickness that is on the order of 4 mils thick, and dwell time in the tank does not cause coating thickness to increase. Most of the time, the galvanizer does not know the chemistry of the steel being dipped, and therefore through experience has developed a knowledge of dwell time the piece should be immersed to get a galvanized coating that meets the quality control requirement of ASTM A123 for both reactive and nonreactive steels. ASTM A123 defines the sampling requirements for hot-dipped pieces by which coating thickness is assessed and accepted by.<sup>(27)</sup> For the typical thickness of plate used in bridges, ASTM A123 generally would require a minimum galvanized coating thickness of 3.9 mils or thicker.

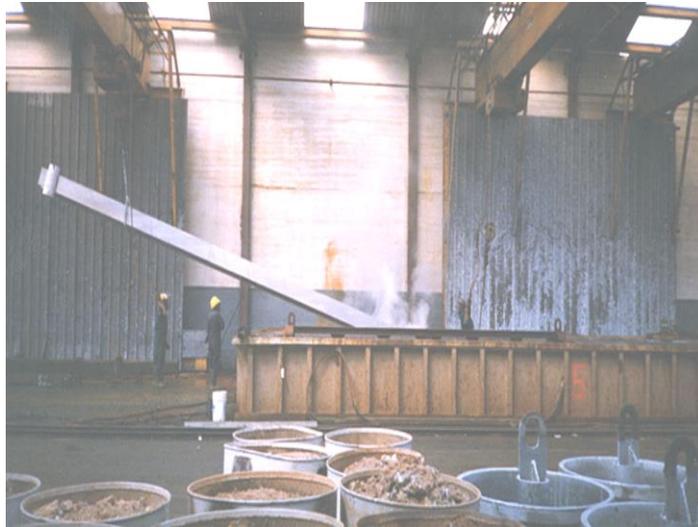
Figure 7. Photo. Hot dip galvanizing kettle with long beam being dipped at one end.

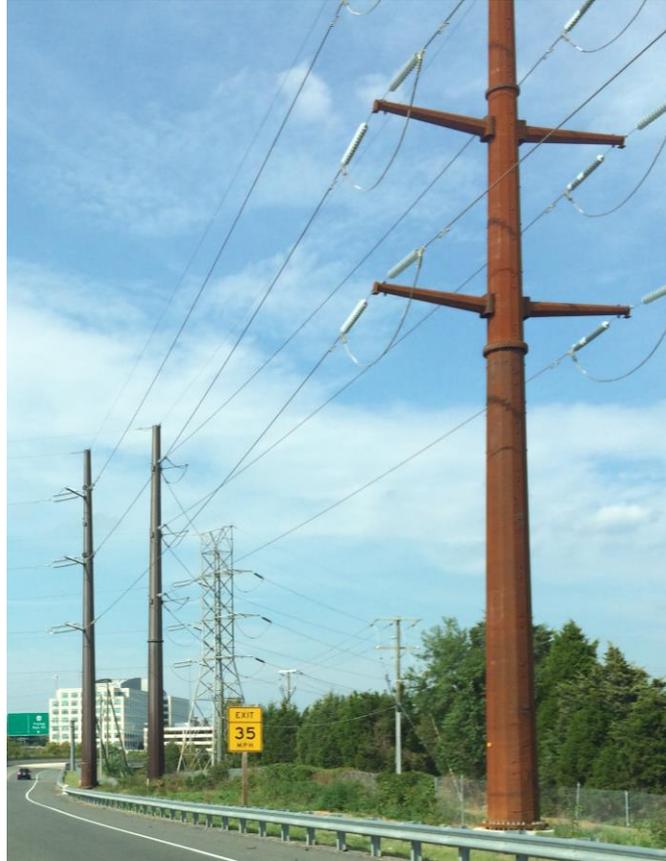
Figure 8. Photo. Different color of rust patina in new transmission tower (close) and older (far).

Oxidation of steel is the process of corrosion. Most people understand that “rusting” is the oxidation of steel, though in this case the oxides that develop continually flake off and expose new uncorroded steel, which is an unstable for of rusting. Alloying the steel can enhance its corrosion resistance. For instance, alloying with small amounts of copper, nickel, chromium, silicon, and phosphorus creates a class of corrosion-resistant steels referred to as “weathering” steels. Under a wide range of exposure conditions, weathering steels also rust, but form oxides that remain tightly adherent to the steel substrate and develop a much more stable oxide layer than non-weathering steel. Shortly after blast cleaning to remove mill scale, weathering steel turns “rusty” in appearance, but as the stable “patina” (oxide) develops over many wet and dry cycles (usually between 6 and 24 months depending on environment), the oxide layer will stabilize to a deep brown, almost purple color when the patina is fully developed.<sup>(12)</sup> While not a bridge, the transmission towers shown in Figure 8 show the difference is recently erected weathering steel transmission tower with a brown patina versus one that has been in-service for many years with the dark chocolate/purple color.

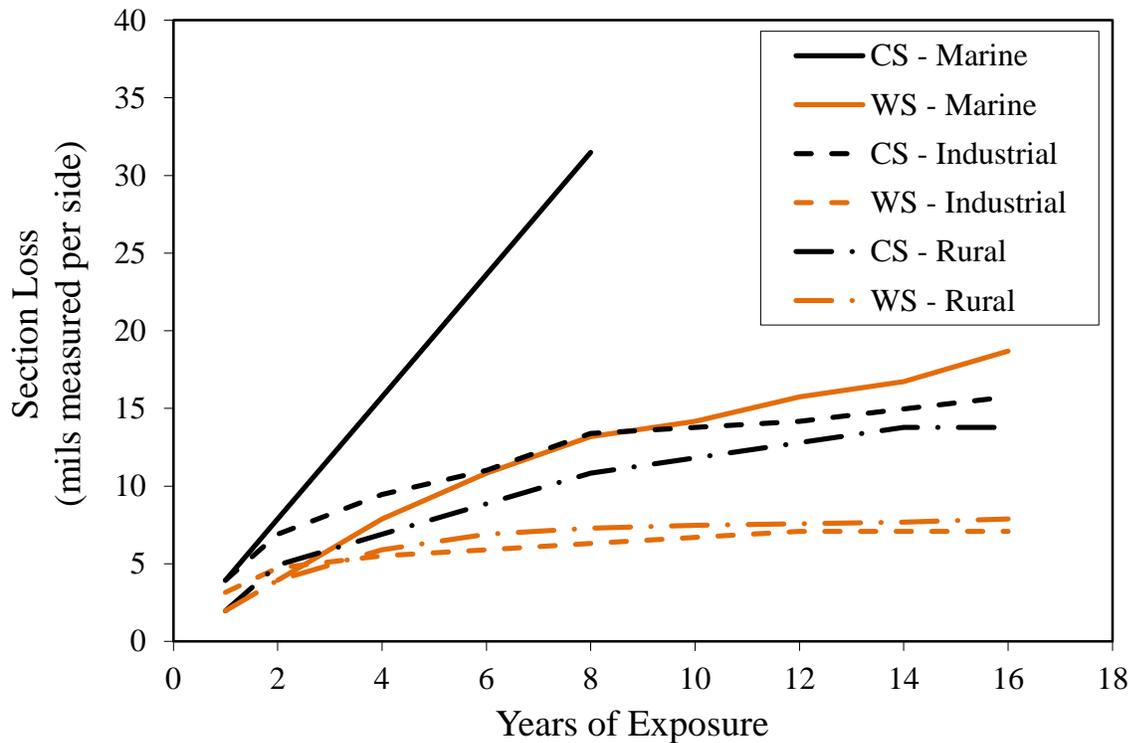
Figure 9. Graph. Relative corrosion rates of carbon and weather grade steels in various environments.

Figure 9 was constructed as a composite from long-term corrosion exposure data available in the literature.<sup>(34)</sup> The values used are averages from various exposure programs under a variety of conditions and do not represent worst-case estimates for the particular cited macro-environment. The data show that in the three exposure categories, weathering steel (denoted “WS” in figure) does corrode at a lesser rate than carbon steel (denoted “CS” in figure). However, the more important distinction is that for the marine environment, the rate never plateaus and corrosion continues, though for the industrial and rural environments, the corrosion does stabilize. In these two environments the rate of corrosion stabilizes to a very low (i.e. negligible) corrosion rate of approximately 0.3 mils per year per side (or lower in many cases). Understanding the steady state corrosion rate of weathering steel allows for the designer to determine the amount of sacrificial plate thickness to include in the design once the service life has been established.

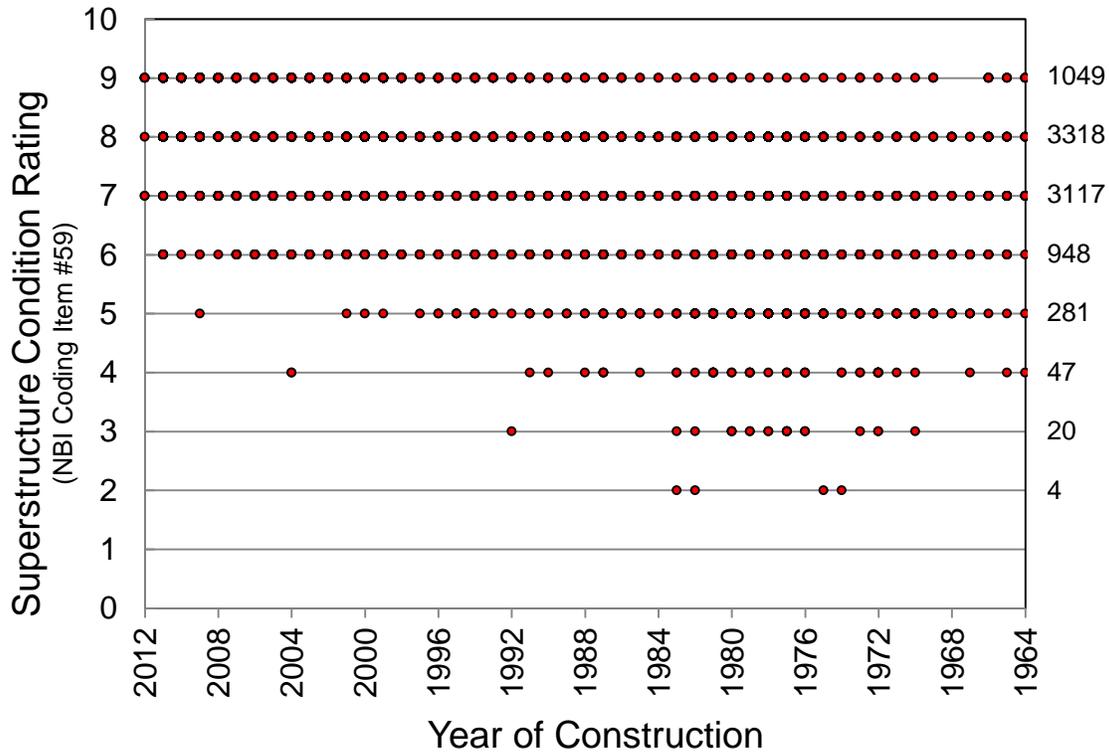
Figure 11. Graph. Superstructure condition ratings of uncoated weathering steel bridges by year built.

- A negative perception of uncoated weathering steel still persists with some agencies on performance, despite an overall good condition rating from querying those agencies NBI data. It was hypothesized that a few poorly performing bridges generally caused an overall negative perception.
- Overall, FHWA Technical Advisory T5140.22 is preventing bridges from being built in harsh environments, or with detailing that is not conducive to good performance. Of the 4,653 uncoated weathering steel bridges built since 1990, 94.5 percent of them have SCRs of 7 or higher (i.e. good, very good, and excellent condition).

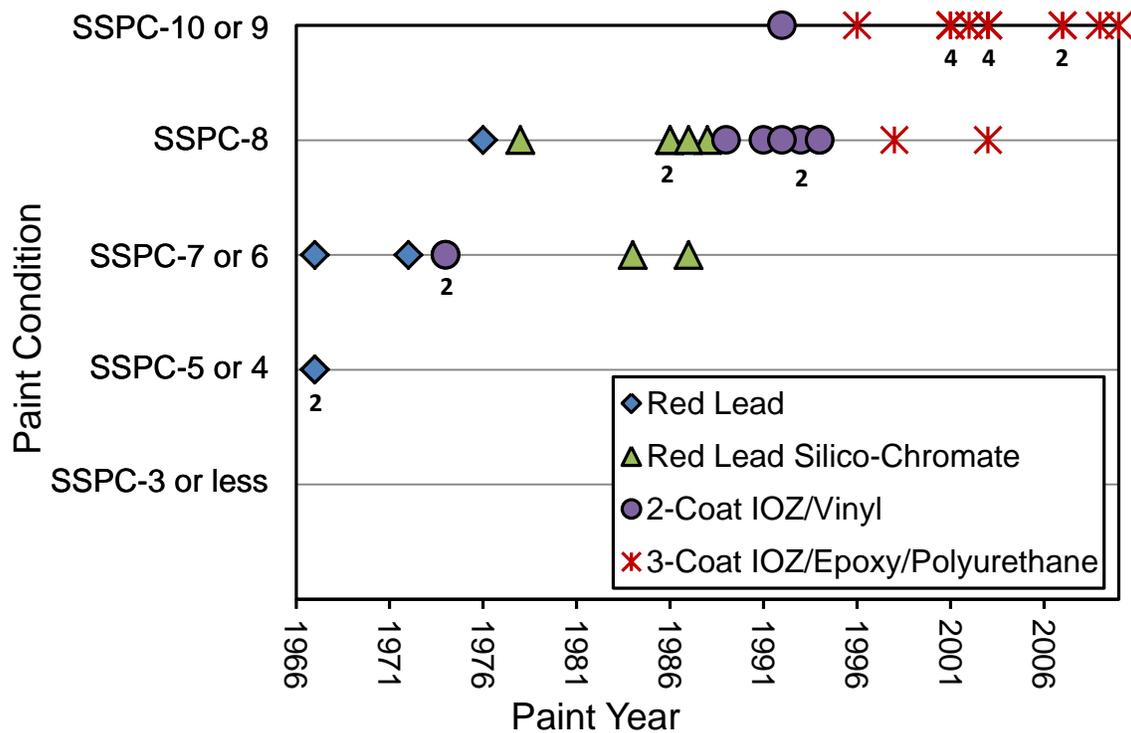
Figure 12. Graph. Condition ratings of original coating systems in Missouri (numbers by data points represent replicates).<sup>(reproduced from 61)</sup>

Missouri conducted an assessment of their current coating practice and surveyed the performance of paint systems from November 2009 to July 2010.<sup>(61)</sup> Figure 12 is reproduced from Missouri's collected data and shows the performance of coatings that had not received any maintenance throughout their life. Coatings were assessed at beam ends and midspan to the SSPC VIS 2 guidelines. Interestingly, there was a small population of bridges with 20 to 42 years of service with red lead coatings that still only had about one percent rusting. All of the bridges using the conventional zinc-rich 3-coat system were in very good condition, with one being in service for 14 years. One of the major conclusions from the study was that the bridges performing well (regardless of the coating system used), were those that had a deck in good condition, a jointless design, well operating drainage systems, or large deck overhangs.

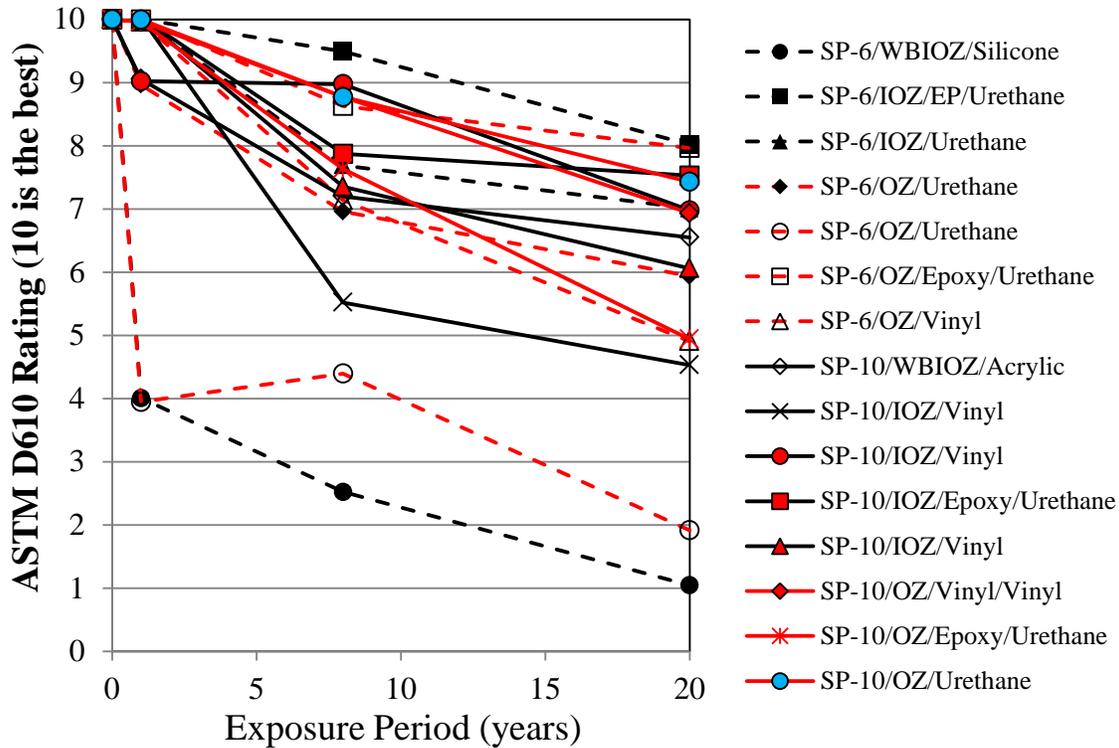
Figure 13. Graph. 20-year performance of zinc-rich systems on the Mathis Bridge. (reproduced from 53)

In the Mathis Bridge study described in 4.1.2, systems using both IOZ and OZ primer with both SSPC-SP 6 and SP 10 preparation were also evaluated after 20 years of marine exposure.<sup>(53)</sup> This study evaluated a number of different systems, even some that did not use zinc-rich primers (so-called “barrier” systems). The performance data validated the trend that for these conventional coatings, three coats of paint is generally more effective than two or one coat (however, more recent developments in the coatings industry have produced materials that provide high levels of durability with two or even one coat at a higher build). The data show that systems with zinc-rich primers prove to be the best performers, but not all zinc rich primer systems performed well. The coating performance ratings after 1, 8, and 20 years of exposure are represented in Figure 13 for just those systems that used zinc-rich primers. Looking strictly at the five 3-coat systems, after 20 years of exposure in this marine environment, the ratings ranged from five to eight on the ASTM D610 scale. However, of those 15 zinc-rich systems, the top seven performers (roughly the top half) survived to a rating of 7 or higher after 20 years in a very severe exposure, applied as a maintenance coating over previously deteriorated steel. Interestingly, this data set does not show a clear separation between systems applied over SSPC-SP 6 versus SSPC-SP 10 blasted surfaces. But in a practical sense, there is often only a slight difference between those two specifications in field work.

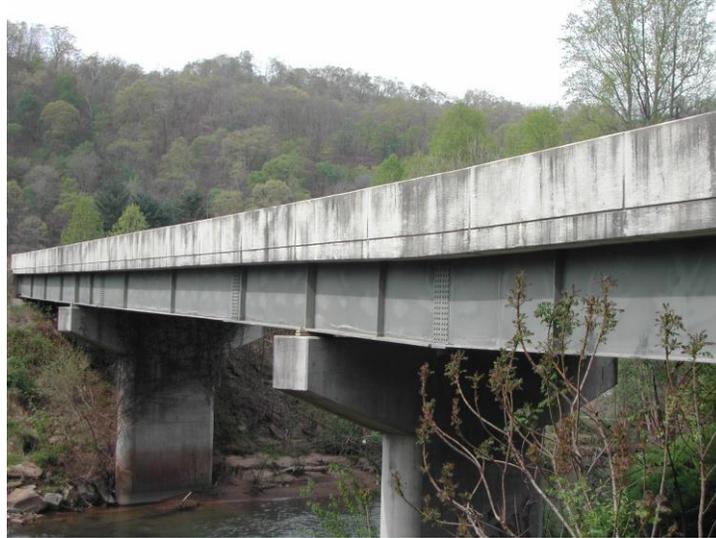
Figure 14. Photo. Bridge in West Virginia with a single-coat inorganic zinc-rich paint system after 25 years.

result reinforces the overriding premise that holds for all of these highly durable corrosion resistant coatings—the life of the coating is often determined by the very severe local conditions created by detailing of the structure as it intersects with concentrated salt-containing runoff, splash and drainage.

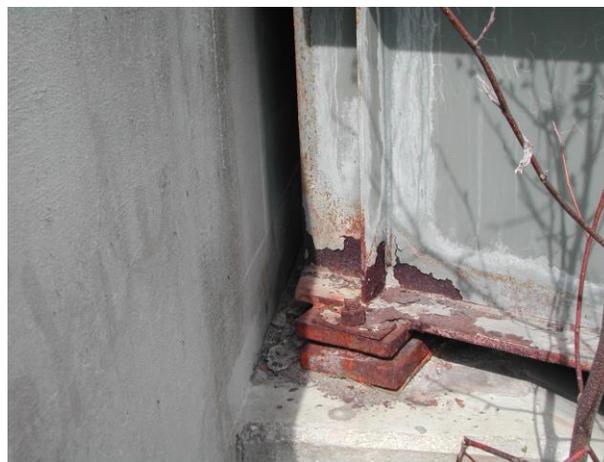
Figure 15. Photo. Deterioration of bearing area beneath a leaking joint with only single-coat inorganic zinc-rich paint.

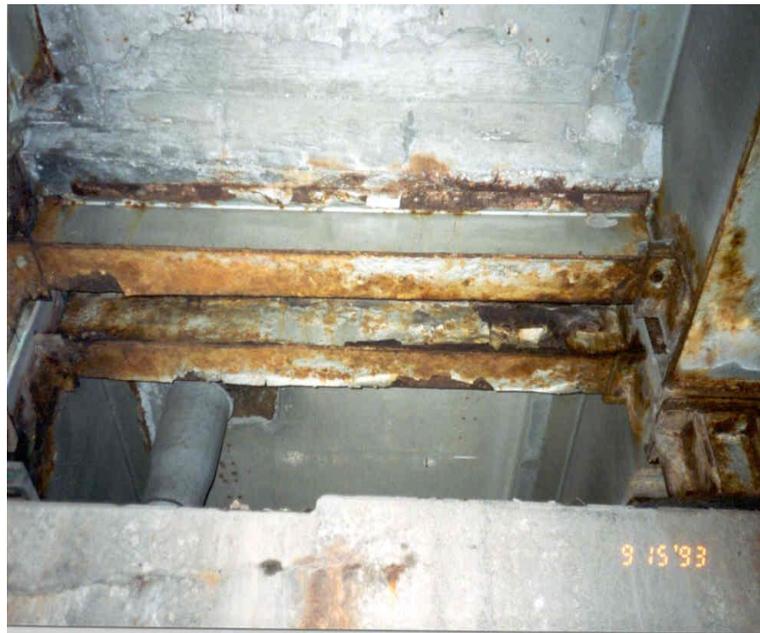
Figure 16. Photo. Steel directly beneath transverse expansion joints that have leaked corrosive runoff from the deck.

debris over time, limiting their effectiveness. Consider use of sealed modular joints in place of multiple single compression seal joints.<sup>(71)</sup> Figure 16 and Figure 17 depict corrosion due to water leakage and entrapment.

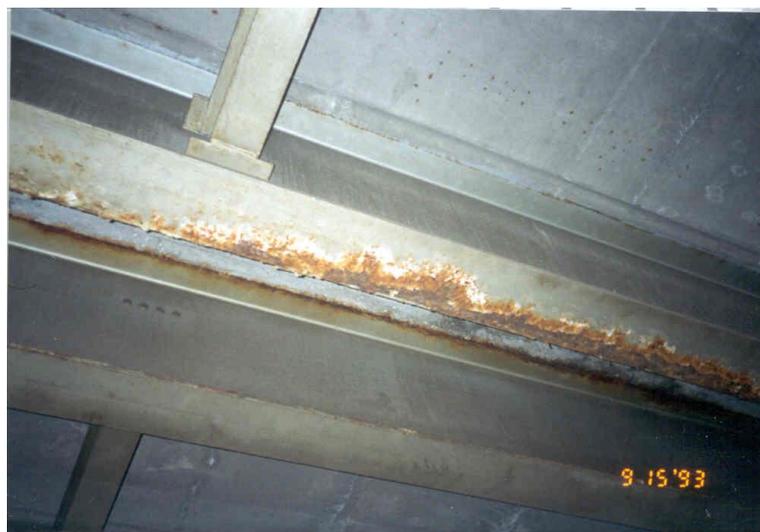
Figure 17. Photo. Steel directly beneath longitudinal expansion joints that have leaked corrosive runoff from the deck.

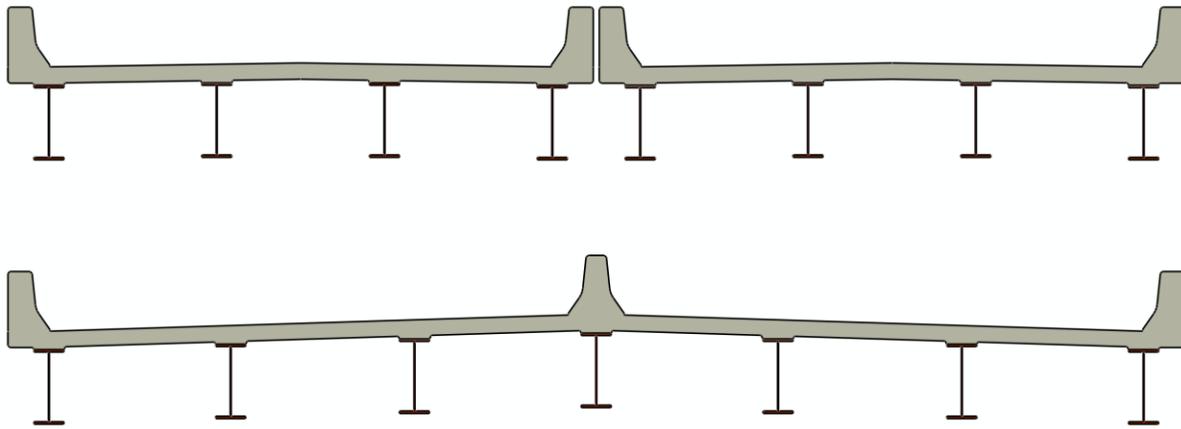
Figure 18. Illustration. (Top) Closely spaced parallel bridges. (Bottom) One bridge carrying both directions of travel.

It would be better, and more economical to eliminate the girder line and combine both structures, as shown in Figure 18 (bottom). Additionally, this eliminates closely spaced girders as highlighted in Figure 19. The closely spaced girders may promote a microclimate with high time of wetness, but also create a space that is difficult to access for performing maintenance activities such as painting, and the quality of the maintenance painting will be expectedly low with poor surface preparation, coverage, and film thickness due to the restricted access. The effect of closely spaced members is also highlighted in Figure 16 where a transverse joint leads to closely spaced end diaphragms, which for the same reasons would lead to poor coating quality in maintenance activities. This could have been avoided if the span was continuous.

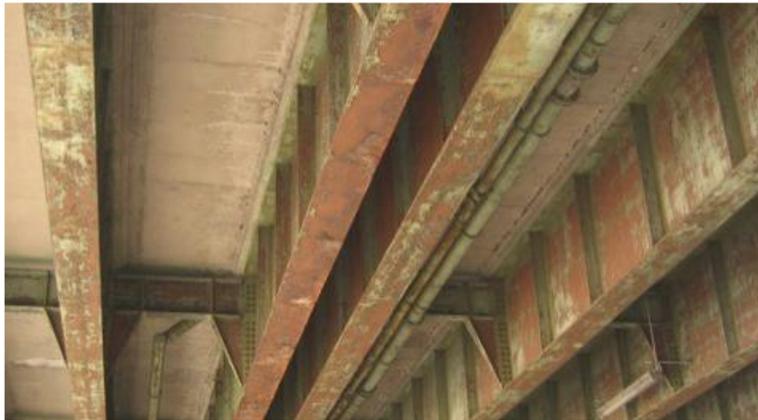
Figure 19. Photo. Closely spaced girders lead to difficult access for maintenance activities.

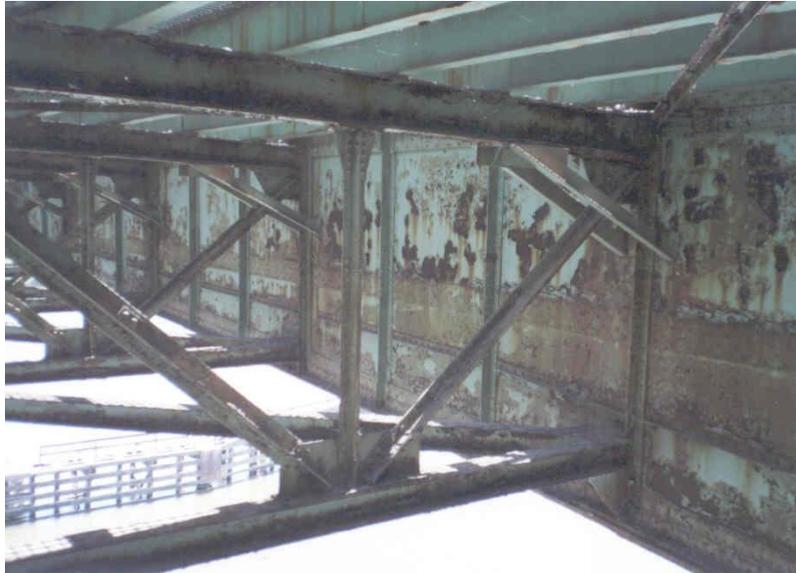
Figure 20. Photo. The area under an open grid deck acting as one large leaking joint.

is shown in Figure 20, in which it can be seen that the majority of the steel coating has failed and active corrosion is occurring.

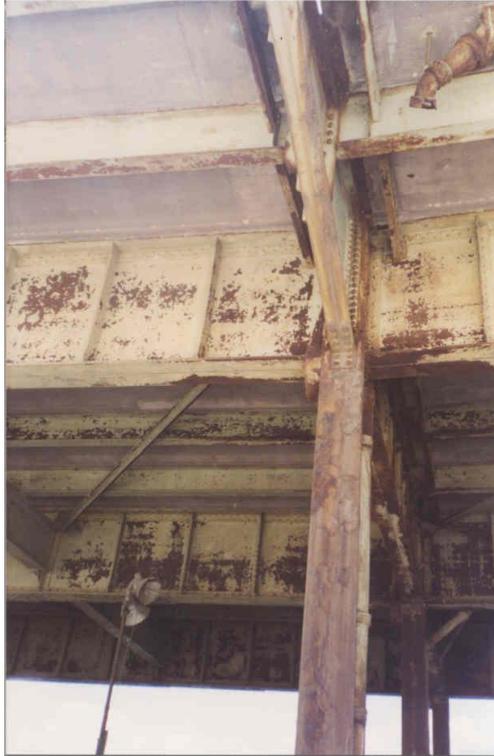
Figure 21. Photo. Missing portion of deck drain downspout.

Certain areas of the steel structure below the roadway surface will see the majority of drainage and runoff from the deck above. These areas will have a higher time of wetness than the rest of the steel structure. They will also receive an increased level of dirt and debris from the roadway. This is critical in areas that receive significant amounts of deicing salt. These areas will often have a much higher corrosion rate relative to the rest of the bridge. Designed, directed drainage is often inadequate and deck-mounted expansion joints often leak as well. An example of corrosion due to drainage can be seen in Figure 21 where a drain pipe can be seen coming from deck, but there is a missing section of pipe between the portion coming from the deck to the vertical drain pipe attached to the steel column, thus allowing water to directly splash the vertical steel column. Figure 22 illustrates a drain that has clogged and is leaking directly on the structural steel.

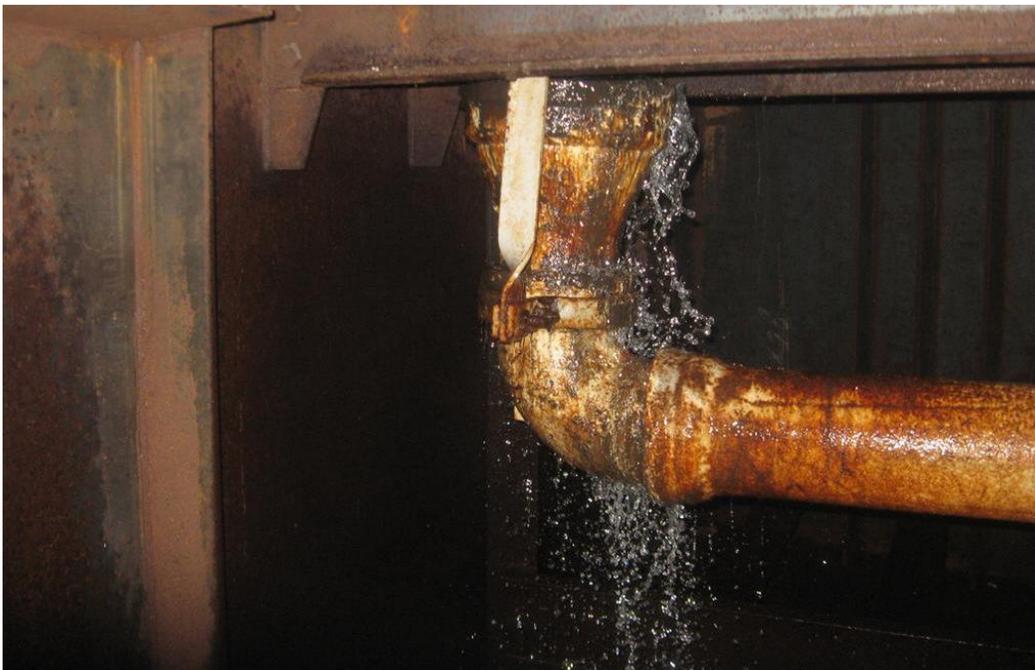
Figure 22. Photo. Clogged drain leaking water onto superstructure.

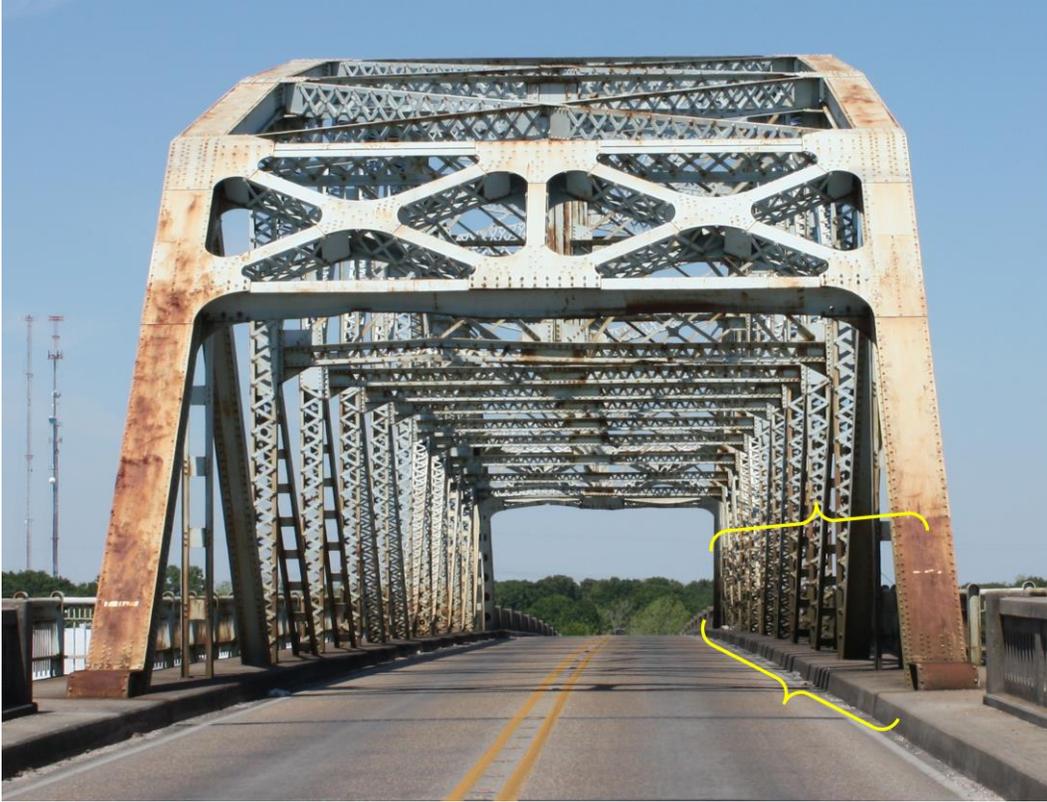
Figure 23. Photo. Through truss showing darkened area in close proximity to the travel lane (i.e. splash zone) that is corroding faster than other parts of the truss outside the splash zone.

Splash zones exist in the lower parts of bridges over any body of water and also in areas that receive significant splash and spray from traffic. These areas include the lower parts of towers and pilings; parapets, curbs, and guardrails; and lower portions of overhead truss structures and overpasses. For example, splash zones are prevalent on through trusses where traffic travels very closely to the truss members, and the zone ranges from the curb level to about ten feet over the roadway; this is shown in Figure 23. The area highlighted in the figure with yellow brackets denotes the zone that would be frequently wetted by spray from vehicle tires, and it can be seen that the coating is starting to break down in this zone. Another situation is illustrated in Figure 24 with two closely spaced parallel structures with an elevation difference. Traffic or snow removal equipment on the left span will inevitably inundate the left fascia girder of the right-hand span. In this case, it would be ideal if the two structures could be combined, eliminating the longitudinal joint between them. If there must be parallel structures, they should be spaced 30 feet or more away from each other to avoid splashing. Splash zones may be unavoidable, but consideration should be given to using a more durable protection scheme in these locations, and providing accessibility for maintenance of the protection system.

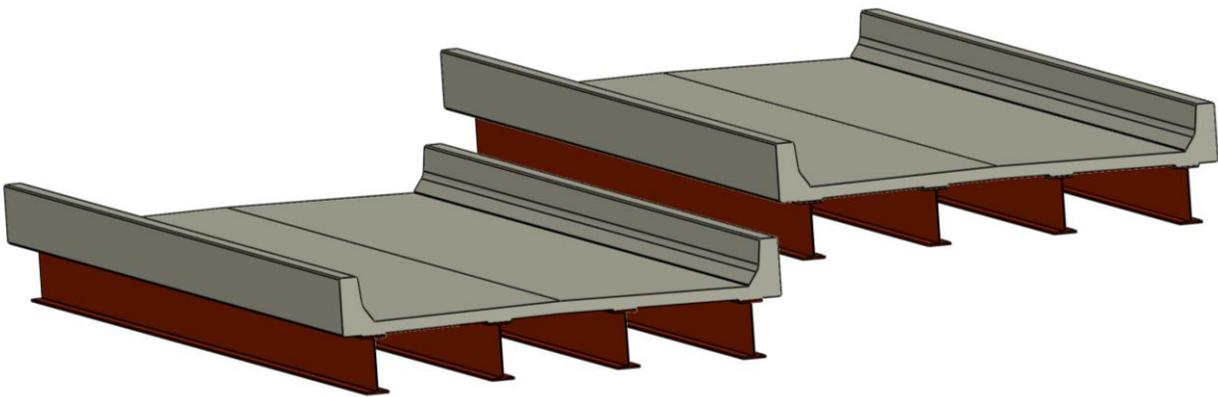
Figure 24. Illustration. Closely spaced parallel structures with a grade difference.

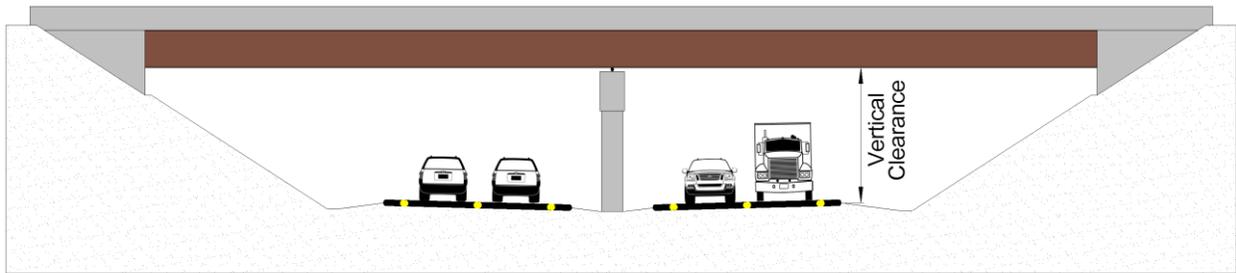
Figure 25. Illustration. Vertical clearance of a grade separated structure.

Vertical clearance is required to prevent the splash and spray of traffic from increasing local corrosion rates in the structure, particularly over travel lanes. This is frequently encountered at grade separation structures as highlighted in Figure 25 and it is sometimes referred to as the “tunnel effect”, where the grade separated structure forms the “ceiling” of the “tunnel.” A common observation is the inbound fascia girder will receive the majority of the spray, with a lighter concentration of spray deposited on the outbound side. This is shown in Figure 26, where in the direction of travel the fascia girder has a coating failure over the right travel lane (coincidentally the most frequently used lane, particularly for truck traffic) and the outbound fascia girder on the other side of the freeway is still pristine. There is no defined vertical clearance number that would eliminate any of these effects; however, the effect is accentuated by proximity of the abutment/pier to the travel lane, the average daily traffic, and local wind conditions. Historically, minimum vertical clearance on the Interstate system has been 16 feet, and this has proven to be susceptible to “tunnel effect” conditions.

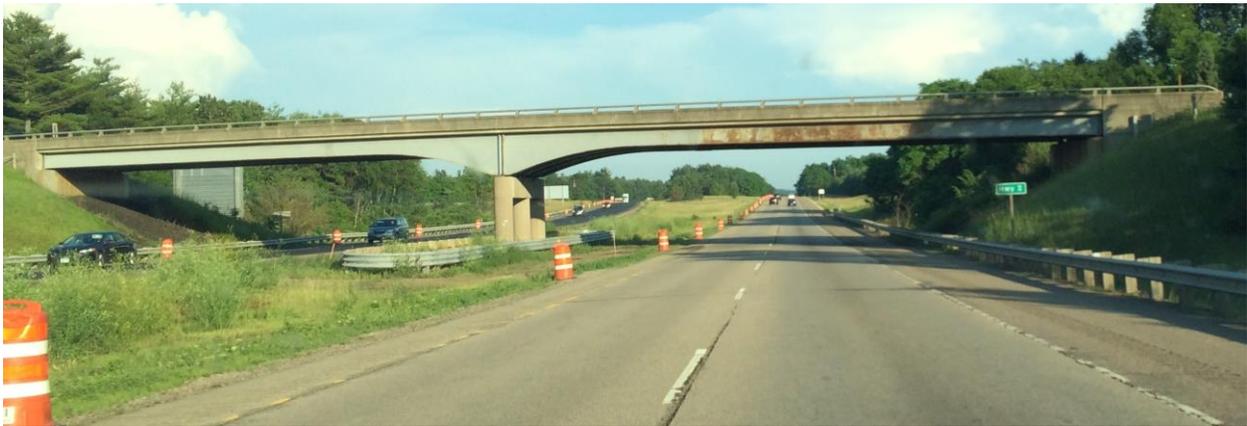
Figure 26. Photo. Accelerated corrosion on the inbound fascia girder of a grade separate structure, particularly over the right travel lane.

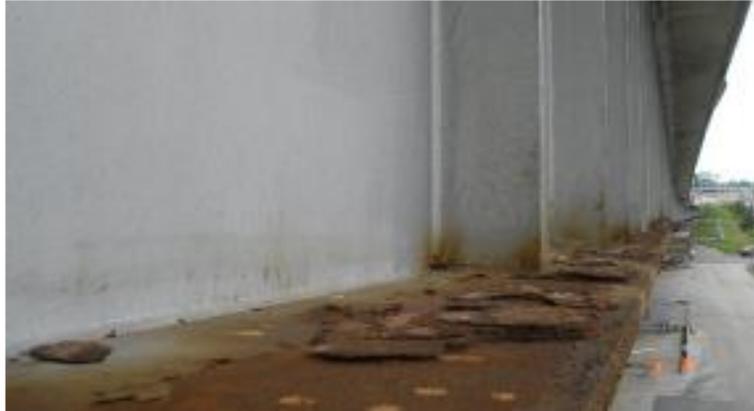
Figure 27. Photo. Corrosion localized to upper surface of lower flange, the rest of the bridge is fine.

Commonly it is observed that the upper surface of I-shaped bottom flanges will corrode before the rest of the I-shape, as seen in Figure 27 and Figure 28. The lower portions of flanged structures corrode early due to higher times of wetness for these parts relative to the rest of the bridge, because they are likely horizontal and can pond water. The higher time of wetness is also caused by preferential condensation on the lower portions of a steel element. While not a recommendation of this handbook, an ideal solution would be to curve the lower flange such that water could not pond on it. This is illustrated in Figure 29 where the right-hand girder in the zoomed in view has a transversely curved lower flange. Certainly, there are logistical issues with the concept; such as how to bend the flange, cutting transverse connection plates to fit, and making bearings to accept the curved surface. However, it illustrates that prevention of ponding water is the goal, but it is not always attainable (unless the entire bridge has a vertical grade). In the case of lower flanges, designing away the problem is not possible and only more durable protection schemes can be specified.

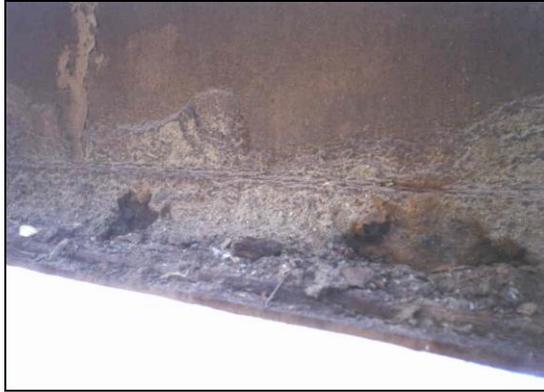
Figure 28. Photo. Heavy corrosion of bottom flange and web due to collection of poulitice.

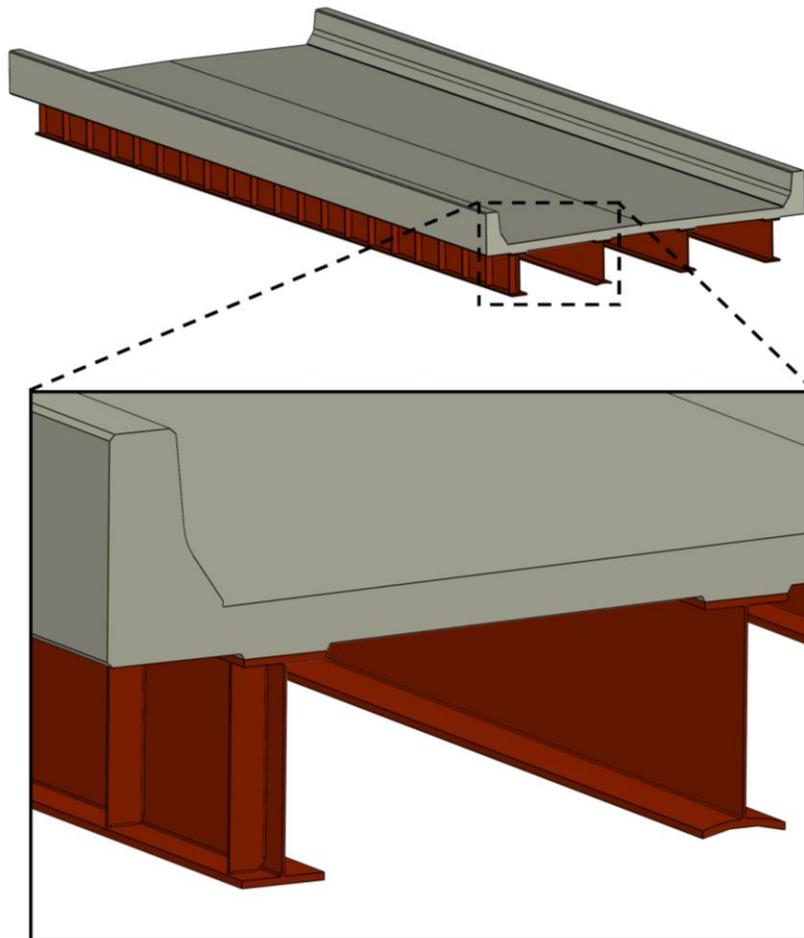
Figure 29. Illustration. Flat flange (left) and transversely curved flange (right).

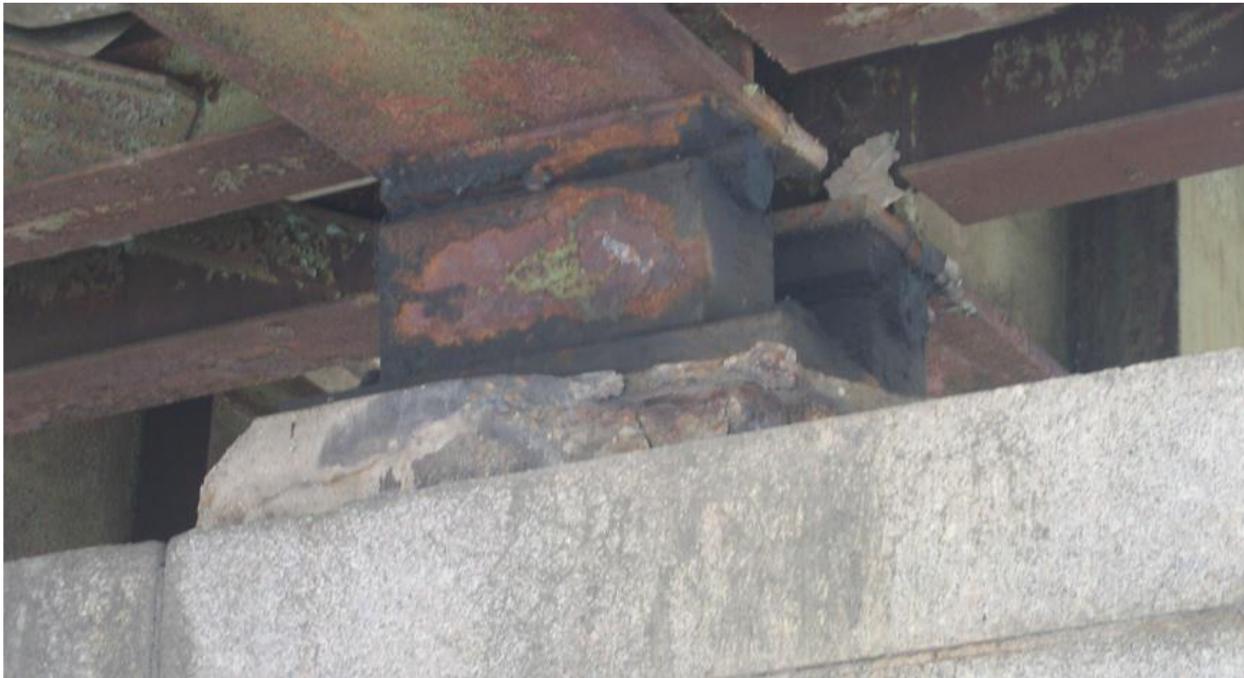
Figure 30. Photo. Corroded bearing.

These elements are difficult and inefficient to paint in the traditional manner. Bearings represent the lowest point on the superstructure, and as such are likely subject to the highest time of wetness, and typically are difficult to protect from corrosion. An example of a corroded bearing is shown in Figure 30. Consideration should be given to galvanize, metalize or fabricate these types of elements from inherently corrosion-resistant alloys.

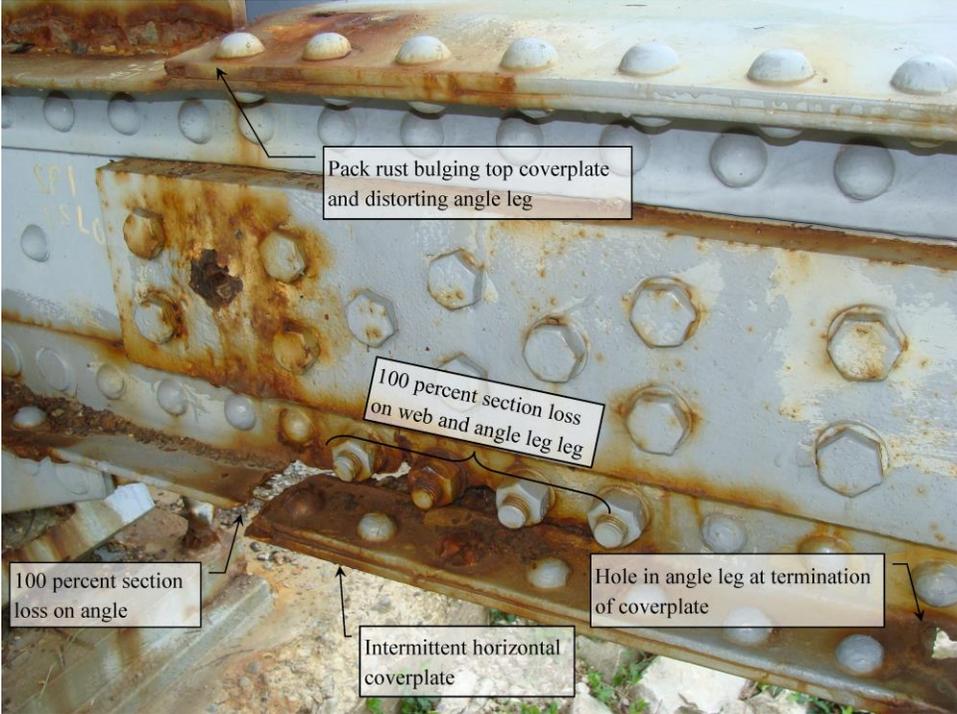
Figure 31. Photo. Annotated picture of riveted, built-up lower chord truss member.

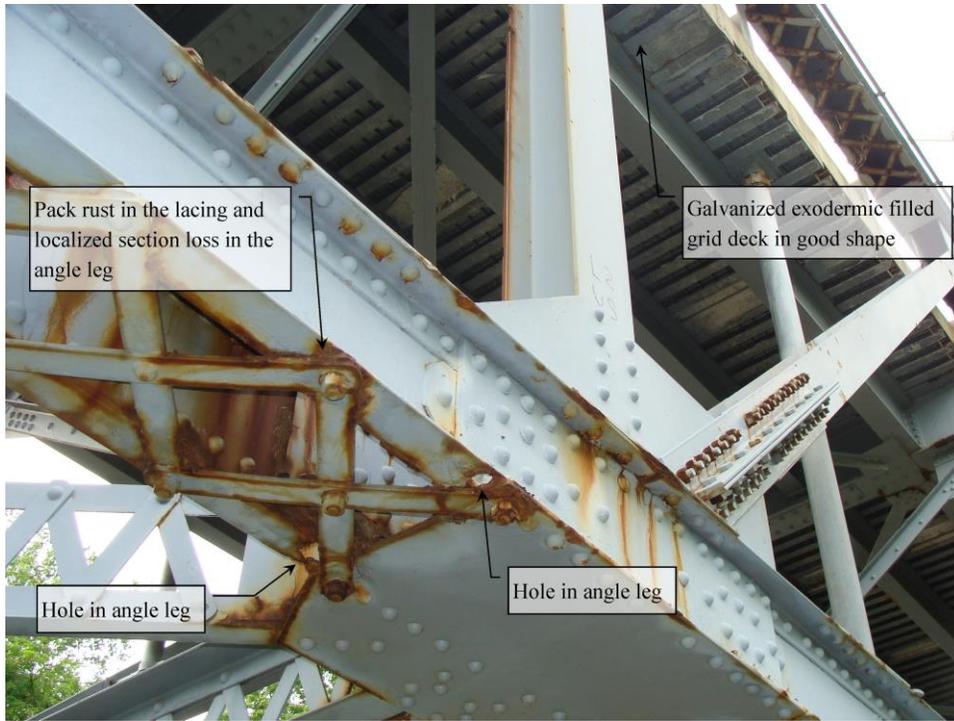
Figure 32. Photo. Annotated picture of riveted lower truss chord connection.

picture from the same truss, but of a lower chord connection. The lower chord elements are tied with lacing, which creates many intersecting surfaces that all show corrosion and pack rust.
