Steel Bridge Design Handbook

**CHAPTER 19**

# Corrosion Protection of Steel Bridges

February 2022

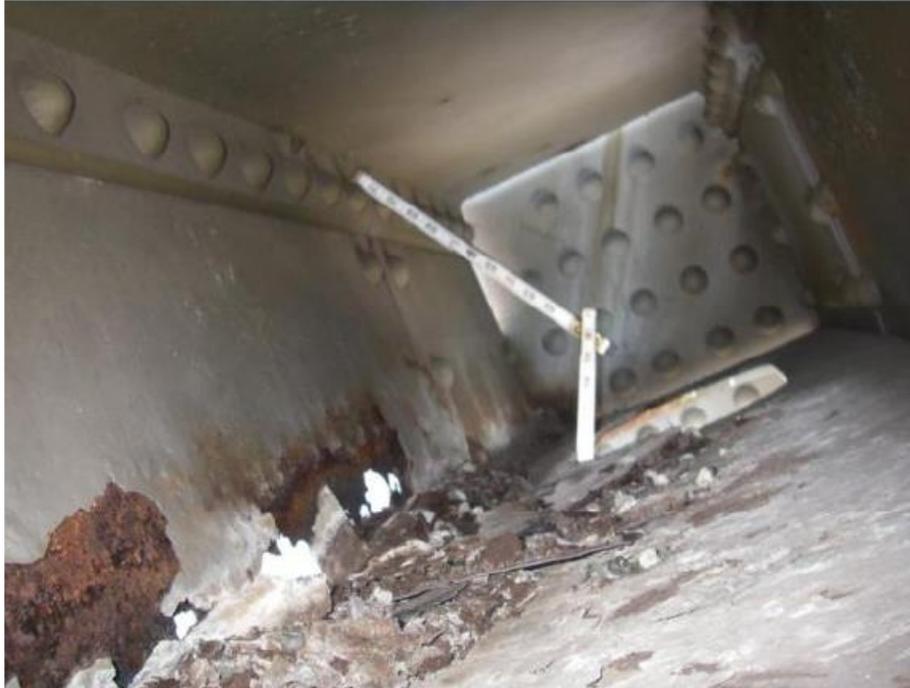
Figure 33. Photo. Inside of built-up box member.

Figure 33 shows the inside of a closed, built-up box member from a truss. The picture was taken through an access hole and not oriented with respect to gravity, but the member was horizontal. Because the member was horizontal, water ponded on the inside atop the bottom box cover plate, and caused through-thickness corrosion in the box web plate over an approximate four-foot length. Small box members also pose maintenance and corrosion remediation challenges due to limited access.

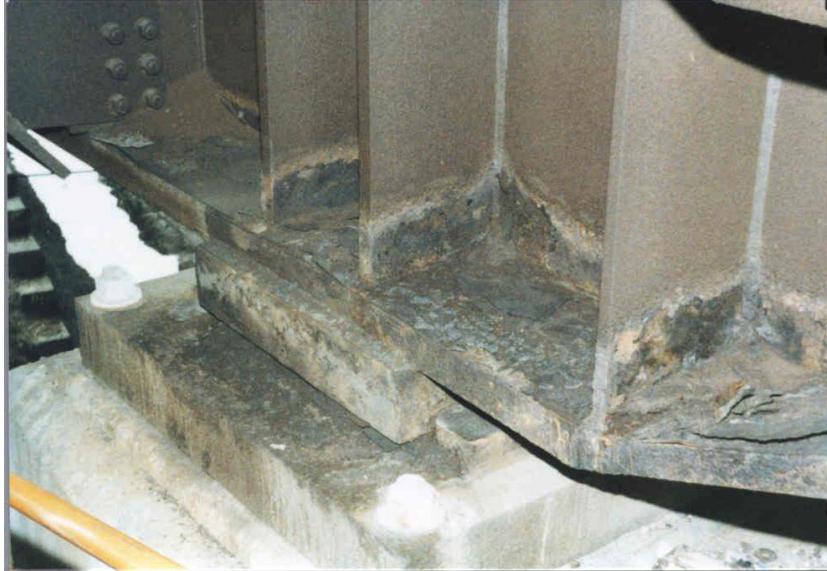
Figure 34. Photo. Girder end on a bearing below a leaking deck joint. Horizontal flange and vertical stiffeners create an excellent trap for debris and moisture.

Water traps are the hardest details to identify in design. Figure 34 illustrates a bearing stiffener detail that was below a leaking joint. Since the flange is horizontal, water can become trapped near each of the stiffeners because it cannot flow away from the area. This also has cascading consequences because as rust product develops in this area, the rust itself begins to hold moisture that further exacerbates the corrosion. Also note in the background of this picture is the connection plate detail bolted to a transverse element; there is an accumulation of dirt and rust between the girder flange and connection plate.

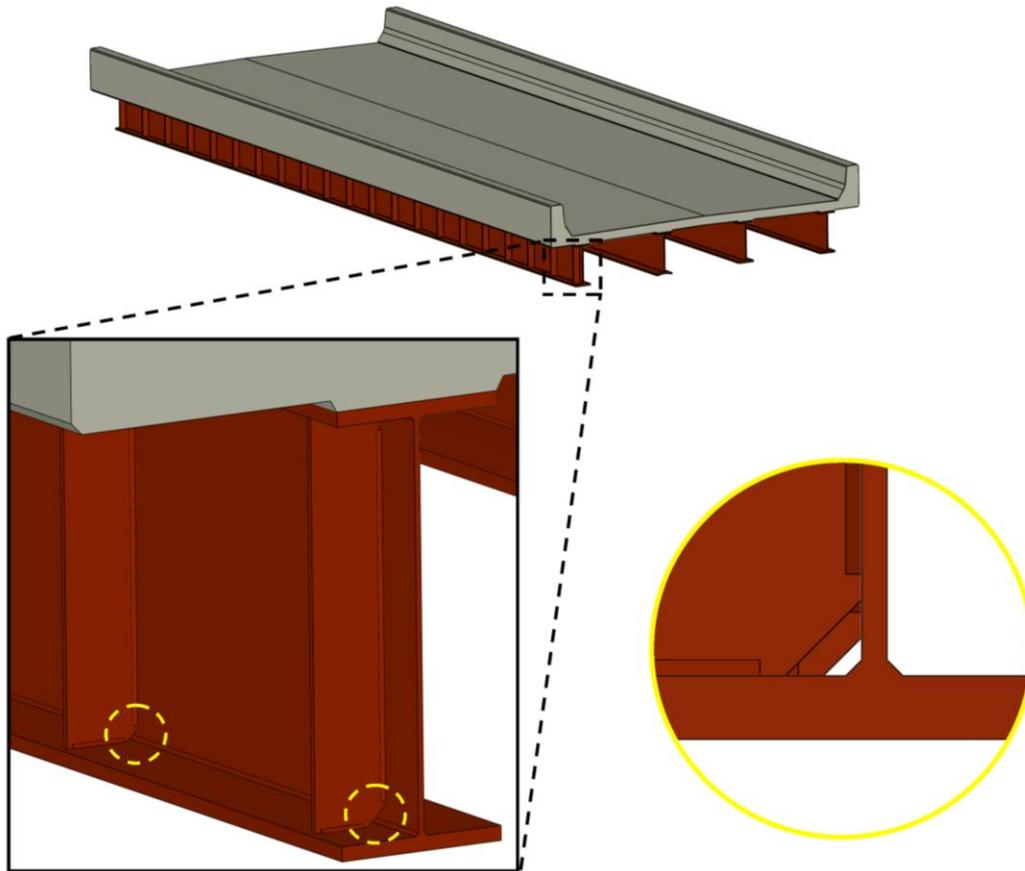
Figure 35. Illustration. Transverse plate snipe size, larger is better.

If the bridge has connection plates, or transverse stiffeners that are connected to the bottom flange, this represents a localized dam for water. Typical detailing practice would be to snipe the corner of the plate to provide clearance for the web-to-flange welds. If the snipe is too small, it could easily trap debris and create a dammed condition. Figure 35 highlights two connection plates with different sized snipes, and the larger would be preferred for reduced tendency to trap debris and become clogged. AASHTO has no guidance for minimum/maximum size of the snipe, but it should be as large as possible. Experience has found that one by one inch snipes are not adequate. If coatings will be applied, larger snipes also facilitate easier blast cleaning and ability to achieve adequate film thickness within the snipe. Proper snipes are an important consideration on bridges with a vertical grade so water can freely flow downhill, rather than being trapped behind every connection plate.

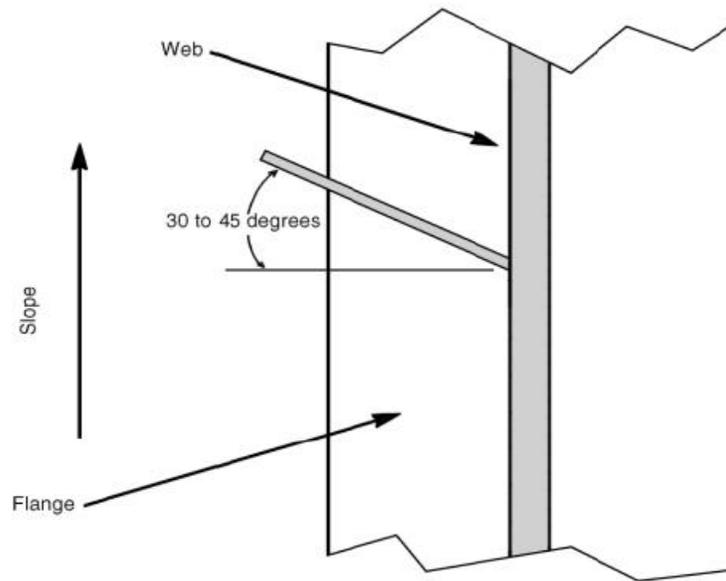
Figure 36. Schematic. Proper orientation of drip bar. Taken from Reference 14.

Drip bars can also be welded in place to divert water before getting to a trap. However, careful attention must be paid to orient them at the correct angle so they themselves do not become a water trap. Figure 36 illustrates how to determine the orientation of a drip bar.

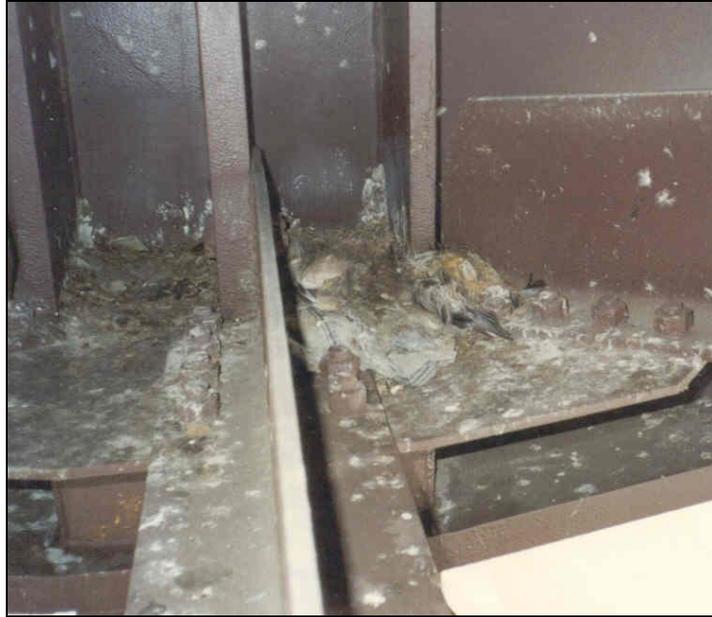
Figure 37. Photo. Debris accumulation at a lateral gusset plate detail.

Figure 37 shows a picture of a lateral gusset plate detail and the accumulation of dirt, bird guano, and even a dead bird. Since the lateral plate is horizontal, poulitice tends to collect on it and not freely drain away, causing localized high times of wetness, leading to corrosion. Figure 38 shows a lateral gusset plate detail that has mostly corroded away because it was perfectly horizontal and ponded water. It is not practical to slope these plates, but drainage holes can be provided to help mitigate any ponding. Where members such as horizontal gusset plates must be used, consider using a high level of corrosion protection (duplex galvanizing/painting or metalizing) for these specific elements.

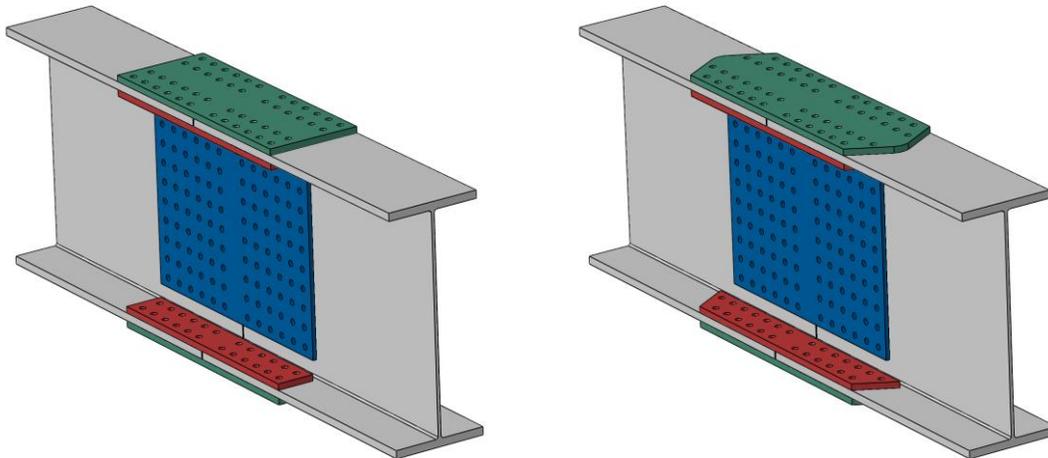
Figure 39. Illustration. Difference between squared off flange splice plates (left), and tapered flange splice plates (right). Bolts not shown for clarity.

Another less commonly identified water trap is flange splice plates within a bolted field splice. If the girder is on a vertical grade, water flowing down the flange will get trapped by the flange splice plates. A solution is to combine the functionality of the drip bar into the flange splice plate itself so it can shed water away from the web. This is illustrated in Figure 39 where the left-handed splice has square-ended splice plates, and the right-handed splice has a downhill taper.

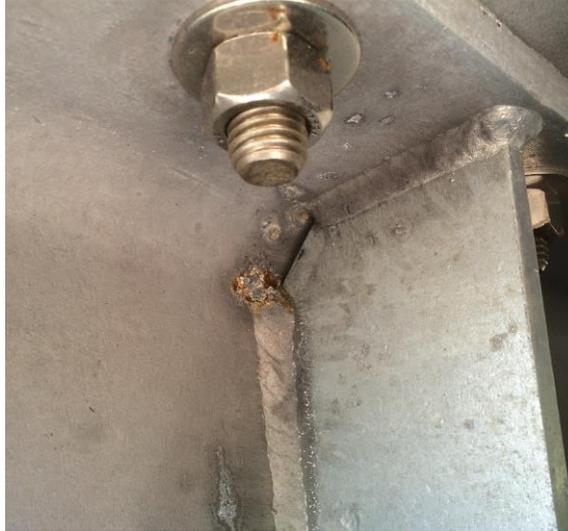
Figure 40. Photo. Connection plate welded to rolled I-beam along with corrosion emanating from unsealed weld.

in opposing directions around a common plane is prohibited, in particular Clause 2.8.8 in D1.5 and Clause 2.9.3.5 in D1.1.<sup>(40, 73)</sup> First, this type of weld is difficult to implement because the welding position has to change and second, there is a high likelihood of undercut when wrapping welds in different directions. Steel bridges always have connection plate details that are unsealed when being welded to the flange because of potential undercut, though wrapping this particular weld has been shown not to be detrimental to fatigue.<sup>(74)</sup> Designers should work with owners to reach consensus about how to handle seal welds as there are consequences to both the long-term corrosion performance and possibly the structural function.

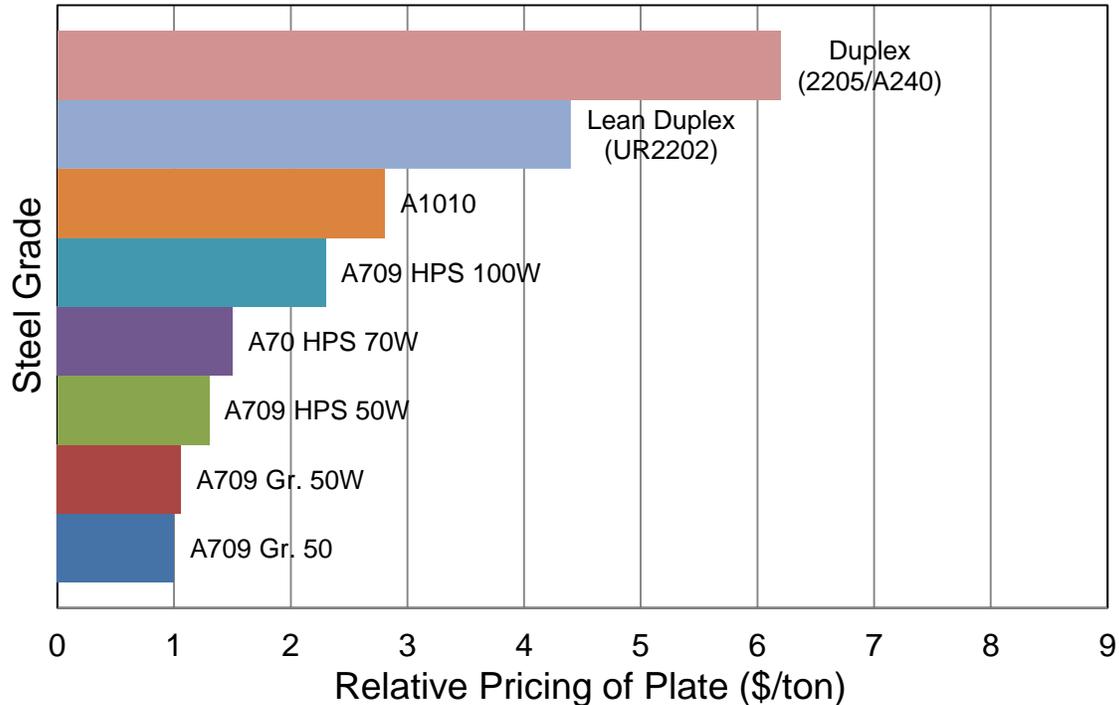
Figure 41. Graph. Relative pricing of various steel alloys (March 2013).

Shown in Figure 41 is the relative cost between various steel alloys using ASTM A709 Grade 50 as the basis, normalized considering a plate size of one inch thick by 96 inch wide and 480 inch long (because plate size has a major influence on price). The numbers were provided by a steel producer in March 2013 and, considering that steel prices are highly variable (caused by unusual steel market conditions, plate dimensions, energy costs, alloy surcharges, scrap costs, etc.), these numbers are a snapshot in time and will certainly vary (up or down) month to month, and year to year.<sup>(89)</sup> Designers and fabricators should not use these cost ratios in a life-cycle cost analysis and should contact suppliers directly. Additionally, these are just the steel material cost borne by a fabricator, and do not consider the cost associated with the actual fabrication of the bridge. As seen in the figure, the more corrosion-resistant alloys are three to six times more expensive than ordinary steel. However, if they can truly offer a maintenance-free structure, then a life-cycle cost analysis may show these options represent the best value.

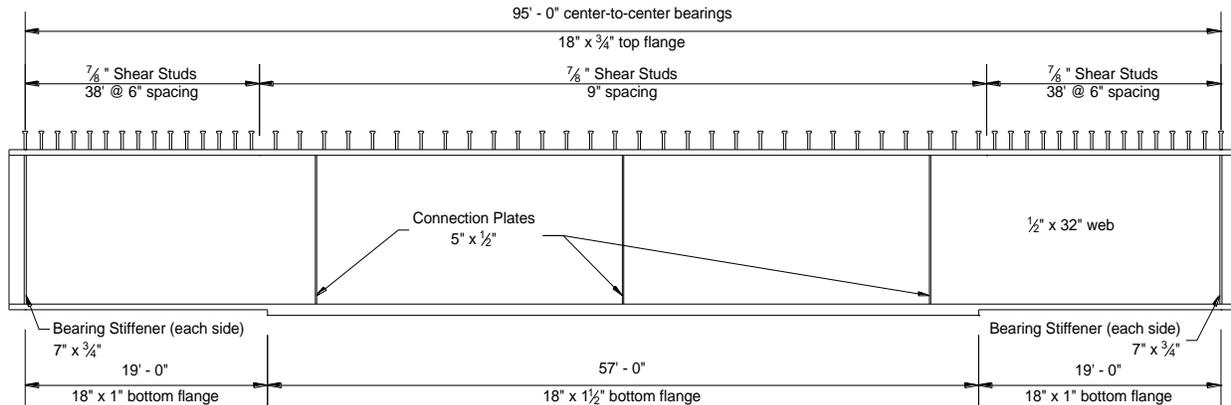
Figure 42. Schematic. Elevation view of girder detailing.

As part of this publication in 2016, the National Steel Bridge Alliance queried four of their member fabricators to provide differential steel bridge fabrication cost estimates for an example girder. The sample of four fabricators was diverse representing large and small production abilities, and located on each coast and in the north and south. The detailing of the girder is shown in Figure 42. Each fabricator was asked to provide a cost estimate to fully fabricate the girder considering five corrosion mitigation strategies; uncoated weathering steel, non-weathering grade steel with 3-coat paint system, galvanized non-weathering grade steel, metalized non-weathering grade steel, and ASTM A709 Gr. 50CR (ASTM A1010) steel.
