# Modern STEEL CONSTRUCTION

# Steel Bridges 2014

## Welcome to Steel Bridges 2014!

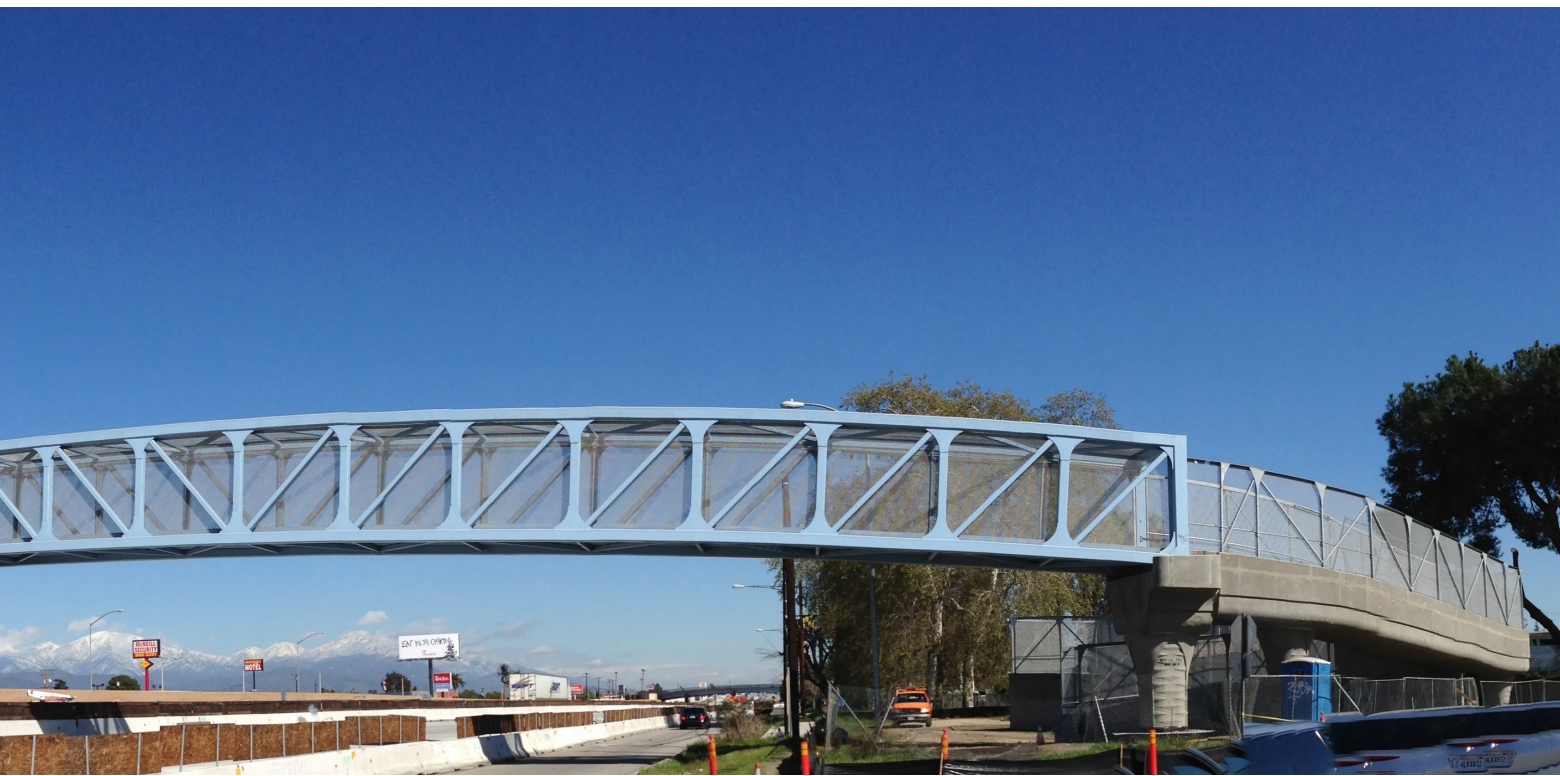
- ▲ The bridge's total length is 654 ft, including approaches.
- A special 247.5-ft-long through-truss is used as the main bridge element.

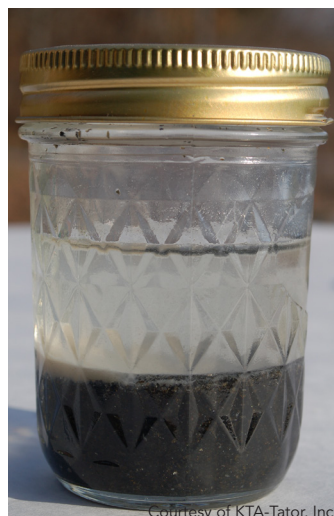
▼ Fig. 2

**Abrasive cleanliness.** There are two primary concerns related to contamination of the abrasive media: oil and elevated conductivity caused by soluble salt contamination. The transfer of either of these contaminants onto the steel during cleaning can adversely impact the performance of the coating system; testing is particularly important when the abrasive is recycled. The procedure described in ASTM D7393, *Standard Practice for Indicating Oil in Abrasives* can be specified to verify that the abrasive is not contaminated with oil (Figure 2).

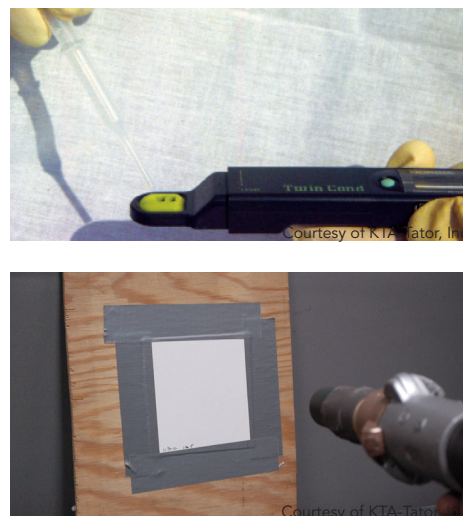
▼ Fig. 3 (above) and Fig. 4 (below)

The procedure described in ASTM D4940, *Standard Test Method for Conductimetric Analysis of Water Soluble Ionic Contamination of Blasting Abrasives* can be specified to verify that the abrasive does not contain elevated levels of ionic contamination (Figure 3).

**Compressed air cleanliness:** Anytime compressed air is used to propel the abrasive during blast cleaning, perform a blow-down to remove surface dust or atomize a coating (e.g., conventional/pressure pot spray), its cleanliness must be verified—i.e., do not assume that the moisture and oil extractors are providing adequate air cleanliness. The procedure described in ASTM D4285, *Standard Test Method for Indicating Oil or Water in Compressed Air* can be specified to verify that the compressed air does not contain water and oil contamination (Figure 4).

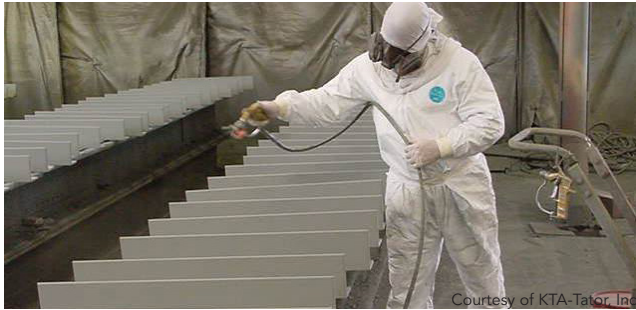
◀ Fig. 10

**Coating mixing, thinning and application inspection.** In this case, a review of the manufacturer’s product data sheets, combined with observation, is the best “tool” available to verify that the coating materials are being mixed, thinned and applied properly

(Figure 10). In fact, coating specifications often invoke the PDS for mixing and thinning instructions. PDS' also contain recommendations for compatible application equipment, spray pressures, tip sizes, etc. Note that the thinner type and amount is considered an essential variable by the *Specification for Structural Joints using High Strength Bolts*, Appendix A—"Testing Method to Determine the Slip Coefficient for Coatings Used in Bolted Joints," published by AISC and the Research Council on Structural Connections (RCSC). Consideration should be given to this when connections are slip-critical. The minimum cure time, coating thickness and thinner type/amount are all listed on the test certificate prepared by the testing laboratory. The certificate can typically be provided to the shop by the coating manufacturer.

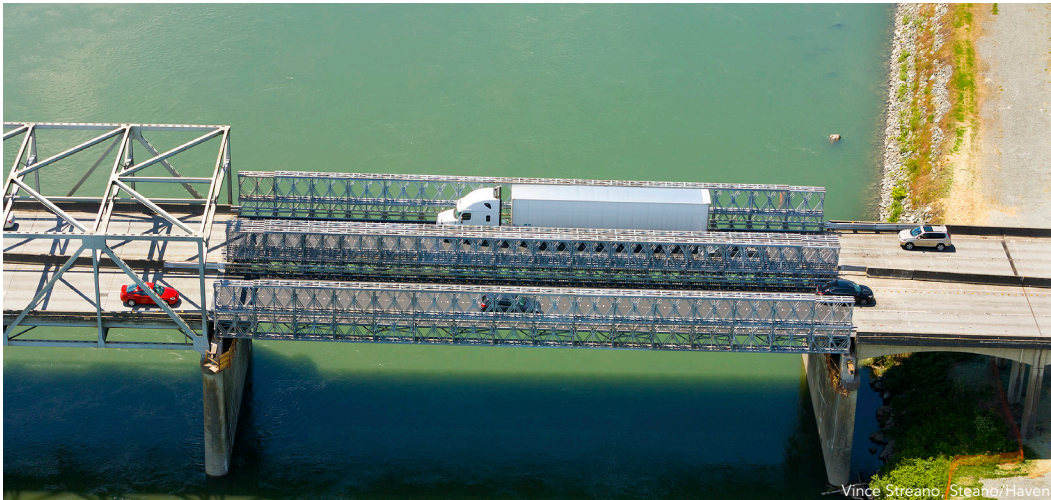
◀ Temporary spans were erected, and the bridge reopened only 23 days after the collapse.

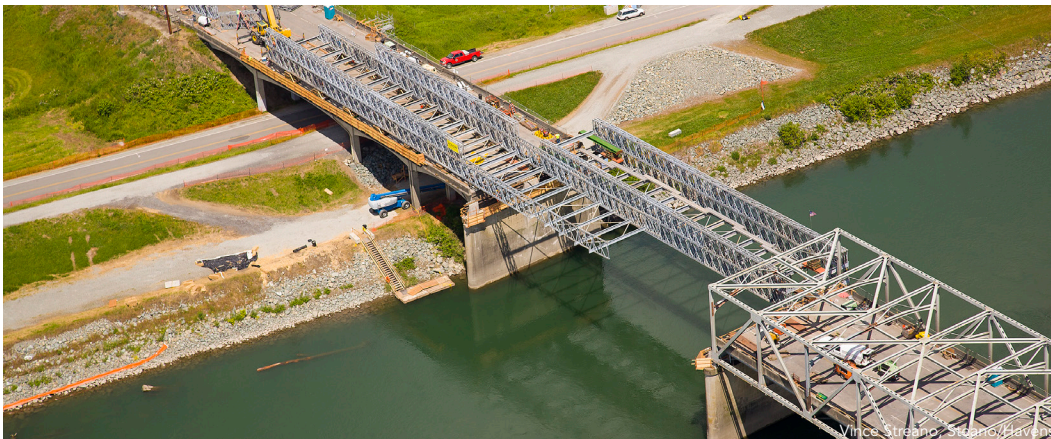
◀ Erection of the temporary spans.

WSDOT awarded Atkinson Construction the emergency construction contract two days after the incident, and Acrow Bridge, a fabricator of modular bridges, became part of the team charged with engineering a rapid solution for bridge replacement. Acrow supplied two modular, prefabricated steel panel bridges. Each bridge weighed 180 tons, with clear spans of 160 ft and road widths of 24 ft, to replace the damaged section of the bridge. Modular steel orthotropic deck sections, which were overlaid with asphalt, were used for the roadway, and heavy-duty crash barriers were installed on each side for driver safety.

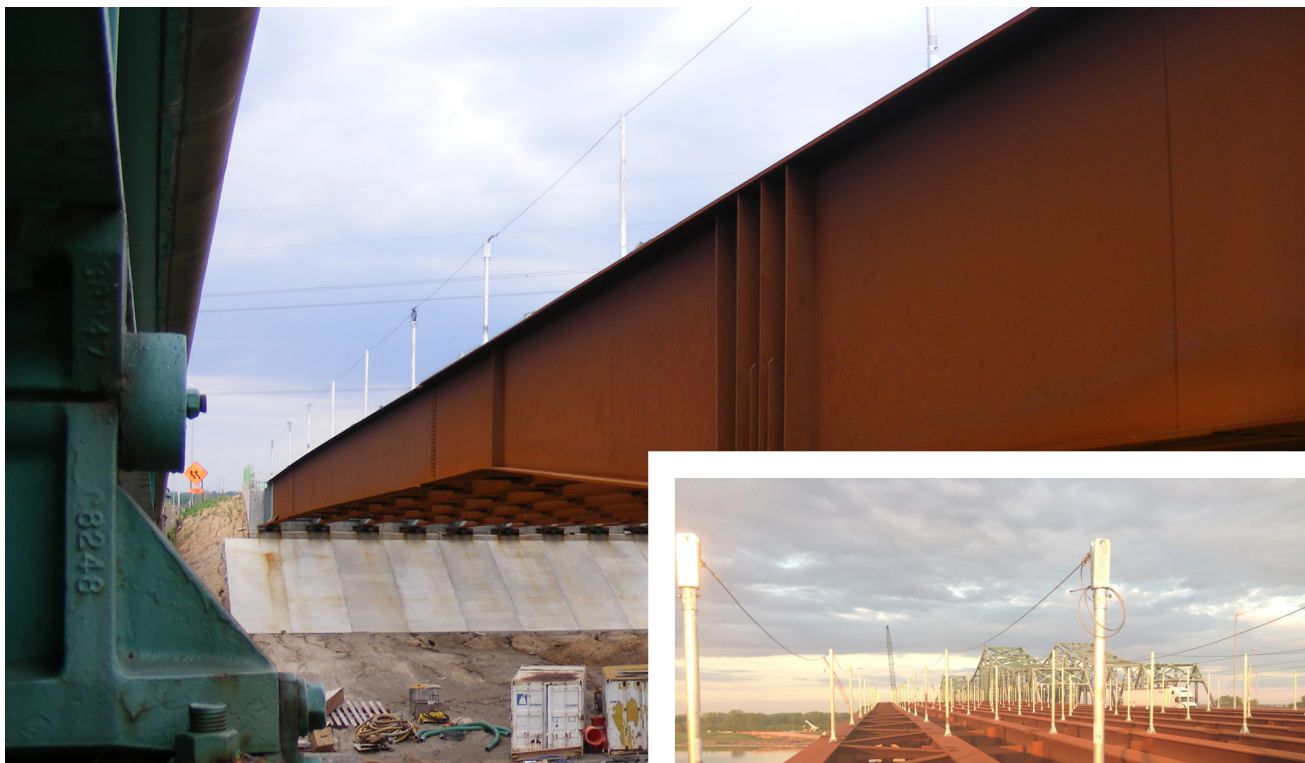
- ▲ Girder web depth transition at Pier 1 of the I-270 bridge.
- Top flange lateral bracing for the bridge.

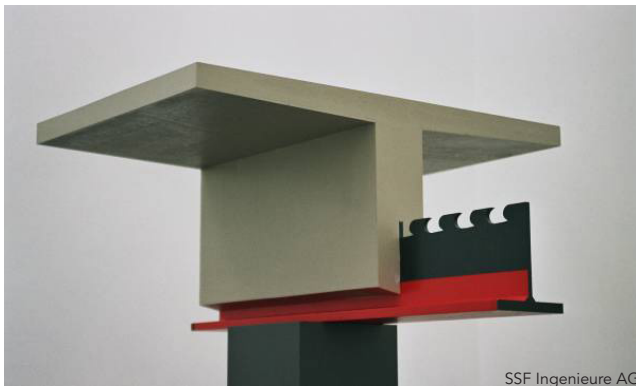
▲ A conceptual Precobeam section.

The Precobeam concept combines the advantages of prefabricated prestressed concrete beams (the upper T of the section) with the steel girders (the lower T of the section). There are currently two assembly types: Duo-Precobeam and Mono-Precobeam. With Duo-Precobeam, two halved sections are positioned beside each other and filled with

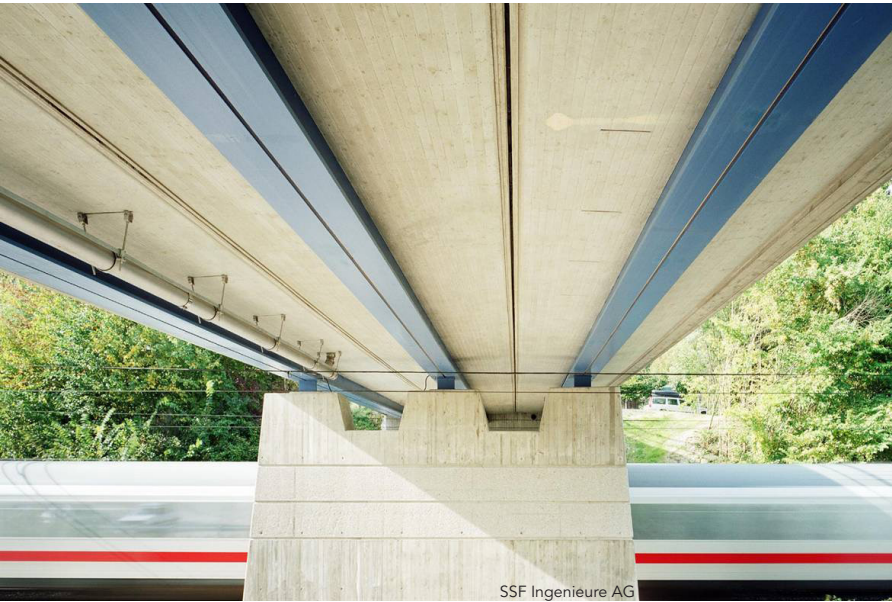
▲ View beneath the Pöcking Bridge (Germany) with Precobeam elements.

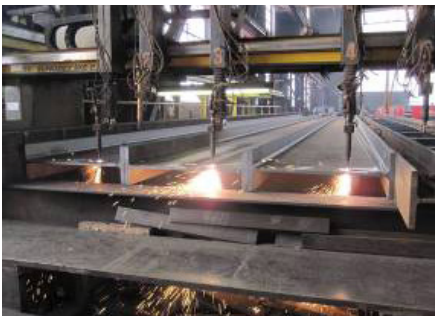
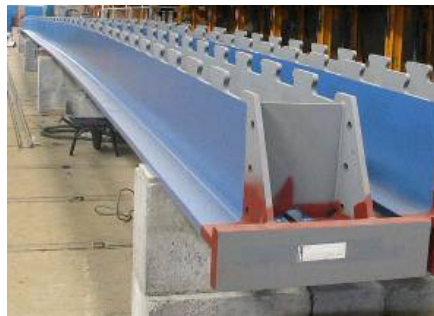
◀ Steel fabrication of the Pöcking Bridge.

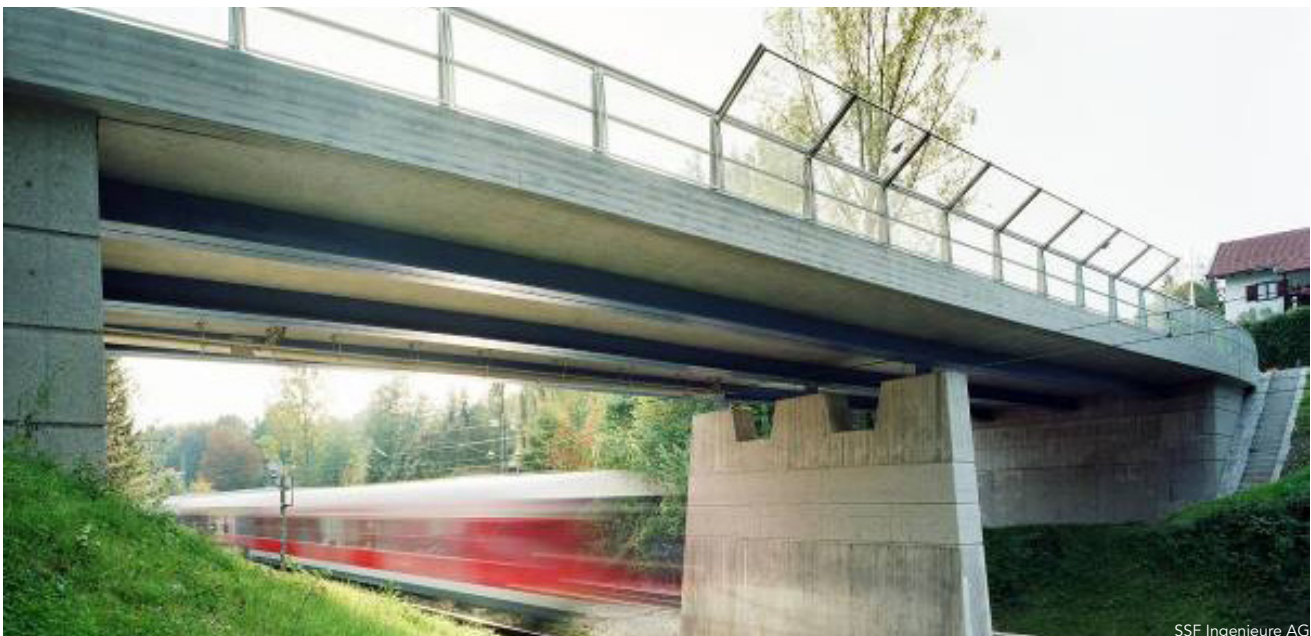
▼ Finished Pöcking Bridge.

Using Precobeam technology reduced the construction phase significantly, and the three elements were erected in one night. Next, 25 cm (10 in.) of concrete C35/45 was cast in-situ to solidify the three elements, and neither scaffolding nor formwork were needed.

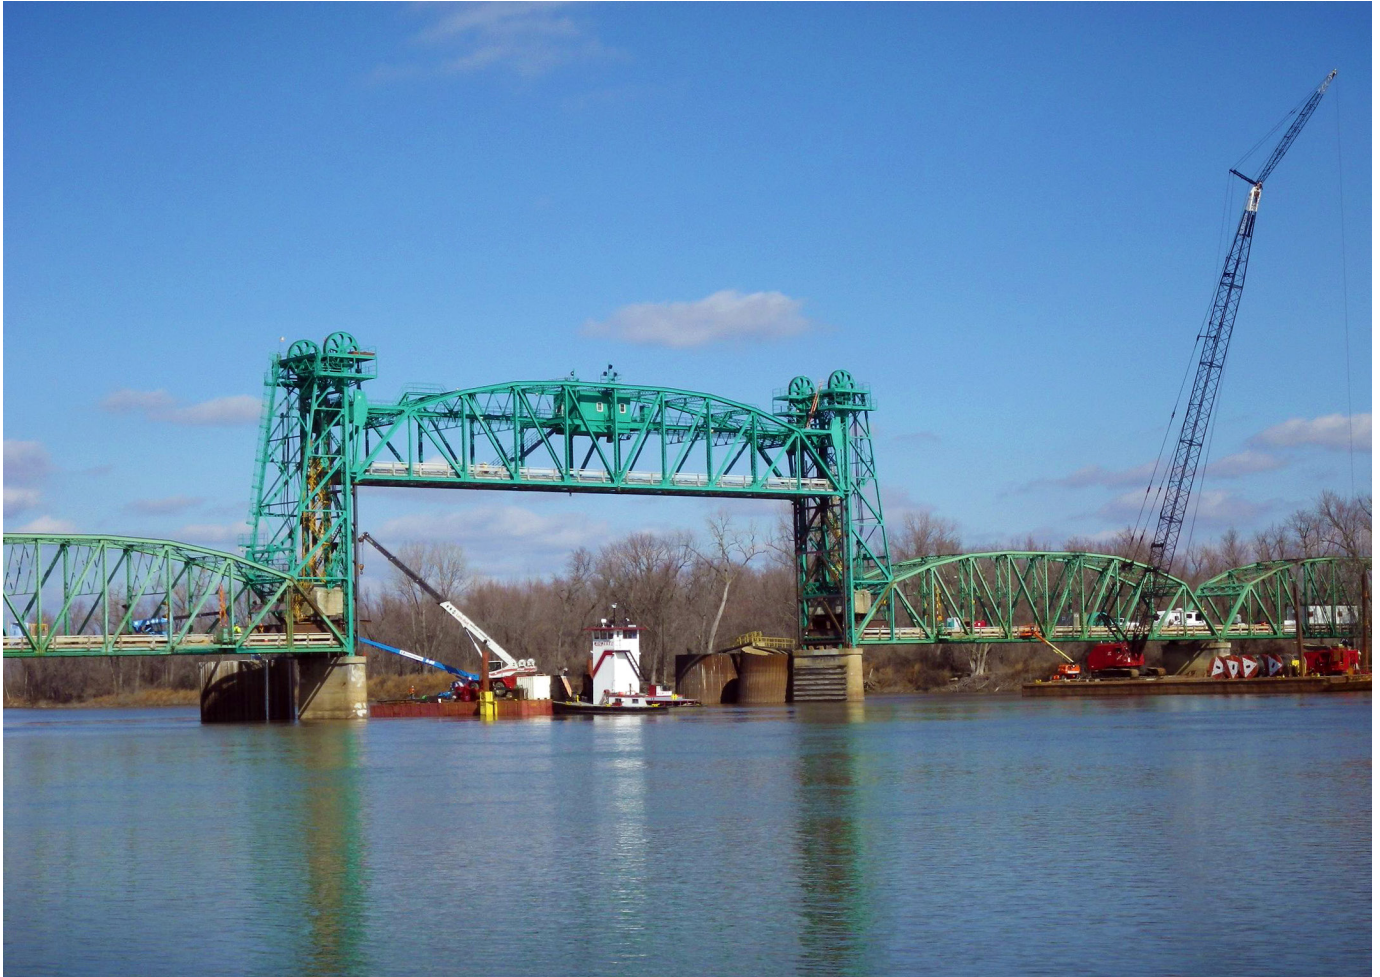
▲ The lift span was supported in the open position, thus allowing barge traffic to continue during the rehabilitation work.

Although the bridge was to remain closed to vehicular traffic, the M&M team recommended that the lift span be supported in an open position, thus allowing barge traffic to continue; ordinarily this type of work would be performed with the lift span sitting in the lowered position. A structural system was designed to support the span in the raised position and involved placing the span on structural "stilts." These stilts were supported at the live load strike plates and extended 55 ft high to support the live load bearings on the lift span. Intermittent anchors attached the stilts to the existing towers for stability. During the active repairs, the stilts carried the full dead load of the lift span.

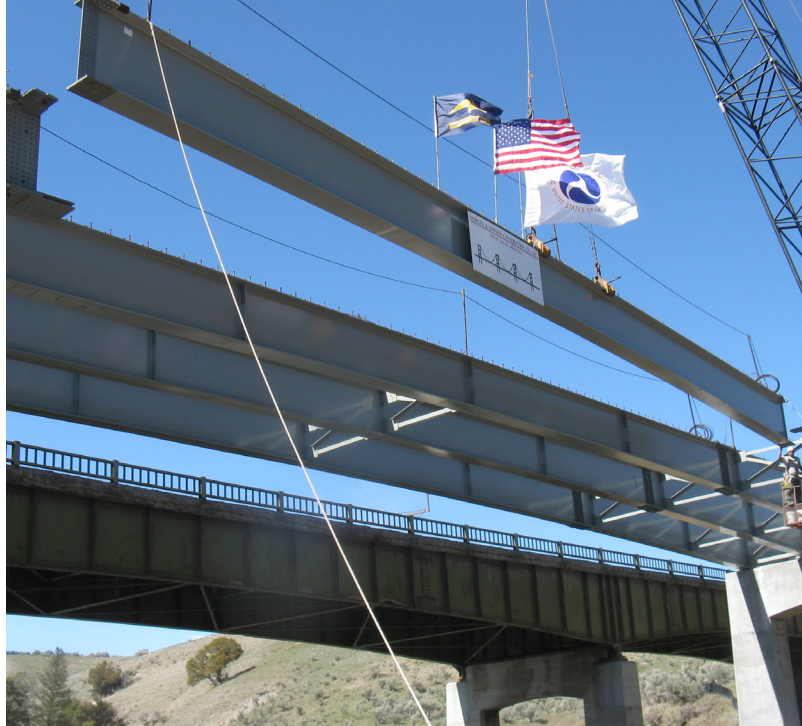
Setting the middle section of the last girder.

Lamar River Bridge. From there, they asked the Central Federal Lands Bridge Office design team in Lakewood, Colo., to finalize the TSL plans, design and detailing of the project. The plans called for a two-lane, 420-ft-long, 33-ft, 4-in.-wide, three-span (127.5 ft-165 ft-127.5 ft) steel plate girder bridge. It also required four spliced haunched girders supported by two concrete abutments founded on drilled shafts and two concrete piers located within the Lamar River and founded on drilled shafts.

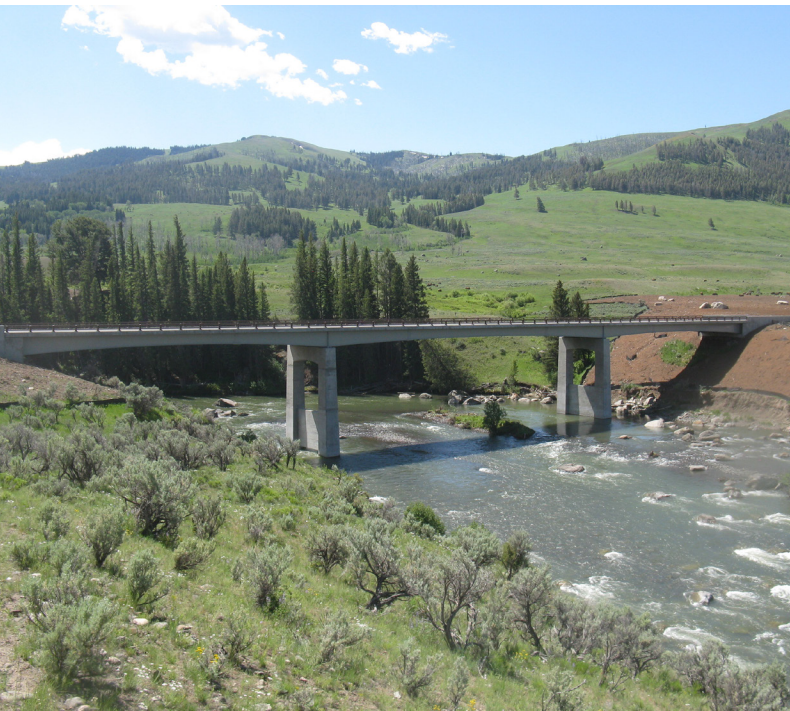
The new Lamar River Bridge is a two-lane, 420-ft-long, 33-ft, 4-in.-wide, three-span (127.5 ft-165 ft-127.5 ft) steel plate girder bridge.

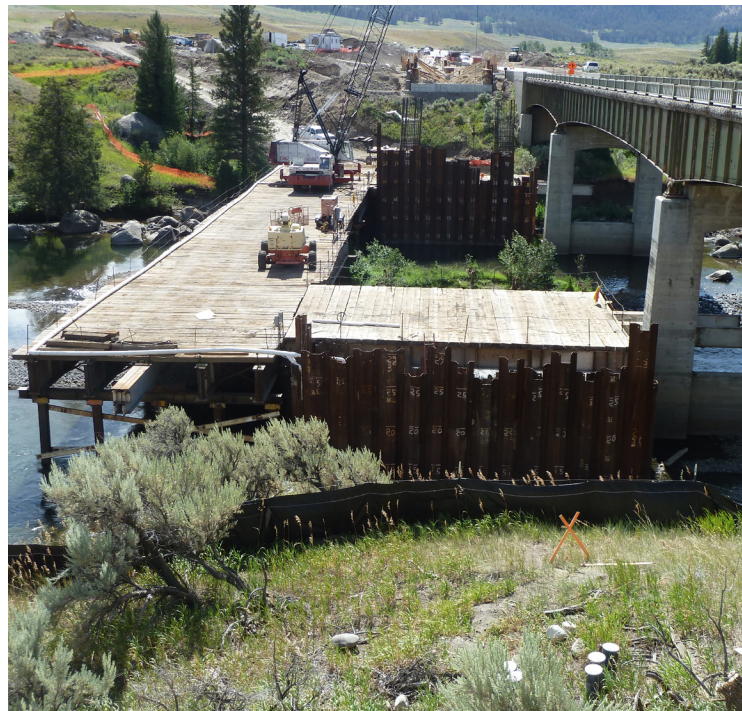
An independent platform was built to carry all construction equipment and materials across the river.

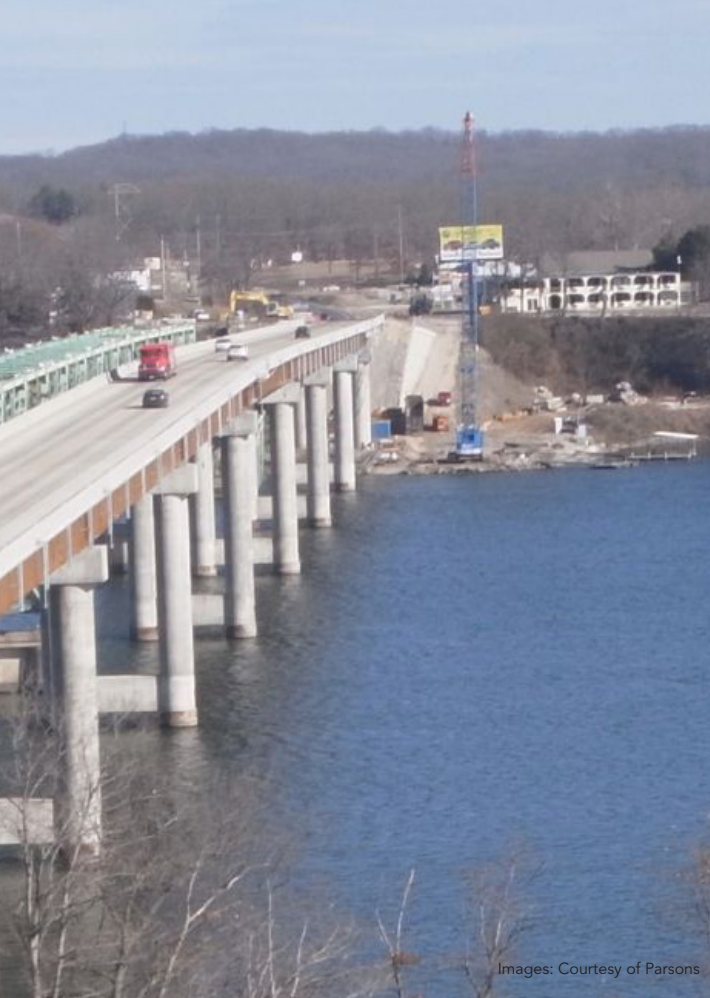
- ▲ The completed new bridge, open to traffic.
- Erecting the girders.
- ▼ An ATC bridge elevation for the new crossing.

General Contractor American Bridge Company's ATC involved a total redesign of the baseline concept with a new permanent structure on a new parallel alignment, leaving just 2 ft between the new structure and the old structure. The new structure comprises two plate girder units with six typical spans of 265 ft, 210-ft end spans and an in-span hinge connecting the two units. The steel superstructure is founded on twin 8.5-ft-diameter, steel-cased drilled shafts. An 8-ft barbell strut that sits between the drilled shaft and the 8-ft-diameter column ties the columns together.

The slender substructures are up to 120 ft tall and are braced against sway by the steel superstructure. Instead of proposing a three-girder bridge, as in the baseline design, a four-girder, unpainted ASTM 50W steel bridge with 93-in. web depth was used, reducing deck thickness (8.5 in.), reinforcement, forming and future replacement expenses.

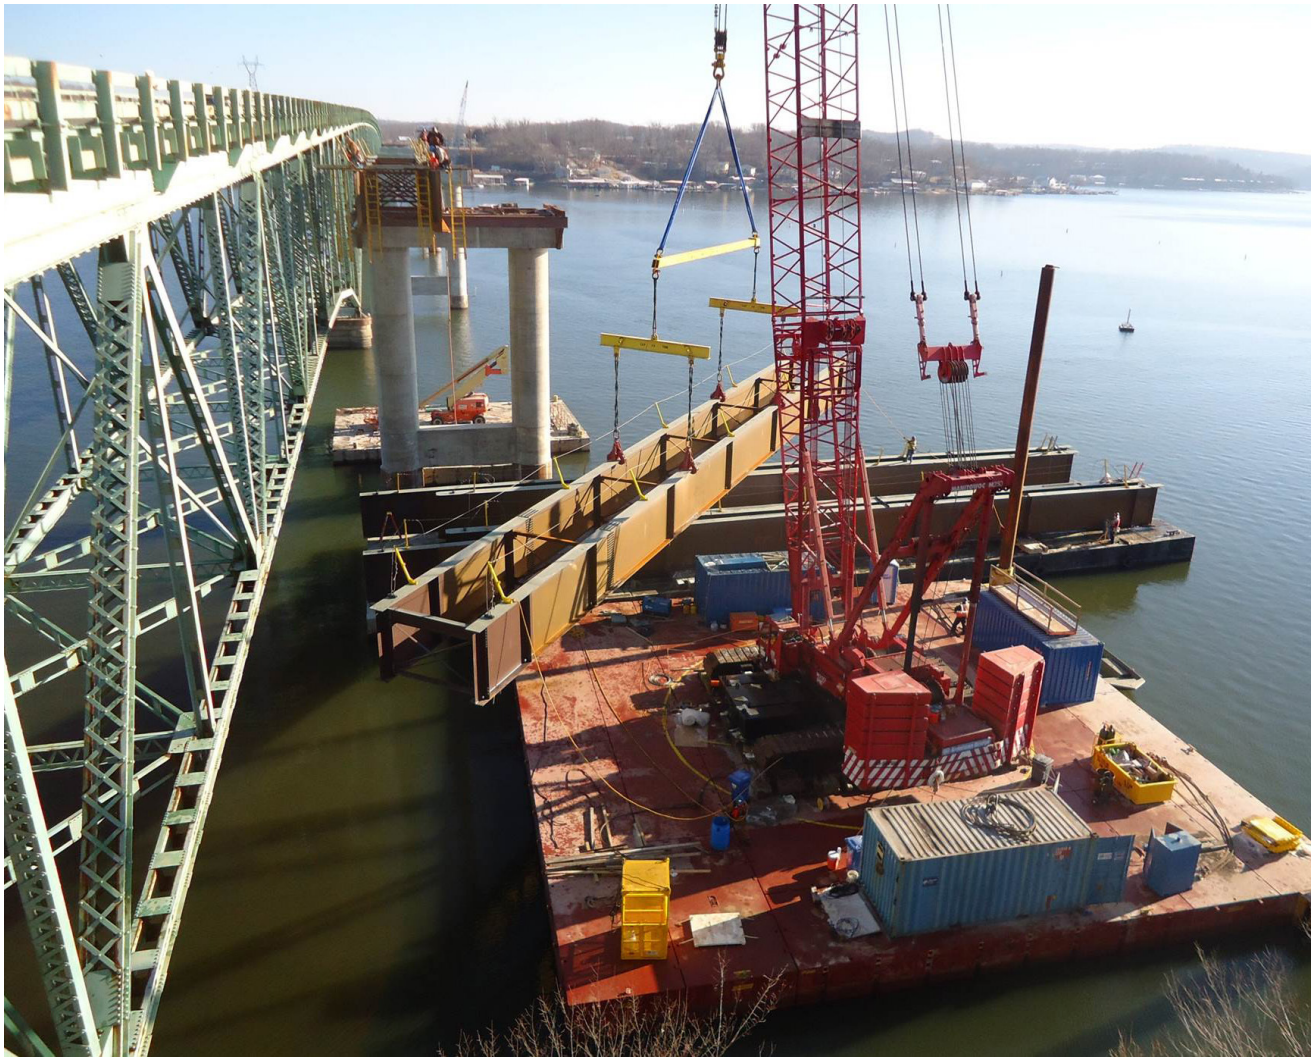
▲ The new structure comprises two plate girder units with six typical spans of 265 ft.

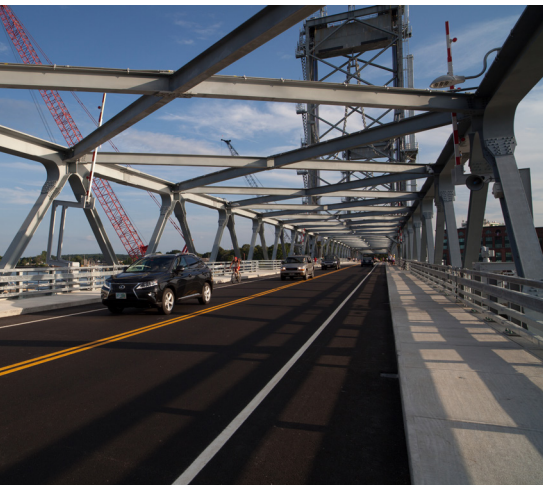
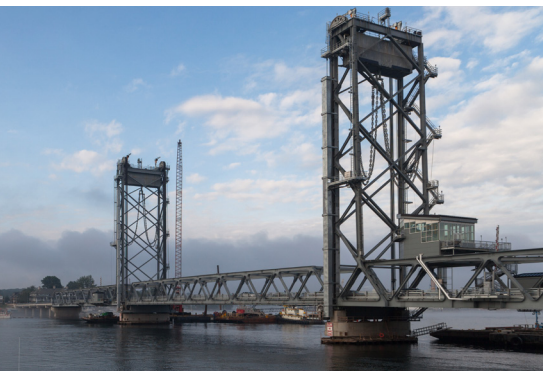
- ▲ The center span can raise to provide 150 ft of clearance.
- ▼ Night work.

Weighing 1,250 tons, the center span of the truss bridge raises to provide 150 ft of clearance during high tide. It is balanced by counterweights of 625 tons each.

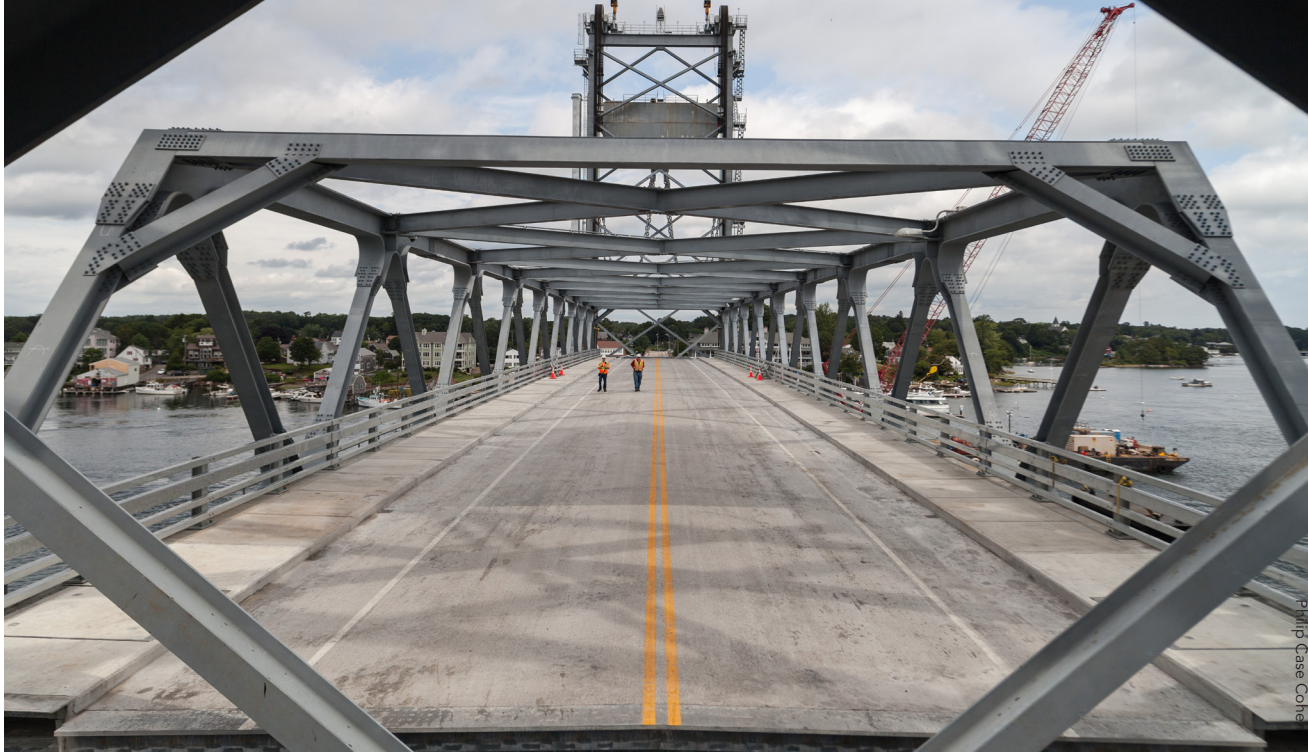
▲ The design features two 11-ft through lanes, two 5-ft shoulders for bicyclists, two 6-ft sidewalks and overlooks at both flanking spans.

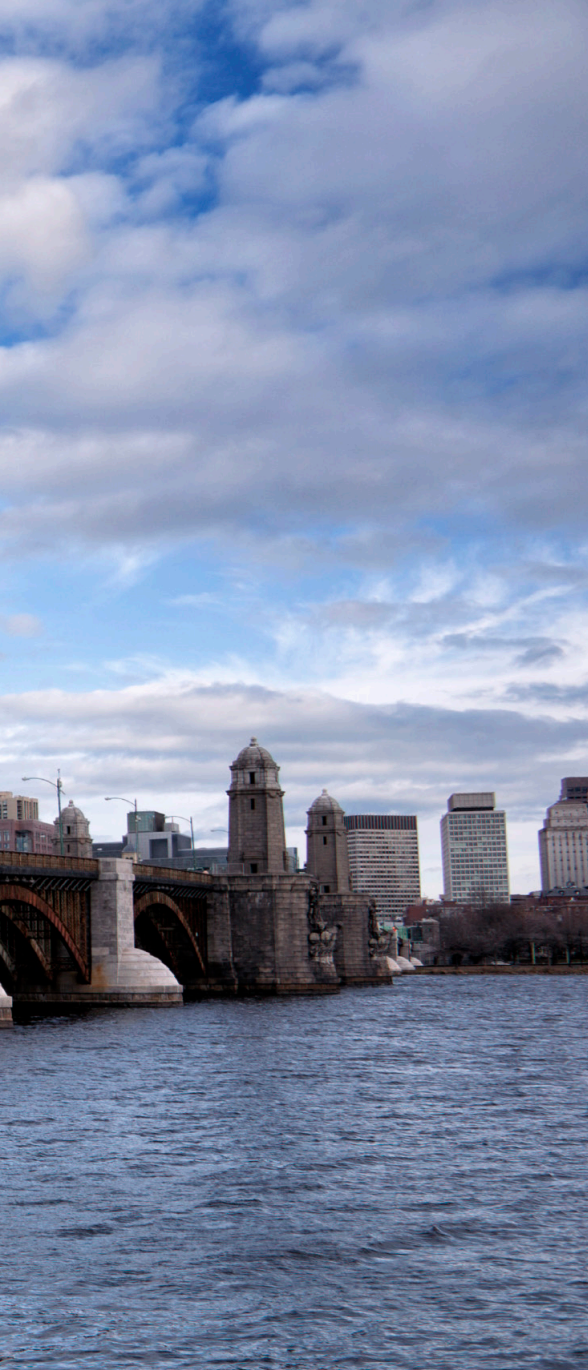
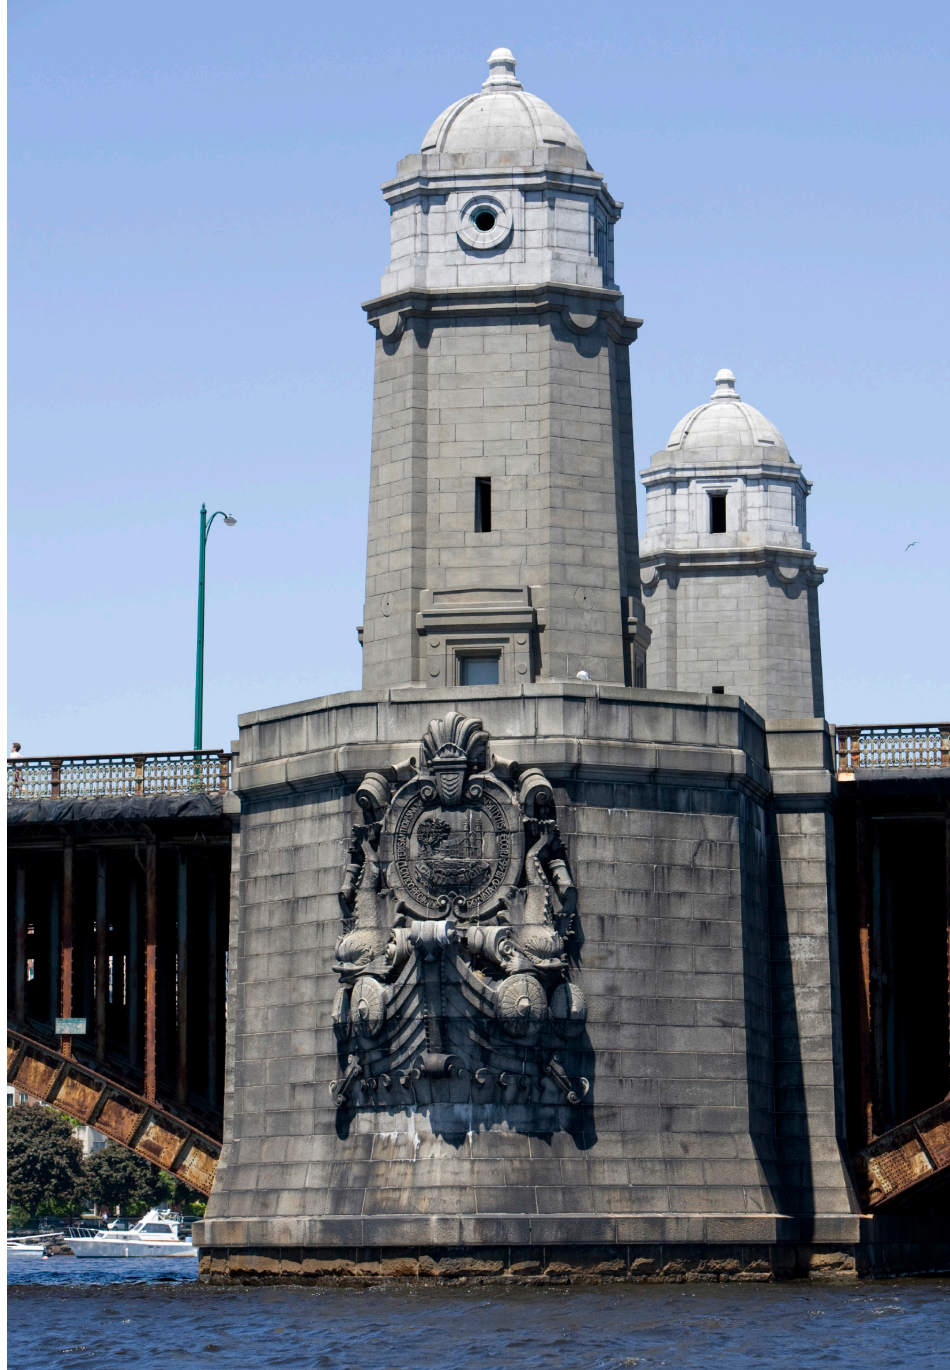
▲ Boston's Longfellow Bridge opened in 1907 and is currently undergoing a rehabilitation project, which is scheduled for completion in 2016.

▲ The bridge is colloquially called the "Salt and Pepper Bridge" thanks to the ornate granite towers that resemble shakers.

This project, scheduled for completion in 2016, will repair structural deficiencies, restore historical features and widen pedestrian walks and bicycle lanes. To maintain historic accuracy, rivets rather than high-strength bolts will replace failed rivets. The project will also restore or replicate the original or-

The piers and abutments consist of concrete masses of similar design supported by piles driven into the bolder clay to bedrock. Heavy facings of granite cover the piers and abutments above the foundations. The piers are hollow and concrete cross walls connect the two sides of the piers on the lines of the ribs and skewbacks that transmit the arch thrust to the foundations; the cross walls opposite the four center ribs merge into one thick wall. The masonry above the foundation capstone and arch skewbacks serves to carry the deck as it passes over the piers. These are also hollow, containing concrete interior walls where necessary to stiffen the walls and support deck loads.

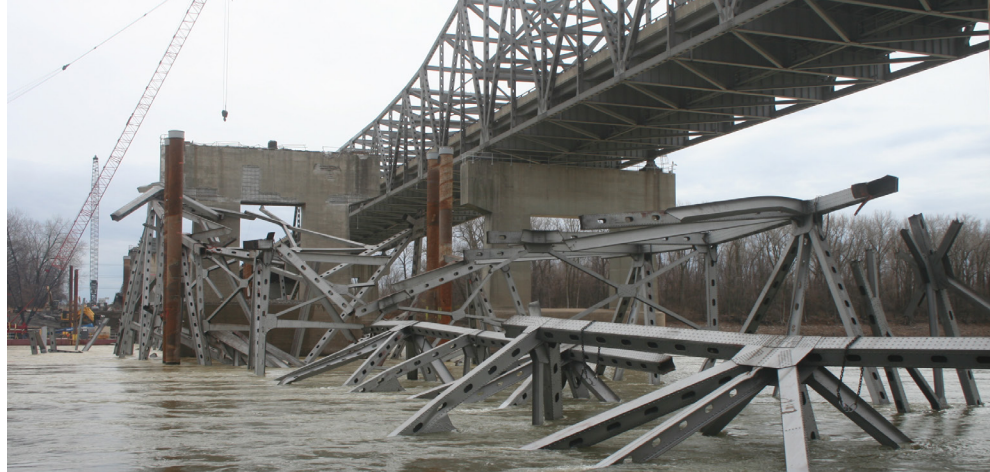
- ▲ Taking down the original Blanchette Bridge. The new bridge opened less than 10 months after the original was closed.

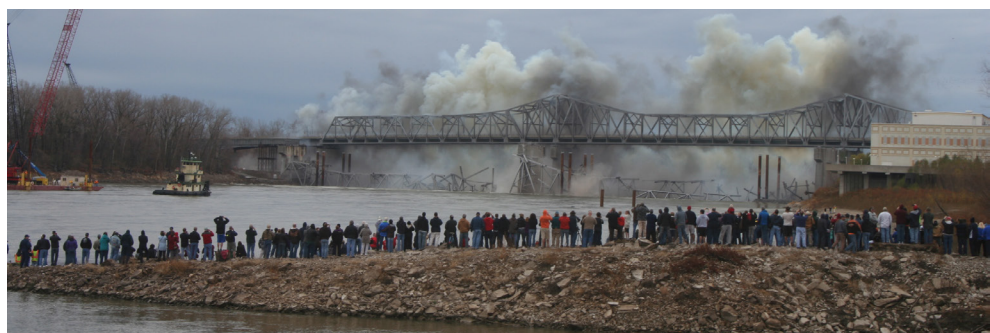
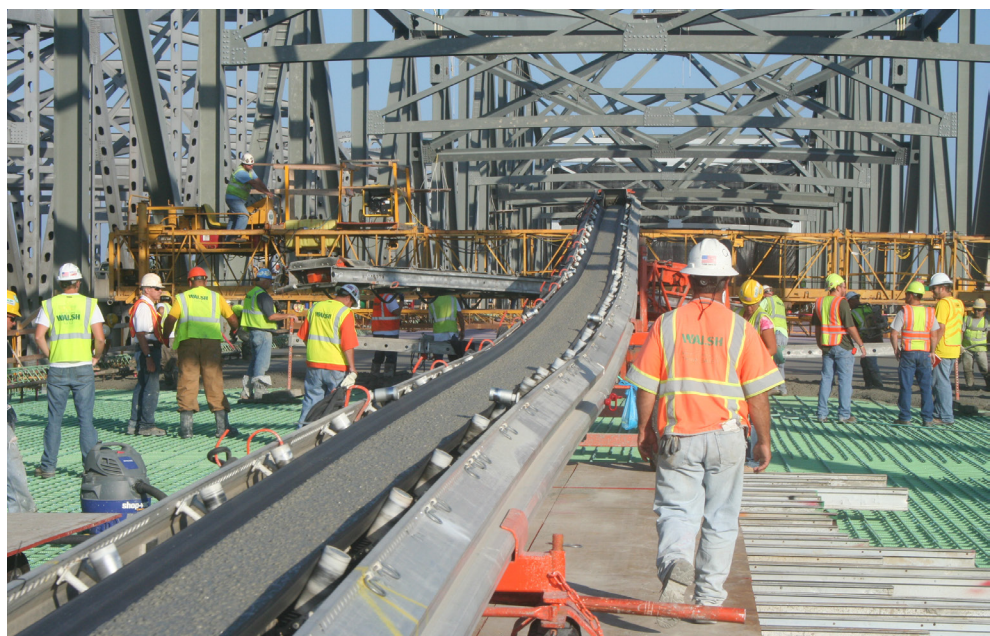
- ▲ Crews installed approximately 2,200 pieces of steel for a total weight of 3,250 tons in the truss and 750 tons in the approach girders for the Blanchette Bridge project.

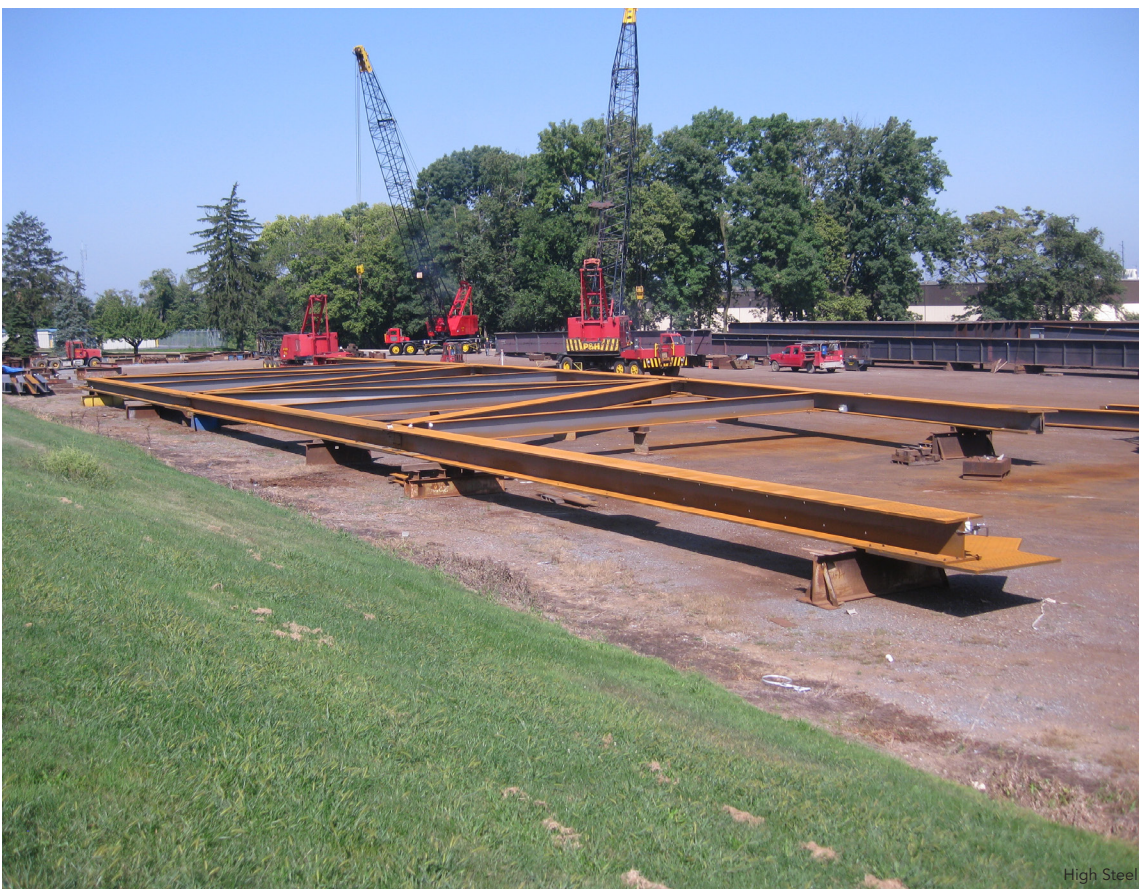
- ▲ The original Plattsmouth Bridge, built in 1879, was renovated in 1903, and in 1976 the west approach was replaced and the alignment was straightened to eliminate a 12° curve by building a new deep cut.

The Burlington Northern Santa Fe Railway has crossed the Missouri River at the Plattsmouth Bridge since 1879, the year it replaced a ferry operation with the completion of two Whipple Through-Truss spans. The original bridge was renovated in 1903, and in 1976 the west approach was replaced and the alignment was straightened to eliminate a 12° curve by building a new deep cut.

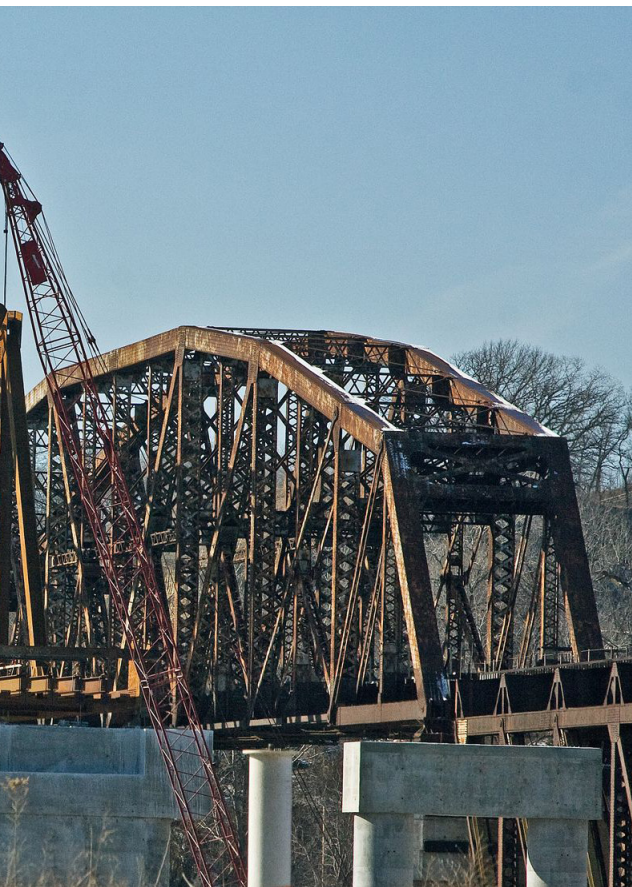
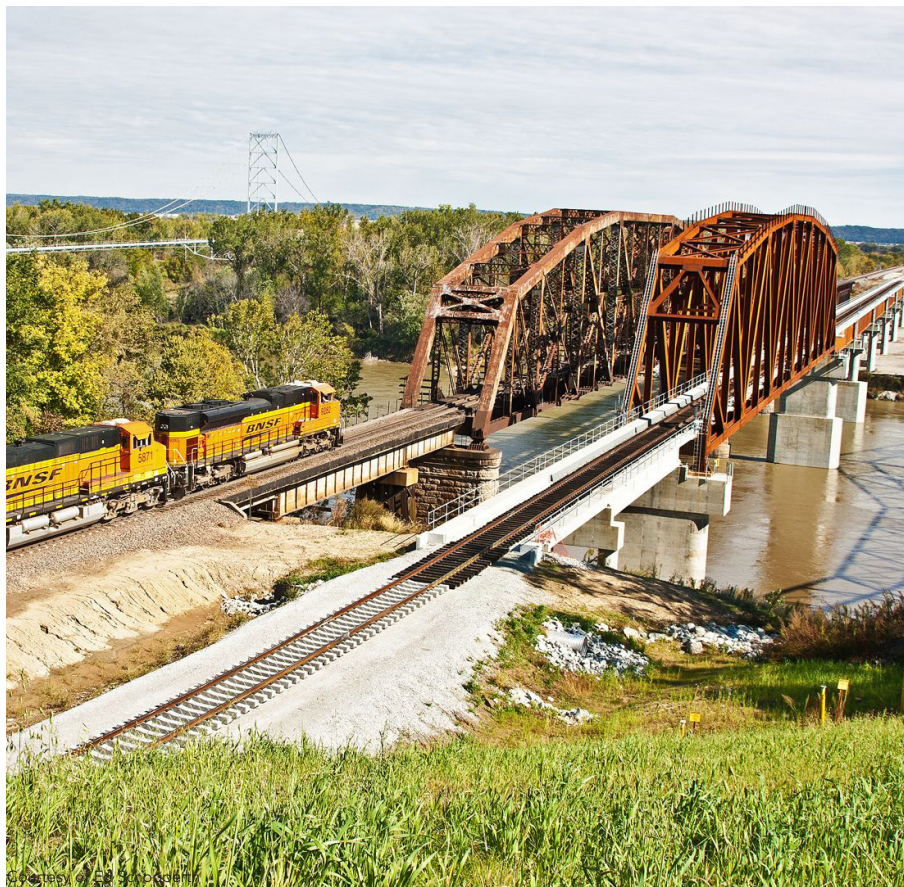
▲ The new Plattsmouth Bridge carries nearly 50 trains daily and provides approximately 400 ft of clearance for river traffic.

▲ High Steel provided 1,213 tons of fracture-critical steel for the railroad truss, while Capital Contractors provided 2,046 tons of plate girders for the approach spans.

Ames Construction was awarded the contract to build the new 1,683-ft bridge 60 ft north of the existing bridge. High Steel Structures provided 1,213 tons of A588 Grade 50W fracture-critical steel for the railroad truss, while Capital Contractors, Inc., provided 2,046 tons of plate girders for the approach spans.

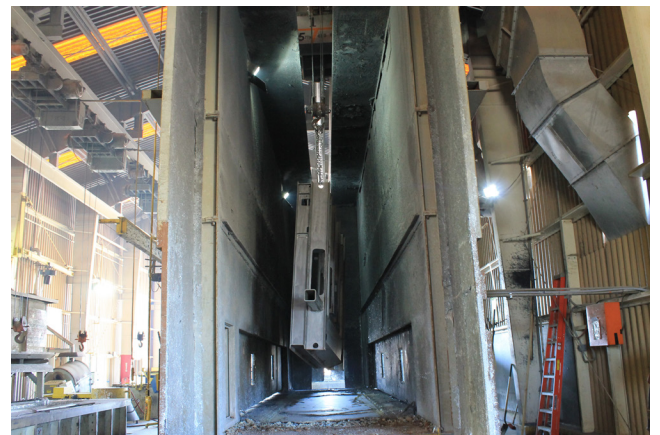
▲ The galvanizing process was discovered in the 1700s and the basics haven't changed much since. The mixture that the steel is dipped in is 99% pure zinc, along with a small amount of aluminum (which gives it a shine) and other proprietary chemicals.

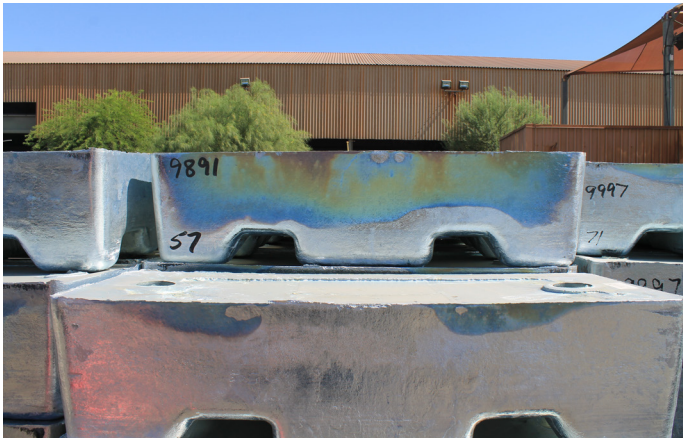
- ▶ Zinc arrives at the facility in approximately 2,400-lb pieces and is added to the kettles regularly as the levels get low; the operators keep the level 2 in. to 3 in. below the lip of the kettle to prevent spillage when elements are dipped. This facility has three kettles in two different buildings, as well as a decommissioned kettle. The two longest kettles—43.5 ft long and 36 ft long—are both 6 ft wide and 9 ft deep, while the third kettle is 23 ft long, 3 ft wide and 6.5 ft deep.

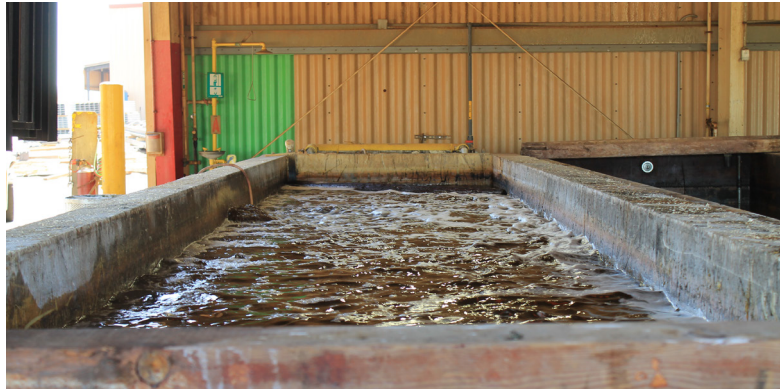
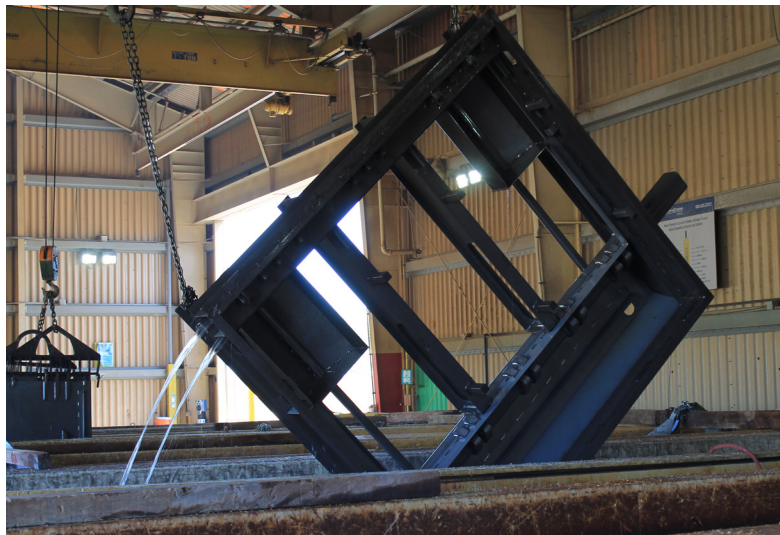
- ▶ From the pickling tank, the batch goes into another water bath to rinse off the acid. The next and final bath before the actual zinc dip is a low-pH zinc ammonium chloride mixture, which acts as a fluxing agent. It also contains a chlorine salt that encapsulates the metal and prevents it from oxidizing again.
