# Modern STEEL CONSTRUCTION

# Steel Bridges 2014

## Welcome to Steel Bridges 2014!

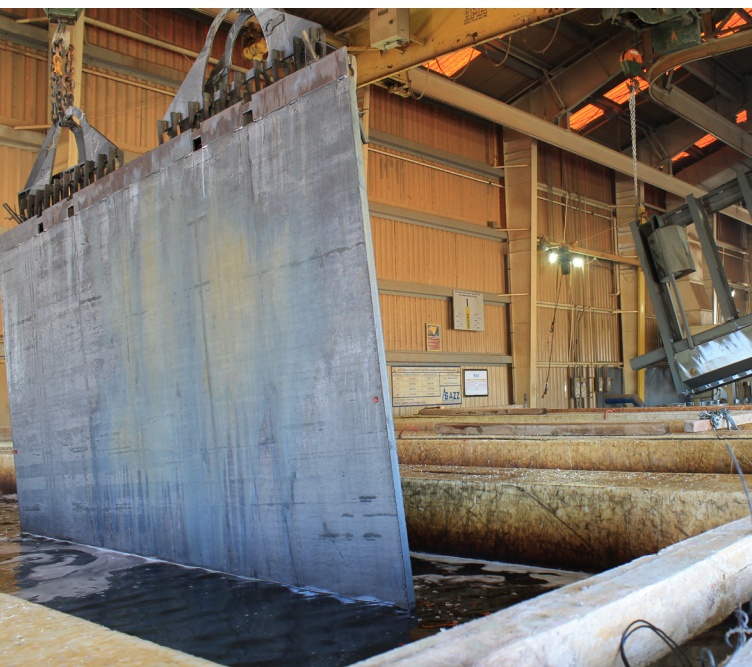
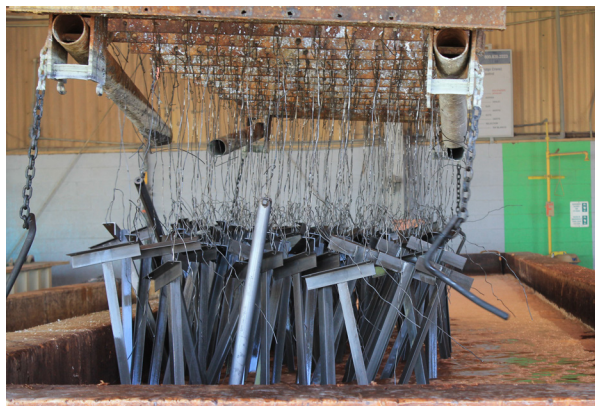
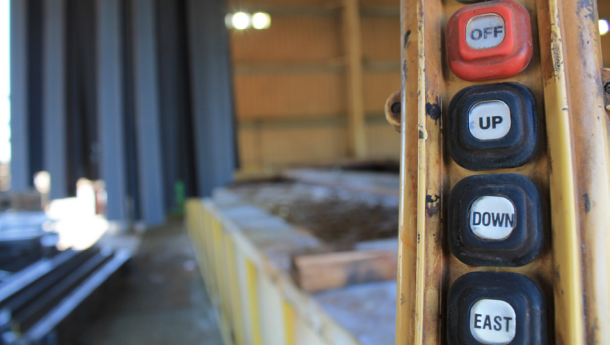
- ▶ Operators move each batch from kettle to kettle via wired remote control.
- ▶ Following the flux, it's time for the zinc. The batch is dipped in a kettle that holds, in the case of the largest kettle at the facility, around 1.1 million lb of molten zinc. A blast shield is lowered for the initial dip to prevent splatter on the operators.

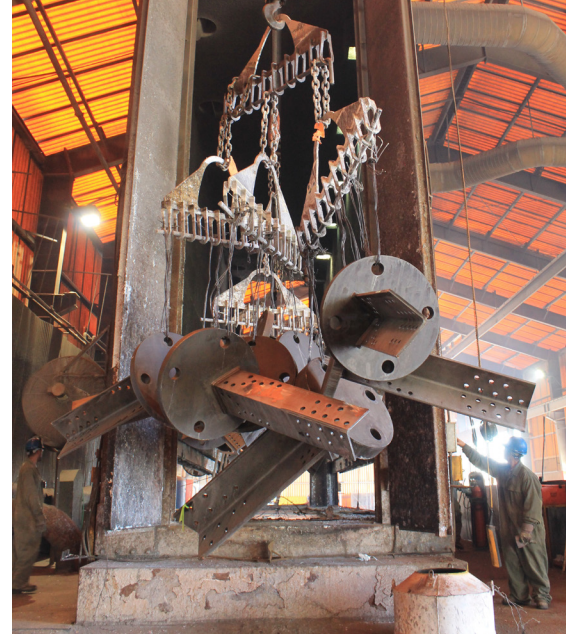
- ▶ The zinc in the kettle is kept at 835 °F. Once the base metal reaches the 835 °F mark, which usually takes about 3½ minutes, the reaction is complete.
- ▶ The zinc kettle is the most highly skilled position in the shop and operators "finesse" the batches—raising and lowering them into the kettle to make sure the zinc gets into all of the nooks and crannies, tapping them as necessary to remove excess zinc and skimming the top of the tank to make sure that no detritus adheres to the steel as it is brought out of the dip.

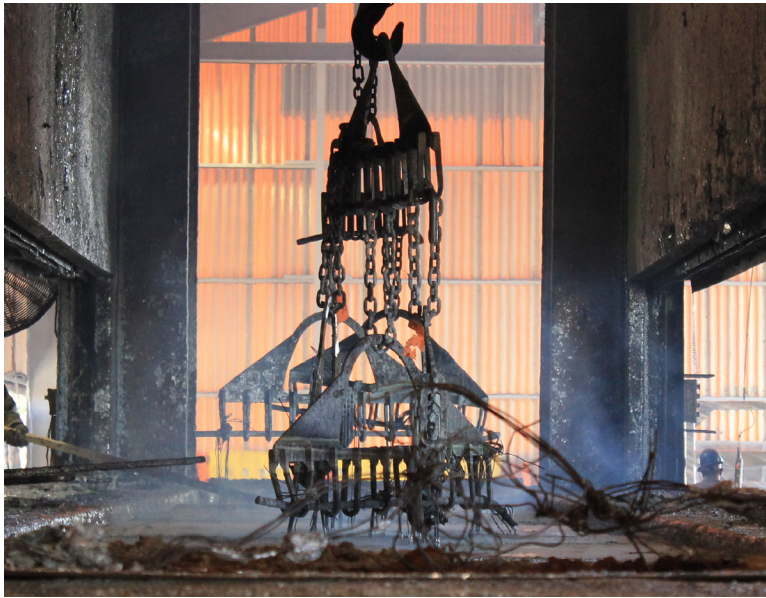
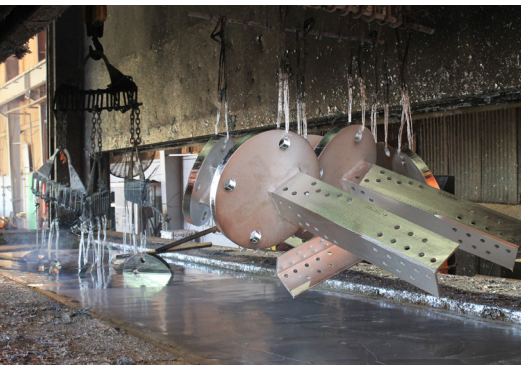
- ▶ The number of times the batch is raised and lowered into the tank (to completely remove trapped skimmings) depends on its geometry, but each batch eventually emerges with a shimmering silver coat.
- ▶ There is no cure time, but each batch is typically dipped in a vat of water for cooling.
- ▶ To maximize productivity, the Goodyear plant lines up jobs so that while one batch is in one bath, another batch is in the bath preceding it, and so on. It also bundles its steel orders together to maximize crane capacity. In addition, there are two lifts for the zinc kettle, one at the front and one at the back, so two batches can be hot-dipped simultaneously.

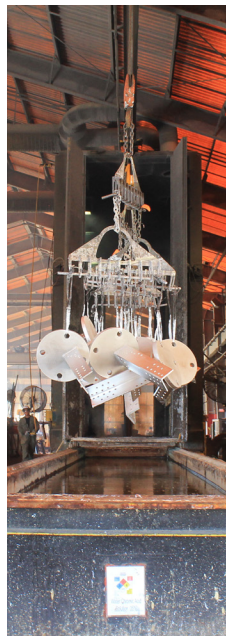
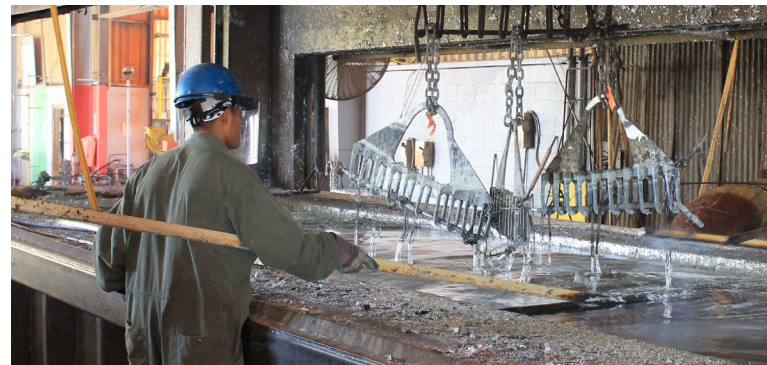
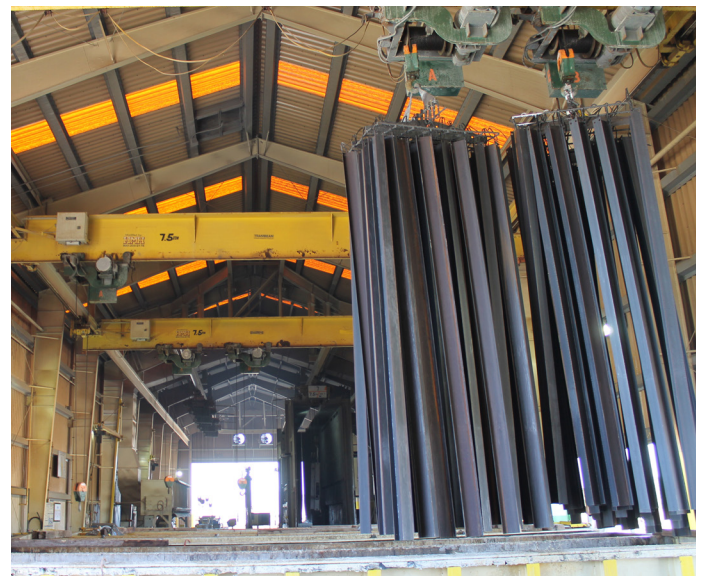
- ▼ The smaller building employs 7.5-ton cranes while the larger building uses 10-ton cranes to move steel batches down the line. Each batch is tagged for tracking purposes, but the tag is attached high enough so that it is not submerged in any of the tanks or kettles.

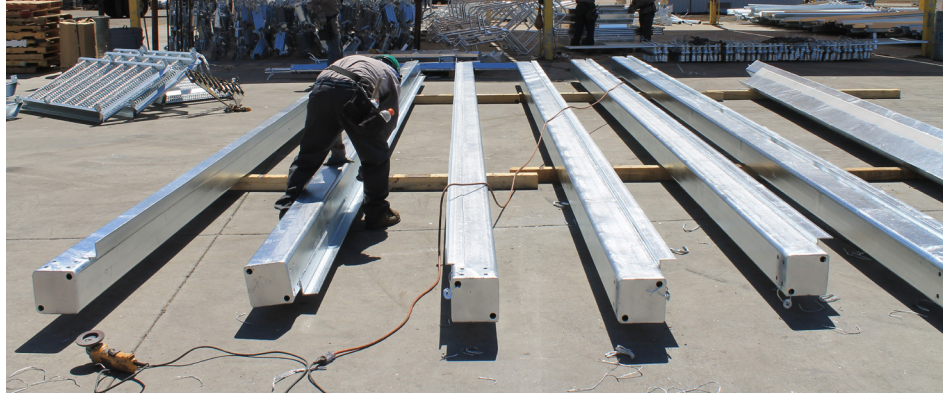
- ▲ Once the steel is galvanized, quality control is essentially built in, as defects or voids in the coating are visible to the naked eye. Deburring is performed outside as necessary.
- ▼ If there are significant defects in the coating, the steel can be put through the entire process again. The plant also performs various touchup processes as necessary, and there is an outdoor area designated for zinc-rich painting and metallizing (where zinc is sprayed onto the steel) operations.

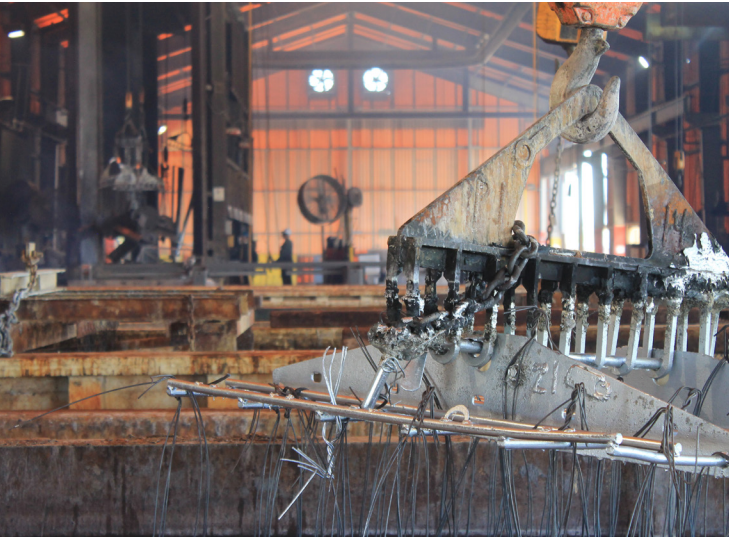
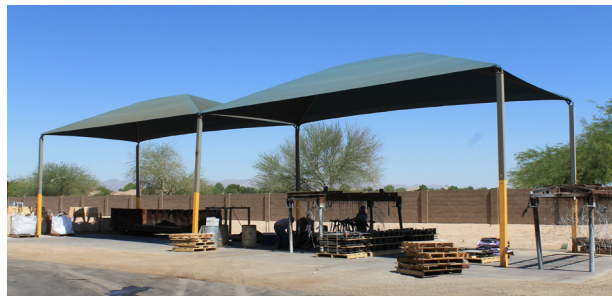
- ▼ A third type of touchup work involves the application of additional zinc via a zinc stick. This can be done immediately after the dipping and cooling process when the steel is still warm enough for the zinc to be melted on.

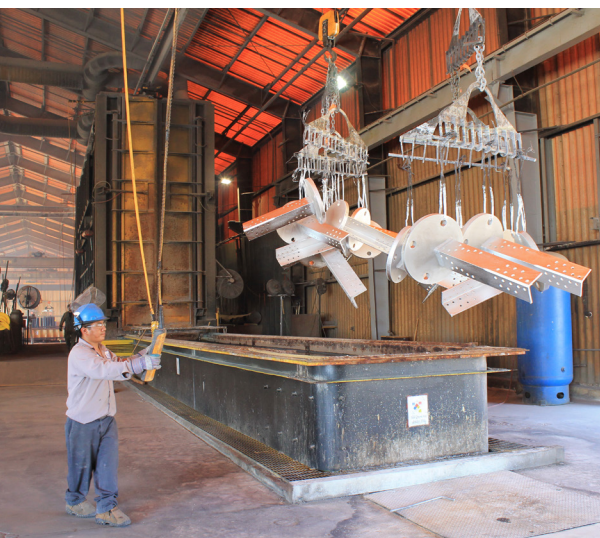
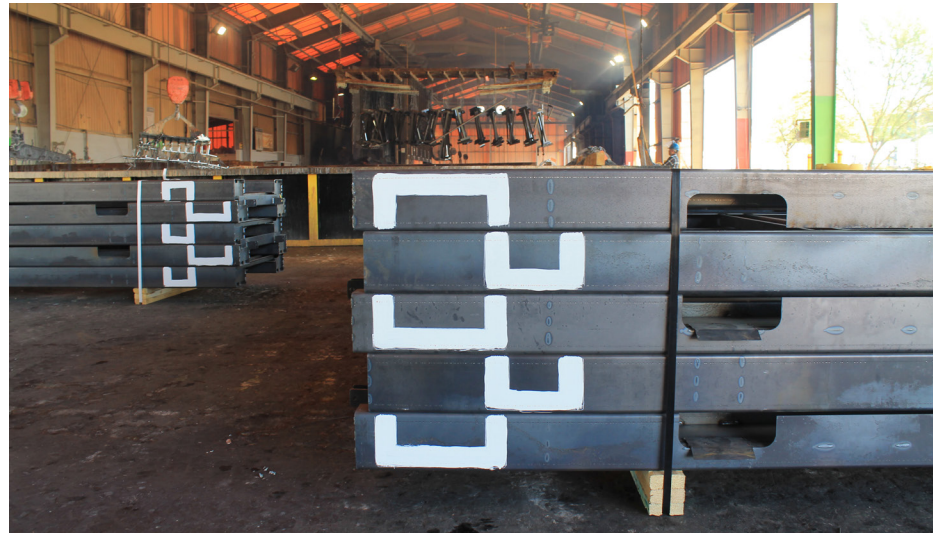
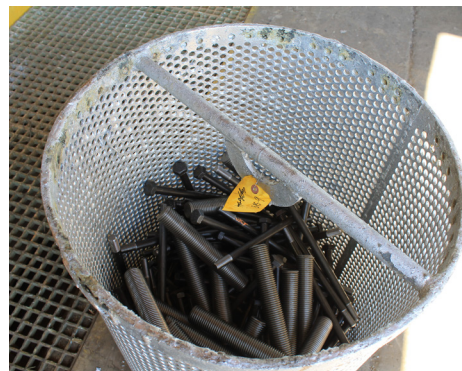
- Smaller elements, such as bolts, go through the galvanizing process in special spinner baskets in the 23-ft tank. After the zinc dip, the baskets are spun in a special machine to remove the excess zinc.

- ▲ Some structural steel elements include portions of the surface that are not to be galvanized. These are covered via a special paint that comes off during the galvanizing process but stays zinc-free when it emerges from the zinc kettle.

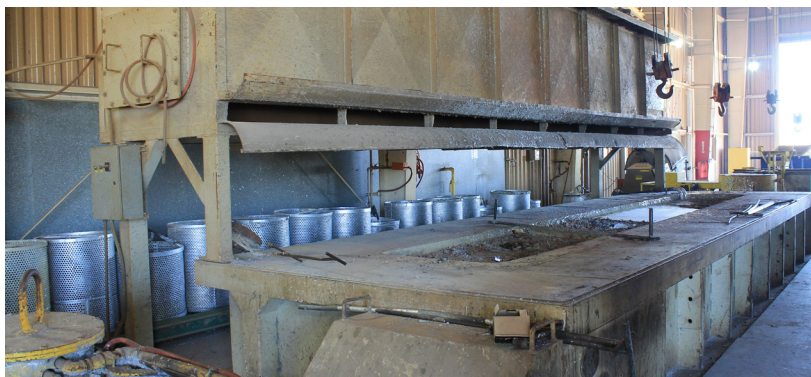
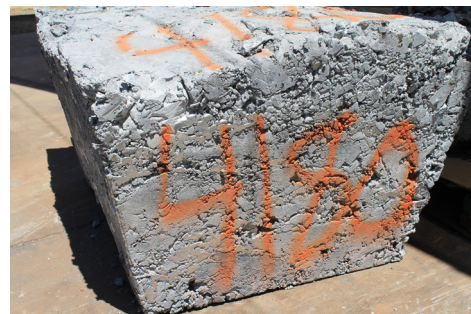
▲ All zinc used at the plant is 100% recyclable. AZZ removes a slag material called "dross" from the kettles about every two weeks. Dross is created from small particles of iron coming off the steel being dipped; the iron particles are encapsulated by zinc, and because they're heavier than zinc, fall to the bottom of the kettle. The dross is compressed into blocks and sold to a company that separates the zinc from the iron, then sells the zinc back to the galvanizer.

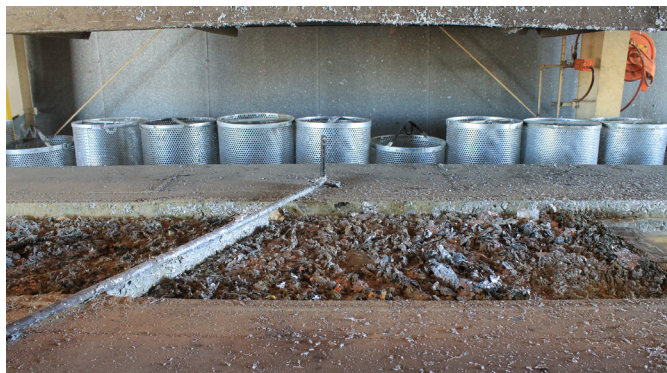
▲ In addition, zinc oxide that forms during the galvanizing process is ladled off the top of the kettle and processed in a machine that separates the zinc from the zinc oxide. The zinc is returned to the kettle and the zinc oxide material is sold to the same company that recycles the zinc from the remaining skimmings. From there, the zinc oxide can be used in a number of applications, including health-care products, cosmetics, animal feed and paint.

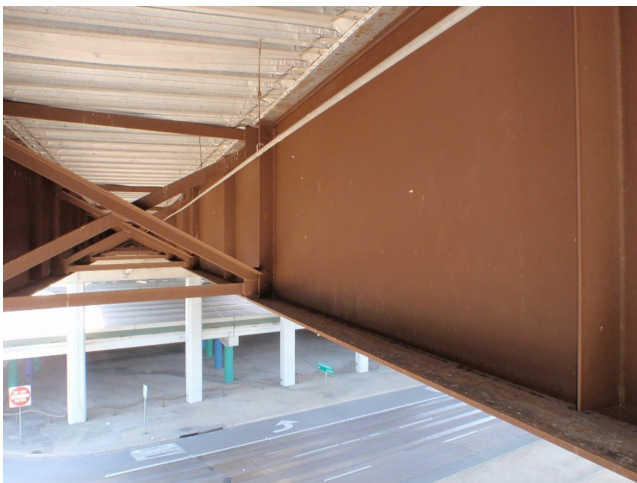
◀ Favorable performance of a UWS overpass.

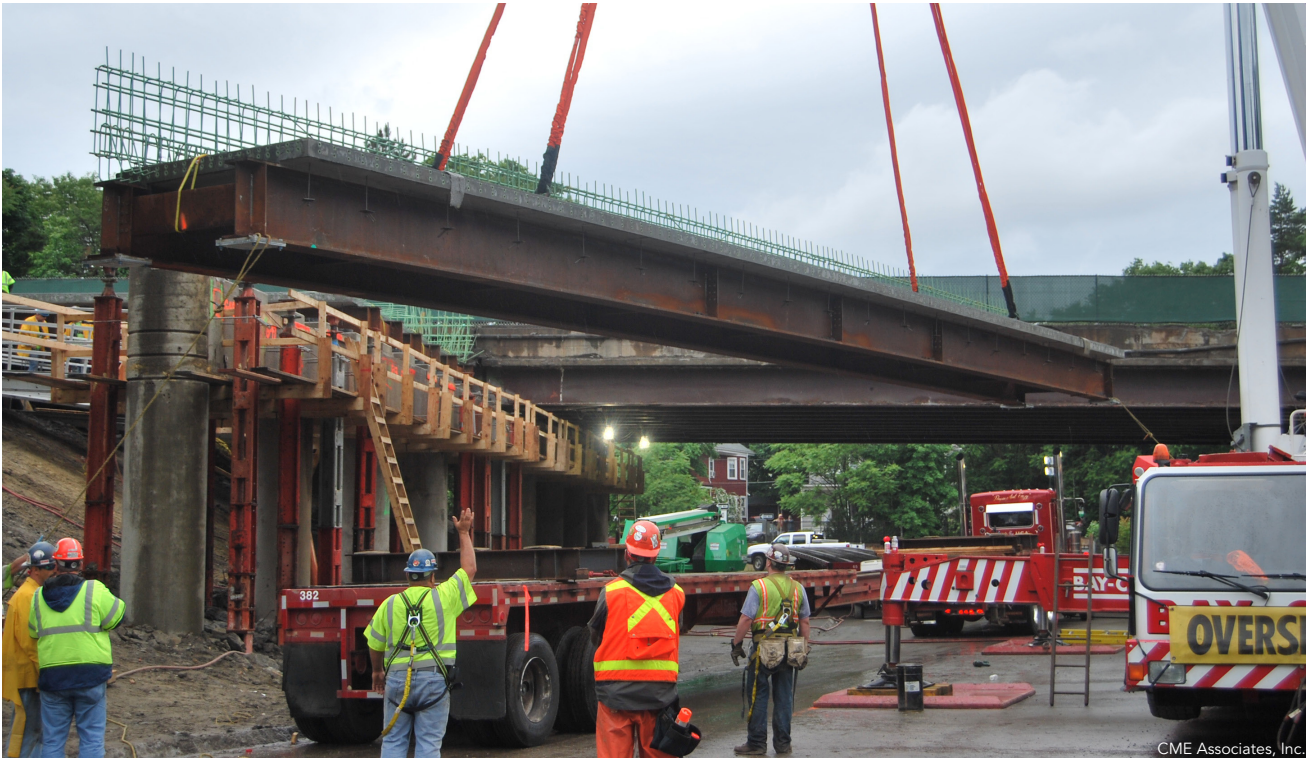
▲ The 93Fast14 Project in Medford, Mass., demonstrated the viability of modular steel bridge construction by replacing 41 spans in ten 55-hour weekend work periods.

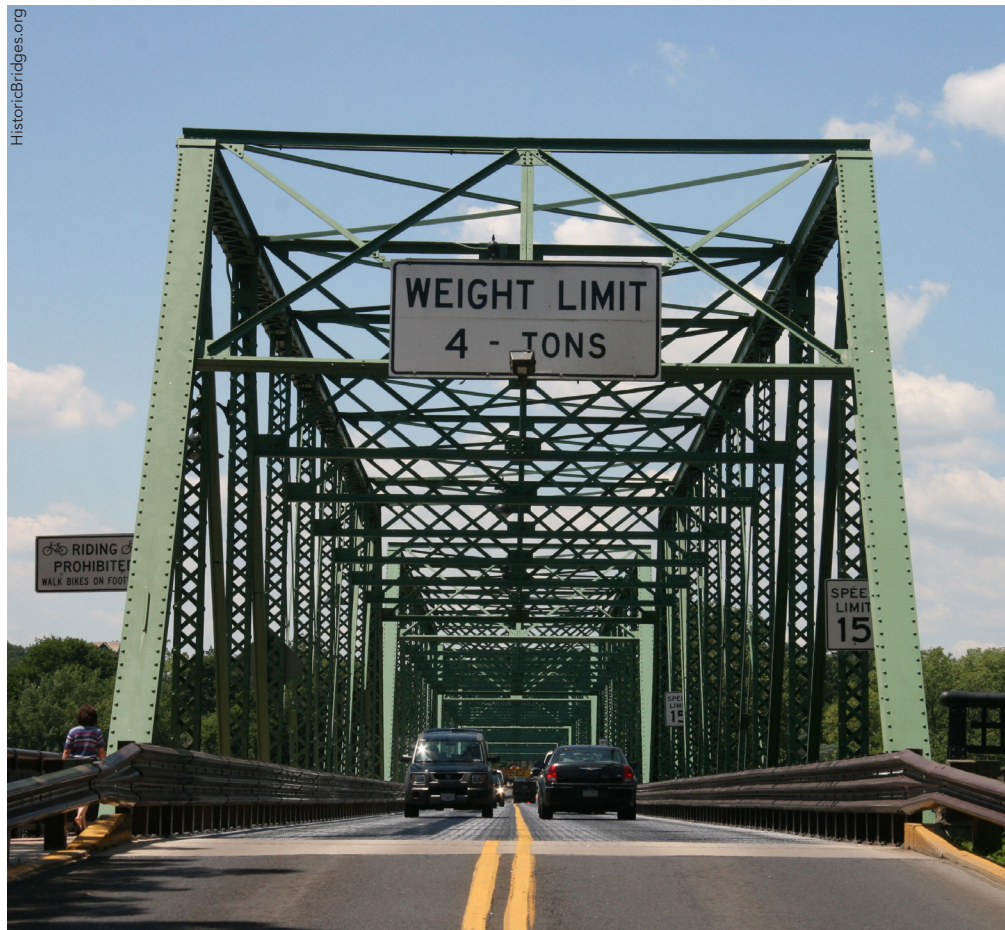
▲ The New Hope-Lambertville Bridge opened in 1904 and currently carries 14,000 vehicles across the Delaware River daily. Each of the bridge's six spans measures 171 ft, and the total length is about 1,050 ft. Vertical truss members measure 27 ft in height, and abutments date back to the original 1814 bridge.

The six-span bridge contains 962 tons of steel. Each nine-panel span measures 171 ft, and the bridge has a total length of about 1,050 ft and a roadway width of 20.3 ft. Vertical truss members measure 27 ft in height,

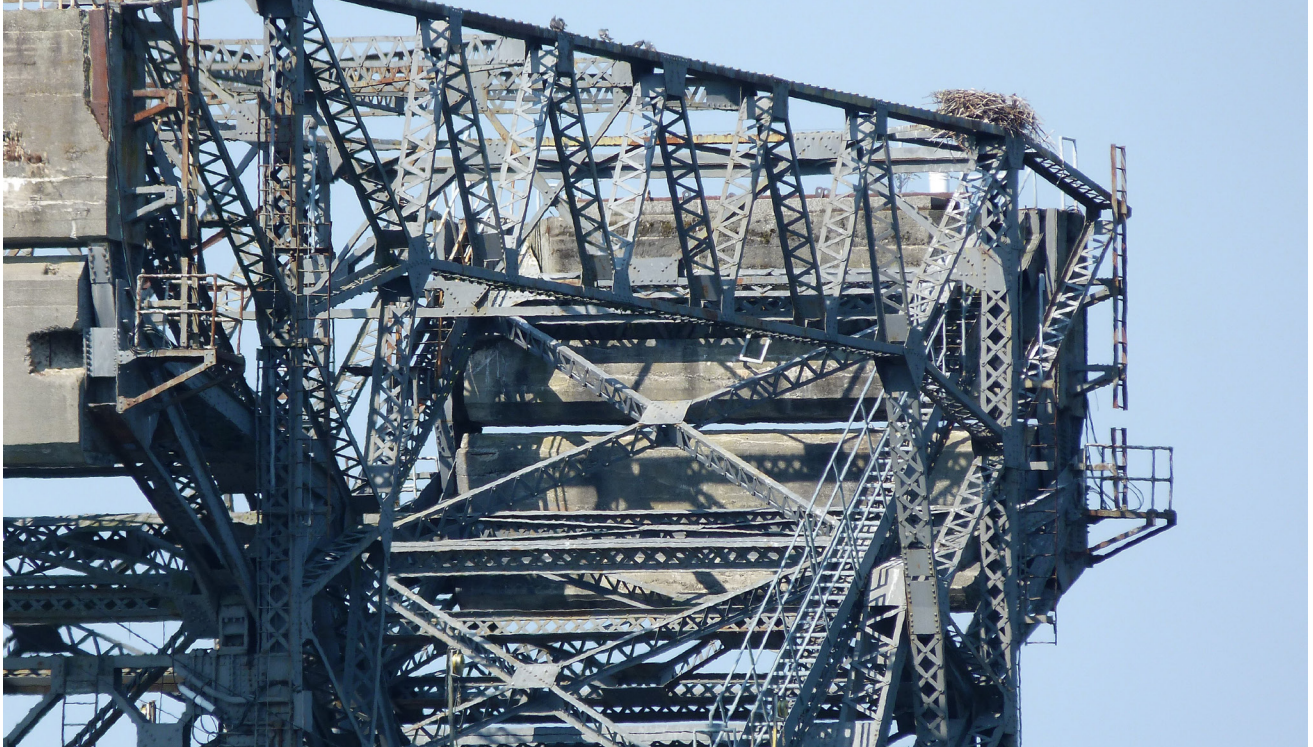
◀ ▼ The Chamber's Bay Bridge is the last of its kind still standing in the U.S.

▲ Steel trusses mounted on the tower posts on either side of the movable span support concrete counterweights.

According to the Historic American Engineering Record (HAER) for this bridge (which goes by several names, including the Chamber's Bay Bridge, Bridge 14 and the West Tacoma Bridge) steel trusses mounted on the tower posts on either side of the movable span support concrete counterweights. A system of counterweights, trusses, hangers and links forms a jointed frame in the shape of a parallelogram. Reportedly, the parallelogram has proportions so as to be in perfect equilibrium in all positions. The lift span, a pony truss, carries two rail tracks.
