# National Steel Bridge Alliance

## Executive Summary

# Edge/Corner Preparation of Steel Members and its Effect on Zinc Rich Primer Performance

KTA-Tator, Inc.

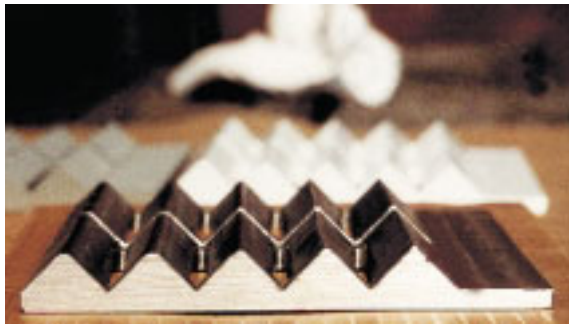
Phase 1, Photograph 2  
Corner Grinding Test Specimen  
“As Fabricated Edge View”

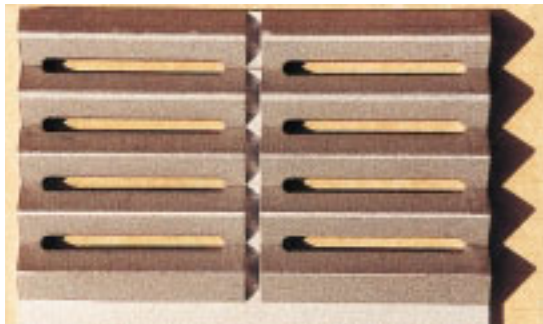
Phase 1, Photograph 3  
Corner Grinding Test Specimen  
“As Fabricated and Blast Cleaned”

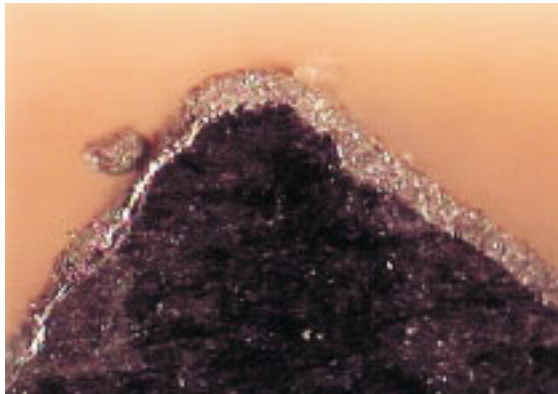
Phase 1, Photograph 14  
Inorganic Zinc-Rich Primer (single coat)  
Corner MR-0 (90°)

The same correlation does not appear to exist in the case of the inorganic zinc-rich primer. After 1,000 hours, there is no evidence of red rusting on any of the corners, even on those which received no preparation. The laboratory microscopic analysis showed that the thickness of the inorganic zinc on the corners was 5-7 mils for the “single coat” samples and 10-13 mils for the “double coat” samples. After approximately 20,000 hours (28 months) ASTM B117 salt fog exposure, there remains no evidence of red rusting on any of the corner preparations, independent of coating thickness.

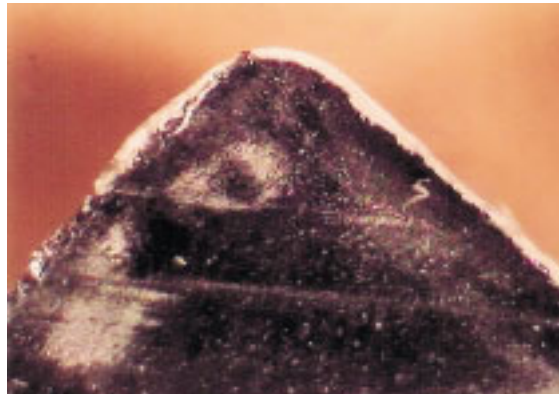
Phase 1, Photograph 26  
Industrial Enamel (single coat)  
Corner MR-0 (90°)

The laboratory microscopic analysis revealed that the single coat industrial enamel measured approximately 5 mils on the corners. The single coat industrial enamel deteriorated over much of the surface after 500 hours of salt fog exposure. Despite the overall deterioration, it was apparent that the edge with no preparation experienced substantial corrosion, while the edges with a 1/16" corner (broken or rounded) did not exhibit substantial deterioration. The performance of the 1/8" corner (broken or rounded) appeared to be satisfactory overall, although a slight amount of corrosion may have been present.

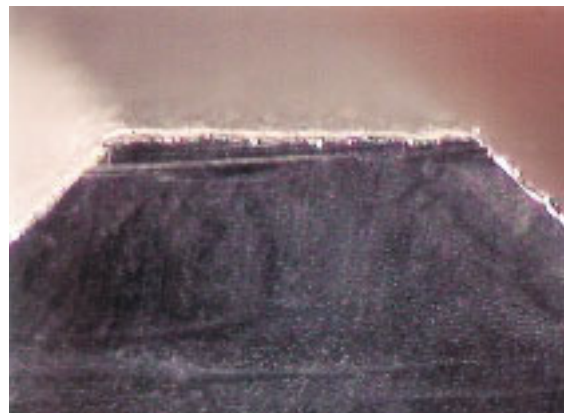
Phase 3, Photograph 33, Specimen 26  
(normal solids inorganic zinc #3)  
Corner MR-3 (1/8" chamfer)

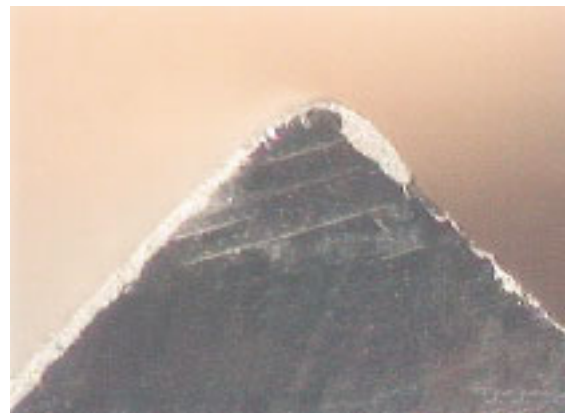
Phase 3, Photograph 66, Specimen 22  
(organic [urethane] zinc)  
Corner MR-0 (90°)

to the thickness on the corresponding edge. The thickness on the corner was approximately 50% of the edge build. Minimal corner preparation (MR1-1/16" broken edge) appears to be adequate for this coating type. Three of the remaining four corner treatments indicated coating thickness build on the treated corner was as good as the film build on the corresponding edge. The fourth corner treatment (MR3) is felt to be an anomalous data point, based upon the corner coverage on treatments MR1, MR2 and MR4.
