# **POPLAR STREET BRIDGE REHABILITATION AND WIDENING**

## **SUMMARY**

# POPLAR STREET BRIDGE REHABILITATION & WIDENING

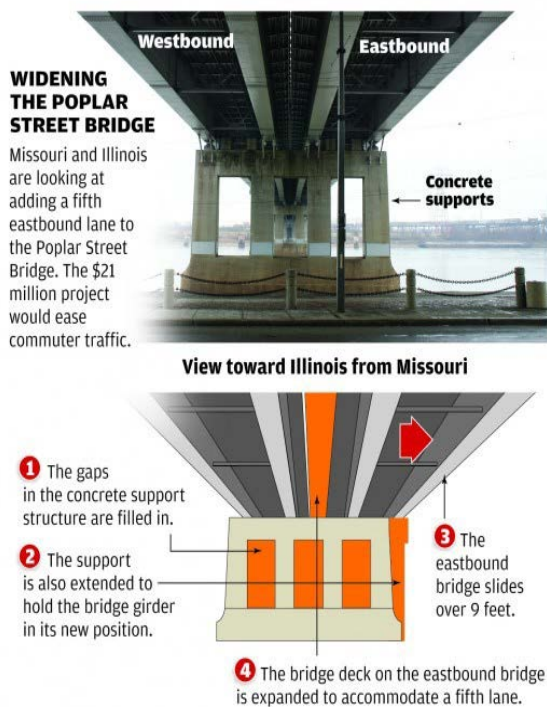
**Figure 5: Basic Bridge Slide Concept**

With the proliferation in recent years of accelerated bridge construction, bridge slides and bridge roll-ins, HDR proposed to slide the existing eastbound Bridge superstructure 9' to the south on its existing supports and connect the WB and EB superstructures together. This concept was significantly less expensive than a conventional widening and also (through the connection of the superstructures) transformed the two 2-girder superstructures into a single 4 girder bridge, thereby adding redundancy to the structure. Figure 5 shows the basic concept of the slide.

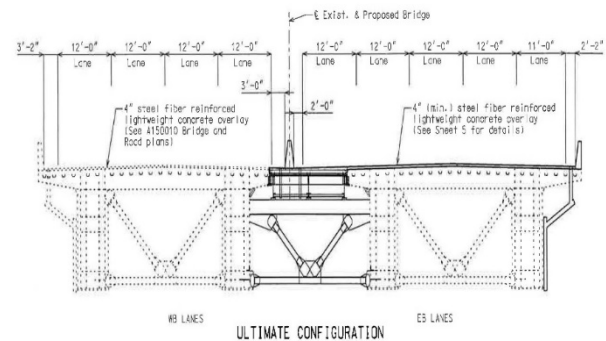
**Figure 6: Structural Steel Infill**

HDR confirmed that the existing substructure and superstructure elements were sufficient for the additional live load from the 5<sup>th</sup> eastbound lane. Connecting the superstructures together improved the performance of the girders as the live load was distributed across to the westbound girders. The connection or “infill” between the westbound and eastbound superstructures consisted of a lightweight concrete reinforced deck supported on a steel sub-stringer-floor-beam system as shown in Figure 6. Continuity was maintained between the infill and the orthotropic steel deck plate by embedding a studded channel into the concrete deck which was bolted to an angle welded to the underside of the orthotropic steel

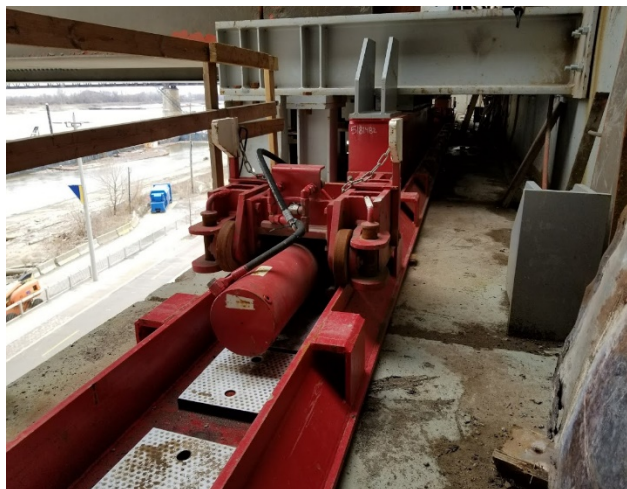
**Figure 8: Slide Track System**

The girder and temporary support system were lowered onto the slide or skid beams which were placed within the slide or skid tracks. Horizontal jacks were placed in the skid tracks to push the slide beam and translate the girders. Teflon pads were placed within the skid tracks to reduce friction and ease the movement of the slide beam. Figure 8 shows the slide track system.

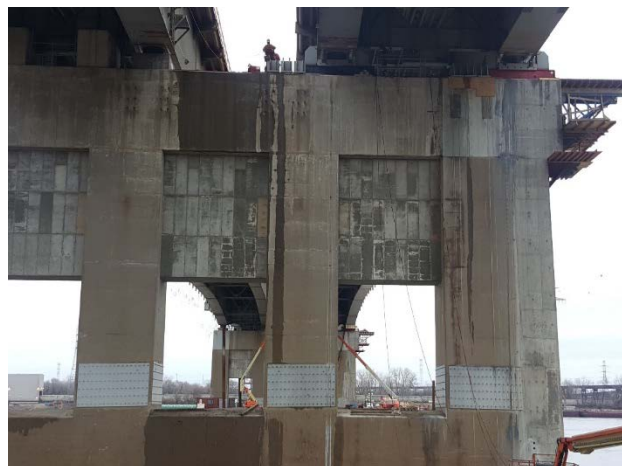
**Figure 9: Post-Slide at Pier 2**

slide beams over the Teflon pads at approximately 18” increments. It would take about 1-2 minutes to move the bridge the approximate 18” increments, then the process would stop for 15-20 minutes to re-stroke the pistons and make sure the girders at each pier were aligned and the crews were ready to continue. Figure 9 shows the bridge just after the slide with girders in their new location.

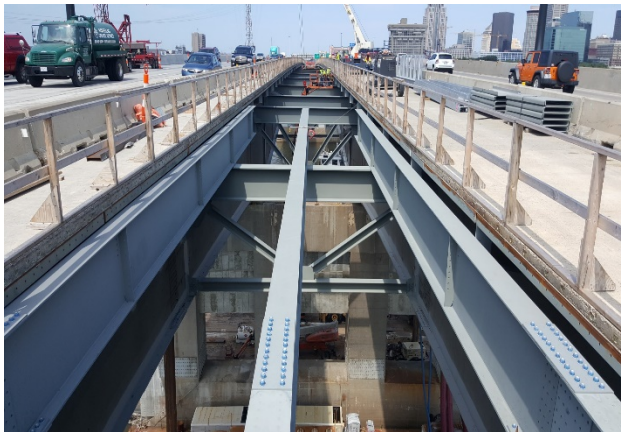
**Figure 10: Structural Steel Infill**

One challenge for fabrication and erection of the infill steel was accounting for the differential deflection of the westbound and eastbound structures. Due to the crown shift of the eastbound structure from the slide, the roadway crown was no longer at the same location as the crown of the orthotropic steel deck plate. This results in a variable depth overlay which at the north side of the eastbound bridge is thicker than the constant overlay of the westbound bridge. The connection members, floorbeams and stringers all had to be fabricated to account for the resulting differential deflection. Another challenge was that the infill steel all had to be fabricated early in the schedule, so field measurements post-slide were not available to aid in determining member dimensions. Figure 10 shows the partial installation of the structural steel infill. Once the structural steel was installed the lightweight concrete slab was poured,

After the eastbound bridge was translated to the south the steel infill was constructed to connect the westbound and eastbound structures together. Field drilling and slightly oversized holes were utilized to facilitate fit-up of the new steel to the existing girders and floor-beams. Connection members, such as WT's with 12” stems, were used to increase field tolerances as much as possible.

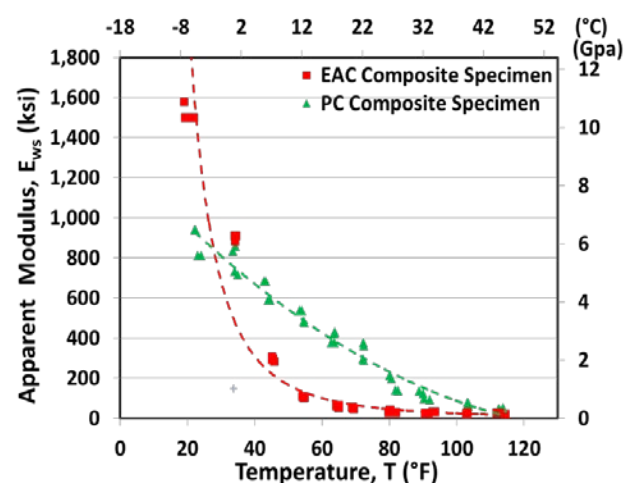
**Figure 12: Stiffness vs. Temperature**

Initially HDR investigated using either a 2.5" layer of Epoxy Asphalt Concrete or a 2.5" layer of Polyester Concrete which would be chemically bonded to the orthotropic steel deck plate. However, research (1) of previous testing indicated that the stiffness of both of these materials is significantly reduced with high temperatures. Figure 12 shows a plot of the apparent modulus or stiffness of the material vs. temperature. Once the temperature reaches 80°F the modulus is less than 200 ksi for the polyester concrete and even lower for the epoxy asphalt. The air temperature in St. Louis in the summer time is routinely over 90°F and with this being a steel structure, the surface temperatures are even hotter, likely approaching 120°F or more. These materials would reduce the overall stiffness of the deck system making the deck plate susceptible to cracking.

overlay materials: A 4" steel fiber reinforced lightweight concrete overlay with a layer of mild steel mechanically connected to the steel deck plate using end welded shear studs. The 4" thickness was needed because a 2.5" overlay without mild steel is susceptible to failure in high tensile areas and if mild reinforcement were added then there would be clearance and concrete consolidation issues. Since the proposed overlay is thicker than the original and existing overlays the existing superstructure and substructure capacities were checked for the additional dead load. The additional dead load was mitigated somewhat by using lightweight concrete with a density of 120 pounds per cubic foot. A benefit of using this concrete overlay is that it utilizes conventional analysis and construction methods. The steel fibers were included for durability to provide an improved riding surface and ensure sufficient deck stiffness for a 30-40 year life with minimal maintenance.

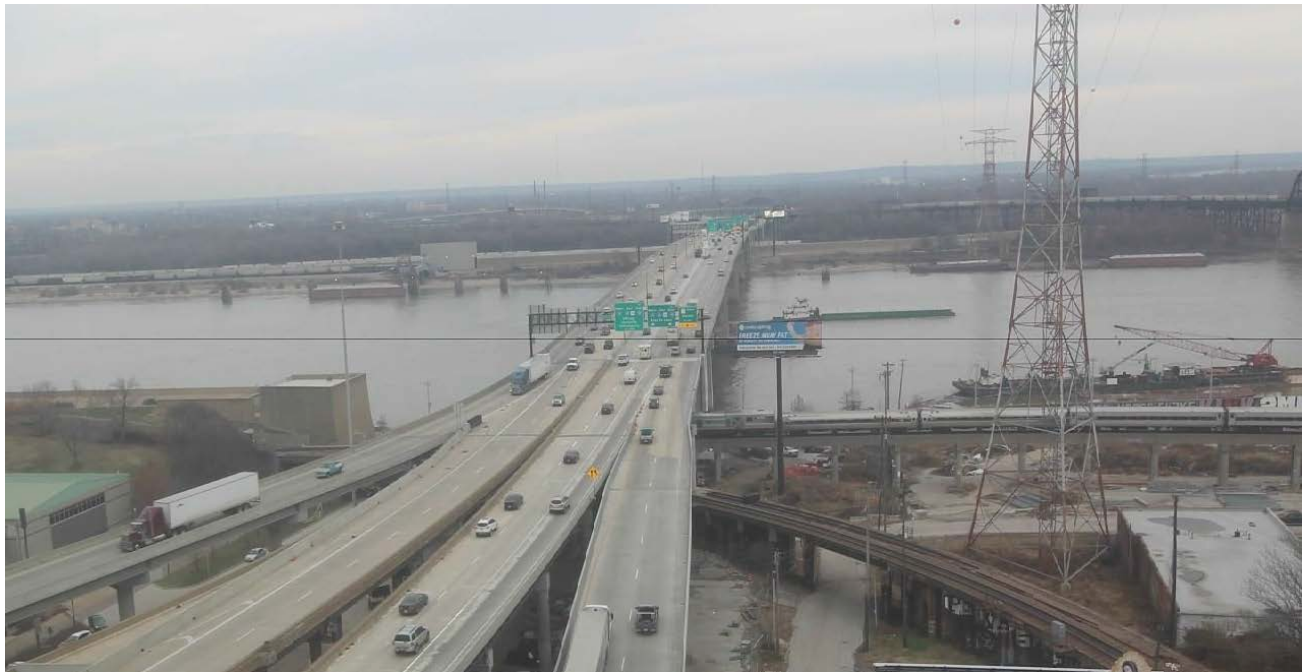
**Figure 19: Completed Poplar Street Bridge**

Also as part of the project, the existing overlay on the Poplar Street Bridge was replaced with a 4" steel fiber reinforced lightweight concrete overlay mechanically connected to the steel deck plate via shear studs. This new overlay not only provides a reliable low maintenance riding surface, but also increases the stiffness of the deck system. The stiffer deck system is less susceptible to fatigue cracking in the deck plate to rib weld. A final portion of the project was a major rehabilitation of the Poplar Street Bridge and Illinois approaches. Rehabilitation included new expansion devices, painting, structural steel repairs, bearing replacement, pier repair and total bent replacements. Figure 19 shows a view of the completed Poplar Street Bridge.
