**TESTS OF FULL-SCALE BEAM-TO-COLUMN
CONNECTIONS**

Reidar Bjorhovde
The Bjorhovde Group, Tucson, Arizona

August 1999

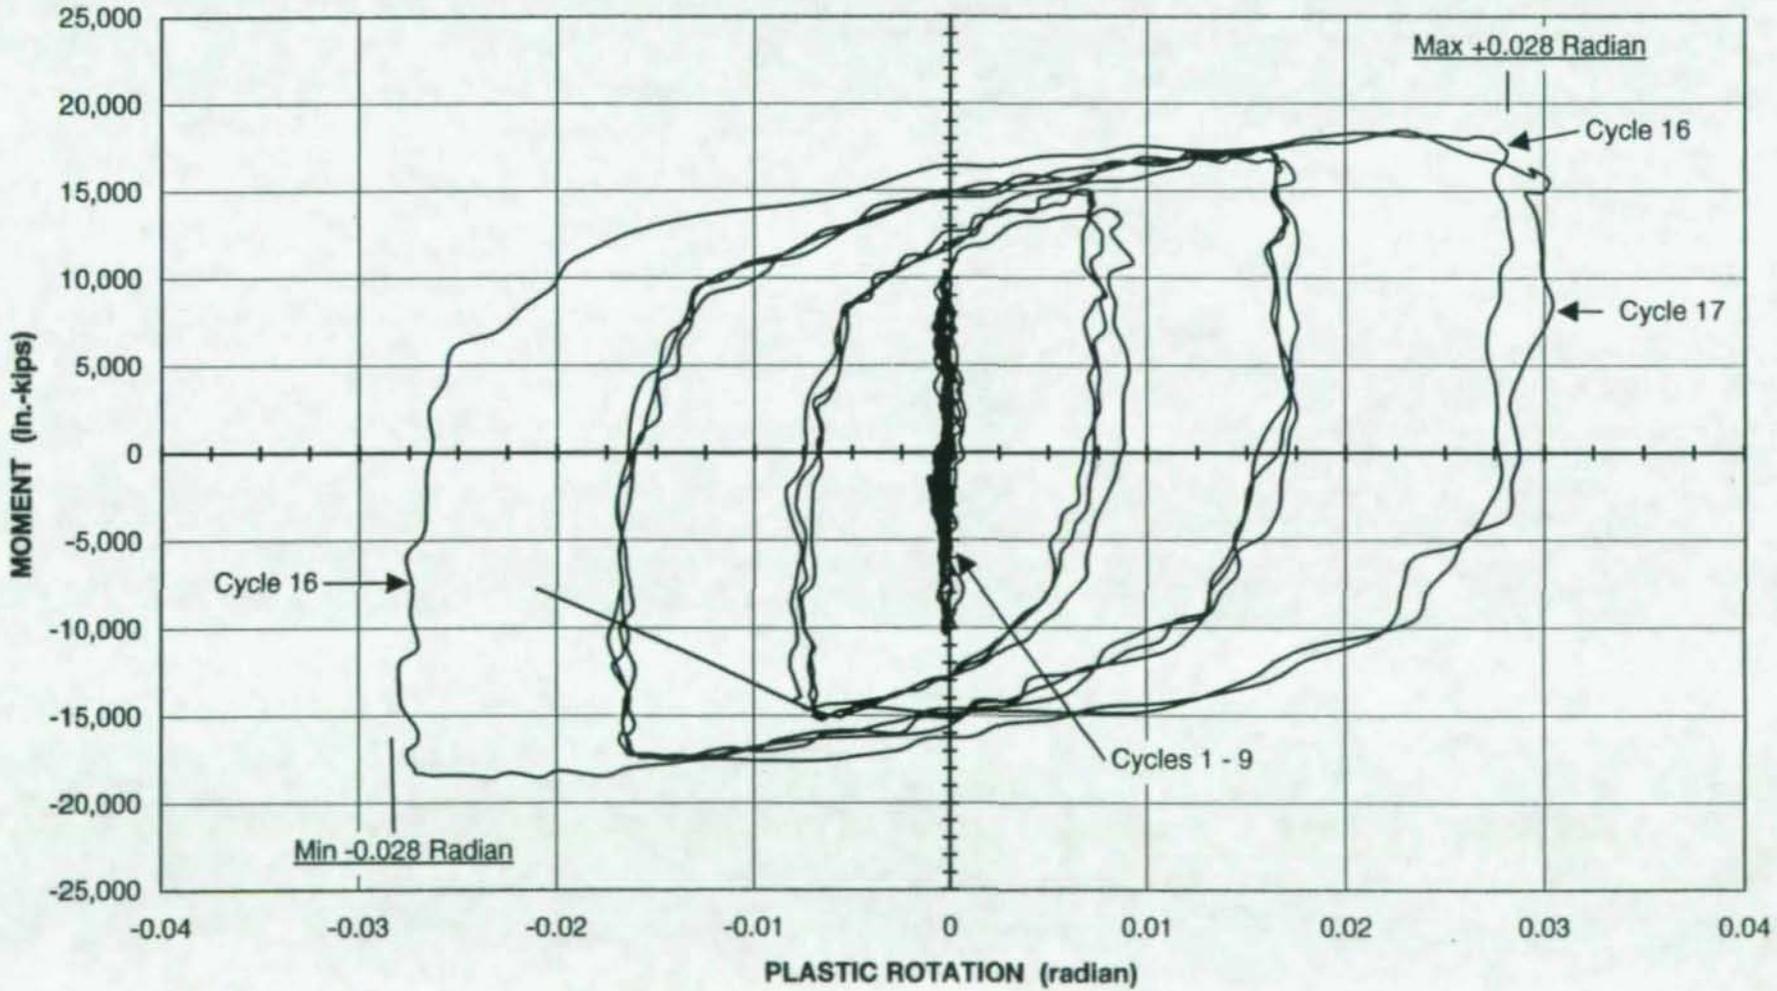
Figure 36 Moment vs. Plastic Rotation Hysteresis Curves for Specimen A6

7.2.1 Specimen Test Performance: Figures 36 and 37 show the moment vs. plastic rotation hysteresis loops for Tests A6 and A7, respectively. The maximum and minimum loads for A6 were +108.8 kips and -111.8 kips; for A7 these loads were +111.0 kips and -110.9 kips.

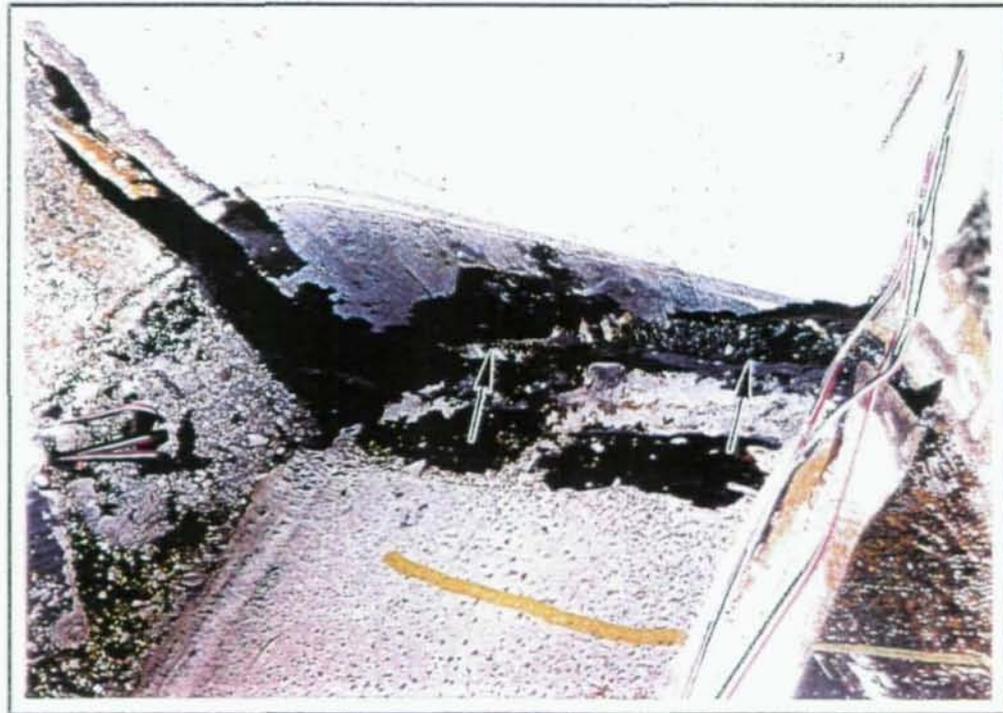
propagated across the k-region and then through the web, away from the continuity plate for a total length of approximately 9.5 inches. Figure 38 shows details of the fractures in specimen A6, and Fig. 39 indicates crack initiation and propagation details for this specimen. The appearance of the mechanisms for A7 are closely similar.

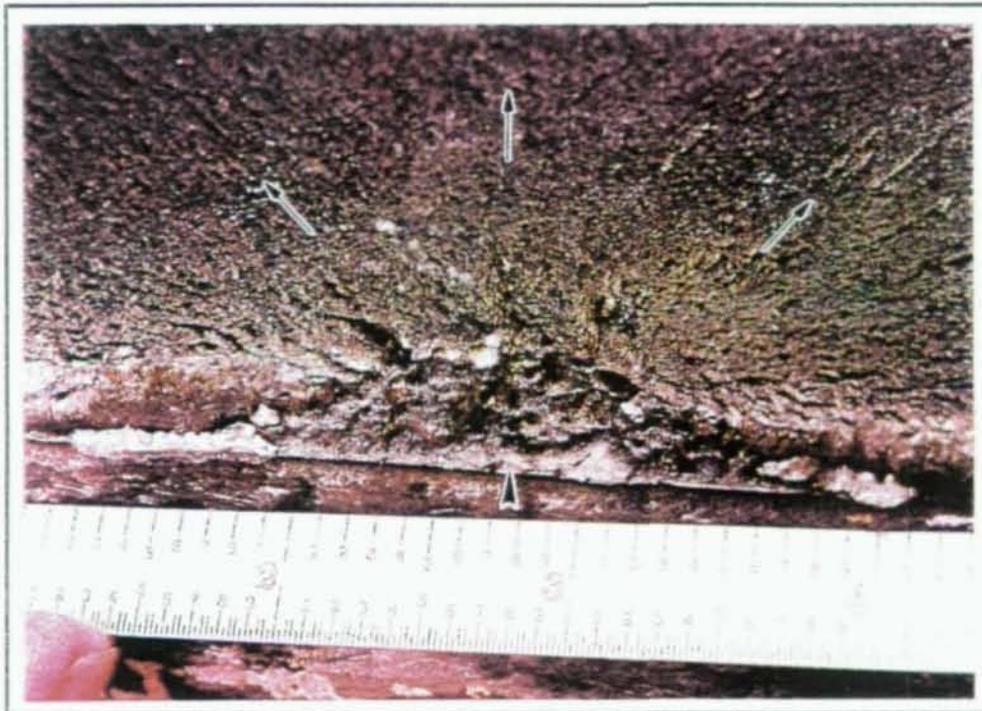
Figure 39 Fracture Origin at Top Cover Plate to Column Weld for Specimen A6. Short Arrows Indicate Origin; Long Arrows Show Crack Propagation Direction

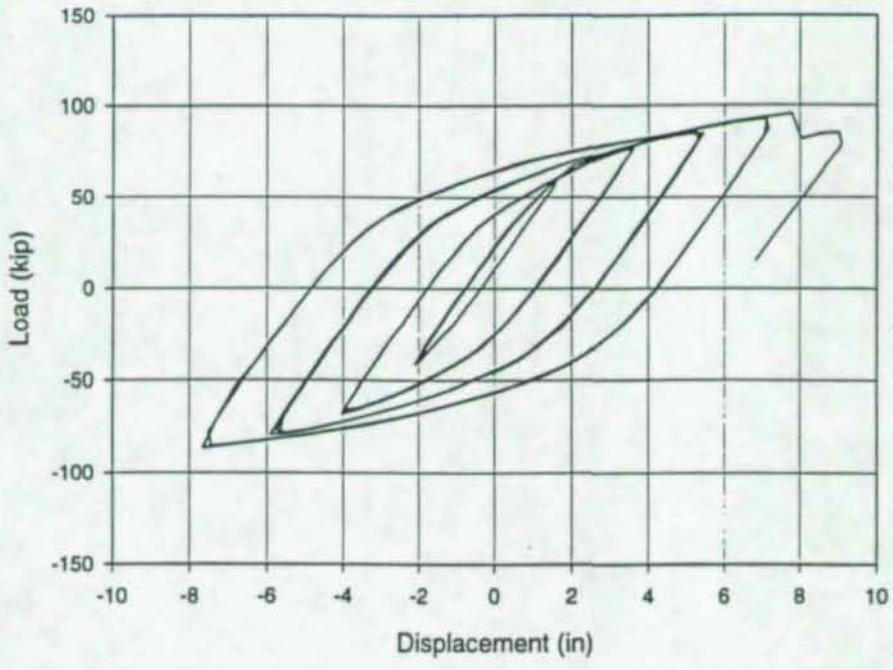
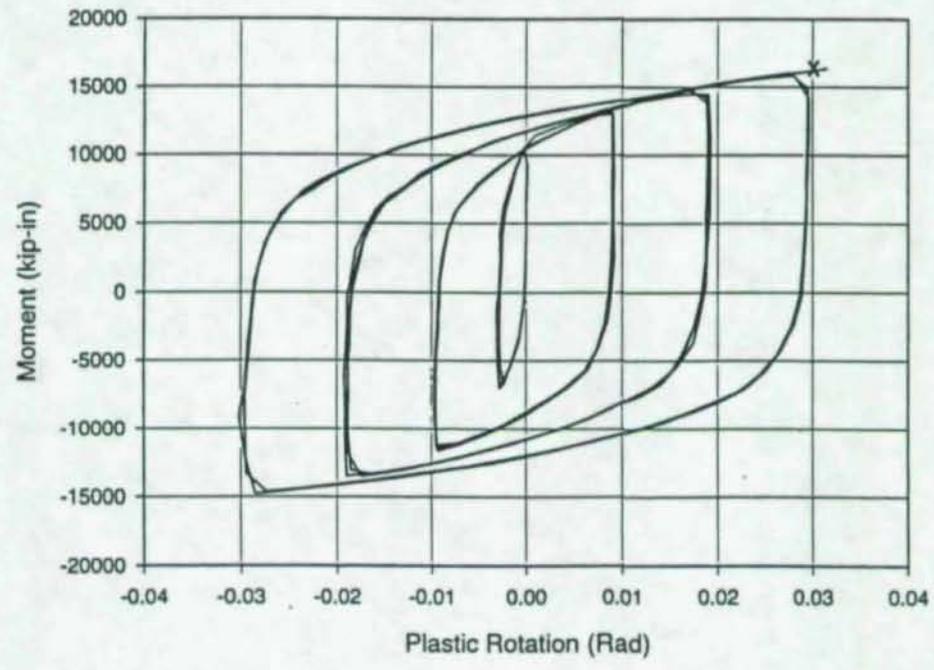
Figure 40 Load-Displacement and Moment-Plastic Rotation Hysteresis Curves for Specimen A8

Figure 40 shows the load-displacement and moment-plastic rotation hysteresis loops for Test A8. The behavior and the load and deformation levels were very similar to the specimens with rotary straightened and gag straightened columns. A8 was able to undergo 1 complete cycle at 8 inch, with maximum and minimum plastic rotations of $+0.028$ and -0.028 radians, for a cumulative plastic rotation of 0.768 radians. The normalized cumulative plastic rotation was 75.3 , evidencing significant ductility. The failure of the connection was initiated by a crack at the toe of the cover plate to column flange weld; a crack also developed at the edge of the cover plate close to the edge of the column flange.

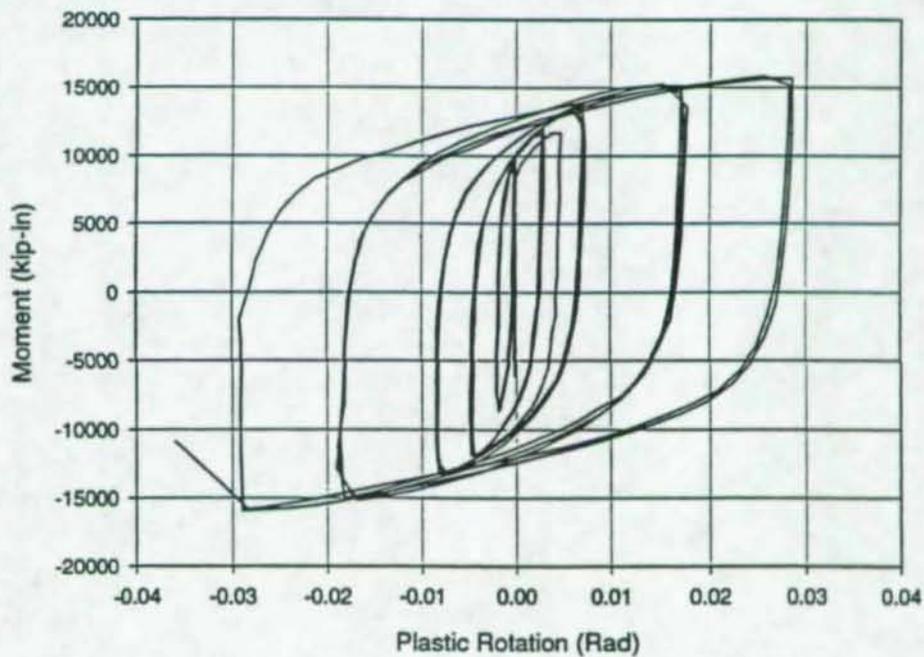
(b)

Figure 42 Load-Displacement and Moment-Plastic Rotation Hysteresis Curves for Specimen R1-2

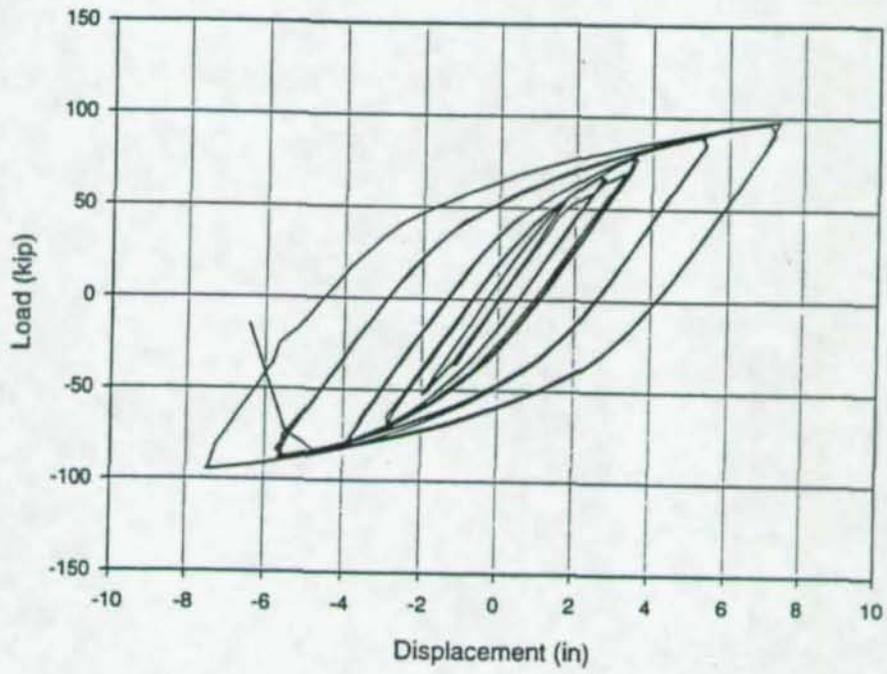
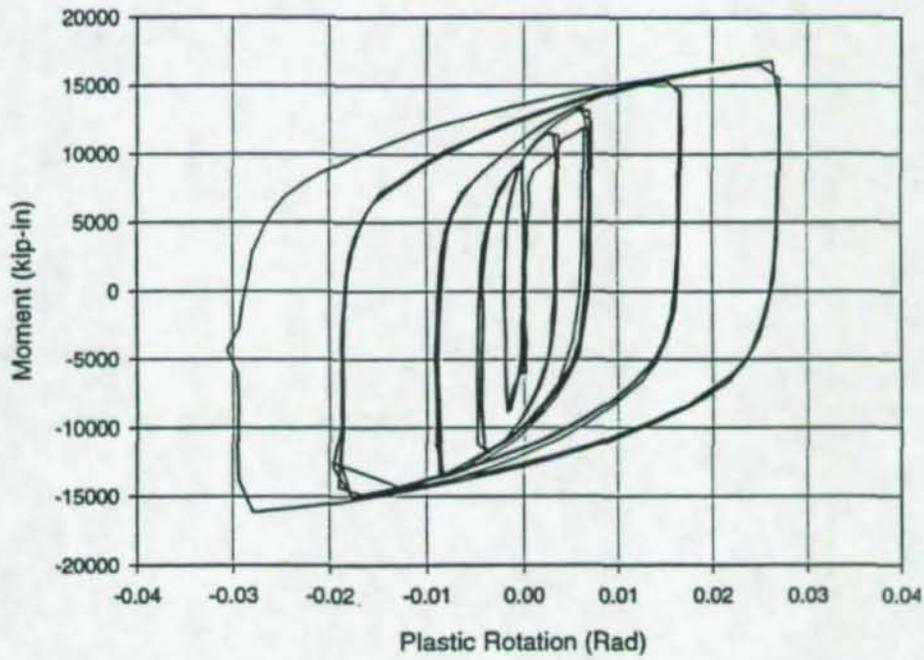
Figure 43 Load-Displacement and Moment-Plastic Rotation Hysteresis Curves for Specimen R1-3

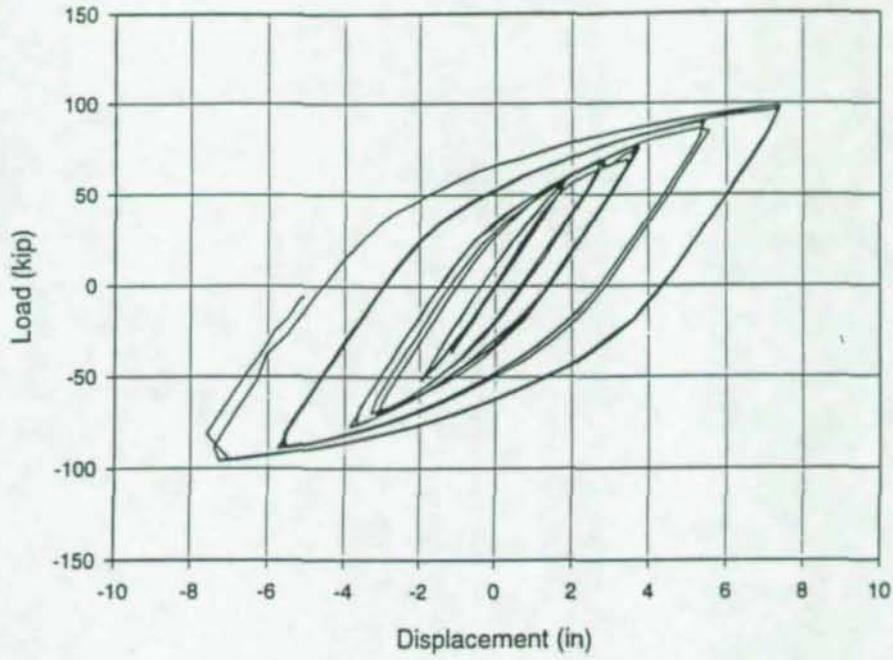
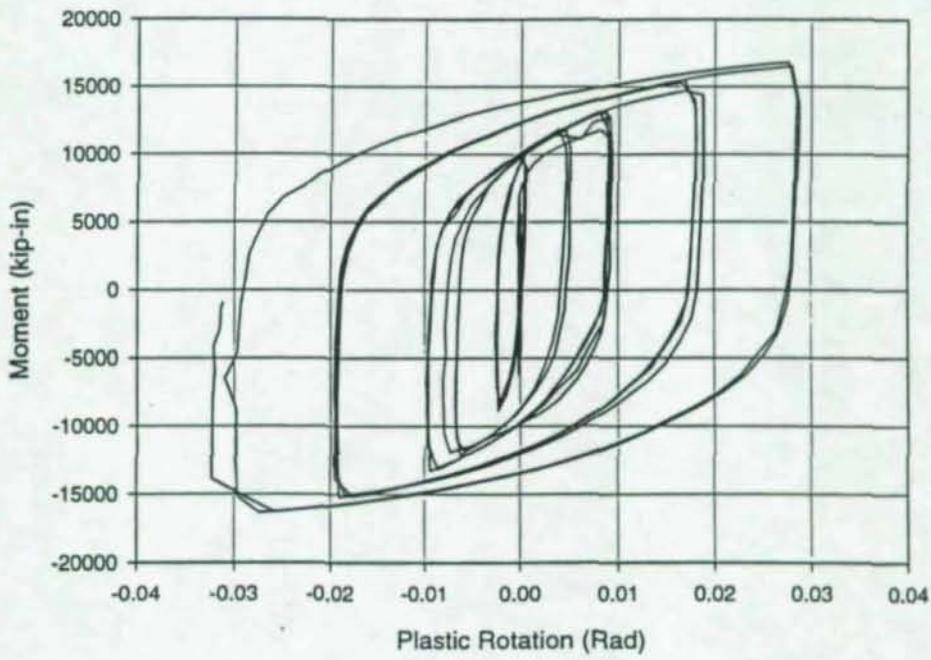
Figure 45 shows the load vs. displacement and the moment vs. plastic rotation hysteresis loops for connection R1-6. This specimen used an unstraightened column. The behavior of this assembly was similar in all respects to that of specimens R1-1 through R1-3, although it did not reach the rotation level of R1-1.

Figure 45 Load-Displacement and Moment-Plastic Rotation Hysteresis Curves for Specimen R1-6

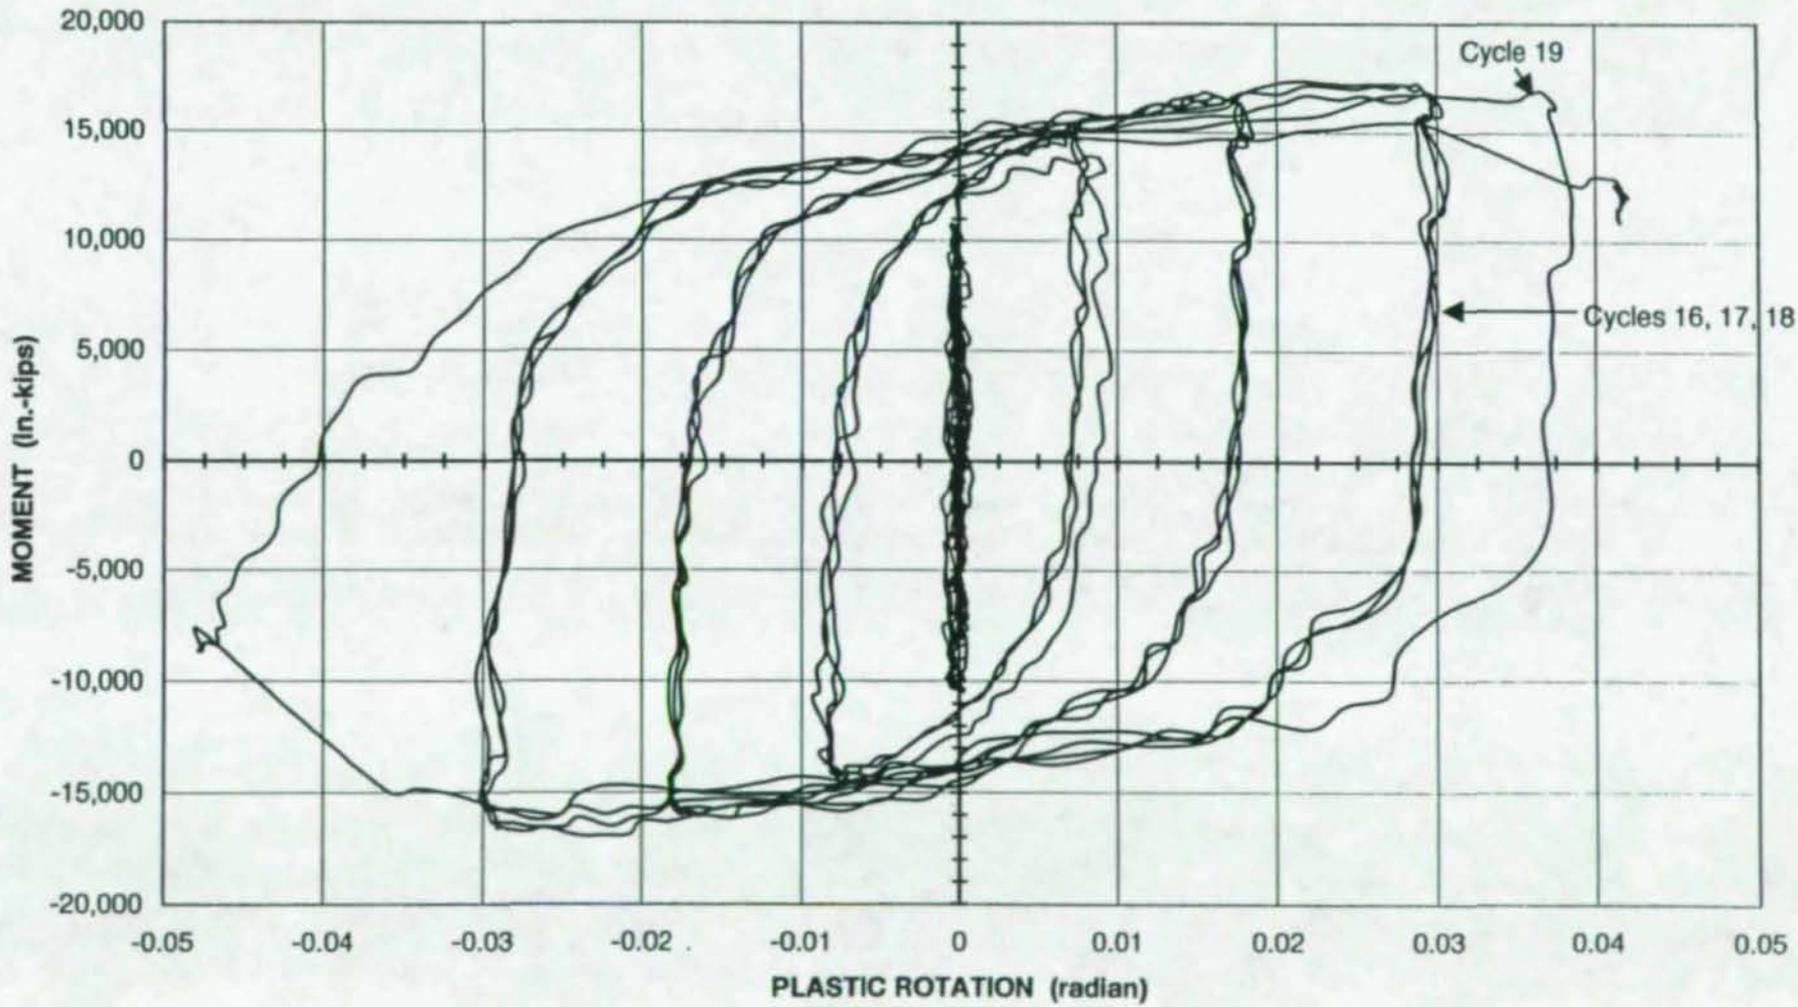
9.4.1 Specimen Test Performance: Figures 46 and 47 show the moment vs. plastic rotation hysteresis loops for Tests R1-4 and R1-5, respectively, and Figs. 48 and 49 are photographs of the specimens after failure.

Figure 46 Moment vs. Plastic Rotation Hysteresis Curves for Specimen R1-4

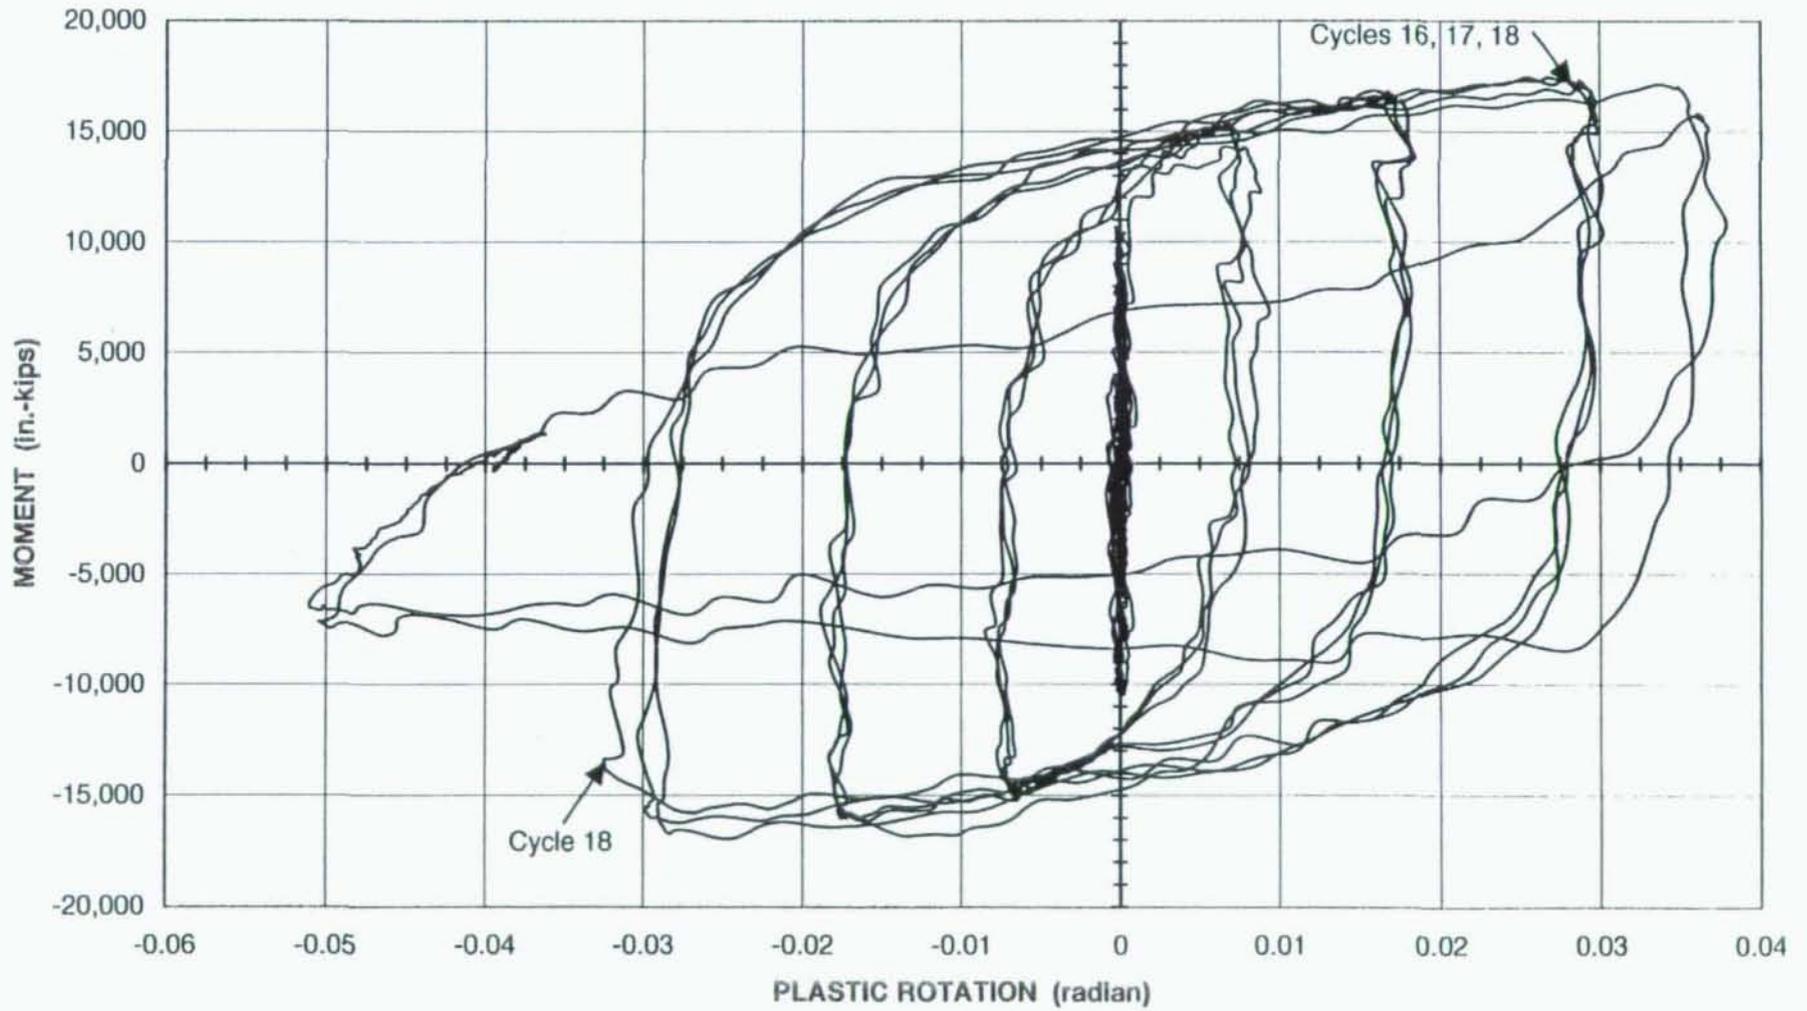
Figure 47 Moment vs. Plastic Rotation Hysteresis Curves for Specimen R1-5

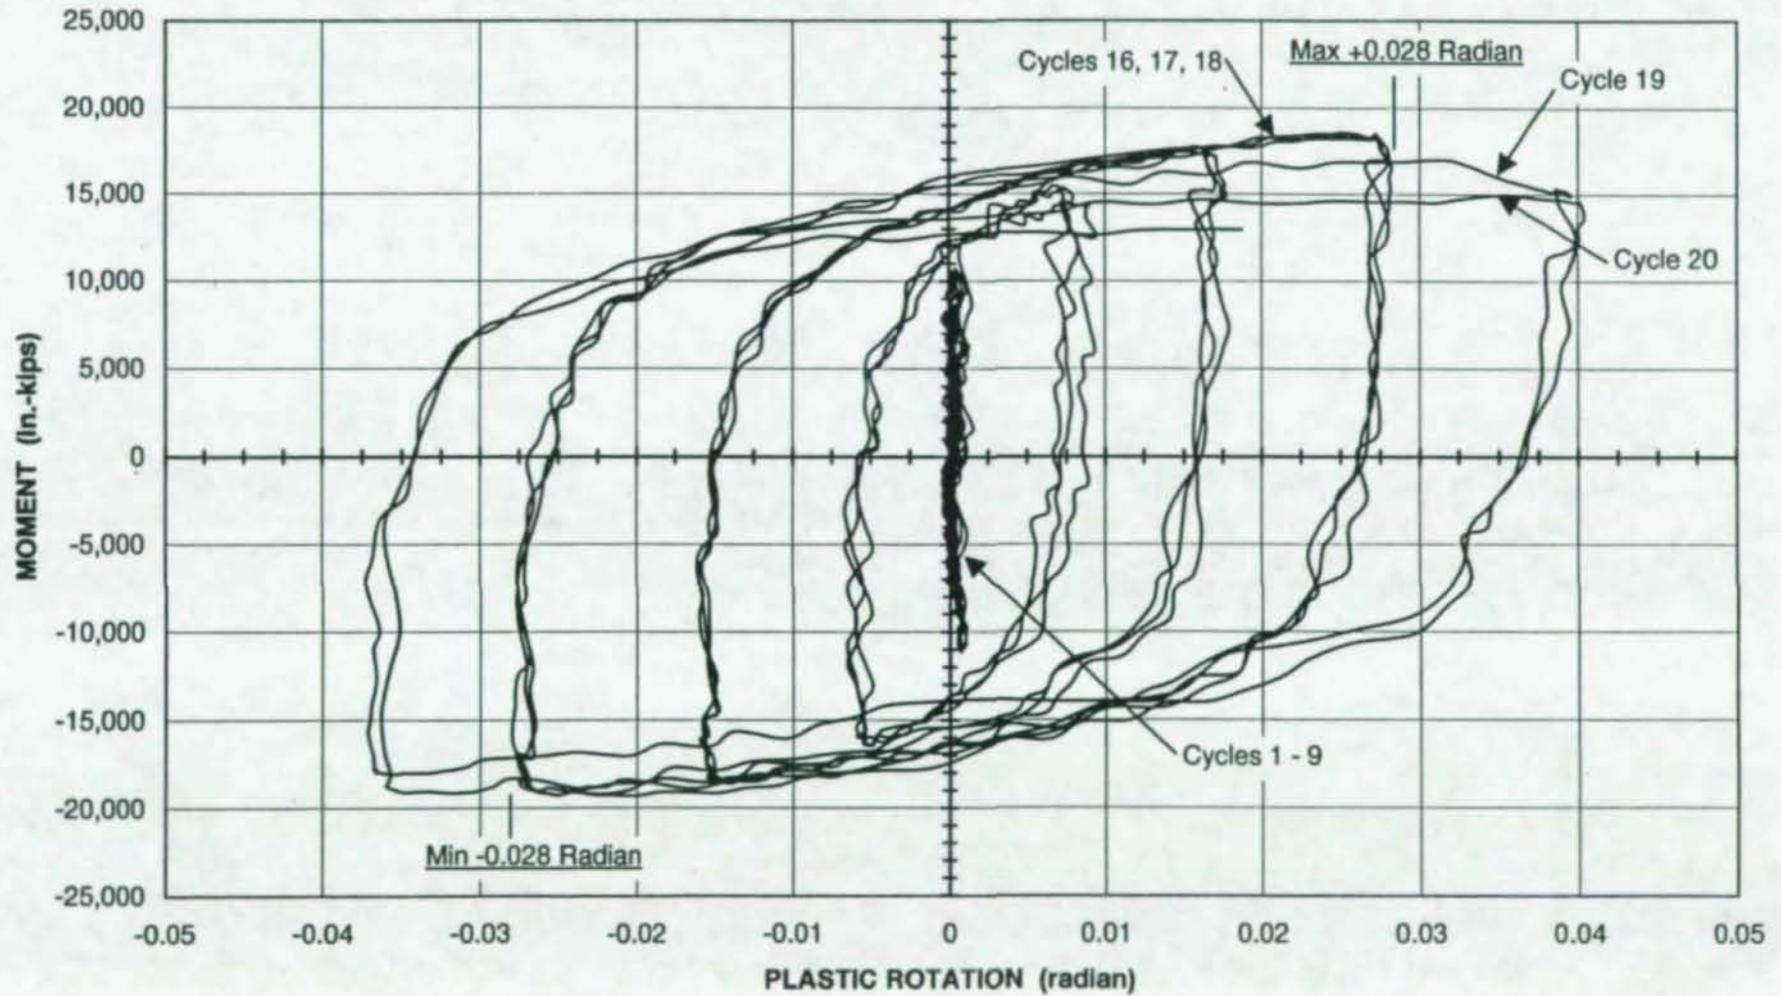
10.2.2 Plastic Rotations: Figure 51 shows that ± 0.028 radians of plastic rotation were achieved for three full cycles (nos. 16-18). Although there was a slight drop in the connection load during cycles 19 and 20, the stiffness was maintained, and plastic rotations of ± 0.038 radians were achieved. It was therefore determined that the FEMA new construction requirement of ± 0.030 radians was met.

Figure 51 Moment vs. Plastic Rotation Hysteresis Curves for Specimen R2

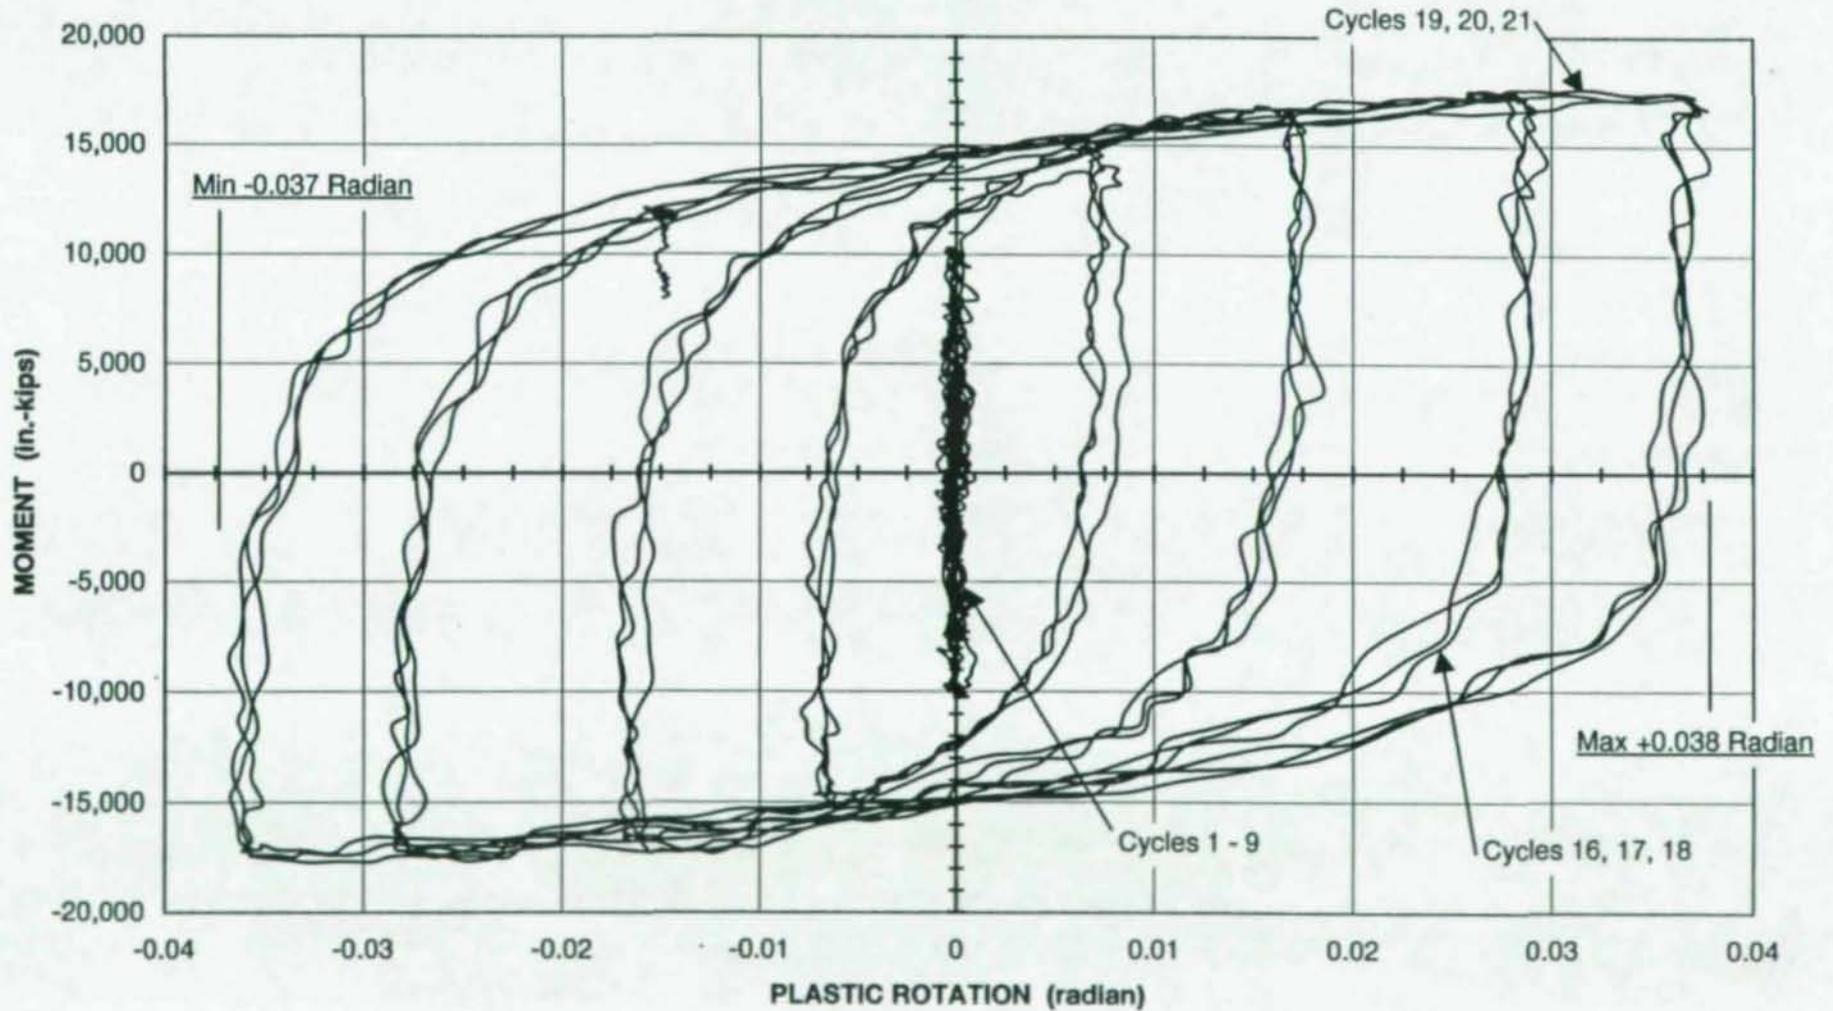
11.2.1 Specimen Test Performances: Figures 53 and 54 show the moment vs. plastic rotation hysteresis loops for connections R3-1 and R3-2. The maximum and minimum loads for Specimen R3-1 were +106.5 kips and -106.0 kips, respectively; this occurred during second cycle of the 8 inch displacement amplitude. The connection maintained full stiffness for all three of the 8 inch cycles (nos. 16-18) as well as the three 10 inch displacement cycles. *At the time of the testing of R3-1, it was the only one of the 16 connections that had been tested so far that was able to sustain more than one complete 10 inch amplitude cycle.* The test of R3-1 continued

Figure 53 Moment vs. Plastic Rotation Hysteresis Curves for Specimen R3-1

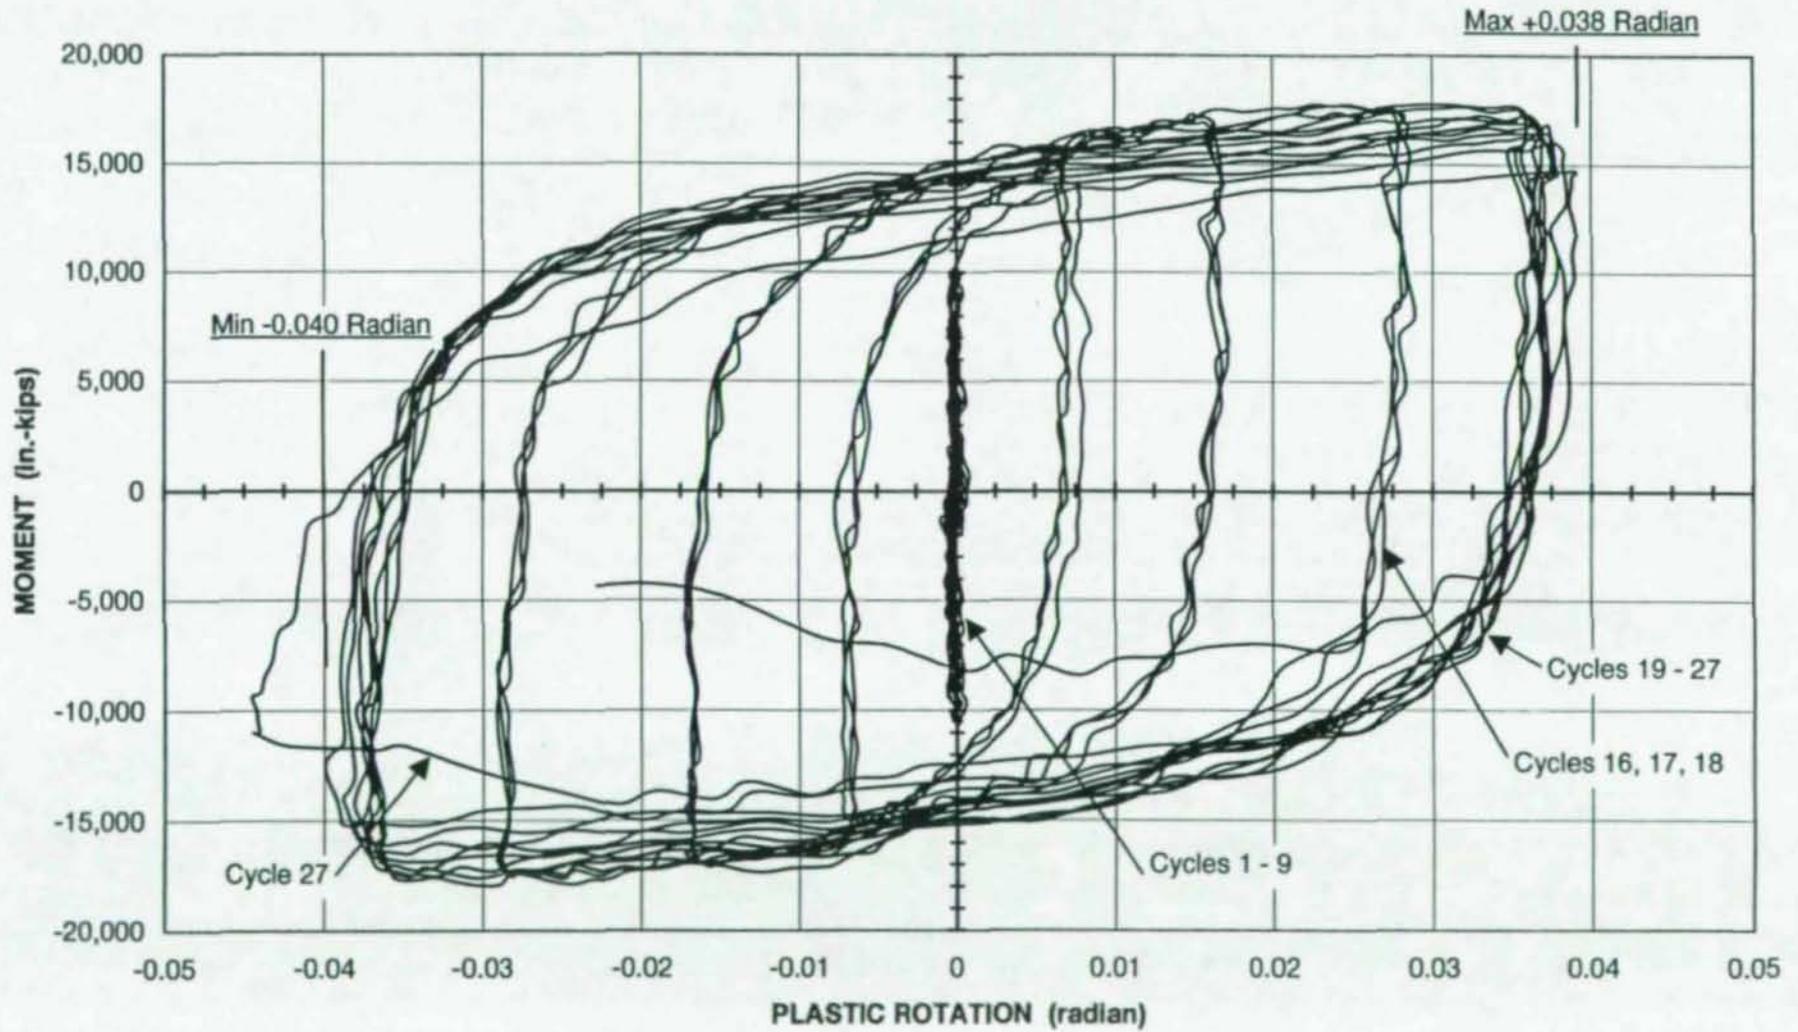
Figure 54 Moment vs. Plastic Rotation Hysteresis Curves for Specimen R3-2
