**STRUCTURAL SYSTEMS
RESEARCH PROJECT**

Report No.
SSRP-2001/05

**EFFECT OF STRAIGHTENING METHOD
ON THE CYCLIC BEHAVIOR OF k AREA
IN STEEL ROLLED SHAPES**

Final Report on a Research Project Funded by the American
Institute of Steel Construction

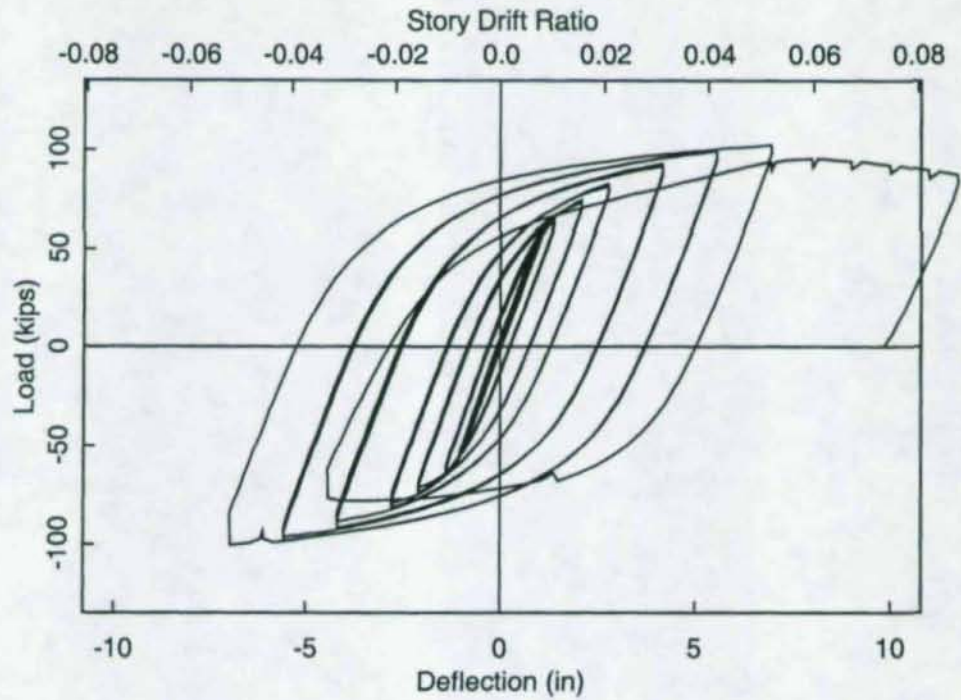
Figure 3.17 Specimen K2: Load versus Beam Tip Deflection Relationship

The load versus deflection relationship of the test specimen is shown in Figure 3.17. Ignoring the incomplete cycle where column fracture occurred, the total plastic rotation reached 0.04 radian (see Figure 3.18).

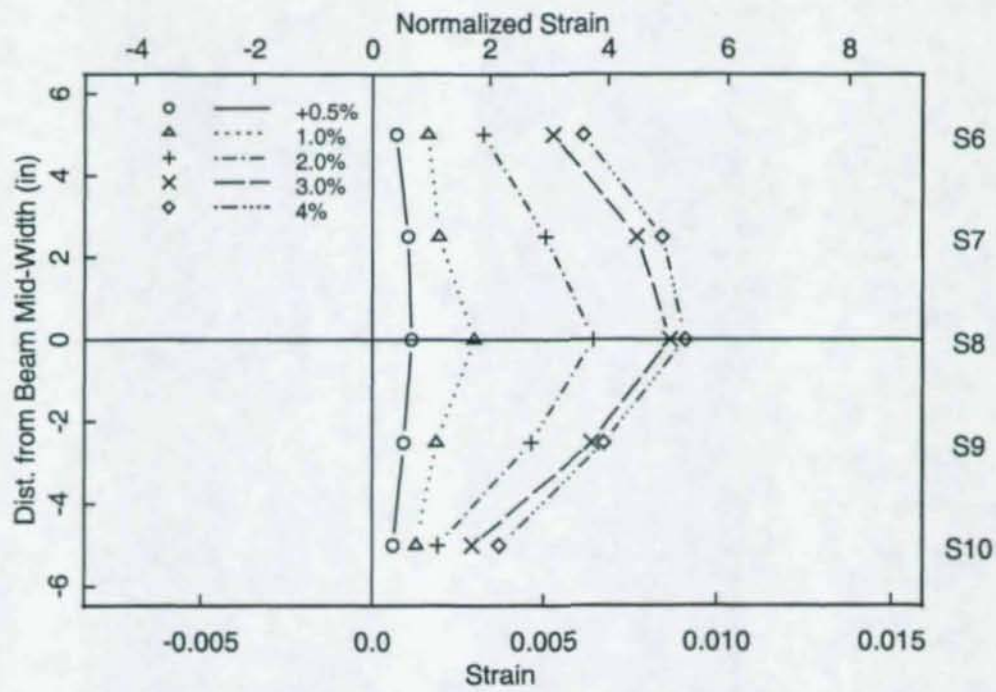
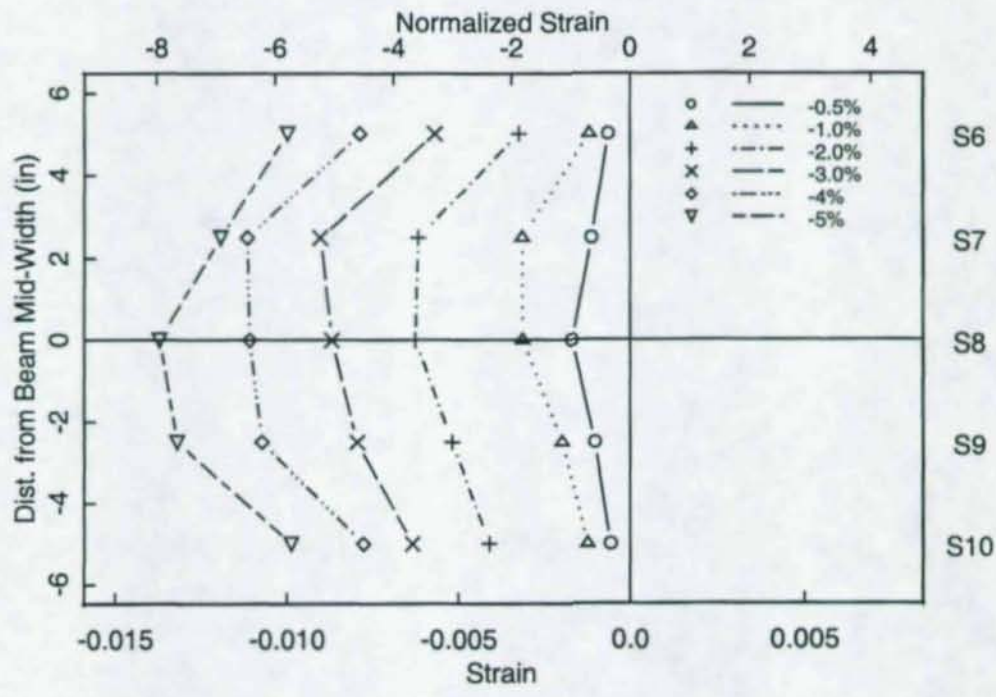
Figure 3.19 Specimen K2: Beam Bottom Flange Strain Profiles

Strain gradient through the thickness of the beam flange, similar to that shown in Figure 3.7, was also observed in this specimen. Figure 3.19 shows the strain profiles across the width of the beam bottom flange, indicating strain concentration at the mid-width of the beam flange. The out-of-plane deformation of the column flange at the top flange level is shown in Figure 3.20(a). The transverse strain of the column flange in Figure 3.20(b) is lower than that of Specimen K1, probably due to the fracture of the column flange at the beam top flange level. The strain profiles along the k line of the column at the top flange level are depicted in Figure 3.21. The maximum tensile strain reached $12\epsilon_y$. The strain state in the k area of the column at the top flange level is shown in Figure 3.22. The measured strains next to the hole at the bottom flange level are shown in Figure 3.23.

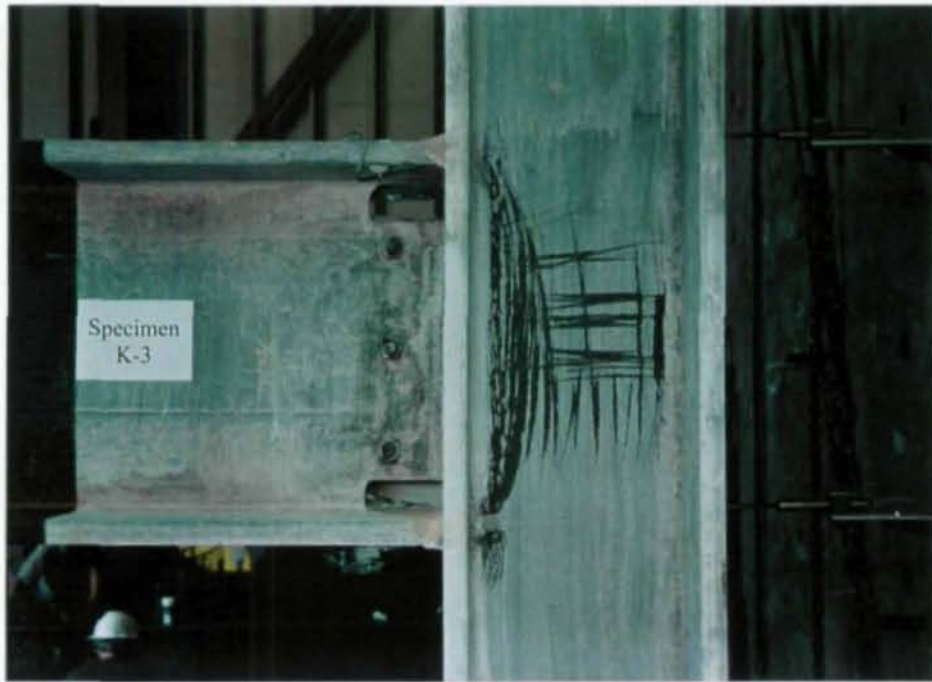
Flaking of the whitewash around the hole was observed at 0.5% drift. Panel zone yielding occurred during the 0.75% drift cycles (see Figure 3.24). Flaking of the column flange just above the beam top flange and below the beam bottom flange was noticed at 1.5% drift. Significant column kinking due to the yielding of panel zone occurred at 3% drift (see Figure 3.25). At the end of 3% drift cycles, sign of cracking at the column flange at both beam flange levels were observed.

Figure 3.24 Specimen K3: Panel Zone Yielding Pattern at 1% Drift

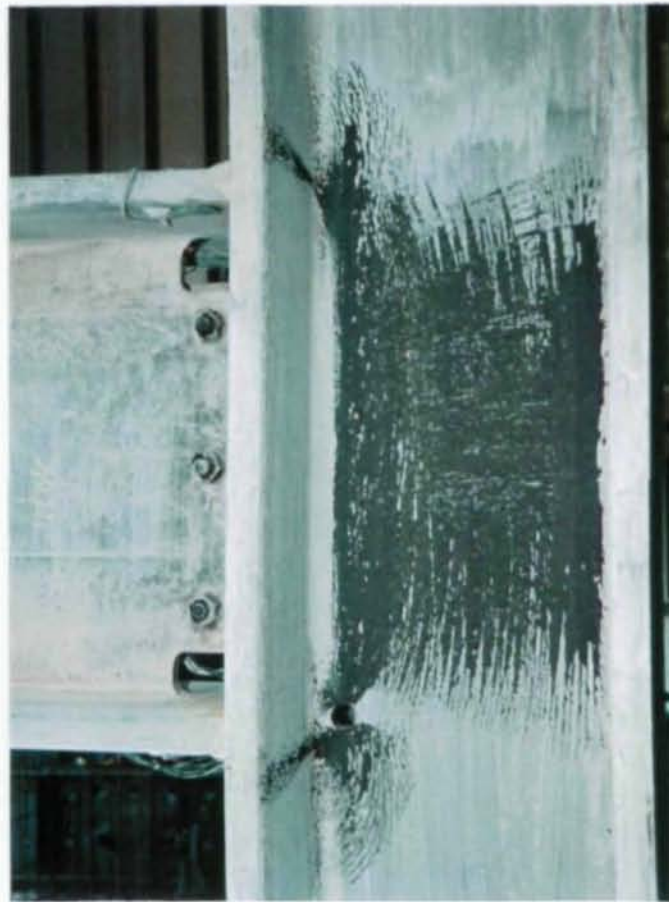
Figure 3.25 Specimen K3: Panel Zone Yielding Pattern at 3% Drift

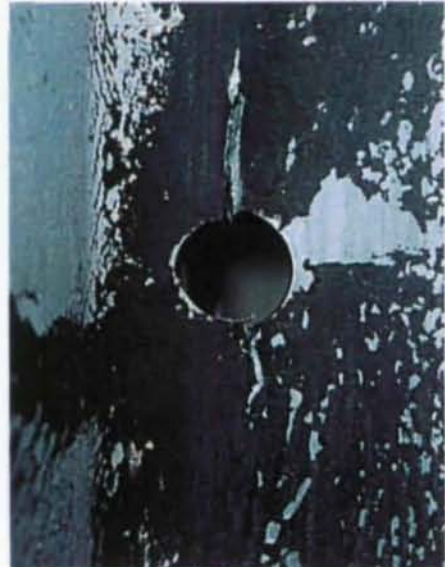
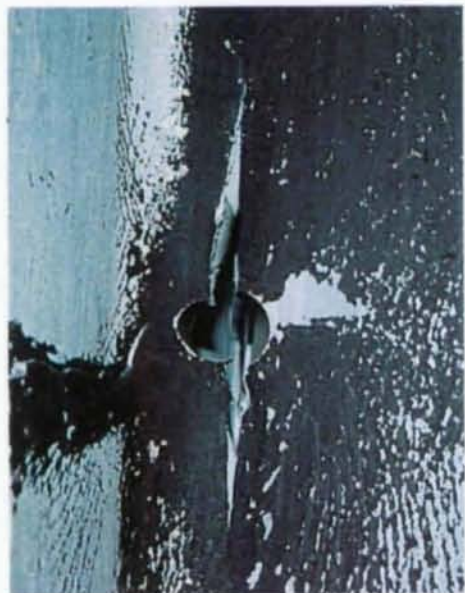
Figure 3.28 Specimen K3: Fracture Propagation in Hole Region

Figure 3.26 shows the extent of column fracture during the first cycle at 5% drift. Shown in Figure 3.27 is the complete fracture of the column flange during the second cycle of 5% drift. The extent of fracture propagation around the hole during the 5% drift cycles is presented in Figure 3.28. Although the propagation of cracks along the k line was relatively fast, the behavior was not brittle and the strength degradation was limited. The specimen was able to experience one excursion at 6% drift before it failed in the reverse excursion. While the fracture in the column flange propagated into the column web near the k area for Specimens K1 and K2, this was not the case for Specimen K3. The latter one also performed better than the other two specimens; Specimens K1, K2, and K3 experienced complete fracture of the column at 4%, 5%, and 6% drifts, respectively.

(b) 5% Drift, 2nd Cycle at 1.02 in

(c) 5% Drift, 2nd Cycle at 3.14 in

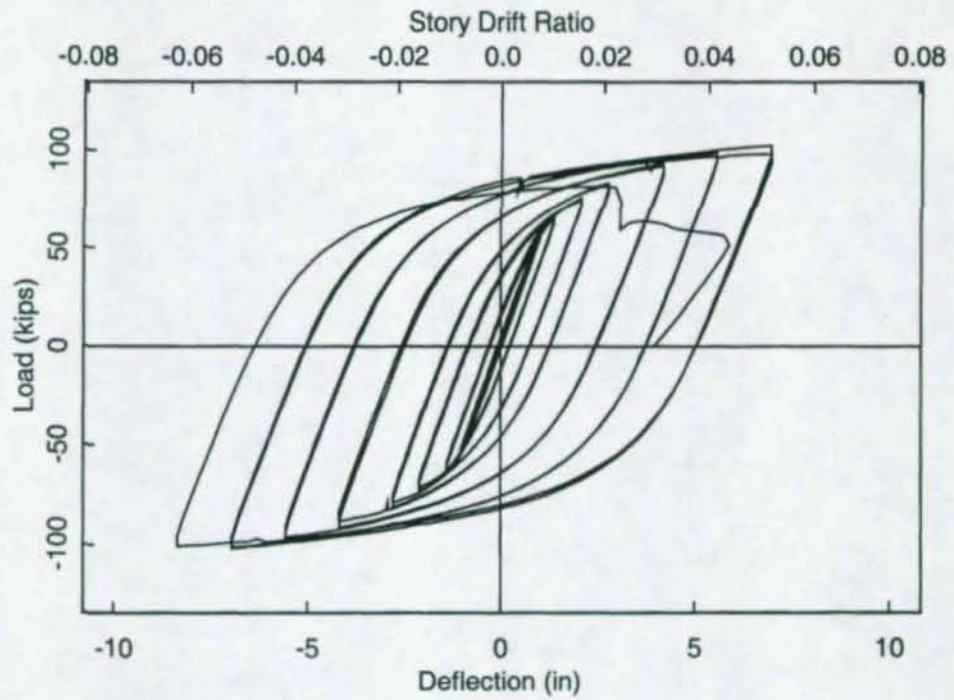
Figure 3.29 Specimen K3: Load versus Beam Tip Deflection Relationship

The load versus deflection relationship of the test specimen is shown in Figure 3.29. Ignoring the incomplete cycle where column fracture occurred, the total plastic rotation reached 0.04 radian (see Figure 3.30).

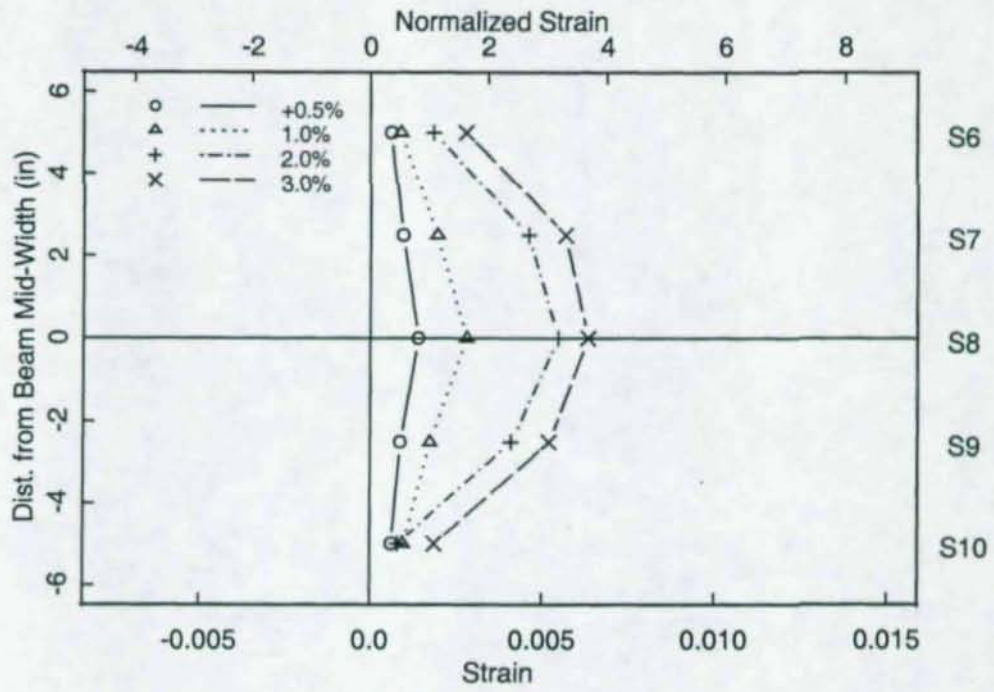
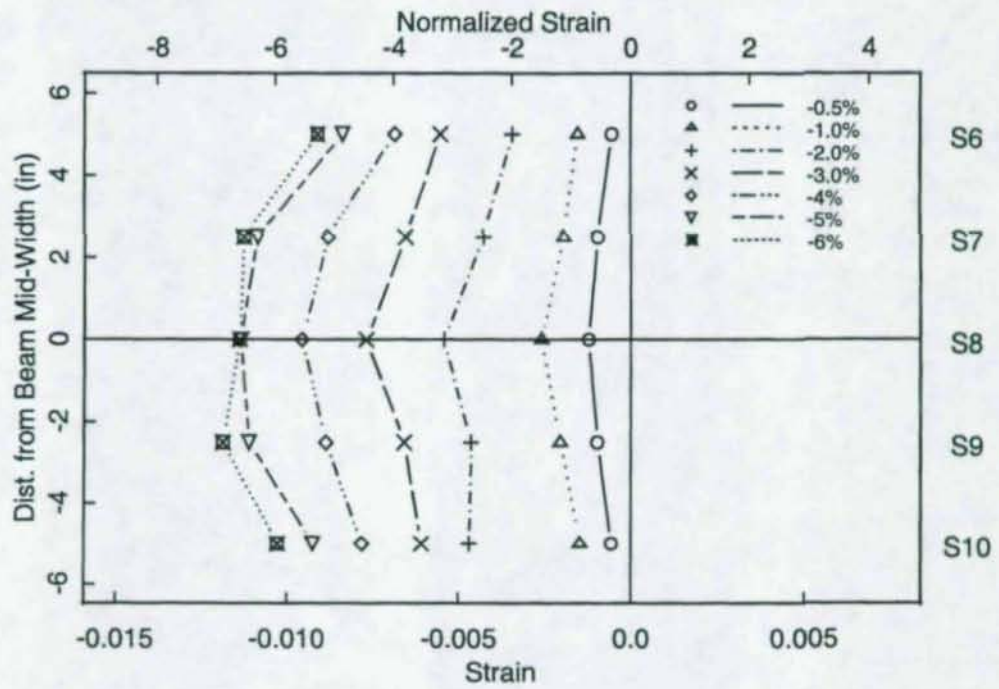
Figure 3.31 Specimen K3: Beam Bottom Flange Strain Profiles

The strain profiles across the width of the beam bottom flange are shown in Figure 3.31. The out-of-plane deformation of the column flange reached 0.15 in. at 5% drift [see Figure 3.32(a)]. The strain profiles along the k line of the column at the top flange level are shown in Figure 3.33. Figure 3.34 shows the strain state in the k area at the top flange level. Figure 3.35 shows the strain state next to the hole at the bottom flange level. Because the extent of crack in the hole region of Specimen K3 at 5% drift was more significant than that of Specimen K2 at 6% drift, the softening of the stiffness attracted less force (or strain) demand in the hole region.

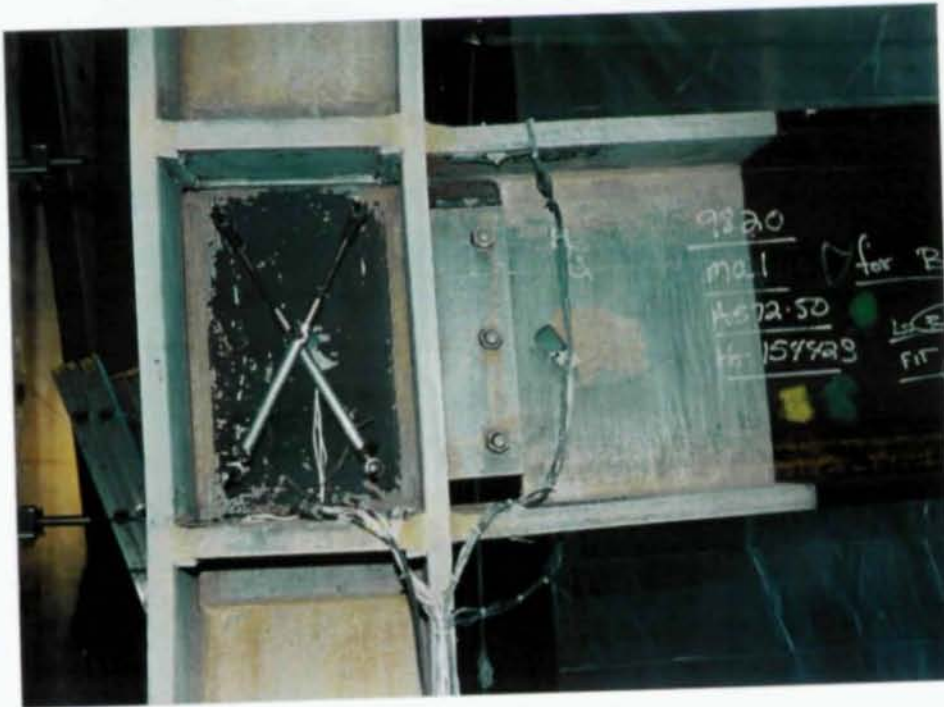
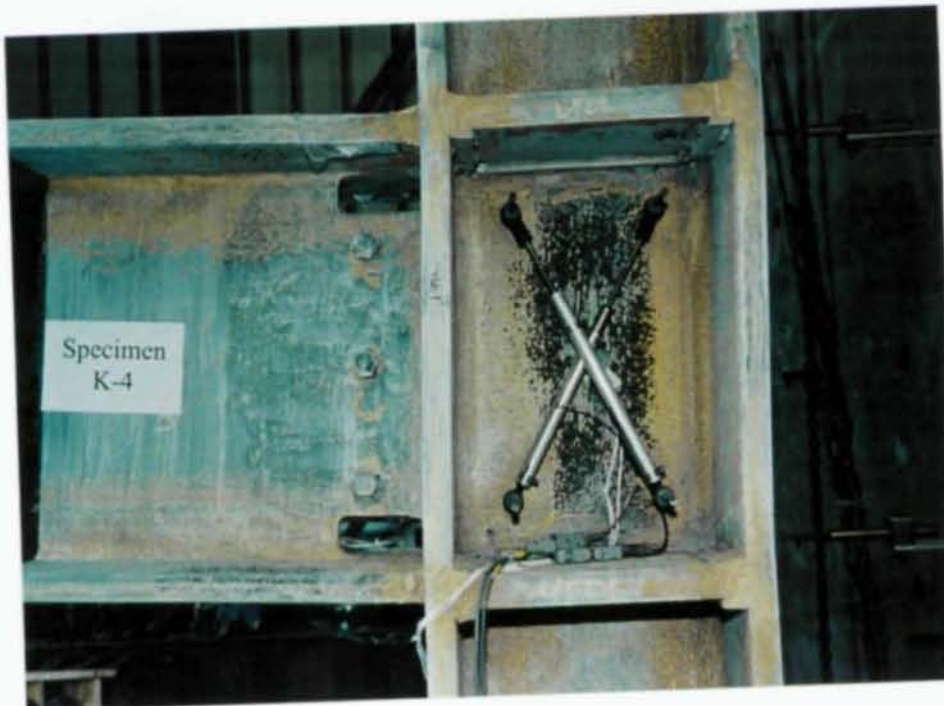
Minor flaking of the whitewash in the panel zone (both the column web and doubler plate) was first observed at 1% drift. Flaking in the beam flanges was observed at 3% drift. Figure 4.1 shows that, at 4% drift, the yielding of the test specimen was concentrated in the panel zone. The doubler plate experienced more yielding than that in the column web because a lower grade of steel (A36) was used. Figure 4.2 shows the kinking of the column due to significant yielding in the panel zone during the first cycle at 5% drift. After completing one cycle at 6% cycle, the beam top flange experienced brittle fracture during the second cycle. Figure 4.3 shows that the fracture initiated from the weld access hole in the k area of the beam web and was due to stress concentration. The test was then stopped.

Figure 4.1 Specimen K4: Yielding of Panel Zone at 4% Drift

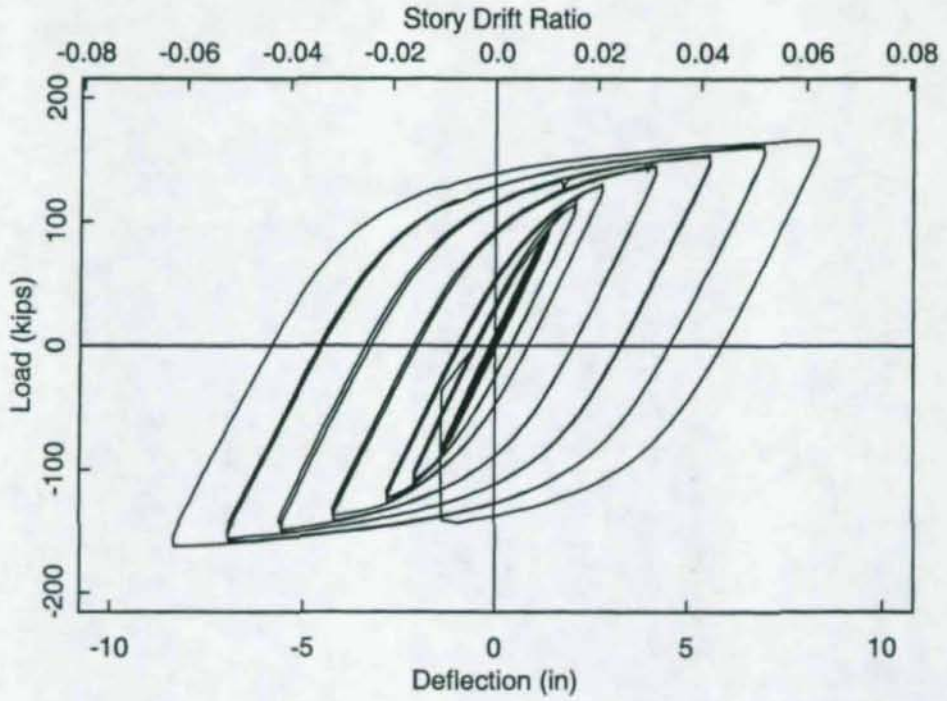
Figure 4.4 Specimen K4: Load versus Beam Tip Deflection Relationship

The load versus deflection relationship of the test specimen is shown in Figure 4.4. Prior to column fracture, the total plastic rotation reached 0.047 radian (see Figure 4.5). Figure 4.6 shows that the shear deformations in both the doubler plate and column web in the panel zone were about the same. The continuity plates were effective to reduce the strain concentration in the beam flanges (see Figure 4.7). Nevertheless, continuity plates did not eliminate the strain gradient through the thickness of the beam flange (see Figure 4.8).

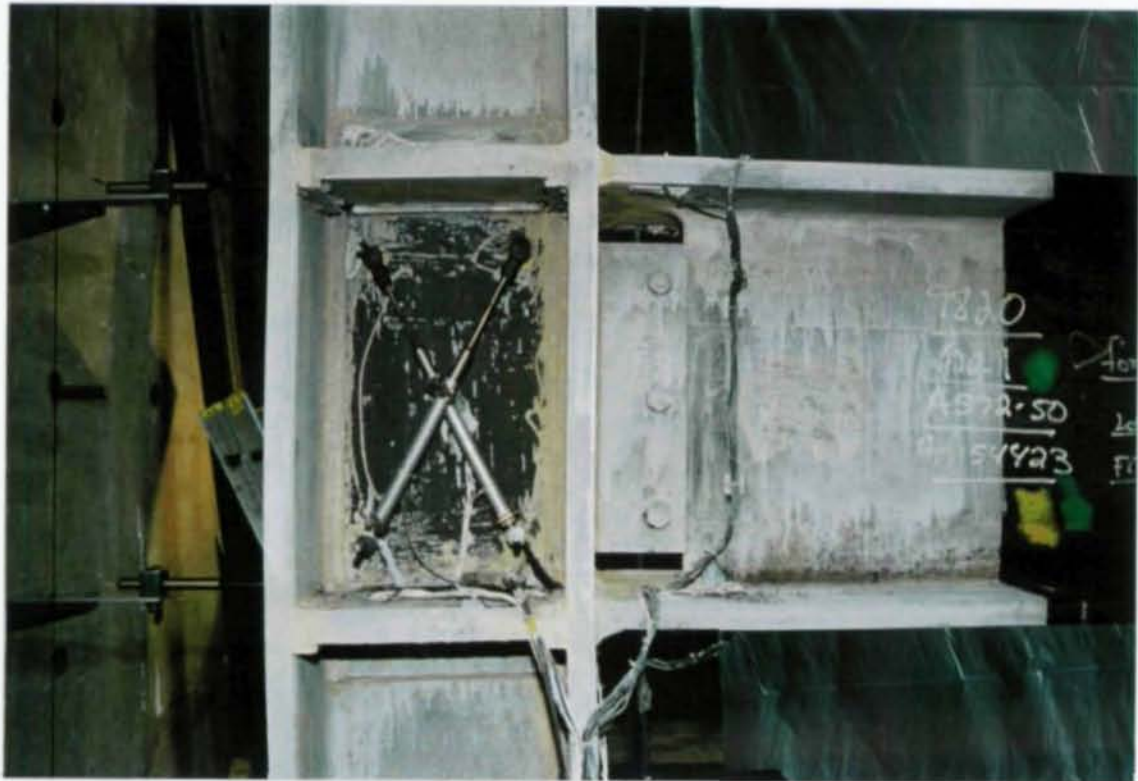
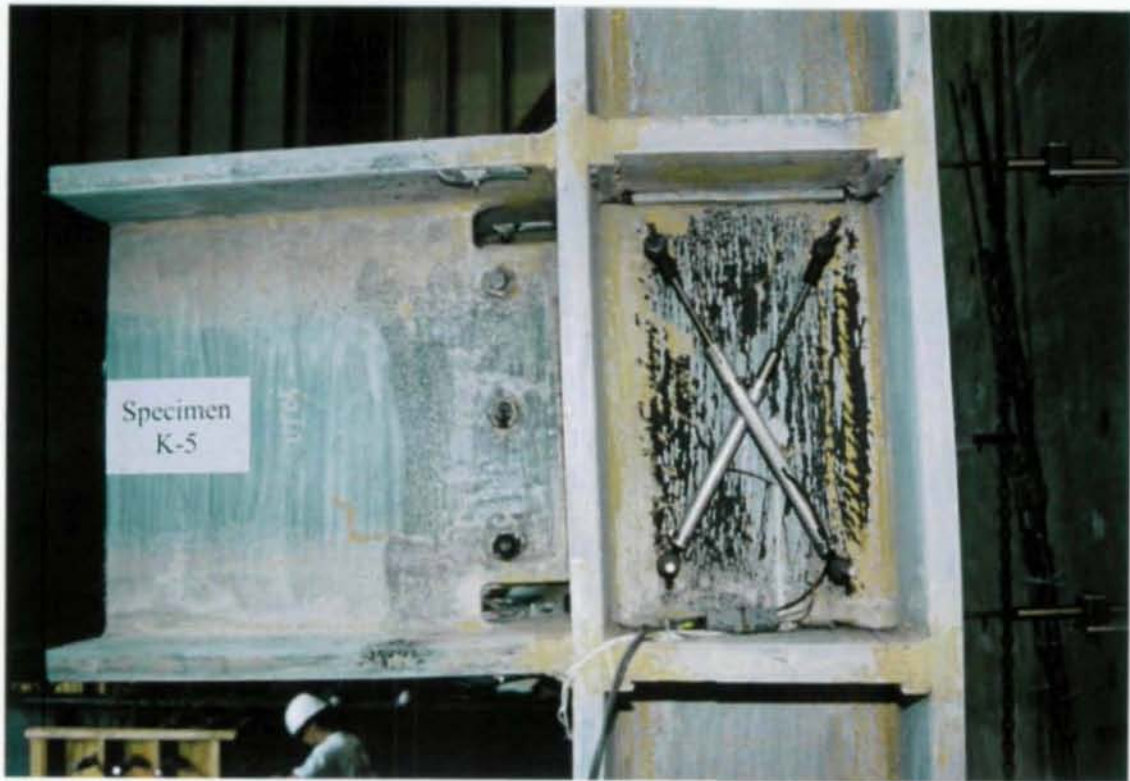
Figure 4.9 Specimen K5: Yielding Pattern in the Panel Zone at 3% Drift

The performance of this specimen was very similar to Specimen K4. Figure 4.9 shows the yielding in the panel zone at 3% drift. Figure 4.10 shows that the beam flange had yielded, but no local buckling was observed. Figure 4.11 depicts the column kinking due to yielding in the panel zone at 5% drift. At this drift level, sign of stress concentration at the weld access hole started to show (see Figure 4.12). The curvature of the beam bottom flange in the weld access hole region, shown in Figure 4.13, was an indication that a significant amount of beam shear was transferred through the beam flanges to the column. Brittle fracture of the beam bottom flange occurred during the first cycle at 6% drift (see Figure 4.14), and the test was stopped. The fracture occurred in the k area of the beam web due to stress concentration in the weld access hole.

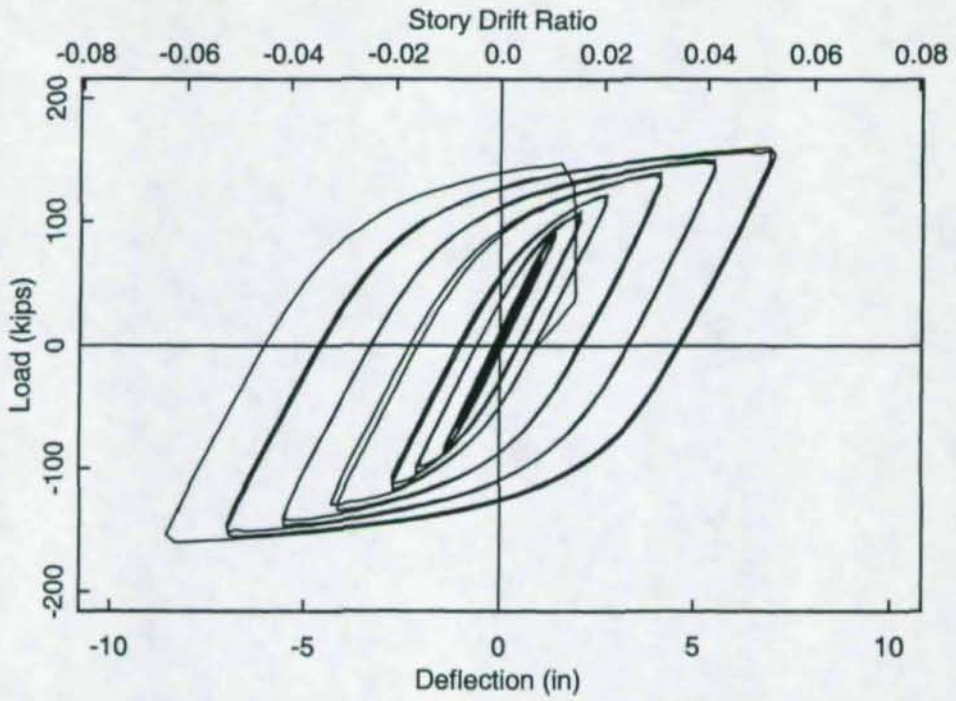
Figure 4.15 Specimen K5: Load versus Beam Tip Deflection Relationship

The load versus deflection relationship of the test specimen is shown in Figure 4.15. Prior to column fracture, the total plastic rotation averaged 0.038 radian (see Figure 4.16). Figure 4.17 shows that the panel zone shear deformations in both the column web and the doubler plate were similar. With the presence of continuity plates, the beam flexural strains across the width of the beam flange were relatively uniform (see Figure 4.18). A rosette (R3) was placed $\frac{1}{2}$ in. from the weld access hole of the bottom flange. Figure 4.19 shows that the vertical component of the strain reached 7.4 times the yield strain.

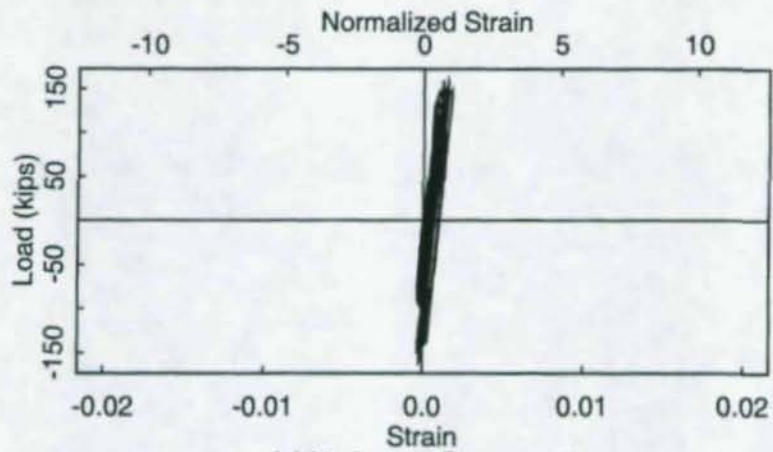
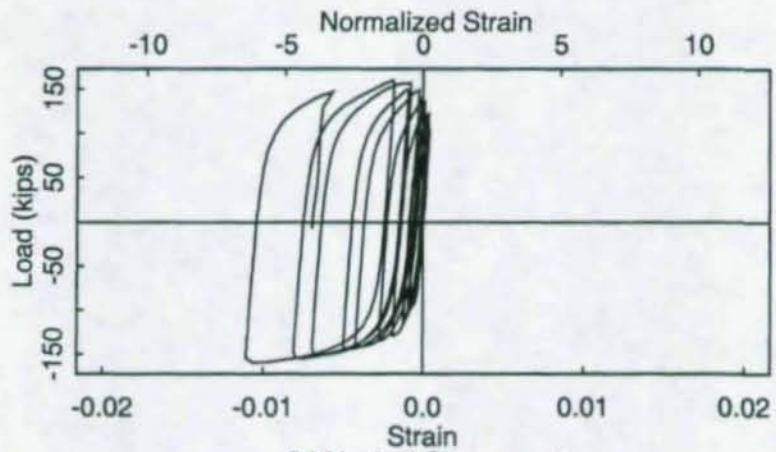
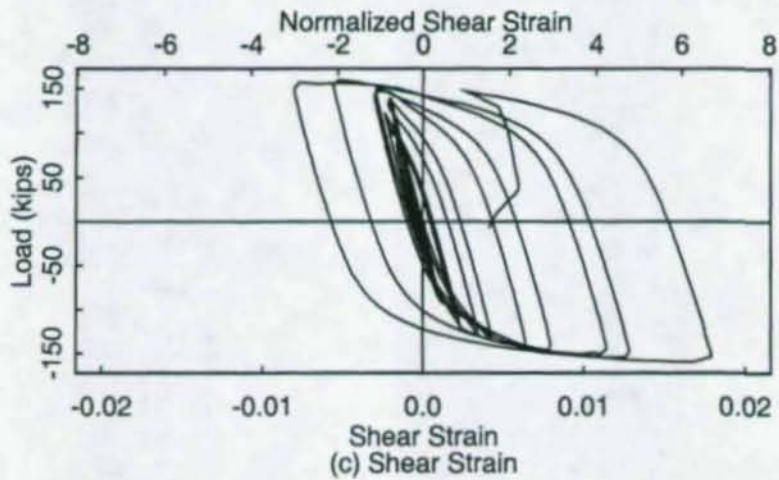
Figure 4.19 Specimen K5: Strains near Beam Bottom Flange Weld Access Hole

Significant kinking of the column due to panel zone yielding did not cause fracture. Instead, since the bending moment in the beam was higher, the beam flange strains ($\approx 15\epsilon_y$) were about twice the values ($\approx 7\epsilon_y$) recorded in the first three specimens. Brittle fracture eventually occurred in the beams, initiating at either the top or bottom flange from the weld access hole. Stress concentration that occurred in the k area of the beam was responsible for the crack initiation. To prevent this type of failure, providing a smooth profile for the weld access hole is very important.

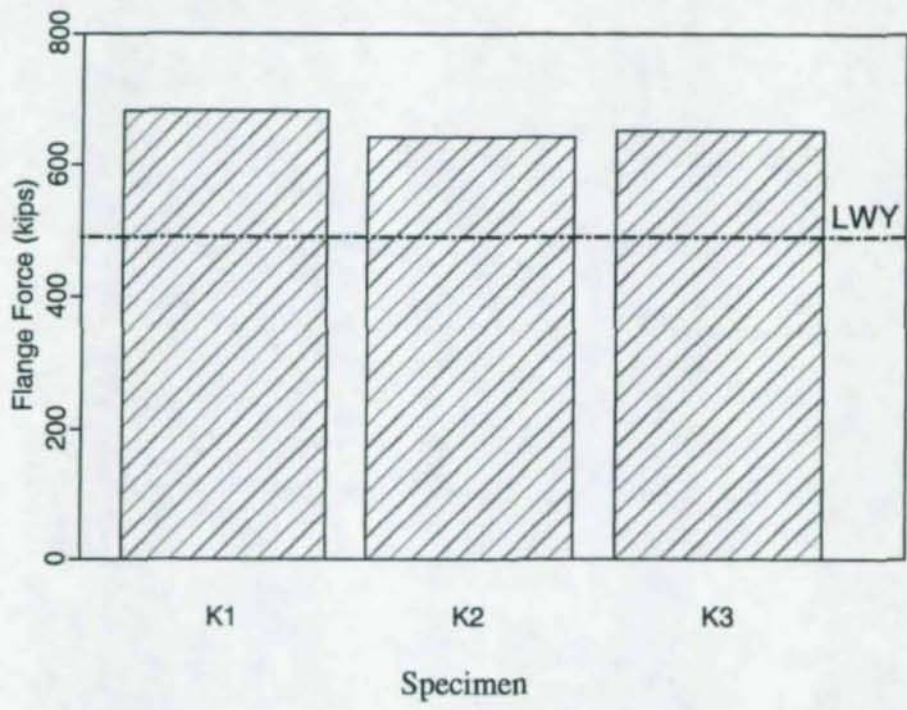
Figure 5.1 Comparison of Strength for Local Web Yielding

The maximum force applied by the top flange of the beam to the column can be estimated by Eq. 2.3. A comparison of these forces with the LRFD strength (Eq. 2.2) for local web yielding is shown in Figure 5.1. The LRFD strength is exceeded by 34% on average. For seismic design, taking advantage of a portion of this overstrength to reduce the thickness and the associated welding of continuity plates appears beneficial. To match the measured strength for local web yielding, Eq. 2.2 can be modified as follows:
