# PROGRESSIVE COLLAPSE RESISTANCE OF STEEL BUILDING FLOORS

FINAL REPORT

REPORT NUMBER: UCB/CEE-STEEL-2001/03  
DEPARTMENT OF CIVIL AND ENVIRONMENTAL ENGINEERING  
COLLEGE OF ENGINEERING  
UNIVERSITY OF CALIFORNIA AT BERKELEY

Report to the Sponsors: American Institute of Steel Construction  
and General Services Administration  
September 11, 2001

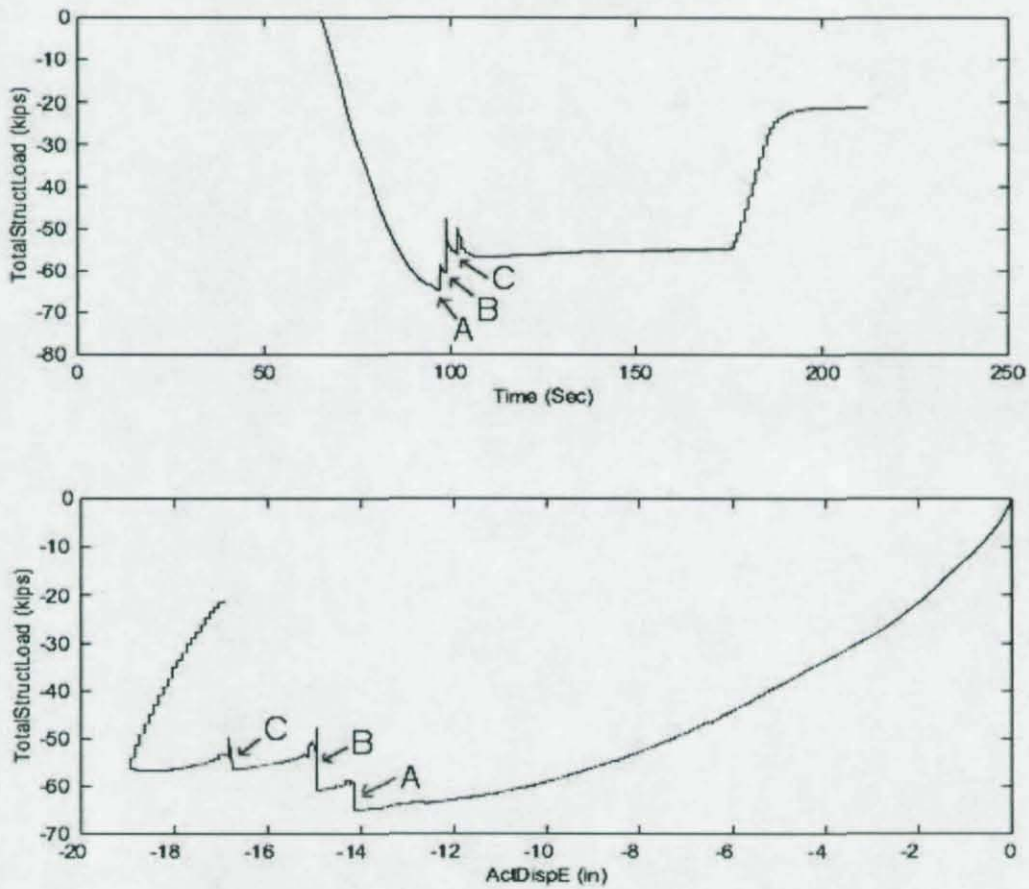
Figure 3.1. Force Time History and Force versus Displacement for 19-inch Drop Test

As the column displacement exceeded 14 inches, failure occurred of the top two bolts on the lower leg of the seat angle that holds the longitudinal beams. This is identified as spike "A" in both the force time history and force displacement plots in Figure 3.1. The end of the bolts, including the nuts, violently shot through the air while the head of the bolts remained in place. Four bolts held the angle to the displacing column, leaving only two bolts to resist the vertical load of the beams. As the bolts were failing, the seated angle itself was undergoing local yielding and deformation. See Figure 3.2 for a photograph of the local damage.

As the displacement approached 15 inches, at the other end of one of the longitudinal beams, west of the displaced column, the two bolts that secured the beam to the top of the seated angle also failed and "popped" (Figure 3.3). Spike "B" in Figure 3.1 clearly shows the loss of strength because of the bolt failures. The shear tab that supported the transverse beam also underwent local yielding.

As the displacement approached 17 inches, slippage at some point within the structure occurred. This is evident by examining spike "C" in Figure 3.1. Although the load carrying capacity of the structure was abruptly decreased at that point, the load gradually increased to the same value as before the spike. A failure would result in an unrecoverable decreased capacity, whereas slippage only resulted in a temporary decreased load carrying capacity.

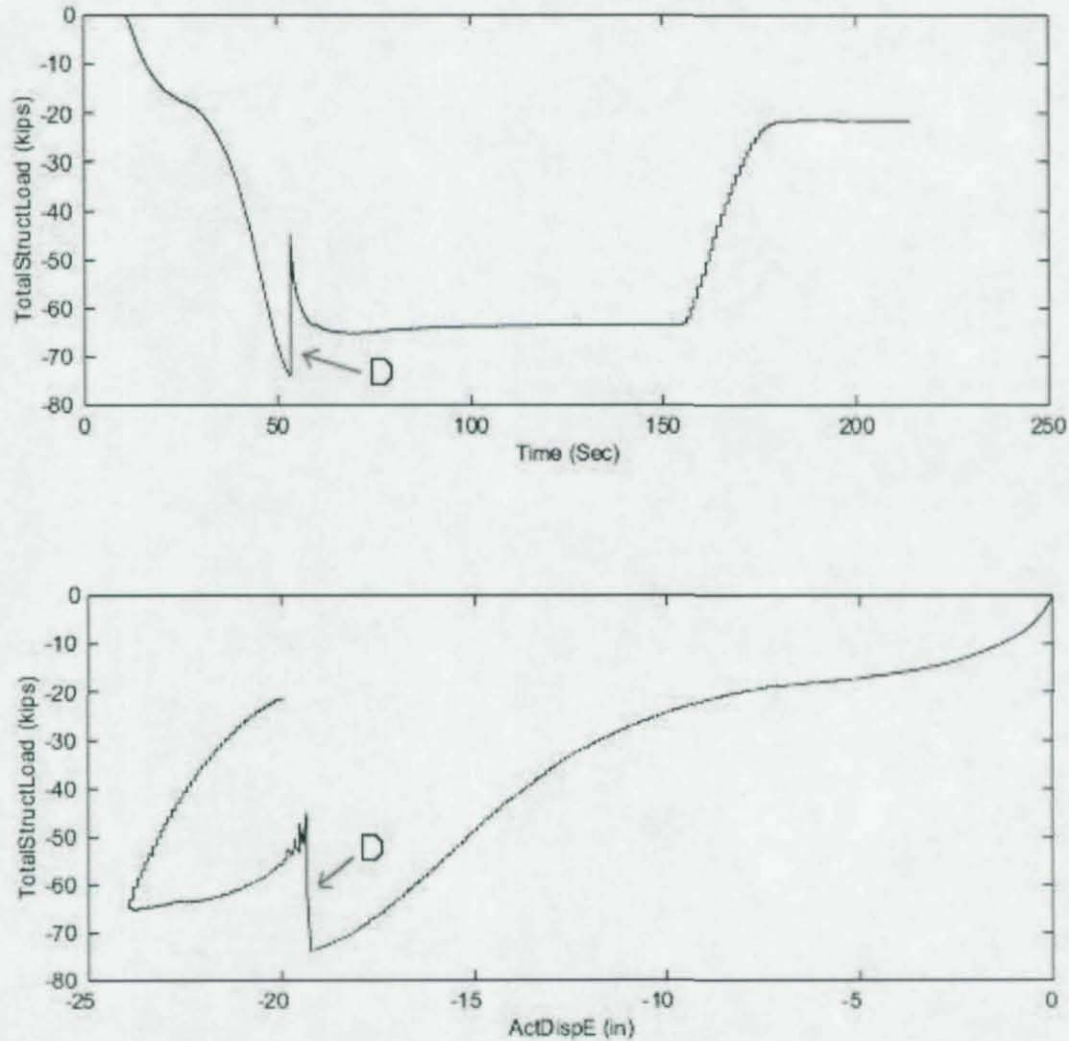
Figure 3.5. Force Time History and Force-Displacement Plot of 24-inch Drop Test.

As the column reached a displacement of approximately 19 inches, the two bolts that held the longitudinal beam, east of the loaded column, on the seated connection at column C2 failed. The dramatic drop in load is evident as spike "D" in Figure 3.5. Local yielding of the seated connection could also be observed. Also, cracking and tearing of the connecting angle between the loaded column and the longitudinal beam directly east had begun.

As a result of the two bolt failures, large eccentricities were created as the east actuator shot back to zero load while the west actuator was still providing 20 kips of load to provide the constant displacement. At a displacement of 24 inches, the west actuator was applying approximately 45 kips of downward force while the east actuator was applying approximately 10 kips of upward force.

The force-displacement plot (Figure 3.5) shows a gradual stiffening of the structure once the displacement passes 5 inches. This results from the replacement of the two bolts in the seated connection at the displaced column. The  $\frac{1}{4}$  inch gap that remained after the replacement affected the behavior of the structure. As the bolts adjusted to the gap and engaged themselves, the structure became stiffer.

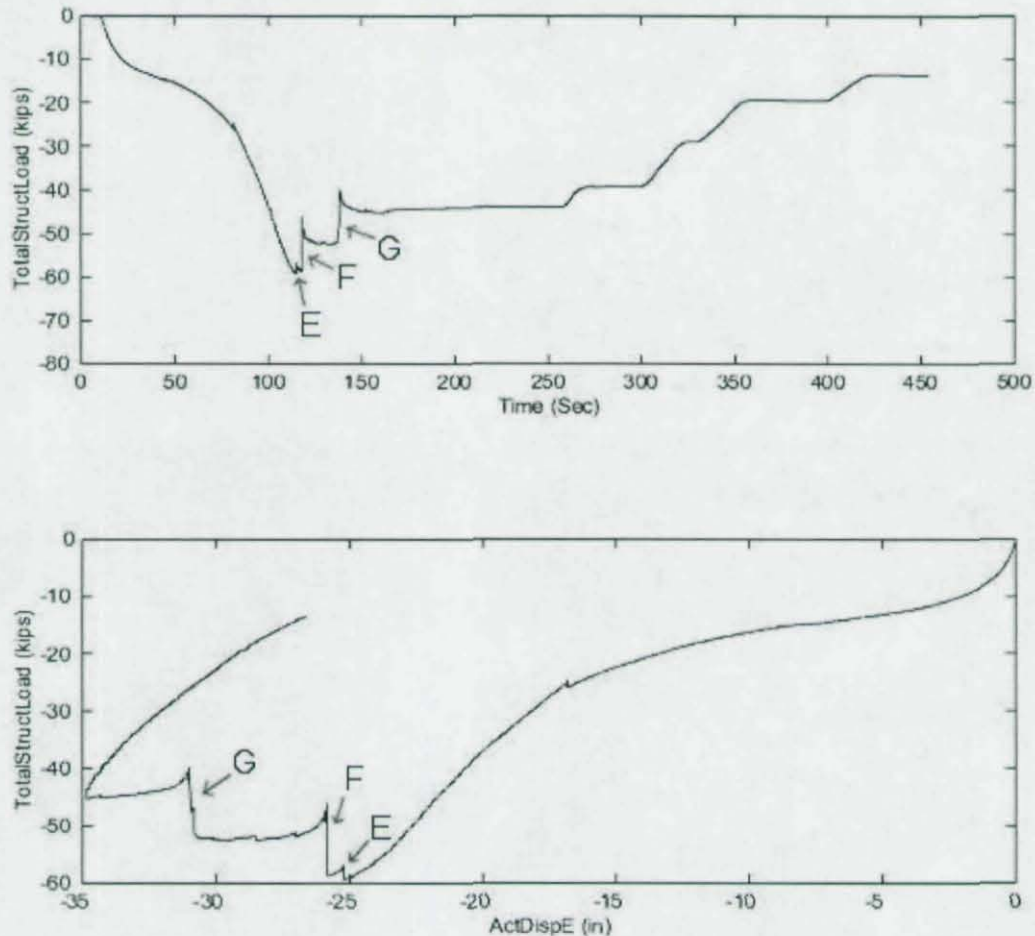
In addition to the above noted behavior, as the column displacement approached 26 inches, complete failure occurred at the connecting angle between the loaded column and the longitudinal beam directly east (Figure 3.8). Spike "F" in Figure 3.8 shows the sudden drop in load after the angle failure. The preceding spike, labeled "E," is the evidence of slippage within the structure, possibly within the angle before complete failure.

After the angle had failed, the concrete slab was the primary element transferring the applied force to the longitudinal beam directly east of the displacing column. Unable to maintain this force transfer, the slab failed in shear along the transverse beam connecting the two central columns. This is represented by spike "G" in Figure 3.8. Figure 3.8 shows specimen after failure.

Figure 3.8. Force time history and force-displacement plot of Test 2D.

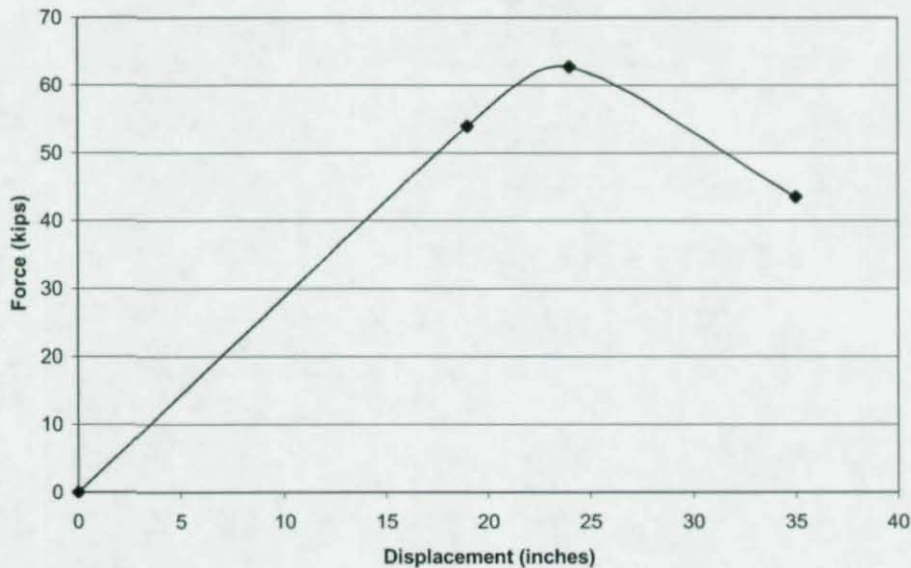
Of the three subtests, the 24-inch displacement sustained the highest load of 62.8 kips. The 19-inch and 35-inch test sustained 54.0 and 43.5 kips of loading, respectively. The load-

displacement plots of all three tests are included on one plot in Figure 3.10. As can be seen in the figure, a maximum load is reached at a displacement somewhere between 19 and 35 inches. Proximity of all five component failures can easily be seen, beginning with the initial bolt failures and ending with the complete transverse cracking of the floor slab. In addition, the stiffness degradation of the system is evident as the same load resulted in greater displacements in the following tests. The capacity of the structure was reached just before failure of the pair of bolts that secured the east beam onto the seated connection at the test column. This failure, occurring during Test 2c, resulted in the largest drop in applied load.

Figure 3.10. Force-Displacement Plot of the Three Tests.

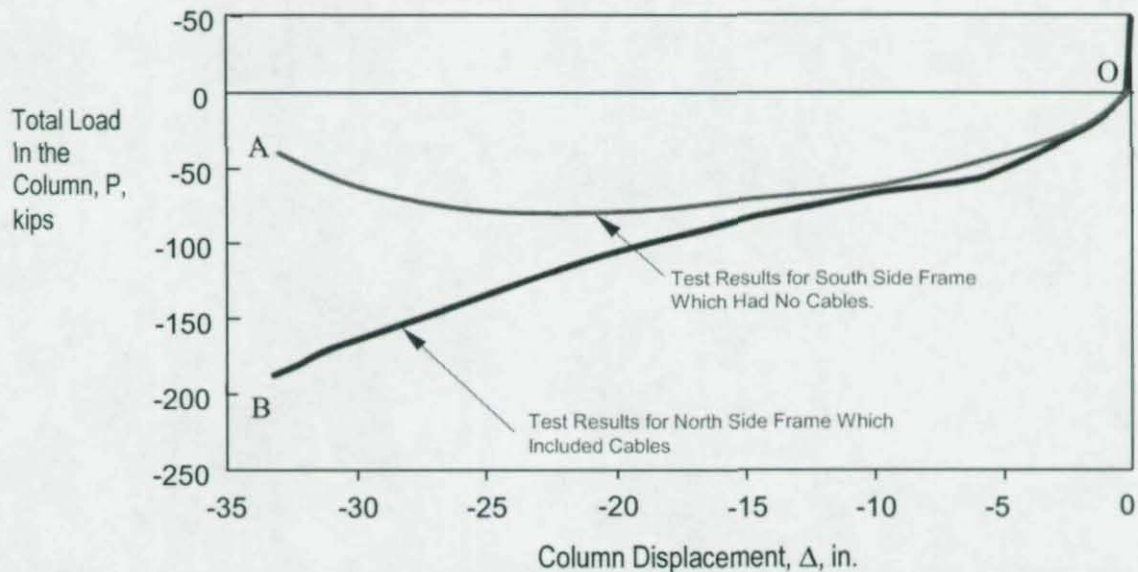
As mentioned in previous chapters, the tests reported here were conducted on a specimen that was also used to test the catenary action of cables placed in the floors. Four 1-1/4 inch diameter steel cables were placed in the slab along the south frame line. The south side was tested first and the results were reported in Astaneh-Asl et al., (2001). The north side, which did not have cables, was tested next and the results were reported in previous chapters of this report. Figure 4.1 shows a comparison of the behavior of two sides.

Figure 4.1. Comparison of Test of Specimen with and Without Cables Embedded in the Floor
