# REBUILDING A LANDMARK

An extensive reconstruction salvaged a beloved courthouse after it was devastated by fire

By Mark B. Peterman, P.E.

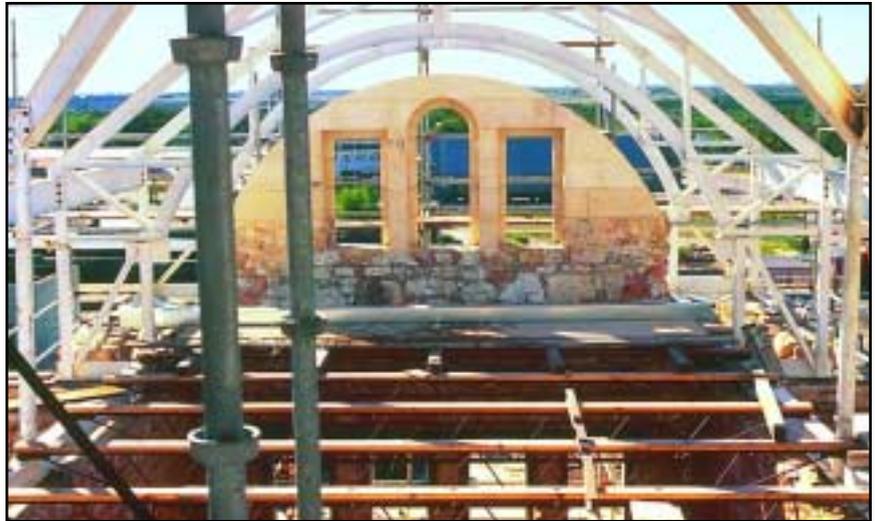
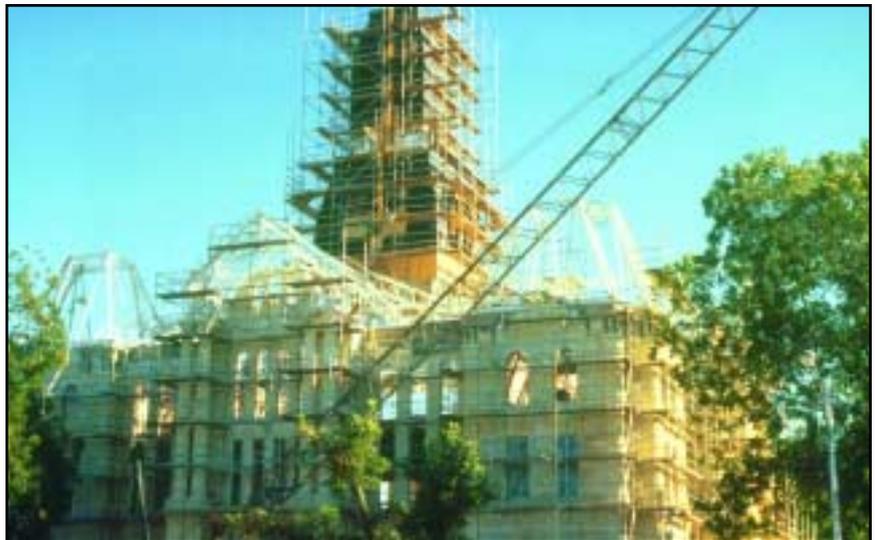
*Pictured opposite top is a portion of the attic level, while shown opposite middle is the completed exterior sheathing plus partially installed light-gage purlins on the rebuilt tower.*
