Failure Analysis of a Column k-Area Fracture

By John M. Barsom and J. V. Pellegrino, Jr.

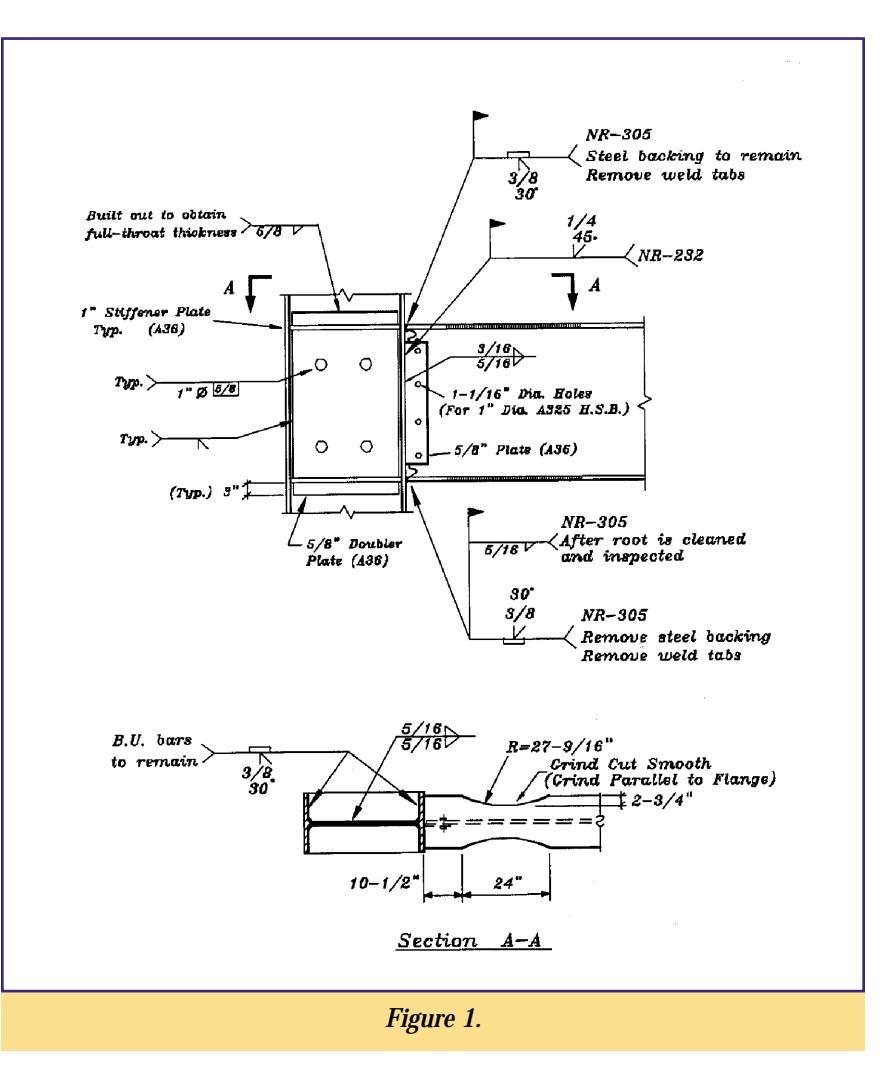
Three deep column moment connections with a Reduced Beam Section (RBS) were tested at the University of California San Diego to investigate the behavior of RBS welded moment connections (Gilton et al., 1999). One of the specimens, DC-3, had a W27×194 column, and a beam of A572 Grade 50 steel with a 5/8" thick doubler plate and 1.0" thick continuity plates. The design of specimen DC-3 is shown in Figure 1. The specimen was subjected to simulated seismic loads recommended by the SAC Joint Venture. At the peak of the second positive 4% drift cycle, specimen DC-3 developed an 8"-long crack along the k-area region of the column at the beam bottom flange level, Figure 2. The crack extended to 33" during the third positive 4% drift cycle.
