Saved from the Wrecking Ball

A deteriorating parking deck in Atlanta gets some positive reinforcement from composite steel deck.

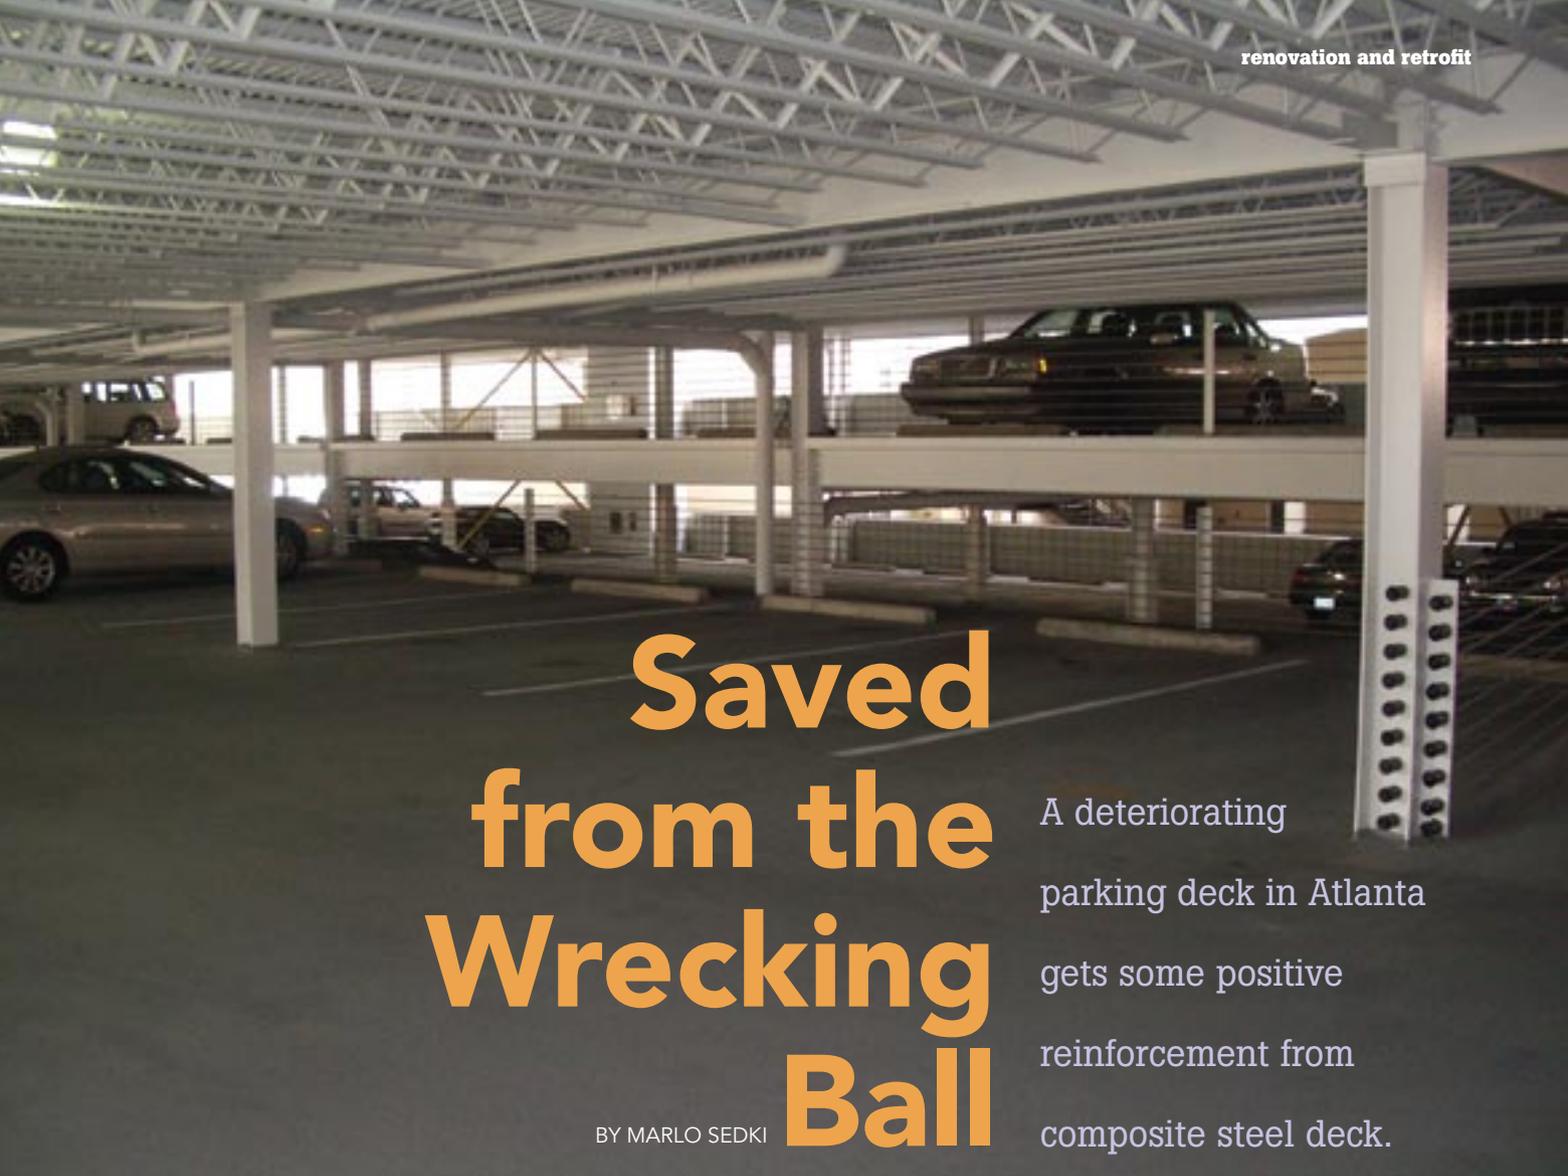
Cornerstone Village's original parking deck consisted of concrete slab on steel joists. Almost immediately after the six-story deck was completed in 1999, problems, such as cracking in the slab, corrosion of the steel frame (due to water seepage through the cracks), and vibrations and

deflection in the deck, began to appear. The cracking got worse with time, and in some locations the slab even punched through the metal deck. Areas where the slab was badly cracked had to be barricaded, and in other locations steel plates and angles were placed under the slab.

The original concrete slab was so badly cracked that it had punched through the deck in some places. Portions of the slab were barricaded.

The consensus was that the concrete slab was unsalvageable and needed to be replaced. Temporary repairs were made, consisting of inverted 1½-in.-deep 18-gauge type F metal roof deck over the slab, spanning between the joists and in the driving lanes only. Wood planks, 2 × 6, were cut to fit and added to fill in the valleys of the deck. The wood planks and decking were connected to the slab with ½-in.-diameter carriage bolts at close spacings.
