On September 13, 2008, winds and debris from Hurricane Ike shredded the 20-year-old fabric roof of the Cynthia Woods Mitchell Pavilion north of Houston. The supporting steel survived intact.

The flexibility of structural steel and tensile fabric combine to allow the rapid replacement and expansion of a landmark amphitheater.

Steeling the Show

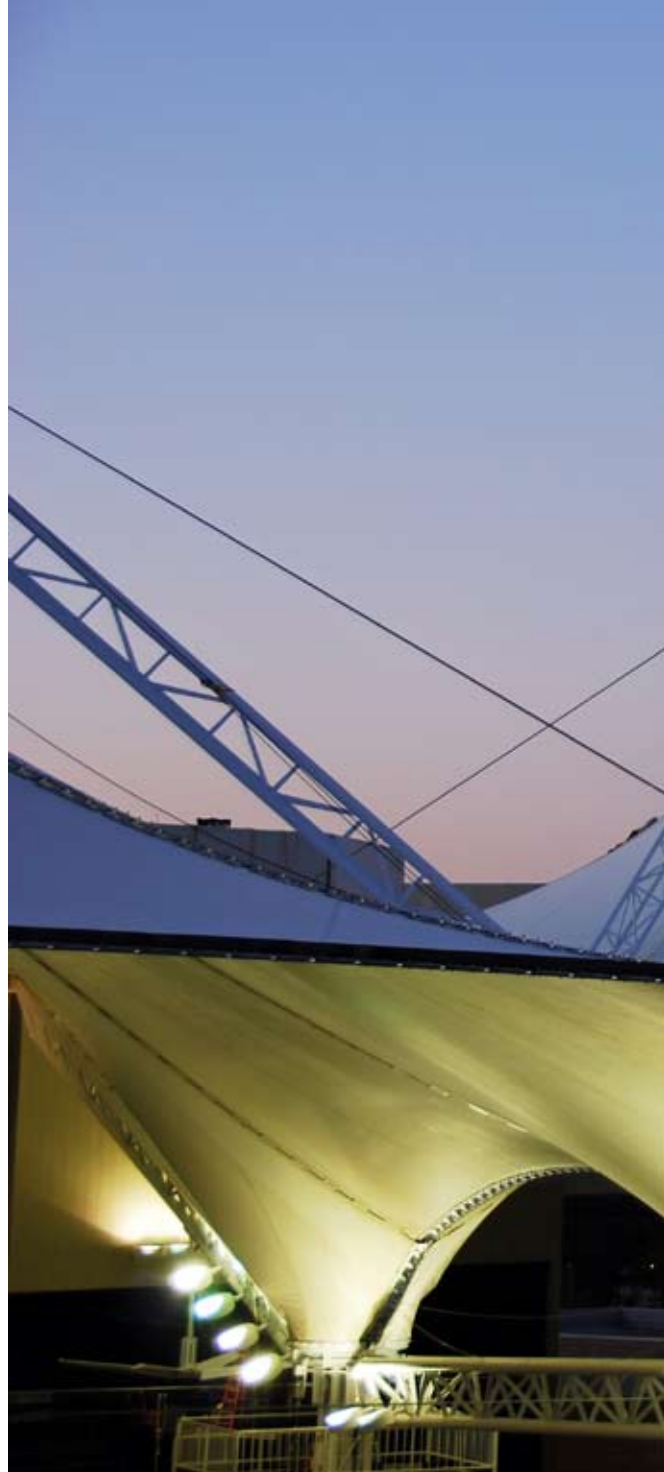
Just 7½ months after Hurricane Ike came to town, the storm-ravaged Cynthia Woods Mitchell Pavilion was once again ready for opening night but with more than double its original capacity.

More than \$3 million in damage resulted from a combination of Ike's strong winds and windborne debris. Although the durable steel substructure survived intact, the venue's fabric roof was irreparably damaged. The Pavilion's board of directors took advantage of the opportunity to expand the structure during the reconstruction process by more than doubling the facility's covered seating capacity from 2,479 to 6,387 seats. After the \$9.5 million renovation and expansion, the total capacity of the venue, including lawn seats, has grown to 16,040.

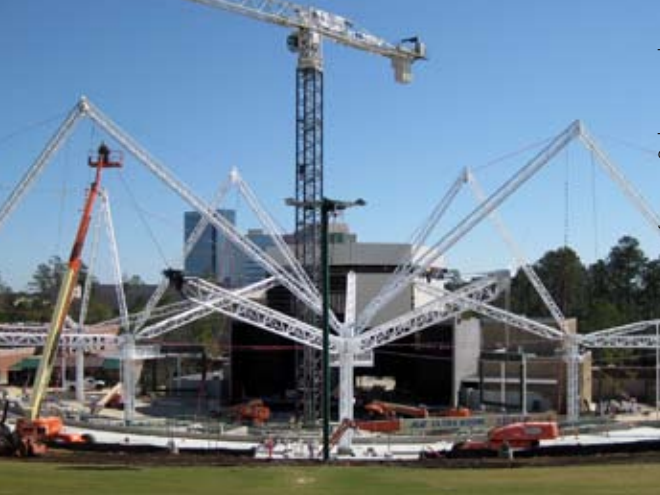
At one point, as many as 13 personnel lifts were being used simultaneously to erect the steel and cable framework as quickly as possible.
