# RESCUE Mission

Carefully restoring  
a historic building  
in the wake of  
a devastating  
earthquake.

▲ The renovated Sherman Building, a piece of national history and a safe haven for veterans, was heavily damaged in a 2011 earthquake.

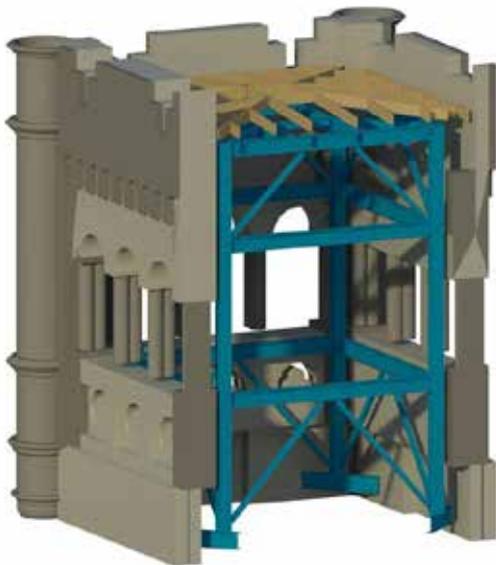
- ▲ A 3D model of the tower steel, which was modeled using point cloud data as a reference. The point cloud was taken after the earthquake and documents the stones in their displaced locations as well as stones that were removed for safety. The steel in the tower was placed to avoid conflict with the reconstructed stone elements.
