A steel-framed office building
in Baghdad is successfully rehabilitated after a series of missile strikes.

Nabeel A. Ibraheem
(nabeelaiibraheem@yahoo.com) is a senior structural engineer with Iraq's Ministry of Science and Technology and a current Ph.D. student at the University of Technology in Baghdad.

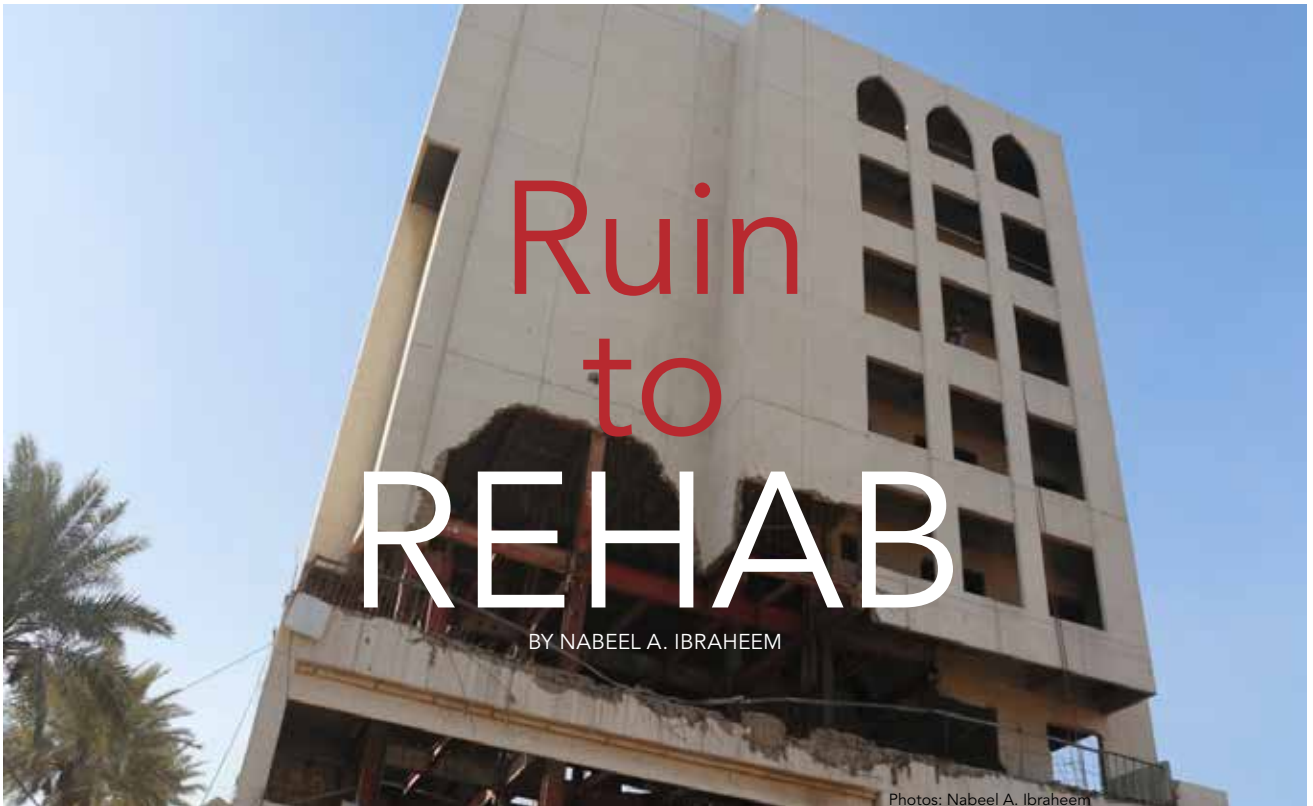
- ▲ The seven-story Almansour governmental office building in Baghdad, before renovation.
- ▼ Holes where missiles pierced the roof.

Built in 1982, the seven-story Almansour governmental office building in Baghdad, Iraq, incorporates a structural steel frame with external cast-in-place reinforced concrete walls. During air strikes in 2003, the building was hit by five smart missiles that penetrated the roof; two detonated on the second and third floors while the remaining three detonated in the basement. Several interior framing bays were destroyed.
