NEW STEEL, Vintage Feel

New steel supports
an old bridge over a busy transit line
in Philadelphia.

The existing Willow Grove Avenue Bridge over South-eastern Pennsylvania Transportation Authority (SEPTA) tracks was a three-span, simply supported, shallow-depth, steel stringer bridge with asphalt deck. The bridge was rehabilitated in 1962 and incorporated the original stone masonry abutments and wing walls that dated to 1884. Located in the Chestnut Hill neighborhood of northwest Philadelphia, the original iron channel and timber superstructure was built by the Edge Moor Bridge Works for the Pennsylvania Railroad—and designed for a live load of horse and carriage.

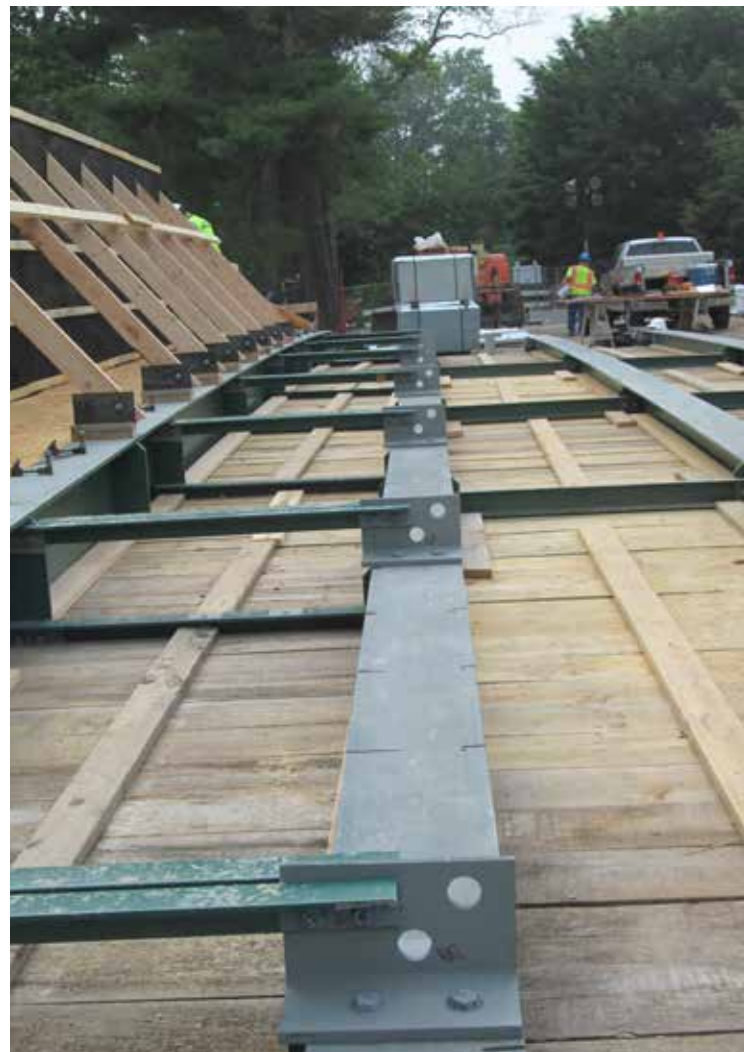
In 2013, the condition and section loss of the stringers became so significant that another emergency repair was performed. Due to deterioration and/or section loss of up to 100% in some places, the bridge was posted for "3 Tons/No Trucks," the minimum allowed by state law. Bridge closure and replacement was imminent unless remedial action was taken. Additional adjacent "buddy beams" were installed to strengthen the weakened center-span stringers, allowing the bridge to remain in service for one more winter without closure and major impact to the commuter rail traffic below. At this point, the structure became the primary design priority for the City's design unit.

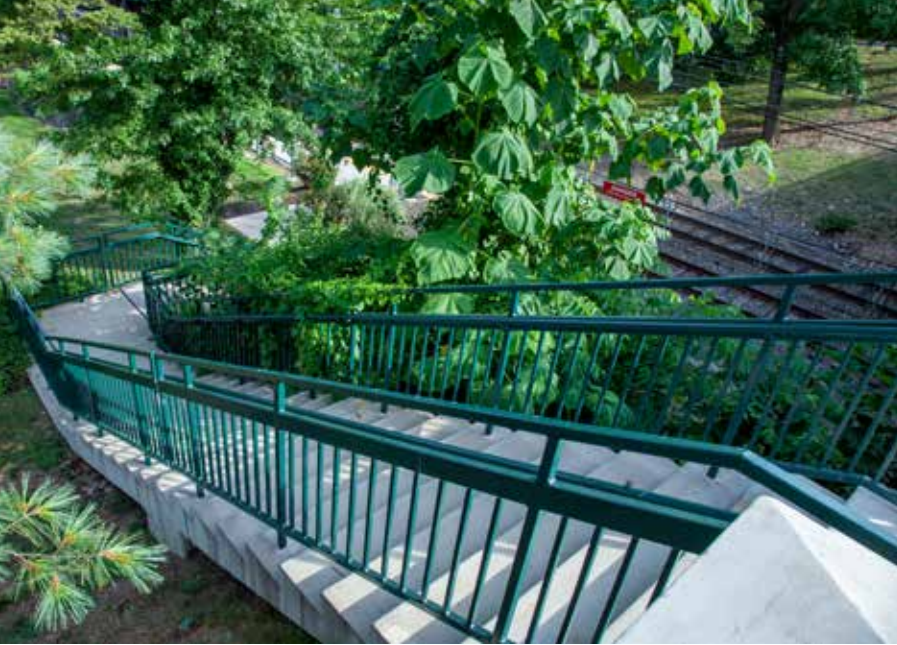
◀ Stairs from street level down to the SEPTA tracks.
