IMPACT DAMAGE REPAIRS ON THE JOHNSON RIVER BRIDGE Bridge No. 518

Travis Arndt, P.E.
Alaska Department of Transportation and Public Facilities

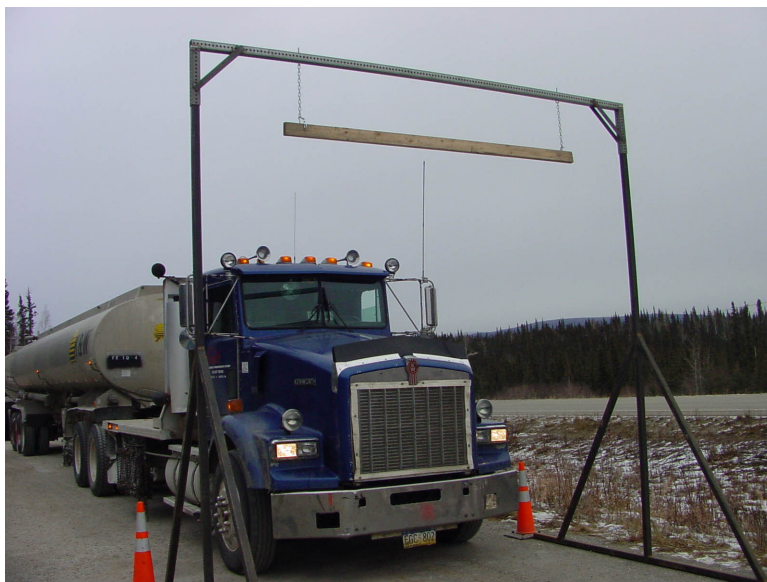
Figure 13: Run Under Bar

The traffic control plan was implemented once all the materials and equipment were staged onsite. In order to complete the repairs while maintaining traffic, the bridge was limited to a single lane with a restricted vertical clearance. Several full closures were required, however they were kept to a minimum and limited to an hour. To maintain single lane traffic, the traffic control plan called for continuous flagging with a pilot car. Two crews of three people rotated 12-hour shifts. The flaggers were also tasked with enforcing the 11-foot vertical clearance, which was needed to protect the temporary portals. To aid the flaggers in this task, flashing signboards were installed in Delta Junction and Tok notifying vehicles, notifications were aired on local radio stations a week prior to work beginning and notices were posted at the weigh stations around the state. Run under bars were constructed at the turnouts to verify vehicle height, see Figure 13.
