EFFECTS OF INCONSISTENT DETAILING IN HORIZON- TALLY CURVED STEEL I- GIRDER BRIDGES

EFFECTS OF INCONSISTENT DETAILING IN HORIZONTALLY CURVED STEEL I-GIRDER BRIDGES

Brandon W. Chavel and Christopher J. Earls, Ph.D.

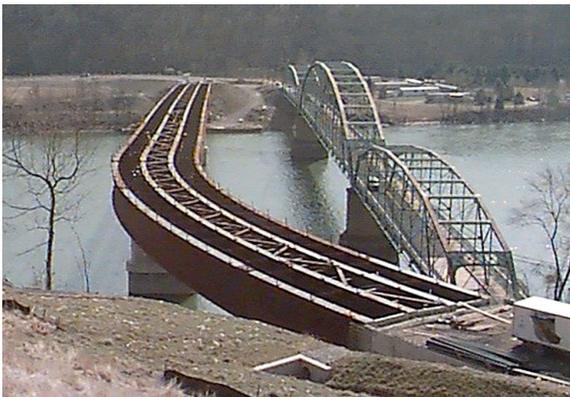
Figure 1. Ford City Veterans Bridge (prior to deck placement)

The Ford City Veterans Bridge is a 1060ft (323m) three-span continuous steel I-girder bridge that spans the Allegheny River, shown in figure 1 (prior to deck placement). The bridge has 322ft (98m) end spans and a 417ft (127m) center span; the northernmost end span is curved. Figure 2 shows a plan view sketch of the curved section of the Ford City Veterans Bridge; also noted is the naming convention used throughout the remainder of this paper.

misalignments, measuring approximately 1.5 inch (38mm), were observed. At this point in the construction, significant additional forces had to be applied to the structure in order to solve these girder and cross-frame misalignment problems. These same types of girder and cross-frame misalignment problems occurred when the fascia girders, G1 and G4, of section 3 were placed.

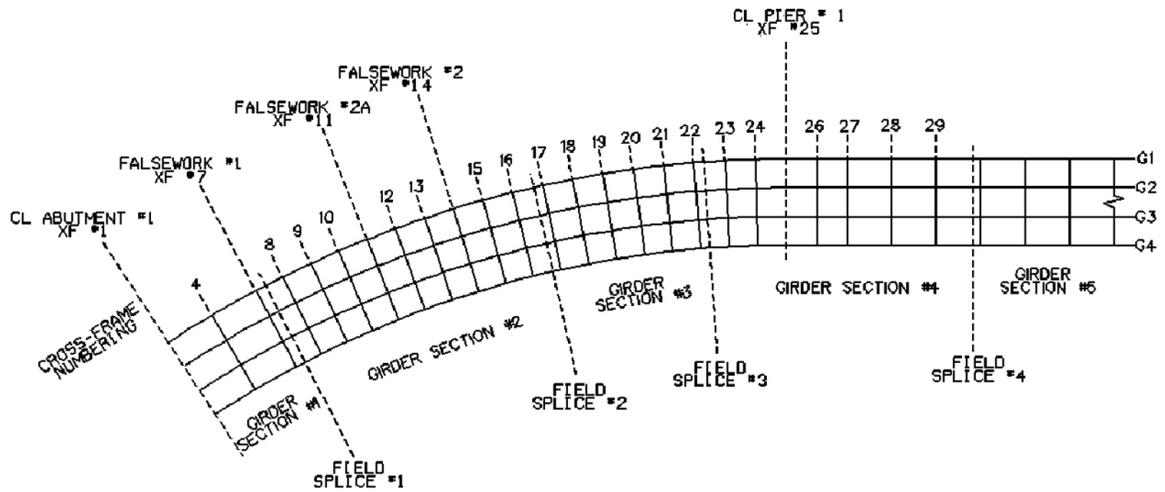
Figure 2. Framing Plan View of Curved Section of Ford City Veterans Bridge

The girders are detailed to be in the web-plumb position at the no-load condition. However, the cross-frames were detailed to fit-up with girders in the web-plumb position at the steel dead load condition; an inconsistent combination obviously ensues. However, an error occurred in the detailing process, and the cross-frames were actually detailed to fit-up with girders in the concrete deck load position (i.e. concrete deck load applied only, which is not possible), nonetheless an inconsistent combination, by definition.

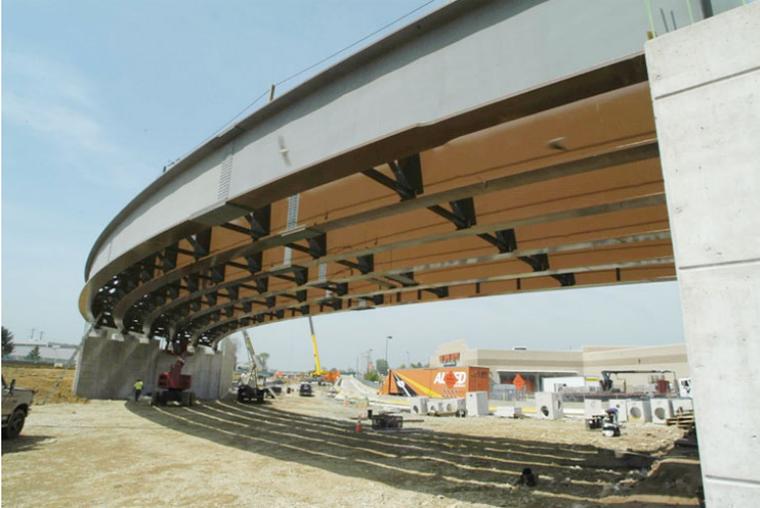
Figure 4. SR 8002 Ramp A-1

The State Route 8002 (SR 8002) Ramp A-1 bridge is a single span composite horizontally curved steel I-girder bridge (as shown in figure 4 after completion of steel erection). The northernmost abutment is radial (abutment 1), while the other abutment has a skew angle of 38.8 degrees; measured from the longitudinal axis of the structure. Figure 5 shows a sketch of the framing plan and the naming convention utilized in the current paper.

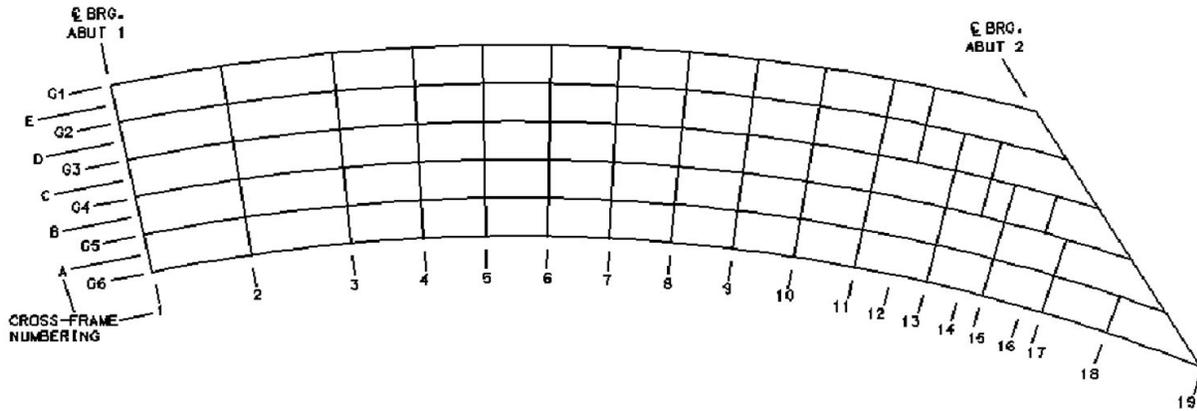
Figure 5. Framing Plan View of S.R. 8002 Ramp A-1

In general, the cross-frame spacing varies throughout the structure, as shown in figure 5, but near the mid-span of the structure the radial spacing remains fairly constant at 10.417ft (3.175m).

The girders are detailed to be in the web-plumb position at the no-load condition. The intermediate cross-frames are detailed to fit-up with girders in the web-plumb position at the steel dead load condition, an inconsistent combination.

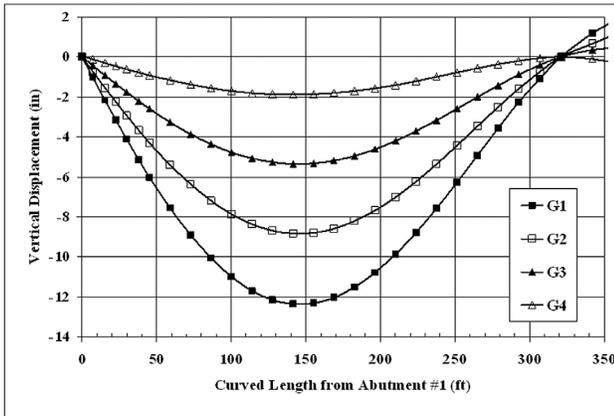
Figure 7. Ford City Veterans Bridge Steel Dead Load Vertical Displacements

The entire steel superstructure of the Ford City Veterans Bridge is analyzed under the application of steel dead load. The steel dead load vertical displacement profile for the girders in the curved span of the Ford City Veterans Bridge is shown in figure 7. As is to be expected, the largest vertical displacement predicted by the finite element model occurs at the mid-span of the outer-most girder, G1. The vertical displacement at this location is predicted to be 12.4in (314mm), and the average differential displacement between the girders at the mid-span is 3.5in (90mm). Additionally, the top flanges of the girders displace in the out-of-plane direction by essentially the same

amount from girder to girder under the action of steel dead load; the maximum displacement of 5.2in (131mm) occurs at the mid-span of the curved portion. The vertical displacement caused by steel dead load, as predicted by the finite element model of S.R. 8002 Ramp A-1, is shown in figure 8. The largest maximum vertical displacement of 3.0in (80mm) occurs near the mid-span of the outer-most, girder G1. The maximum differential vertical displacement between adjacent girders is 0.41in (10mm). Also, as shown in figure 4, due the effects of the skewed end, the maximum vertical displacement of each girder occurs near the mid-span of that particular girder. Additionally, the maximum mid-span top flange displacement in the out-of-plane direction under the action of steel dead load is 0.44in (11mm).
