US 84 MISSISSIPPI RIVER BRIDGE – TRUSS PIN AND LINK REPLACEMENT

SUMMARY

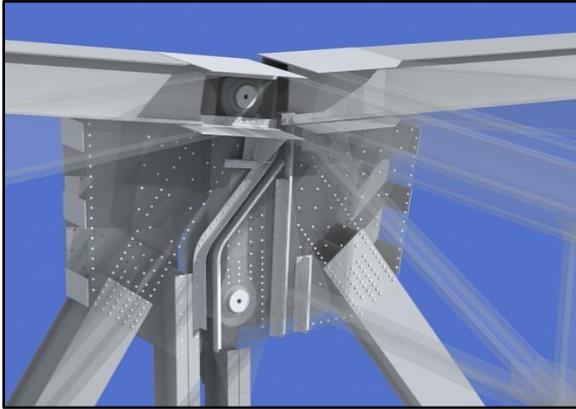
Figure 4 – Upper Joint

suspended span loads pass through the suspended span or quasi-suspended span upper gusset and into the 7'-6½" long links via 10¹/₁₆" diameter lower pins (Figure 4). The load is then transferred from the link into the cantilever span upper gusset via 10¹/₁₆" upper pins. The pins and link also function as expansion joints for the bridge and were designed for up to 9" of movement between the two gussets.

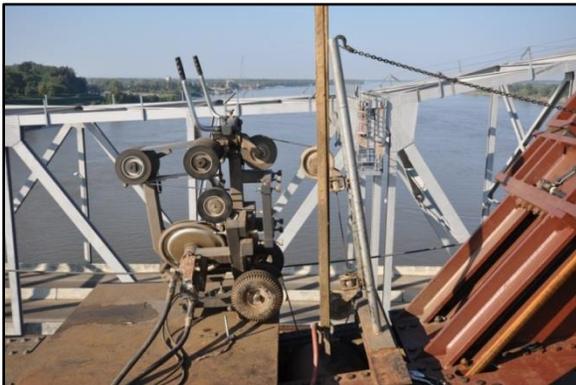
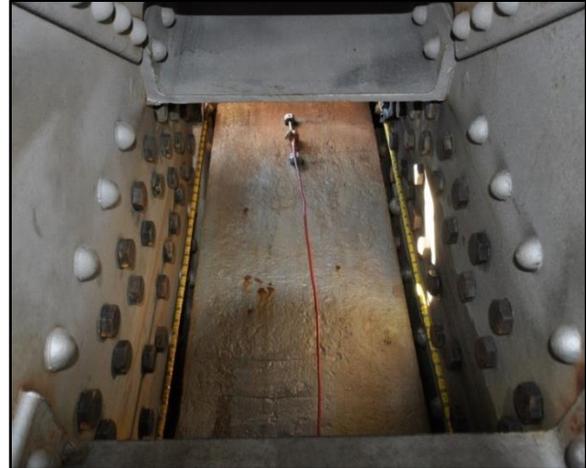
Because of the difficulty the previous contractor had with trying to reset the pins in 1997, the contractor elected to cut the pin with a diamond tipped wire saw. After cutting U49 upper pin, minimal change in force was observed in the link, and U49 and U29 splice plates saw about 1 ksi and 7.5 ksi of stress respectively (Table 2). It was speculated the higher stress in U29 was attributed to the misalignment of the truss. No movement was observed in either joint during removal of the pins.

The contractor attempted to push out U49 lower pin with hydraulics jacks after the upper pin was cut, but after applying 1,000 kips, minimal to no movement was observed. Ultimately, both faces of all pins required cutting and after the lower pins were removed, it became clear from the observed amount of grooving, the pins would not been able to be pushed out (Figure 36).

Step 6 – Remove Pins (Figure 34 and 35).
