**REHABILITATION
OF COLLISION
DAMAGED BEAMS
USING HEAT
STRAIGHTENING
FOR I-66 OVER
ROUTE 29**

Ali Hedayati, PE

REHABILITATION OF COLLISION DAMAGED BEAMS USING HEAT STRAIGHTENING FOR I-66 OVER ROUTE 29

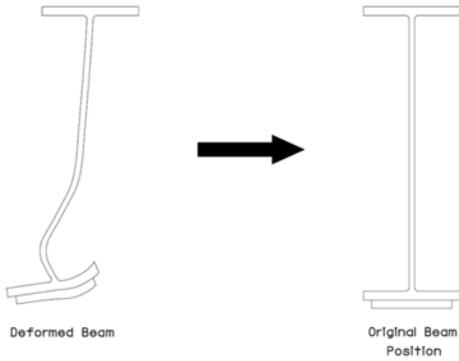
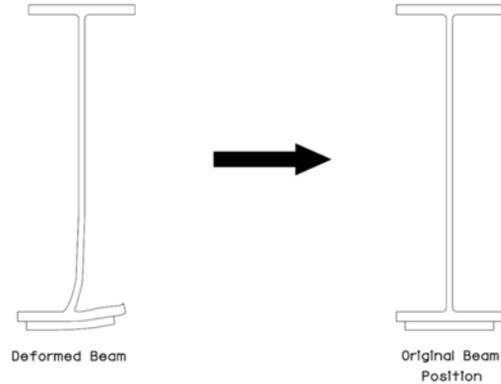
Severely damaged plate girders and rolled beams with and without cover plates, and with cracks in cover plate weld. This category includes six beams in Span 2 at the I-66 EB Bridge, and one beam in Span 2 at the I-66 WB Bridge.

- Step 1:** Remove damaged welds between cover plate and bottom flange where applicable. Heat straighten bulged web and deformed bottom flange (and cover plate) to original position. Bottom flange and cover plate are clamped together during the operation. Grind smooth the gouges and cuts along edges of bottom flange and cover plate.
