# **NONDESTRUCTIVE TESTING AND MATERIALS ANALYSIS OF THE PA / NJ TURNPIKE CONNECTOR BRIDGE**

# NONDESTRUCTIVE TESTING AND MATERIALS ANALYSIS OF THE PA / NJ TURNPIKE CONNECTOR BRIDGE

## Introduction

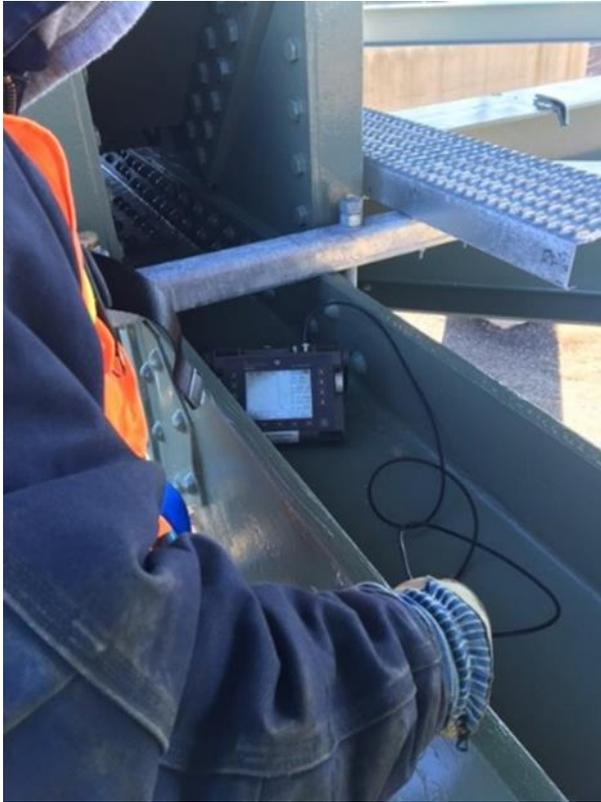
bottom flange edge up towards the web. This is done on both flanges so four individual scans are needed at each tested location. A photo of this procedure being used in the field is provided in Figure 5. The technician is scanning across the flange thickness for a prescribed length, in towards the web, the intent being to identify any plug welds (or other indications of concern) that exist in each half, upper or lower, of a flange.

**Figure 5 UT Scanning of Chord Flange Tips**

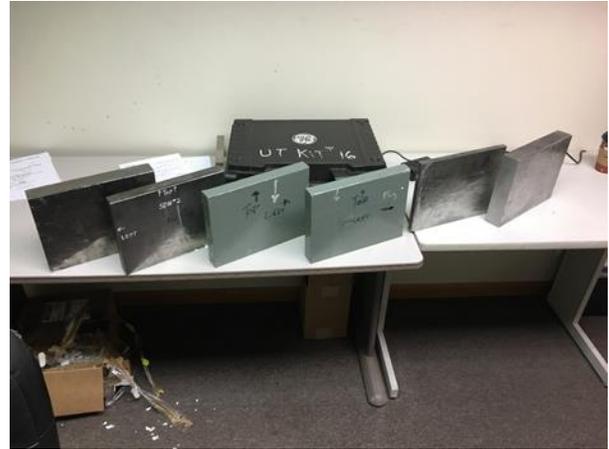
As part of technician qualification, each technician was required to complete a qualification test using two groups of three test plates shown in Figure 6. The testing of technicians is virtually unprecedented including for those who perform shop inspection. This qualification process was adopted as a project specific requirement to provide a high degree of confidence in the work of the various personnel who were working independently in the field. Each technician was required to test both groups of three plates. The first three plates were used to ensure their equipment was functioning and to give them some comfort in what was being asked of them. For the second three plates, each was given roughly one hour to complete a qualification test. They were asked to first scan the plates using a 90-degree compression wave (the same procedures as in the field) and note their findings. Any suspected defects must then be further located, sized and

**Figure 6 Collection of Six Test Plates**

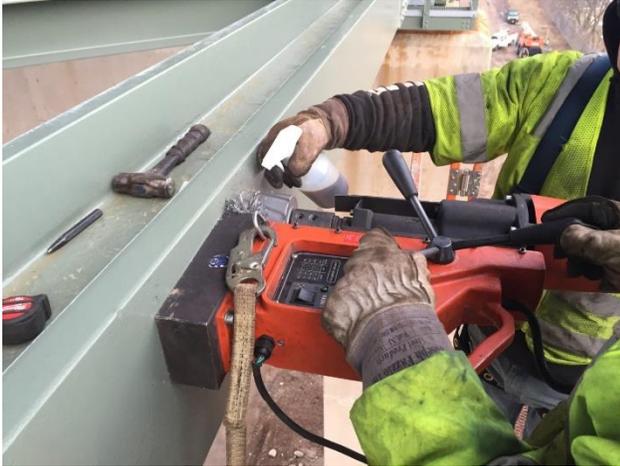
In total, 44 cores were taken from the bridge, with half coming from the PA trusses and half from the NJ trusses. All cores were 4 in. outside diameter, with approximately 3.75 in. inside diameter after extraction. Two coring teams extracted all 44 cores in two 12-hour workdays (February 15 and 16, 2017). All core holes were deburred and cover-

**Figure 11 Removal of Material Sampling Cores**

plated at the clients request though from a stress standpoint coverplating is not needed. The cover plates were designed by selecting plate sizes which replaced the strength of the section area removed because of the core hole.
