# **STRUCTURAL BEHAVIOR AND FATIGUE REHABILITATION OF THE I-64 STEEL DELTA FRAMES OVER KERRS CREEK AND MAURY RIVER IN VIRGINIA**

The twin delta frame bridges carrying I-64 over the Maury River within the Virginia Department of Transportation's (VDOT) Staunton District have experienced fatigue cracking problems that caused structural deterioration and a deficiency in the bridges' inventory ratings. Analytical investigation by researchers at Virginia Polytechnic Institute and State University (Virginia Tech) showed that the bridges could be retrofitted to achieve essentially infinite fatigue life. A fatigue retrofit approach, recommended by VA Tech, has been implemented and a 3-D finite element computer model was developed to examine the stress levels within the structures and its global stability through the retrofit process. In addition, the bridges' structural behavior was monitored through a structural health monitoring program aimed at correlating the actual response with that of the analytical model. The paper discusses the comprehensive structural retrofit program designed to control the fatigue cracks to attain infinite fatigue life. Currently, the bridge rehabilitation has

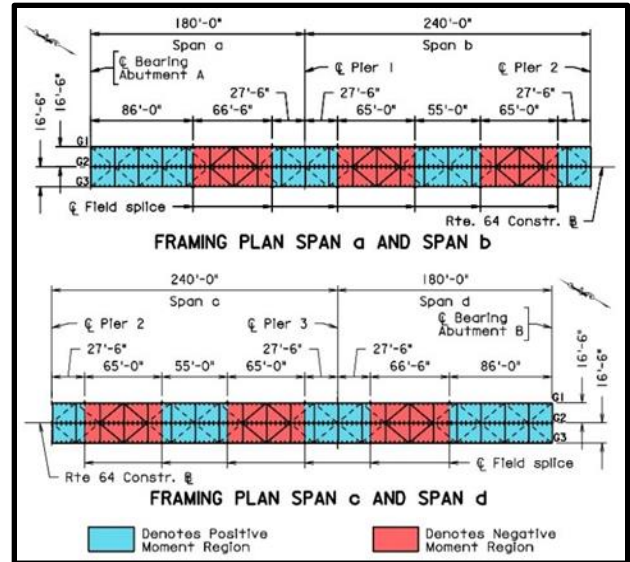
**Figure 8: Lateral Bracing Showing Regions of Positive and Negative moments**

The connection retrofits were to be implemented in the positive and negative bending moment regions as shown in Figure 8.

*In the positive moment regions*, the horizontal lower lateral bracing members and the gusset plates located within the tension areas of the delta frame web-plate were to be removed after replacing the deck. Then the previously disconnected lower cross frame K-brace connections were to be reconnected and the transverse connector plates at the bottom flange of the girders were to be restored with a 5/16” fillet weld along both sides. Finally, the floorbeam copes were to be ground smooth to a uniform radius to prevent gouges and sharp edges thus increasing the fatigue resistance of the connection to at least Category (B). The cope radius was recommended to be between ½” and 1” for copes with no evidence of fatigue cracking while a 2” diameter drilled hole was to be provided at the crack tip for copes with pre-existing fatigue cracks to prevent any crack propagation. The perimeter of the hole was to be ground smooth to reduce any surface stress concentration.

*In the negative moment regions*, the retrofit retained the cross frame K-braces and the lower lateral system attached to the girders to provide compression flange bracing. Gusset plates attached to web areas in compression were to be connected to the transverse plates at the top flange of the girders with a 5/16” fillet weld along both sides. For any observed fatigue cracks in the web of the girders, holes were to be drilled at the crack tips to prevent further propagation.

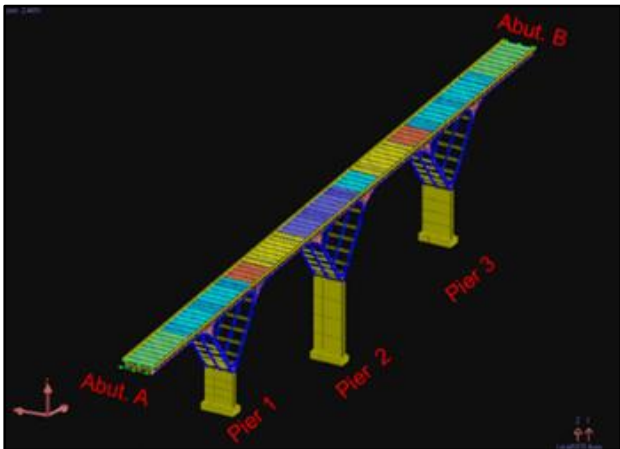
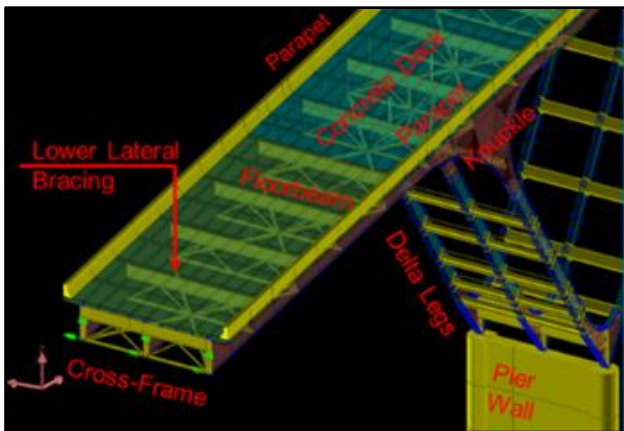
**Figure 9: 3-D Finite Element LARSA-4D Model**

WRA initiated the bridges' structural analyses by developing a comprehensive 3-D computer model using LARSA-4D. The model included the previous structures' retrofits and established the as-built baseline of the element nodal stresses to compare with those developed during the subsequent construction stages (Figure 9).

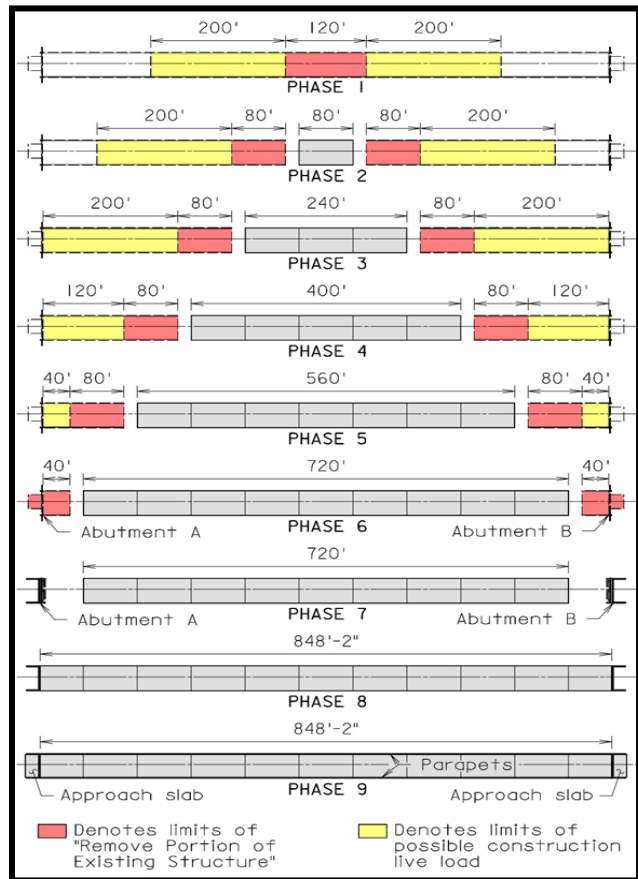
**Figure 10: Layout of Deck Demolition and Construction Phases**

Additionally, the model included the recommended deck reconstruction sequence – beginning with the removal of a longitudinal 120' section in the middle of the bridge. The presence of the shear studs at the top flange of the transverse floor beams were introduced (incrementally modelling 2-way slab action) followed by the replacement of the removed deck section with lightweight concrete. Once the constructed part of the deck was cured, the anticipated two-way composite action was established between the girders and the transverse cross frame floorbeams. The process was repeated until the entire deck was replaced as shown in Figure 10.

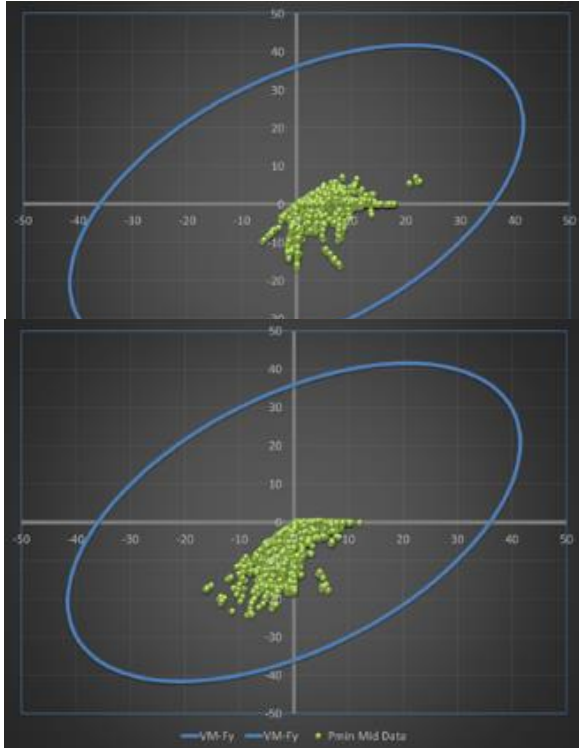
**Figure 11: Max/Min Nodal Principal Stresses vs. Von Mises Criteria**

Nodal element stresses were monitored in all proposed construction stages and the structure model reflected no stresses in excess of those established by the as-built condition threshold or by the AASHTO Standard Specification for Highway

Bridges for the Allowable Stress Design (ASD). The structural element strength capacities were checked against the required force demands and found to be sufficient. Furthermore, the elements' nodal maximum and minimum average principal stresses were compared against those established by the Von Mises yield criteria and confirmed a safe structure response during the retrofitting and the construction sequencing (Figure 11).

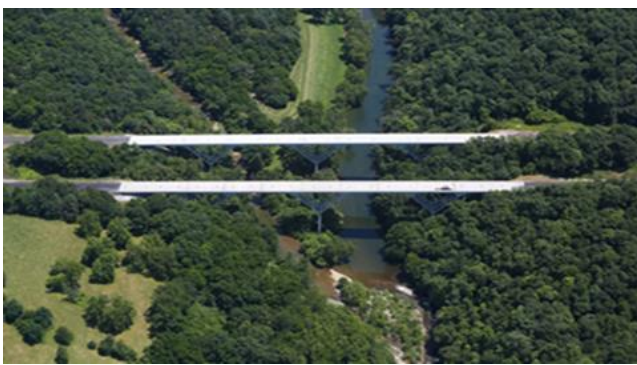
**Figure 22: Complete Retrofitted Structures**

retrofit has increased the fatigue life, mitigating the formation of additional fatigue cracks, and extending the service life of the bridges (Figure 22). The condition of the structures will continue to be monitored through the rigorous VDOT bridge safety inspection program.
