Comparison of Structural Performance of Multi-Story Buildings Under Extreme Events

**COMPARISON OF STRUCTURAL PERFORMANCE
OF MULTI- STORY BUILDINGS UNDER EXTREME EVENTS**

Project Number 9809-000

October 5, 2004

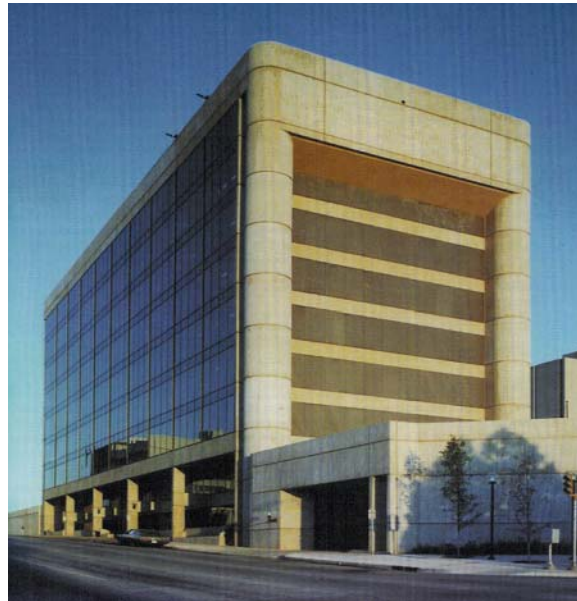
Figure 2. Alfred P. Murrah Federal Building in Oklahoma City Before Explosion

The Alfred P. Murrah Federal Building in Oklahoma City, shown in Figure 2, was a 9-story office building, built between 1974 and 1976. It was designed as an ordinary moment frame of reinforced concrete for the GSA Public Building Service, occupying a plan footprint of approximately 100 ft by 220 ft within a complex that also included adjacent one-story buildings and a multi-level parking garage. A regular 20 ft by 35 ft floor bay pattern was used throughout the major office space on the third floor and above.

A bomb, estimated to be about 4,000 lbs TNT equivalent, was detonated on April 19, 1995. It immediately failed parts of three of the building's columns stacks and four levels of floor bays on the north face, as shown in Figure 3. The detonation occurred about 16 ft from column G20, and caused a crater approximately 28 ft in diameter and 6.8 ft in depth. The initial blast damage area in the Murrah Federal Building can be estimated to have totaled about 11,200 ft² of floor area. Approximately three seconds after this blast detonation, a progressive collapse ensued that brought down almost the entire northern half of the 9-story building, as shown in Figure 4. The term progressive collapse, as used herein, is generally defined as one which the failure is significantly disproportionate to the initial triggering event. The ratio of the final collapsed floor area to that originally damaged by the blast is roughly four, which would qualify the Murrah Federal Building collapse to be considered a progressive, or disproportionate, collapse.

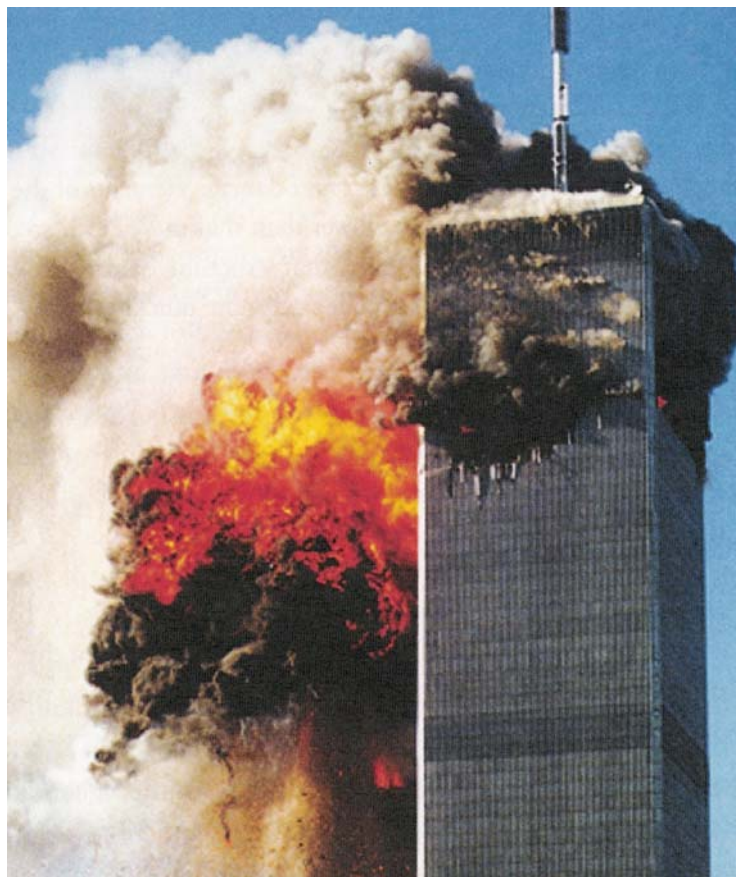
Figure 5. WTC 2 Fireballs – Second Jet Impact on September 11, 2001

- In contrast, the collisions with the steel-framed WTC 1 and 2 high-rise towers were at higher altitudes in the upper floor levels (between the 94th and 98th floors in WTC 1 and between the 78th and 84th floors in WTC 2), with the jets seemingly intentionally banked to hit multiple floor levels. About half of the columns in one face of each tower were thereby destroyed over 4-6 floors. There was no indication that either of the two jets was able to entirely penetrate through the 207 ft. width of either tower, apart from some of their engine fragments, landing gear and similar debris. Hence, the jet impact travel length was roughly estimated to be between 100 ft and 150 ft.

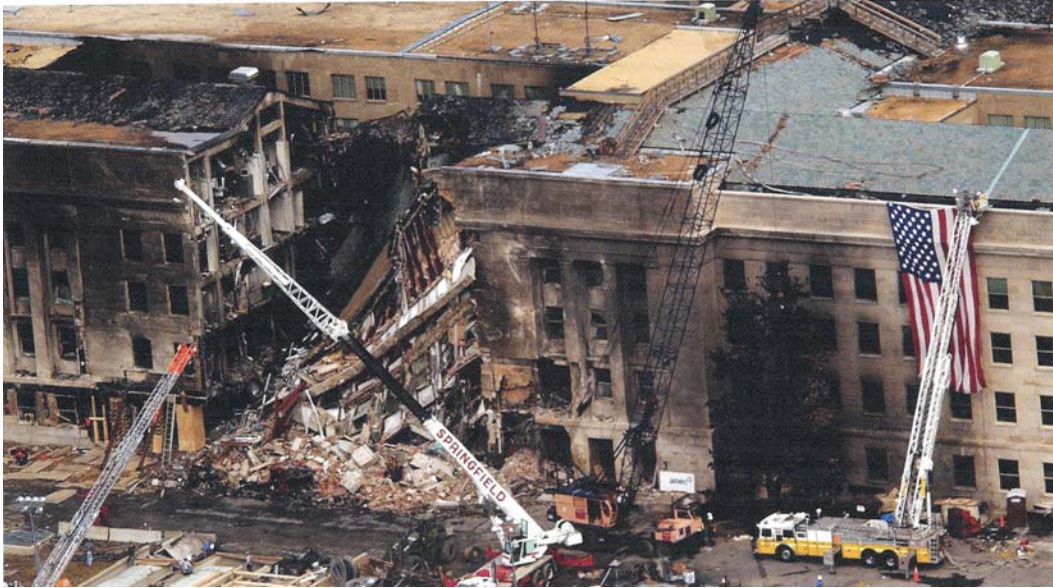
Figure 6. Pentagon Crash Site After Sept. 11, 2001

- The jet colliding with the Pentagon was very close to the ground and roughly parallel to it. Thus, its low and horizontal flight direction immediately damaged only the two lower floors, but affected a relatively longer skewed travel distance of 310 ft (ASCE/SEI, 2002).

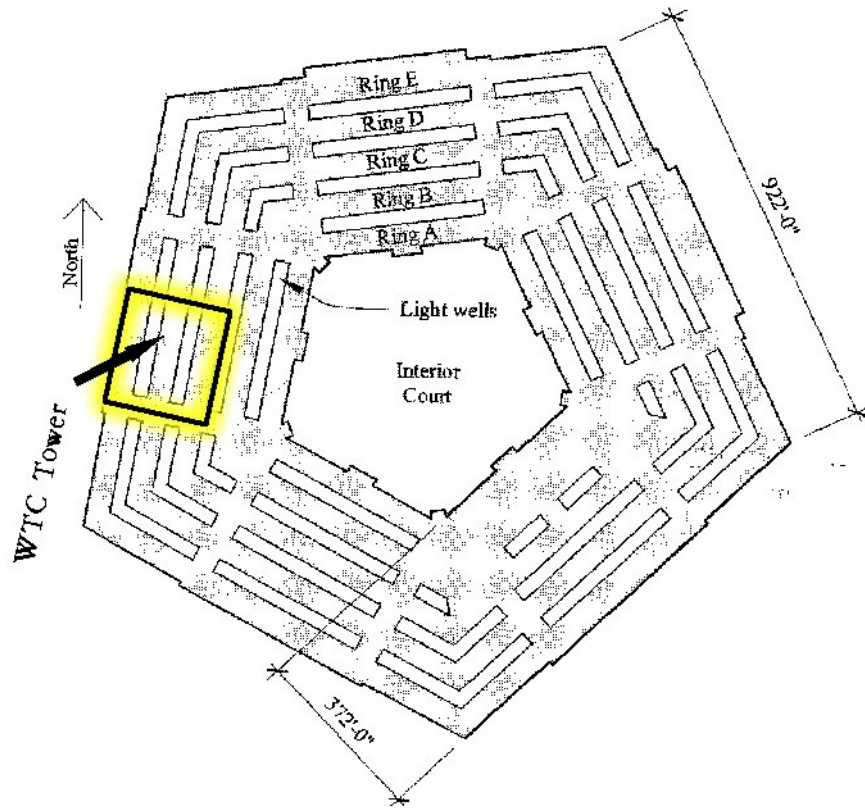
Even though WTC 1 and 2 were high-rise buildings with 110 stories, their total office space per tower was actually much less – about 30 percent less – than that contained in the sprawling 5-story Pentagon. The Pentagon’s total footprint area of 1.32 million ft² dwarfs each Tower’s 42,800 ft² footprint by more than an order of magnitude – about 31 times more. Figure 10 shows a scaled comparison of the relatively small WTC Tower square footprint (207 ft sides) superimposed within the Pentagon’s huge plan area in the vicinity of the Pentagon’s impact damage and collapse. Each of the WTC tower’s total height, or number of stories, is more than tenfold greater than the Pentagon’s – about 22 times more. Based solely upon these purely geometric comparisons, it can be seen that the Pentagon and WTC 1 and 2 are each very unique buildings, with the wide range of common multi-story buildings falling in between these two extremes.

Figure 10. Scale Plan View of WTC Tower Footprint Superimposed on Pentagon

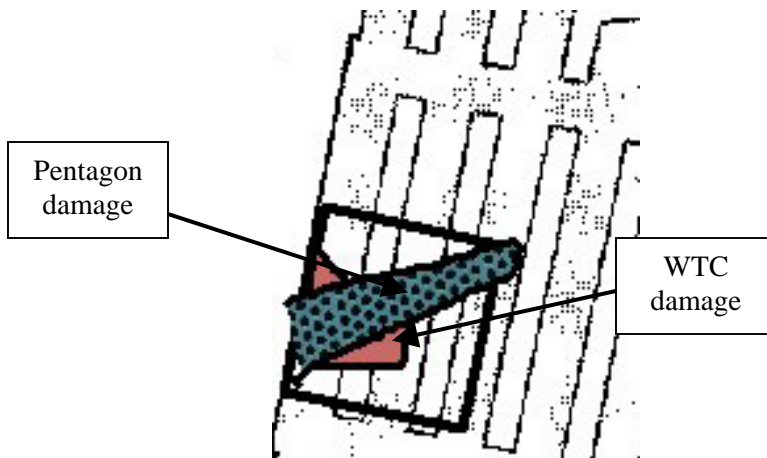
Similar to the Pentagon damage and collapse area, the WTC columns were weakened by the initial impact of the plane and debris wave and/or high-temperature exposure. Loss of floor diaphragm bracing for the steel columns provided another source of the eventual instabilities that led to the total collapses. A scaled schematic drawing comparing the relative sizes of the overlaid damage areas is given in Figure 14 for comparison, with the longer narrow band representing the damage path in the Pentagon. This enlarged view of Figure 10 also helps to illustrate that the estimated total 310 ft jet travel distance into the Pentagon is slightly larger than the full diagonal 293 ft. dimension of the WTC Tower footprint.

Figure 14. Scaled Overlay of WTC and Pentagon Impact Damage Areas

One simple measure of estimated impact damage is the spatial volume enveloping the most seriously damaged areas. This volume is calculated from the approximated length, width, and height distances. Using the average spatial volume of the damage paths given in Table 1, it can be seen that the initial damage patterns are roughly equivalent (within 10 percent) in each of the three targeted buildings at about 500,000 ft³. Essentially, the lower depth of impact damage to the Pentagon relative to the WTC is offset by its longer depth of penetration. Also, a count of the impact damaged column lines in Table 1 is about the same (a total of 50) between the Pentagon and WTC 1, without consideration of the steel columns that only lost spray-applied fire protection material from the impacts. The total number of seriously damaged column lines in WTC 2 was slightly lower (about 35) but their asymmetry (see Figure 13) was a factor in the secondary collapse.
