South Shore Plaza

Keeping all of the stores open was critical during renovation and vertical expansion of the this 40-year-old mall

By Howell A. Gordy, R.A.

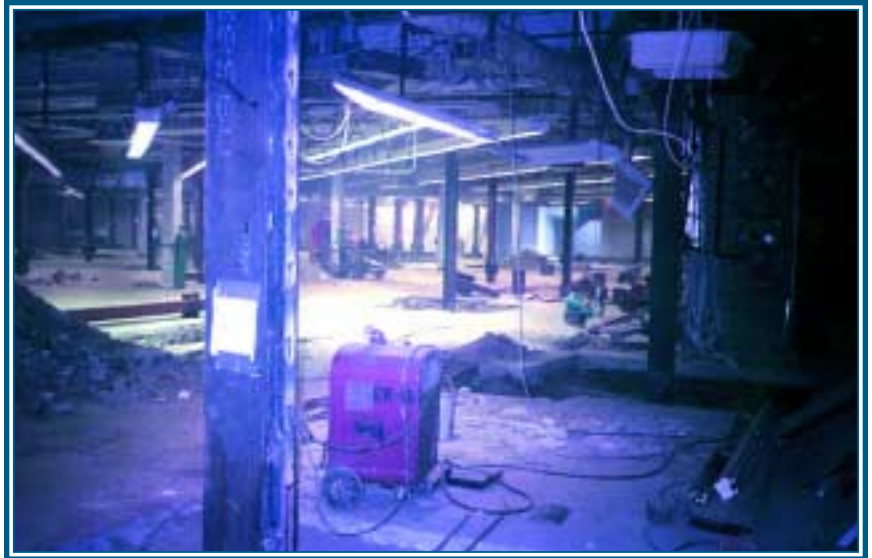
(Top) Typical basement area work scene for column/footing upgrades

shoring was installed to remove the load from the columns, the column was plated or replaced, and the existing footing was excavated, evaluated as explained below, and upgraded appropriately. The shoring was removed and the affected column was reloaded when the new concrete footing had cured properly.

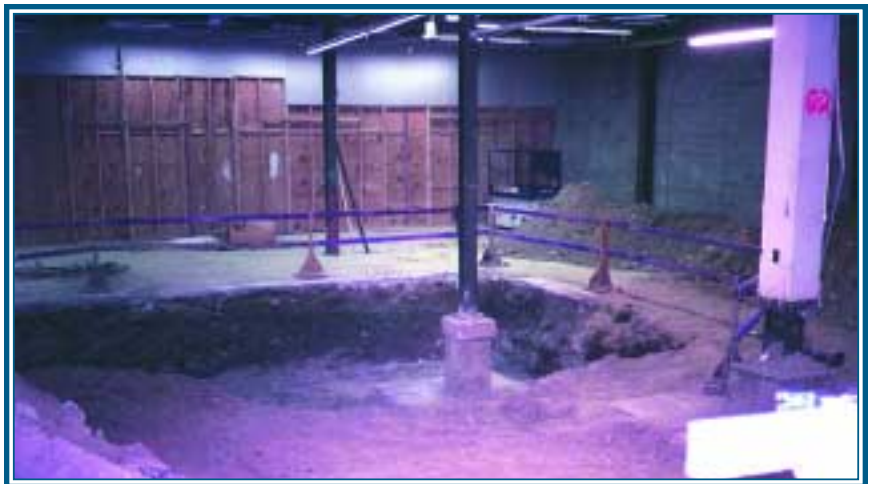
(middle) Basement excavation for column footing removal for new escalator pit

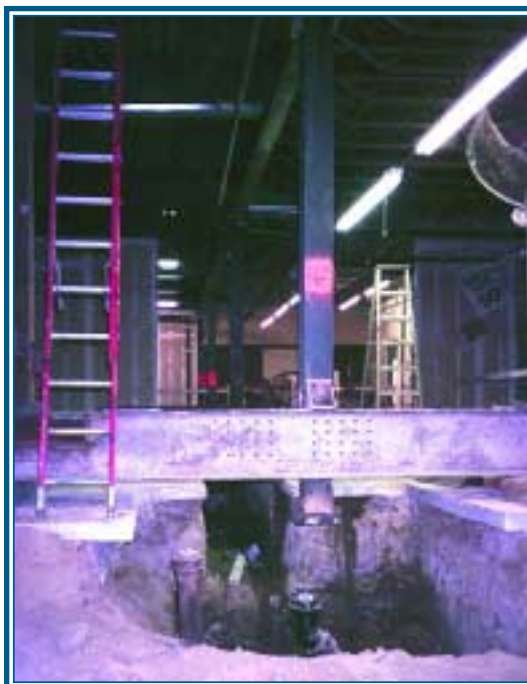
(bottom) Shoring existing column to replace existing footing

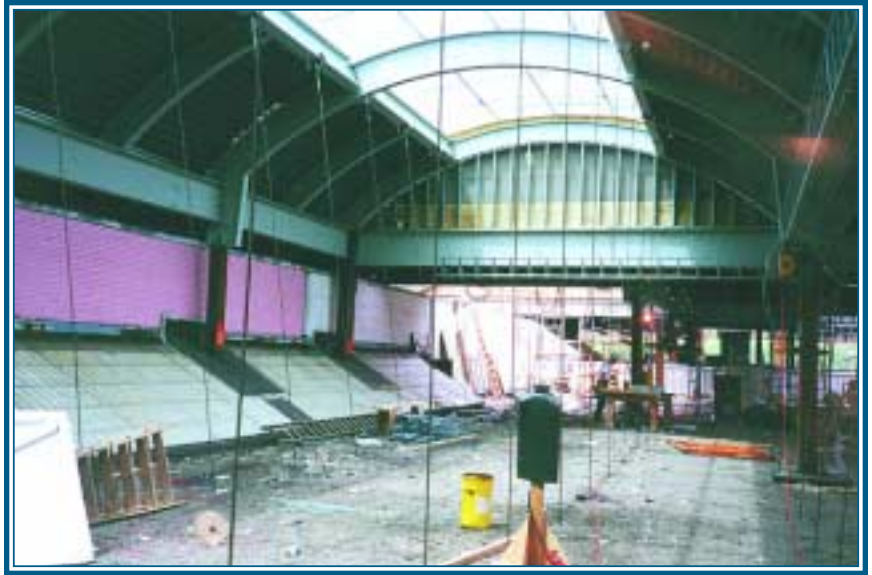
Shown is the second level framing and skylight above a workplatform installed over the existing mall first floor

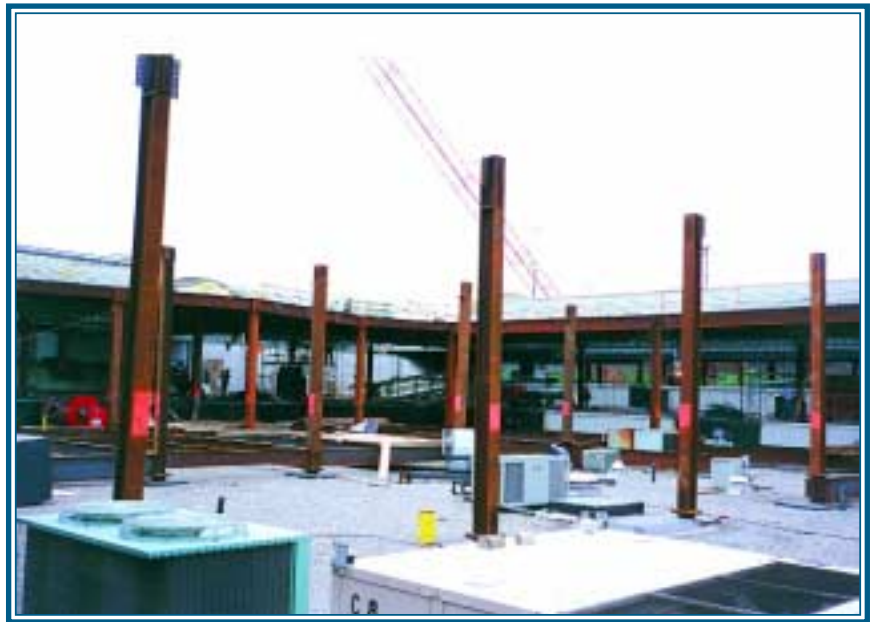
Shown are the column stubs and the new second level columns and framing in progress above the existing roof

As basement column and foundation construction upgrades progressed linearly down the mall, the contractor began to work on existing mall level column upgrades immediately after the holiday shopping season. Work had to be coordinated with the owner's ability to gain access to the various tenant stores, and column upgrade work was handled on a tenant-by-tenant basis. Existing columns were plated or replaced by new columns and a stub column bearing on the reinforced or new steel was installed through the existing roof to accept future new second level columns and framing. Again, existing condition modifications were resolved

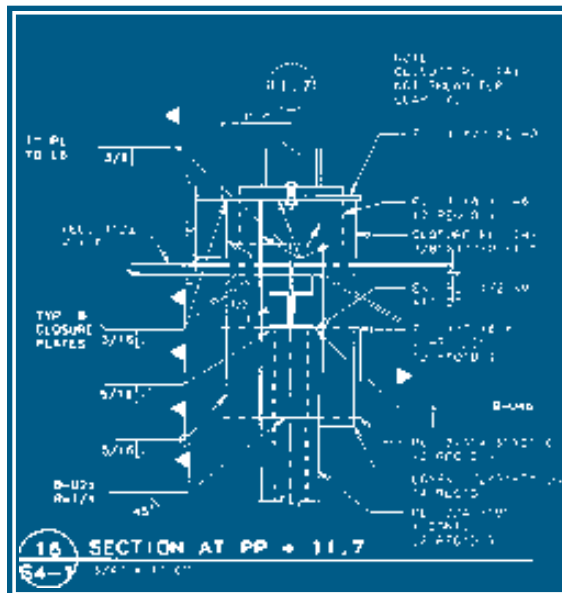
Left: Top of column splice and reinforcing detail between existing and new columns. Detail occurs at existing columns supporting joist girders.
