BOMBS AWAY

This radical renovation included both a seismic update and a complete cosmetic makeover

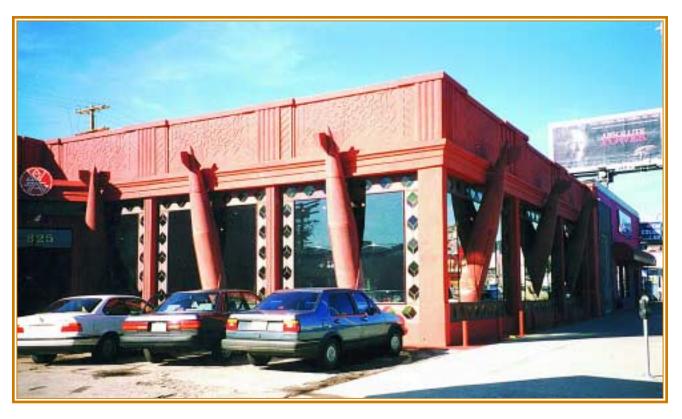
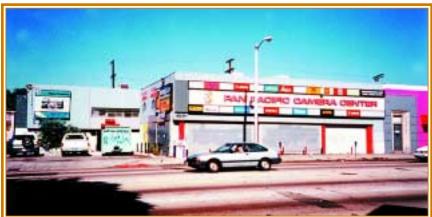
Pictured on the opposite page is the original building and the newly renovated clothing store.

The existing 50-year-old building at 825 N. La Brea Ave. near downtown Los Angeles was a one-story unreinforced masonry retail sales building with an approximate total area (including a mezzanine) of 10,000 sq. ft. within an "L" shaped floor plan. The structure has a roof diaphragm composed of a 1" x 6" straight sheathing supported by built-up wood bowed trusses typically spanned at 20' on center. The foundation consists of continuous concrete footings and a 4"-thick concrete slab floor.

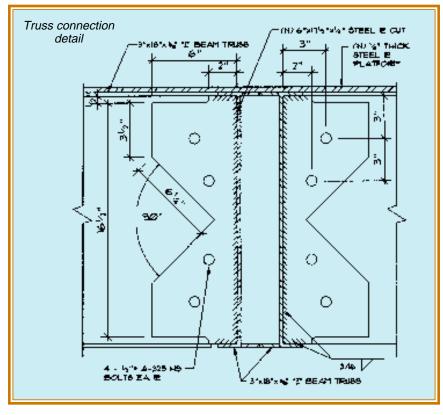
Shown at right bottom is the connection between the steel members.

are the structural elements and satisfying the artist's vision and owner's requirements," Esquivel explained. Both welding and bolting were used for the connections, depending on accessibility and aesthetics. Steel straps and steel rods were used to attach the bombs, which were realthough deactivated—World War II bombs, to the existing steel plates at the headers of the windows. "This accomplished the requirements of the artist to create a unique building which appears to have bombs penetrating the middle of each plane of glass window without any visible support."
