From Darkness to Light

Converting a Warehouse

**By Zareh B. Gregorian, PE,
and Caren B. Gregorian, PE**

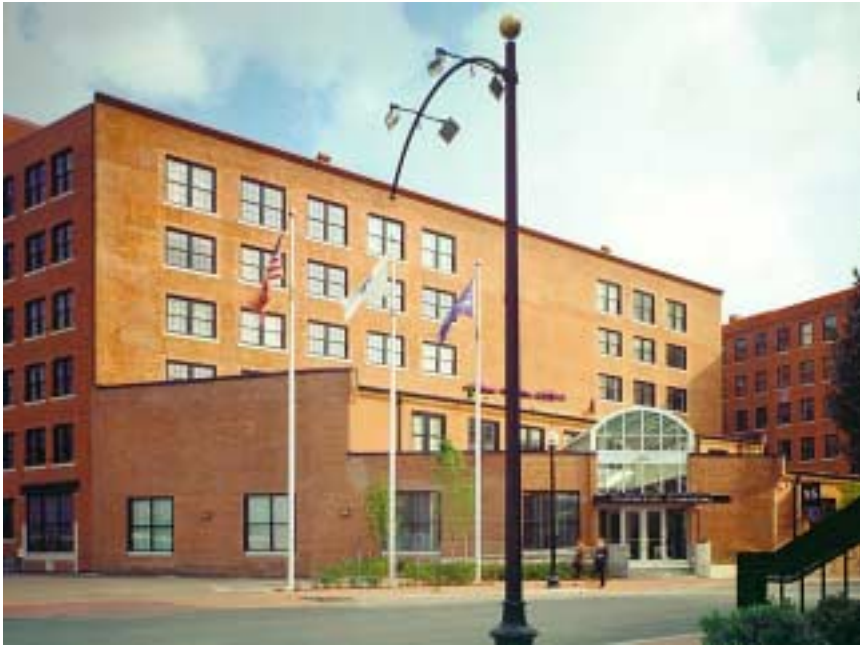
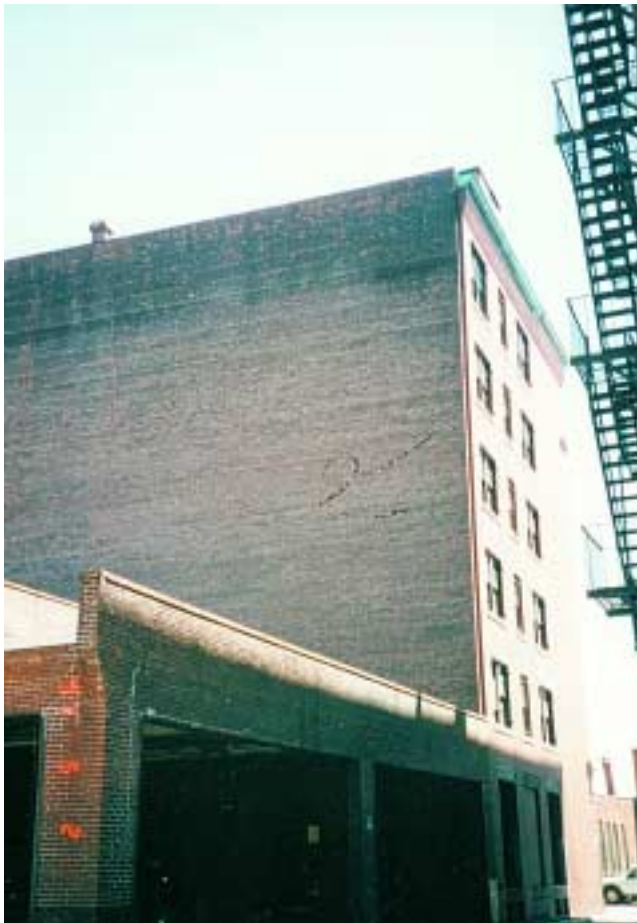
One of the major changes in converting the warehouse (right) into an office building (above) was the addition of 32 new windows.

The intent of the new architecture was to provide more natural light for the new office spaces in the six floors of the building. The western side of the building is constructed with a solid brick-bearing wall with no openings, creating a dark space along the interior west side of the building. The architectural firm, The Stubbins Associates, Architects, prepared the new architectural plans. Vice President, Scott Simpson, AIA, Principal, Youngjo Sul, Vice President, and Fred Clark, Project Architect, required cutting 32 new openings on the west wall for installation of new windows. Discussions and final decisions were made with the architects to select the size of the openings in a way to leave adequate space between the openings for the existing bearing brick walls to carry

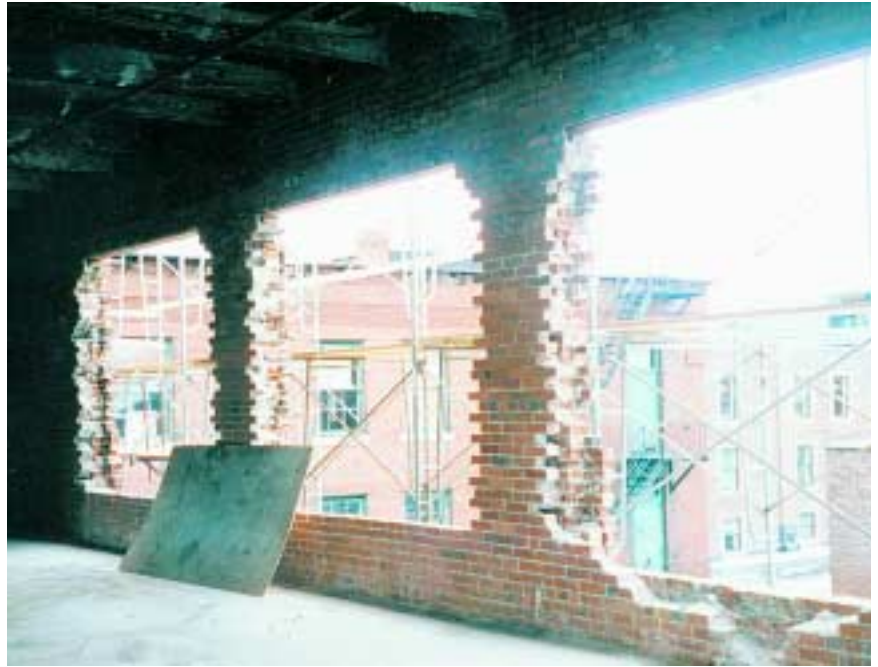
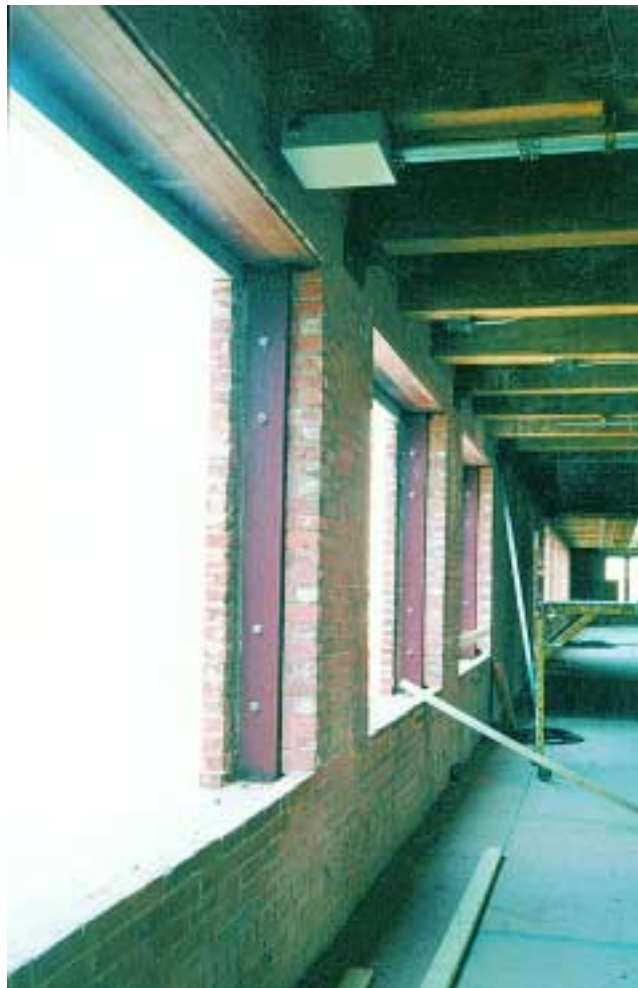
After window openings were cut, they were reinforced with steel frames consisting of double angles at the top and single angles on the bottom and sides. The new frames were anchored to the brick for transfer of vertical and lateral loads through the wall.

A steel frame was designed and installed in the new openings to compensate for the loss of strength from removal of the bricks and to produce a continuous path for the lateral loads around the opening along the wall to the base of the building. The loss of stiffness of the solid wall to introduction of the new openings was compensated by installation of the steel frames throughout all new openings. Double angles were installed at the top working as a new lintel, and three single angles were installed at the sides and the bottom all anchored to the brick for transfer of vertical and lateral loads through the wall. The whole assembly was then welded providing a rectangular steel frame inside the opening.
