Updated, *not* Outdated

Steel preserves the elegance and structural integrity of the University of Chicago's 100-year-old Bartlett Hall during its renovation.

Renovations and additions transformed Bartlett Hall, a 100-year-old neo-gothic gymnasium at the University of Chicago, into a multi-function student commons building with a dining hall, two performance spaces, and various student activities spaces. The building originally had been designed as the men's U.S. Olympic training center in 1901, but functioned as a university athletic facility for most of its existence.

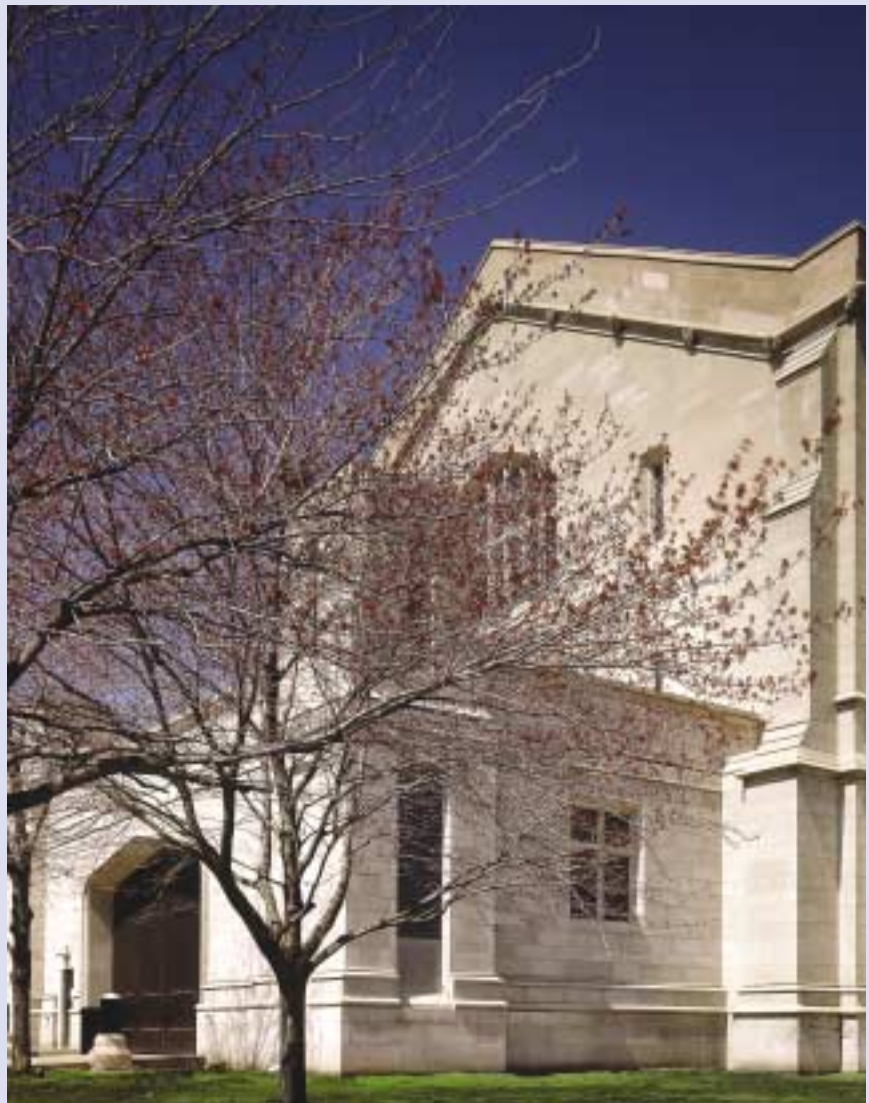
Below: Although clad with limestone veneer rather than solid limestone masonry, the loading-dock addition blends seamlessly with the existing building because of careful detailing.

Steel was also considered the best solution because of its ability to frame a 24'-wide, gothic-arched dock-door opening from which architectural "lintels" could be hung. Load-bearing masonry would have been more costly for an authentic gothic-arched opening.

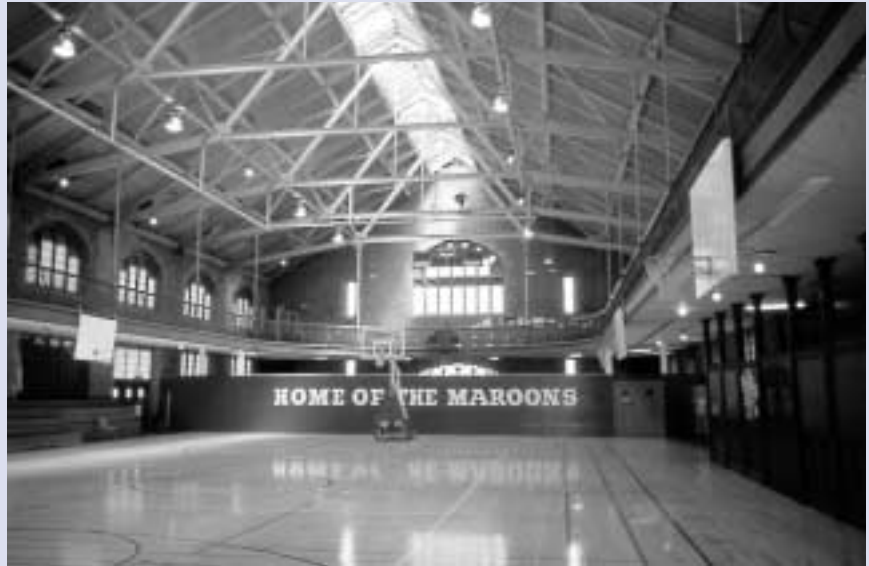
Above: Interior view of the original gymnasium.

The existing steel- and wood-framed running track was converted to a student lounge area and observation deck, with mechanical rooms and stairs inserted into the four corners. Original studies of the building by a previous engineer indicated the running track would not support modern live loads. The engineers recommended demolishing the cast-iron edged track, with its elegantly curved, iron mesh and oak railings. Additionally, the track was found inadequate to support the new heavy water-filled mechanical units. However, because the track structure, suspended from the original trusses with 1½" steel rods, was such an important architectural element to the building, Bruner/Cott sought to save it from the wrecking ball.
