Classic Revival

Seattle's Marion Oliver McCaw Hall, originally built in 1927, was given a major structural and architectural overhaul that included designing to achieve a silver LEED™ rating.

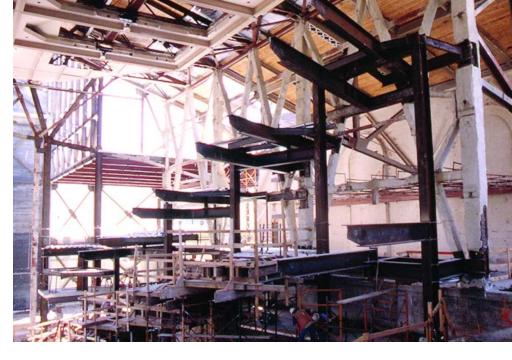
Five new balconies framed with structural steel cantilevers were added on each side of the auditorium. Photo courtesy Michael Dickter and Magnusson Klemencic Associates.

To remedy this, as part of the current renovation, walls were narrowed about 15' on each side. To maintain good acoustics, the upper part of the sidewalls were left open, so the volume of the original room was maintained. Grillwork separates the auditorium from the back area. Five new balconies were added on each side, with structural steel cantilevers to hold them in place. Structural steel also was used to extend existing concrete balconies closer to the stage, adding three rows of premium seating.

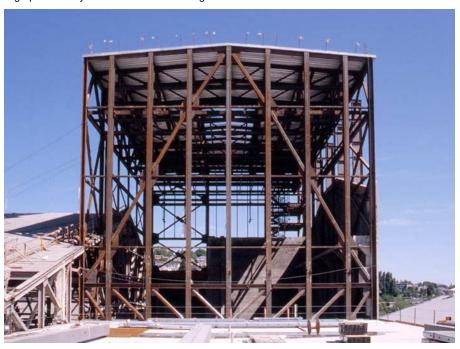
Above and below: New steel framing creates a larger fly loft to accommodate today's theatrical requirements. The peaked steel truss is part of the original 1927 roof structure. Drawing and photograph courtesy Michael Dickter and Magnusson Klemencic Associates.

The stage's existing fly loft was not tall enough to be used with many of the modern scenery sets commonly used around the country. To bring the facility to current standards, the existing fly loft was removed, and a new one was constructed 25' higher. The flyloft was raised by adding structural-steel column and braced-frame extensions to the existing lower structure. Atop the new flyloft, a full-width rigging gridiron was introduced to provide flexibility for line sets and individual point loading. The gridiron consists of heavy-capacity steel grating supported by W8 sections at 5' centers. The W8 members are supported by dual C12 members at 12' o.c. The C12 members are gapped, allowing individual line sets to access the stage below. The C12 members are supported by hangers at 20' centers, hung from 8'-deep trusses that span the 75' depth of the stage.
