DOWN TO THE WIRE

A guide to troubleshooting the most common self-shielded FCAW problems.

BY CHARLES SCHARFY AND BILL GIESE

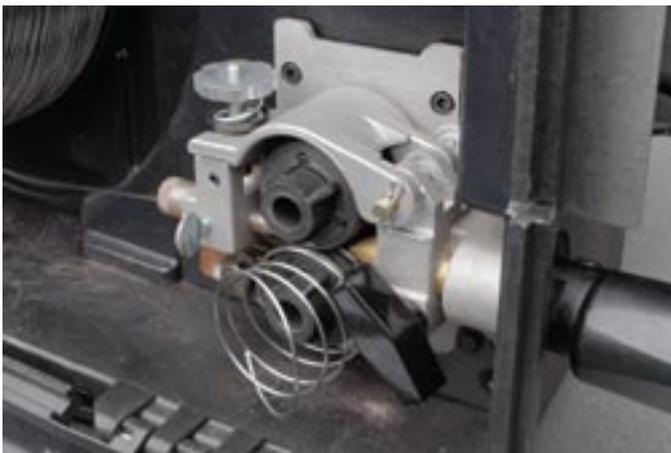
Often resulting from incorrect drive roll tension, birdnesting, as seen here, can be a frustrating source of downtime.

Birdnesting is a tangle of wire that halts the wire from being fed. Incorrect drive rolls, tension settings, blockages in the liner, improperly trimmed liners (too short/burred/pinched), or the wrong liner (too small or large for the electrode diameter) are all sources of birdnesting.

To set the proper tension, a good technique is to start by releasing the tension on the drive rolls. Increase the tension while feeding the wire into the palm of your welding glove and continue to increase the tension one-half turn past wire slippage. Blockages in the liner can also cause birdnesting, so replace the liner if you find

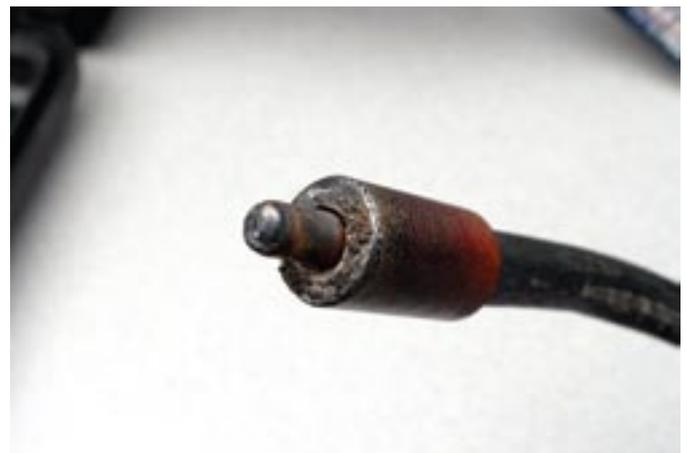
Caused by slow travel speed or holding the tip too close to the weld, burnback requires the contact tip to be replaced.

Burnback is the formation of a weld in the contact tip that occurs when the wire feed speed is too slow or if the gun is held too close to the work piece. Correcting this problem is easy: increase wire feed speed and the distance from the gun to the work piece (the contact tip should be no further than 1¼ in. from the metal). Also remember to replace the contact tip if burnback occurs.

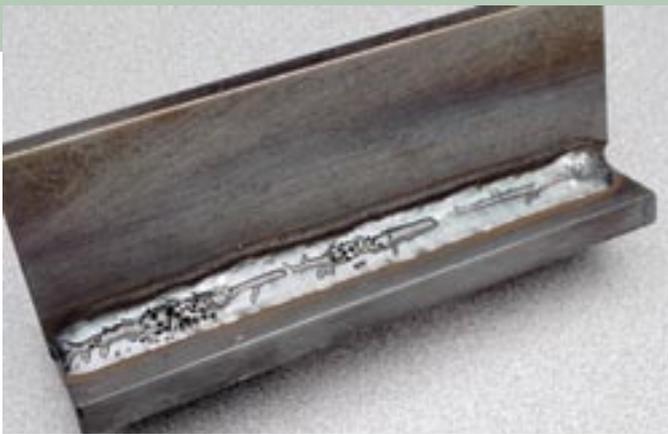
This image shows a combination of worm tracking and porosity, both outcomes of too much voltage. Worm tracking is both easily diagnosed and easily corrected by lowering your voltage. Porosity, seen on the face and cross section of this weld, can significantly weaken the structural integrity of the weld.

Another gas-related problem is **worm tracking**: marks on the surface of the weld bead that are caused from the gas that is created by the flux in the core of the wire. It occurs when there is ex-

cessive voltage for a given wire feed setting/ amperage. To prevent worm tracking, use the manufacturer's recommended parameters for a given wire diameter. If it does occur, reduce your voltage by increments of one-half volt until it no longer appears.

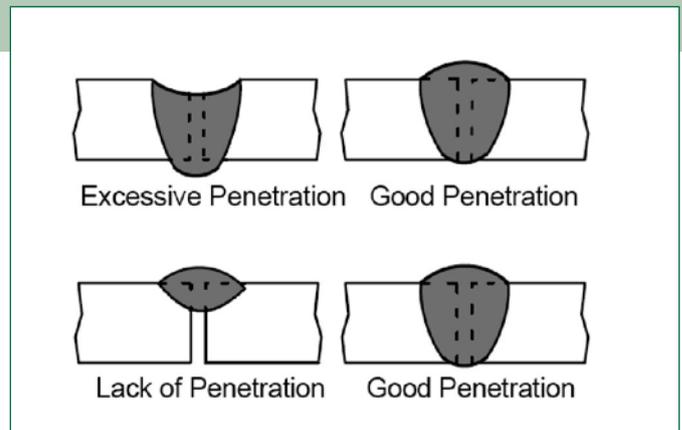
In addition to using increased current and a slower travel speed, a beveled joint can greatly reduce the occurrence of incomplete penetration.

At the other end of the spectrum is **lack of penetration**, the shallow fusion between the weld metal and the base metal. An obvious cause is insufficient heat input. Increasing wire feed speed, selecting a higher voltage range, and/or reducing travel speed are viable remedies.

Lack of penetration can also be caused by improper joint preparation and/or from the material being too thick. Joint preparation and design must permit access to the bottom of the groove, while also allowing you to maintain proper welding wire extension and arc characteristics.
