# In the Club

One Las Vegas nightclub becomes another thanks to an intricate structural addition and reconfiguration project.

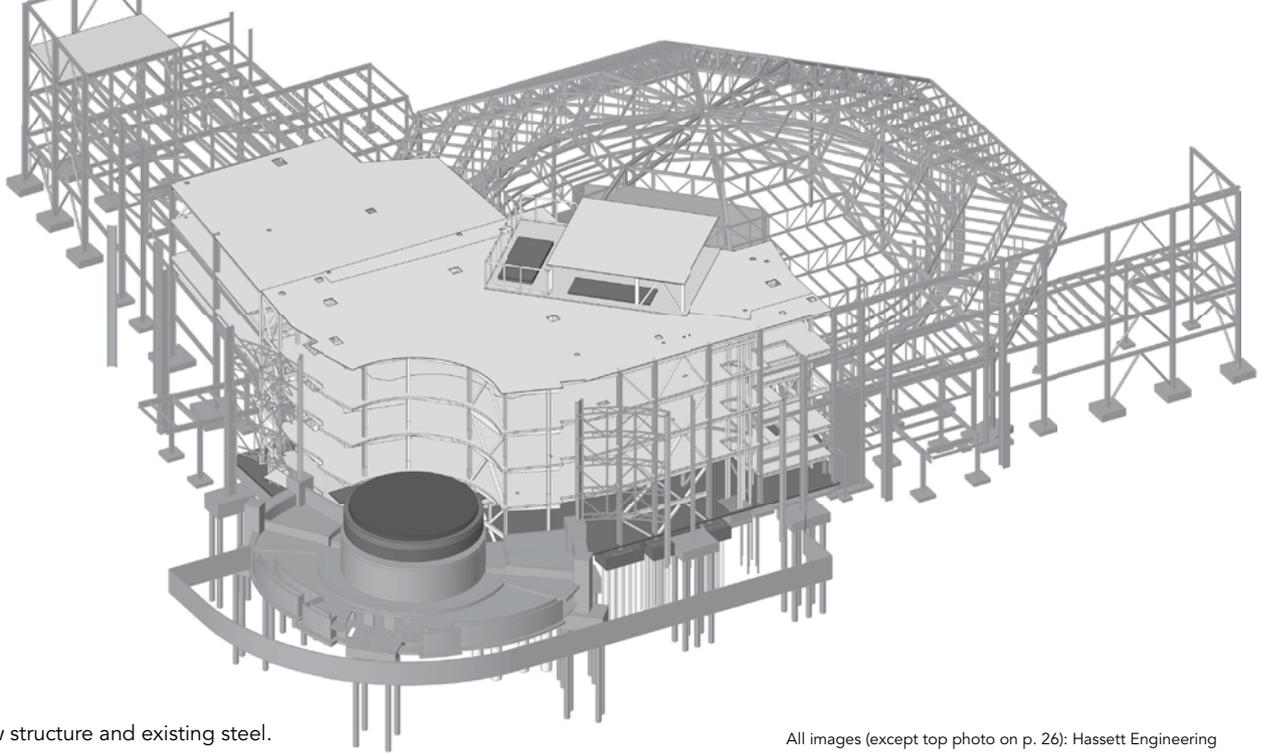
▲ New structure and existing steel.

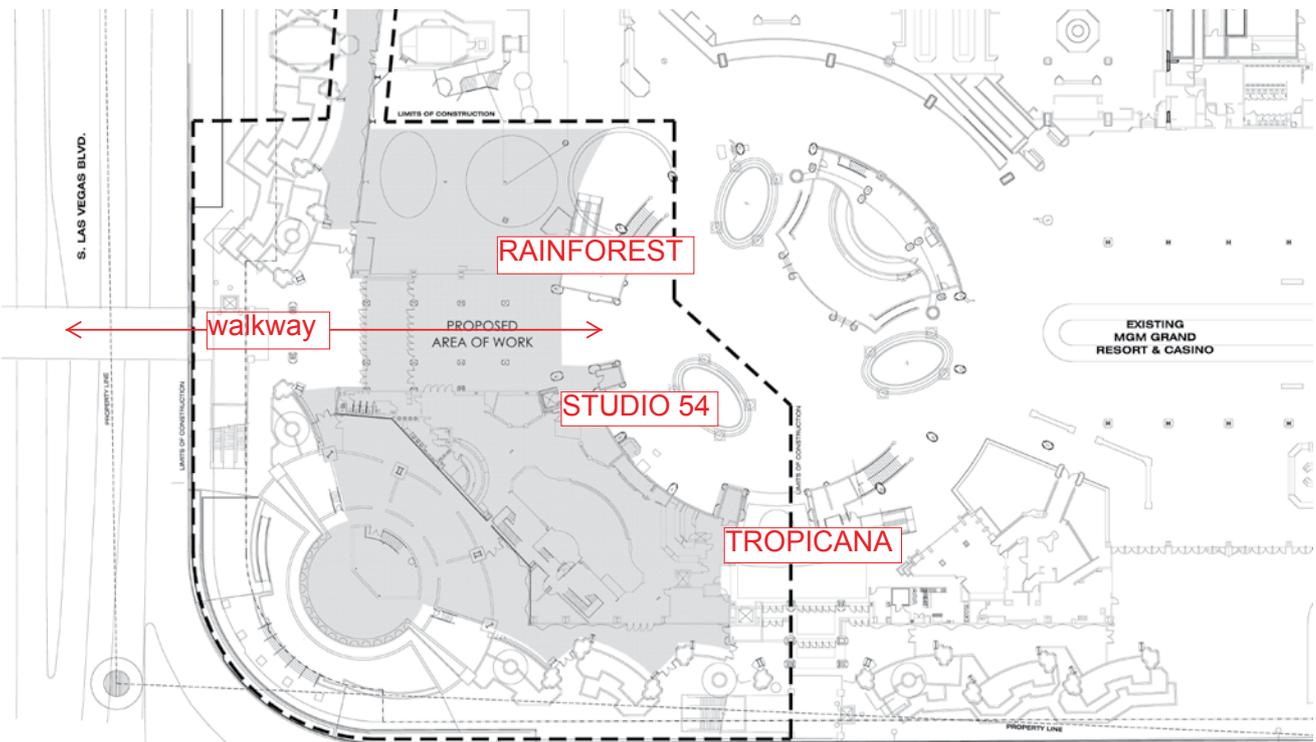
▼ Areas of work.

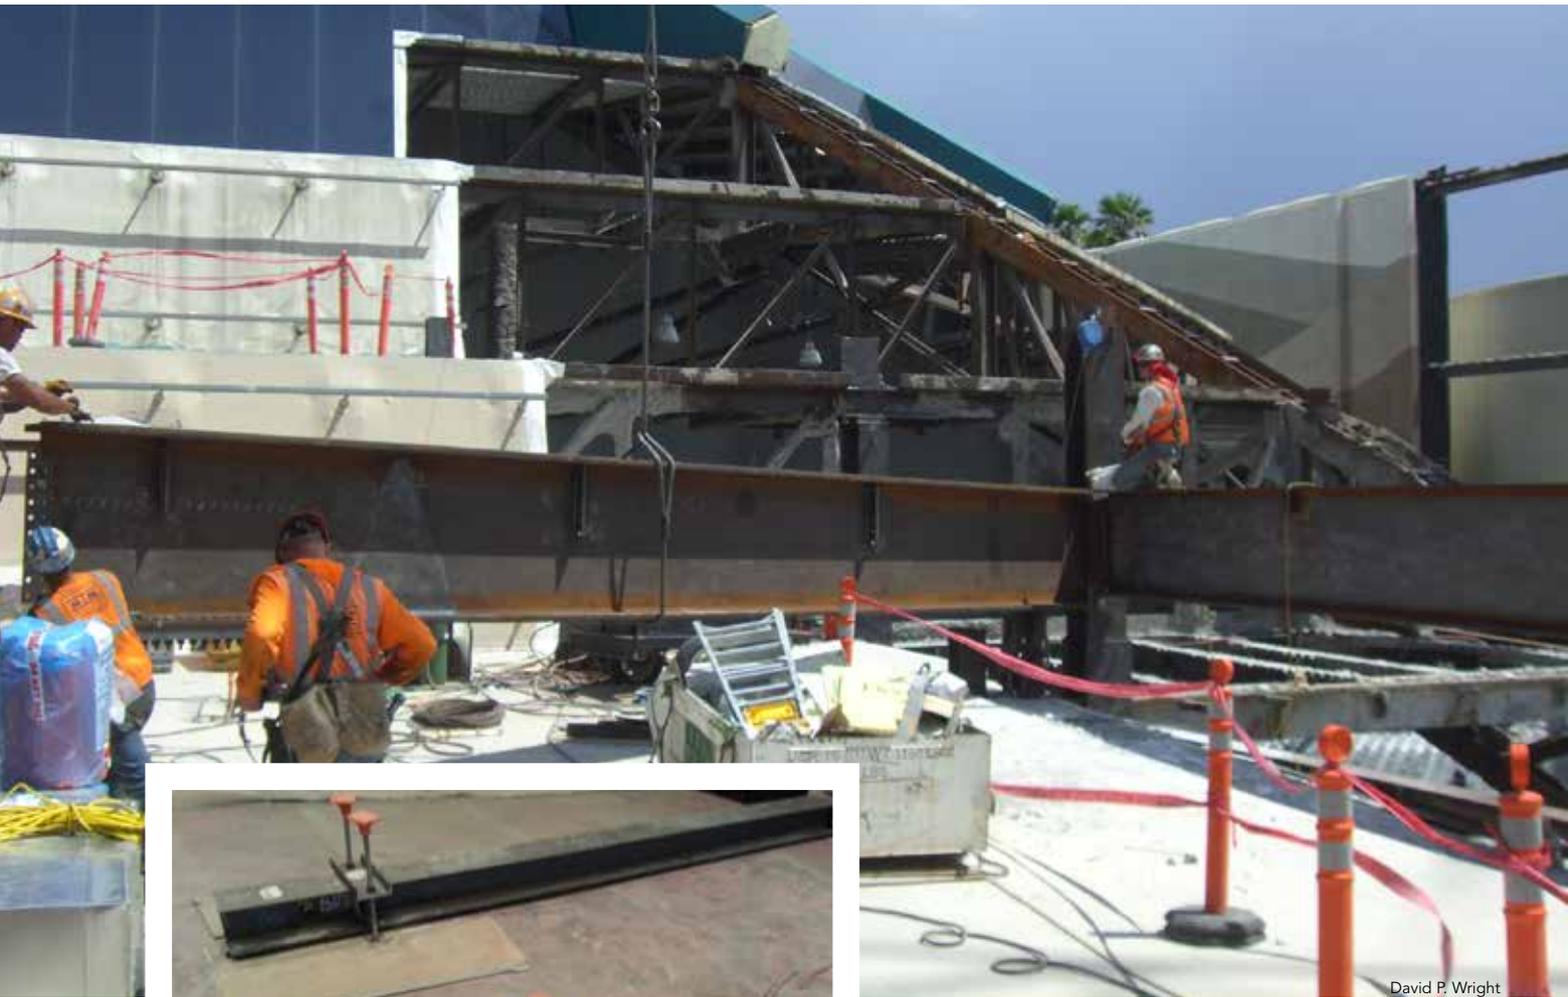
- ▲ New steel being incorporated into the existing frame.
- ◀ Hold-downs for the cantilever spreader beams.

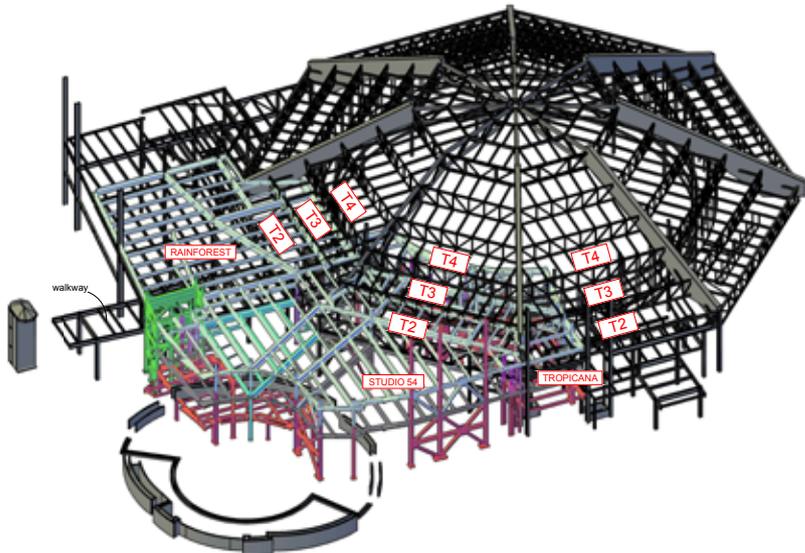
- ◀ New steel up to Level 4 and original steel (gray).

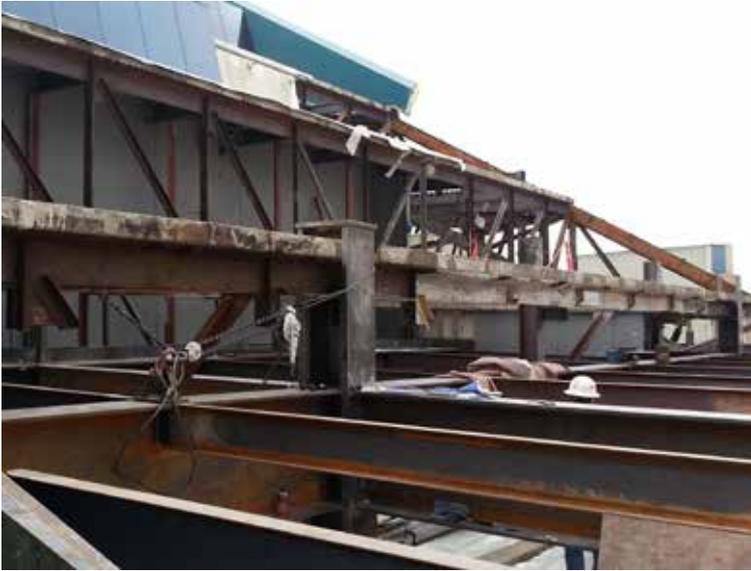
- ▲ An example truss top chord with two shoring posts.
- Example of truss chord shoring (side view).

Each truss had stages of demolition and retrofit that occurred concurrently with the erection of new beams and columns. Since many of the trusses called for the diagonal members to be removed, shoring columns were designed to support the top chords using short cantilever beam stubs with bolted end plates; the typical shoring column consisted of two W8x35 spreader beams supporting a W10x49 column with W8x24 cantilevers. The trusses consisted of WT12 chords with double-angle web members. The outrigger arrangement allowed new steel to be installed in the plane of the truss without conflicting with the temporary shoring column, and also allowed for one shore to support both top and bottom chords concurrently. The shoring locations depended on many factors: the length of the truss, the location of new and existing steel, the magnitude and location of the dead and live loads and the supporting structure below the truss.

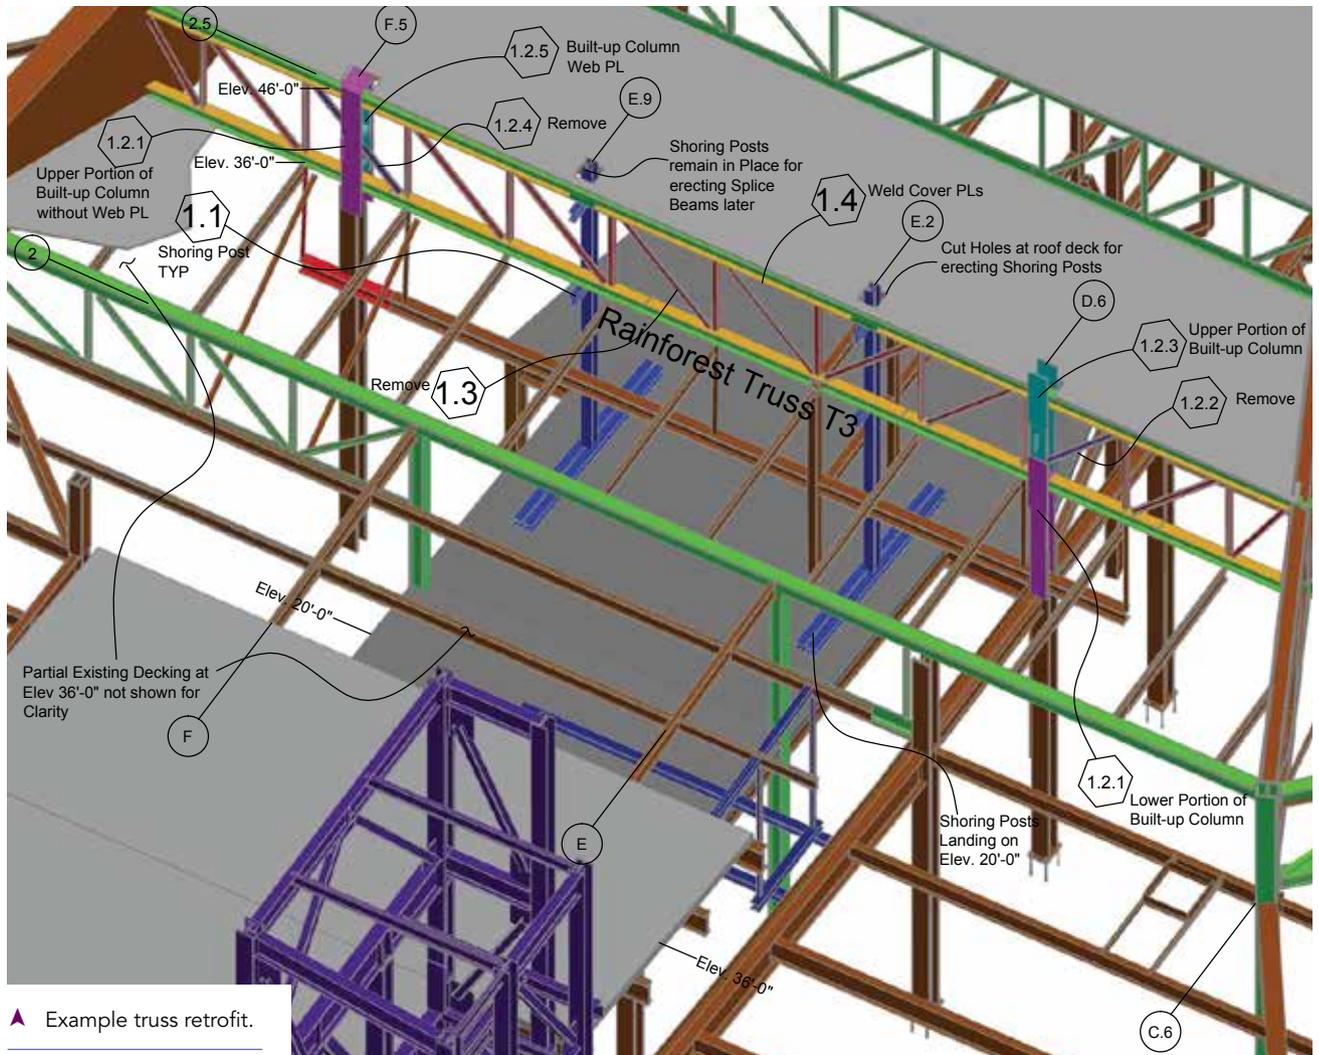
The erection procedure for one of the trusses is shown in the example truss retrofit above. The two shoring columns, shown in blue, were erected on the existing walkway and connected to the top and bottom chords of the truss. The built-up portion of the new column on the right (shown in light purple) was installed

and connected to the bottom chord, then the built-up portion of the new column on the left was installed and connected to the top and bottom chords; the web plate was left out for the existing truss diagonal. Then the two truss diagonals at each column were removed and the erection of the built-up portions of the columns was completed (see the light-blue pieces).

The remaining truss diagonals were removed and the cover plates (shown in yellow) were welded to the top and bottom chords to allow for the increased span length of the chords. The existing roof beams provided lateral stability of the top chord for buckling in compression. In this particular example, one of the cantilever beam stubs also acted as a support for the erection of a spliced girder that was part of the Level 4 incoming steel.
