# MAINTENANCE GUIDELINES FOR STEEL BRIDGES

Addressing Fatigue Cracking and Details  
at Risk of Constraint-Induced Fracture

G14.1-2021

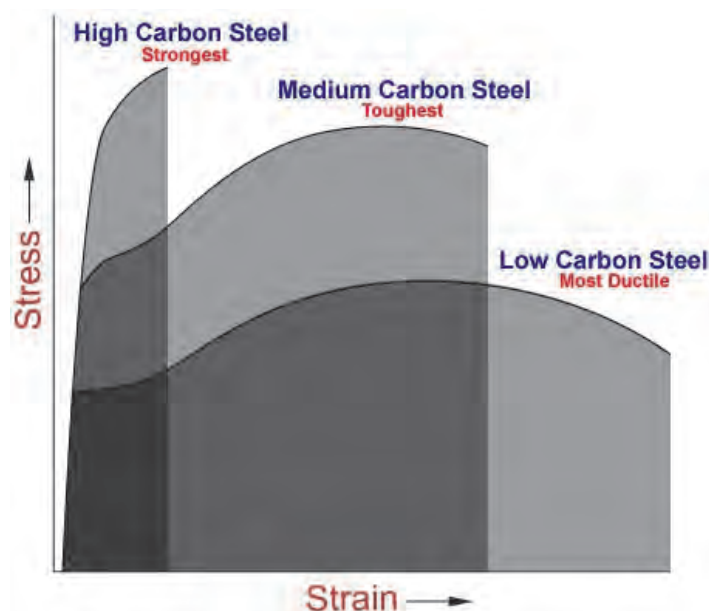
**Figure 2-2. Material Toughness Curves (NDT Resource Center, 2014)**

In simplest terms, crack propagation is a release of stored strain energy. If the release of the energy exceeds the ability of a material to absorb energy, then the crack will continue to grow. Toughness is the material property that quantifies the ability of a material to absorb energy or resist fracture. The amount of energy that can be absorbed relates to the local plastic deformation at the crack tip prior to fracture initiation and throughout fracture propagation. This can be graphically represented by the area under the stress–strain curve. Figure 2-2 qualitatively illustrates

this concept with three different types of steel. The first, high-carbon steel, possesses high strength and low ductility, and the lowest toughness. The low-carbon steel possesses a lesser strength, higher ductility, and higher toughness than the high-carbon steel. The final example is the medium-carbon steel, which falls between the previous types, possessing a compromise of ductility and strength while having the highest level of toughness. In this example, the high-carbon steel would be expected to behave in a brittle manner. The medium-carbon steel better represents a typical high-performance steel (HPS) where the optimal combination of strength and toughness is retained in the same material providing the best possible structural performance for steel bridge applications.

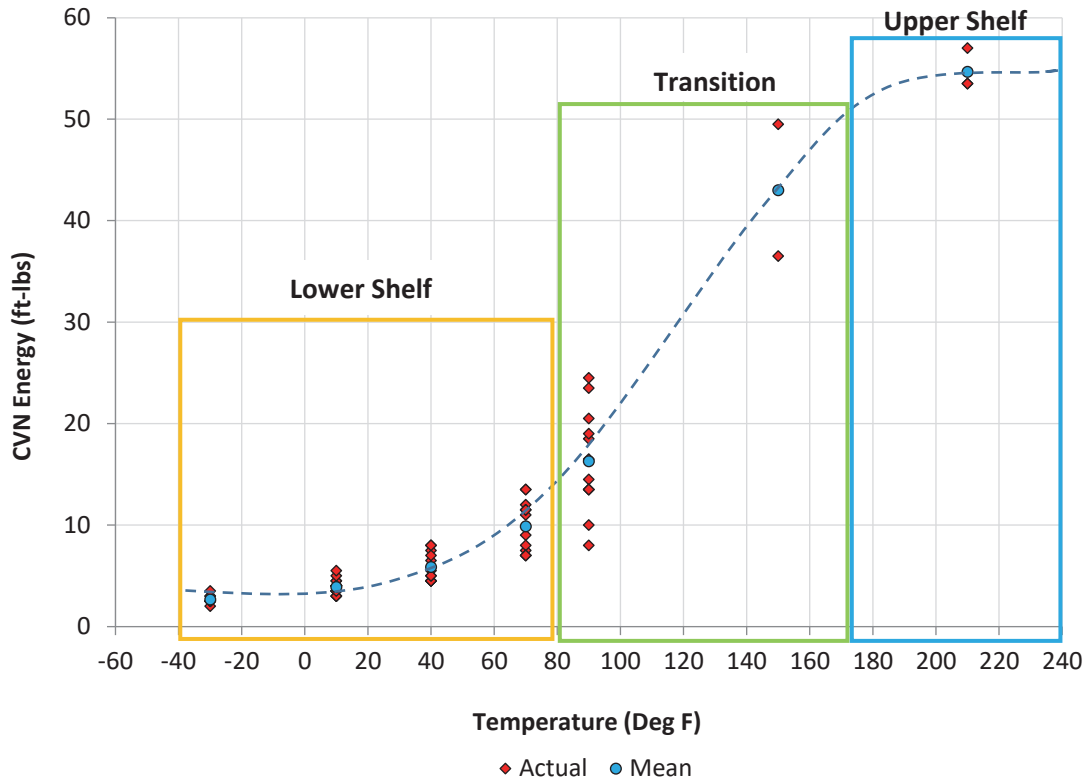
Figure 2-4. Sample of Charpy Impact Test Data Showing Transitions

The effect of temperature on the energy absorbed is often examined by repeating the test using identical specimens that have been cooled to various temperatures. A variety of tests at varying temperatures can establish the relationship between the measured absorbed energy and temperature. Figure 2-4 shows a sample of actual CVN test data from steel from a circa 1900 railroad truss. The general regions of the transition curve have been highlighted for emphasis. This figure illustrates that as the temperature is increased, the steel undergoes a brittle-to-ductile transition

in terms of fracture toughness. The three regions often referred to are lower-shelf, transition, and upper-shelf. The lower shelf is associated with brittle fracture and is the region of fracture mechanics where LEFM is valid. The upper shelf is associated with ductile fracture, or tearing, where significant inelastic deformations form shear lips on the fracture surface. Between the lower and upper shelves is called the transition region, associated with the brittle–ductile, or transitional, fracture behavior. Fractures in this region are characterized by a mix of brittle and ductile and often have larger scatter in the data. The temperature range for the transition region will differ for different steels, some being only a few degrees, while others might be spread over tens of degrees, such as is shown in Figure 2-4. It is noted that not all steels follow such an ideal curve, as shown in Figure 2-4, with some not exhibiting clear upper and lower shelves.

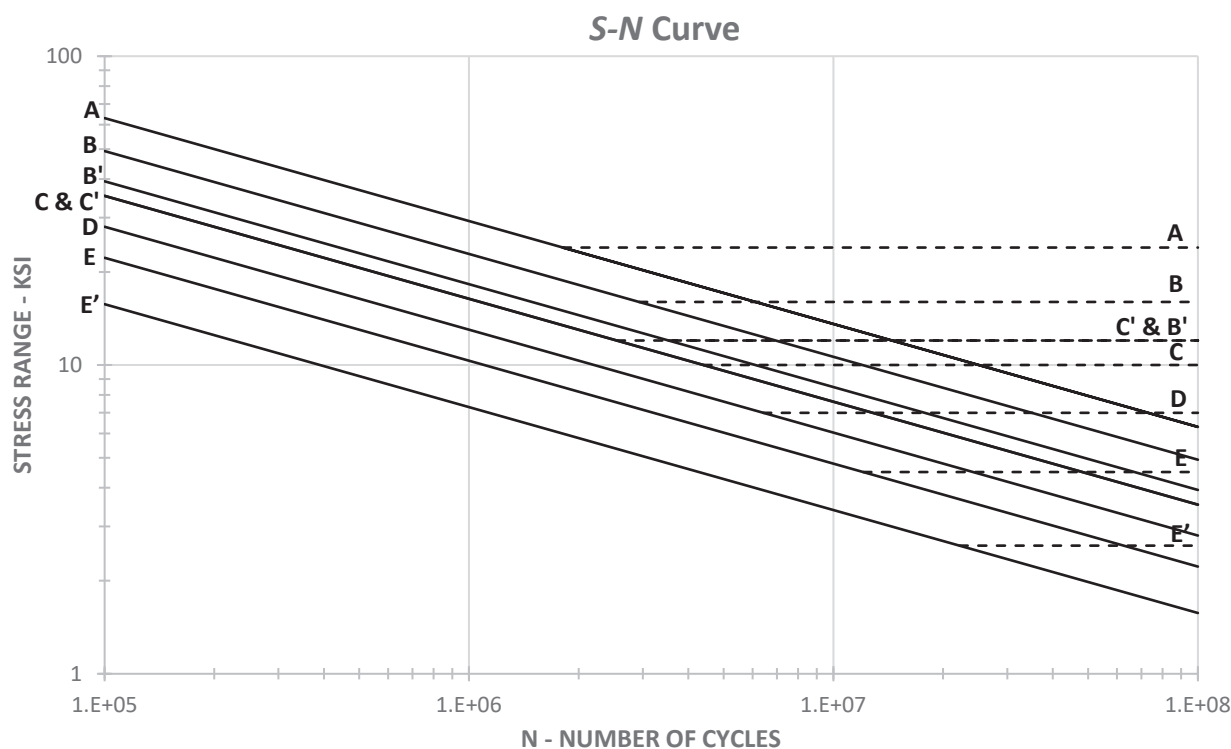
Figure 2-5. Modern  $S$ - $N$  Curve Showing All AASHTO Fatigue Categories

The three most influential factors on fatigue life are stress range, number of cycles, and the detail type (referring to the orientation and configuration relative to the applied stress range). The stress range that drives fatigue cracking

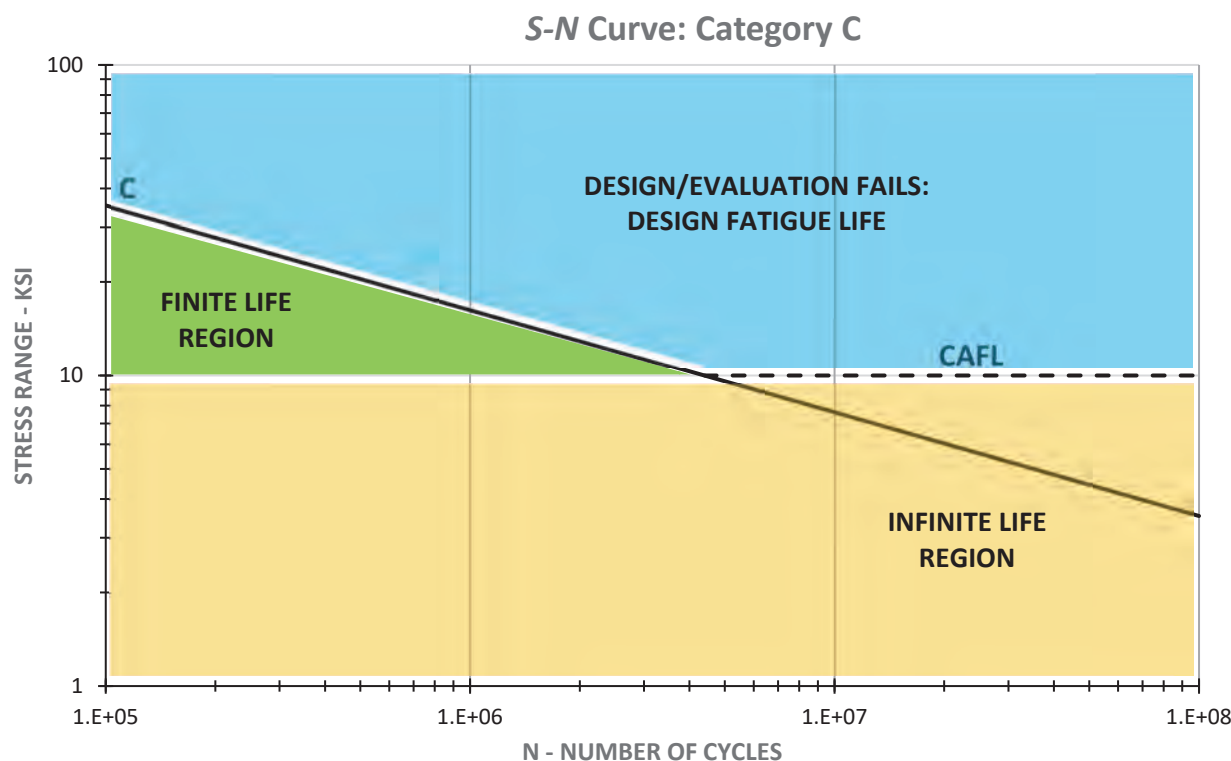
Figure 2-7. Category C  $S$ - $N$  Curve Illustrating the Regions of the Plot

Steel bridge details possessing similar fatigue resistance have been grouped into categories and assigned letters A through E'. There are eight categories in total, listed here in descending order of fatigue resistance: A, B, B', C', C, D, E, and E'. An AASHTO design curve, such as that seen in Figure 2-7, represents the fatigue resistance for each respective category. The sloped portion of the curve represents the number of cycles at a given stress range that can be expected for a detail before significant cracking will occur. The region of the plot below the sloped line is referred to as the “finite life” region. The horizontal section of the curves is called the Constant Amplitude Fatigue Limits (CAFL) or Constant Amplitude Fatigue Thresholds (CAFT). These terms are synonymous and used interchangeably in the literature. If the maximum stress range is less than the CAFL for a given detail category, it can be expected that an infinite number of cycles can be resisted without incurring fatigue damage. The region of the curve below the CAFL is referred to as the “infinite life” region.

where  $N$  is the number of stress cycles,  $S$  is the nominal stress range, and  $A$  is a detail constant (the y-intercept). Notice that the stress range is cubed in Equation 2, implying that small changes in the stress range can have a significant impact on the fatigue life estimation. This should be remembered for two reasons. First, from a design/evaluation perspective it means that accuracy in the estimation of the stress range is very important, and where estimated remaining fatigue life is found to be unacceptable, more sophisticated analysis or field measurement may result in a

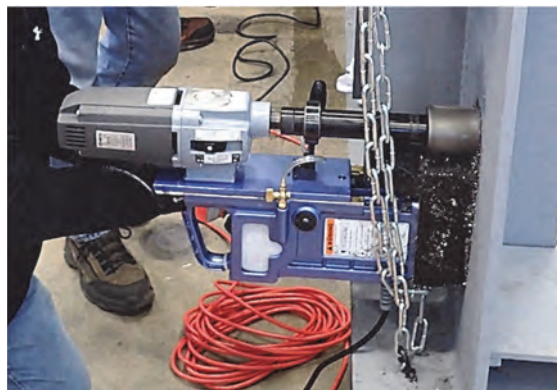
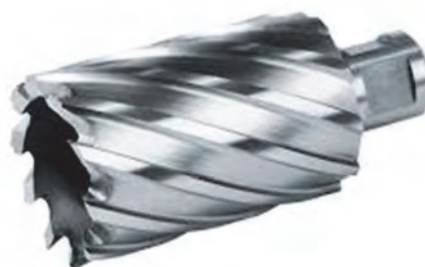
**Figure 3-1. (Left) Example of Magnetic-Based Drill, (Right) Annular Cutter Used for Hole Drilling**

The equipment recommended for hole drilling includes a magnetic-based drill and annular cutter, such as that seen in Figure 3-1. Although hand drills have been shown to be effective, even for larger diameter holes, when operated by trained and experienced crews, magnetic-based drills offer superb control and precision for a wide range of hole sizes. The greatest challenge can be positioning the drill in tight spaces where intersecting elements of a detail leave little room for the drill to seat properly.

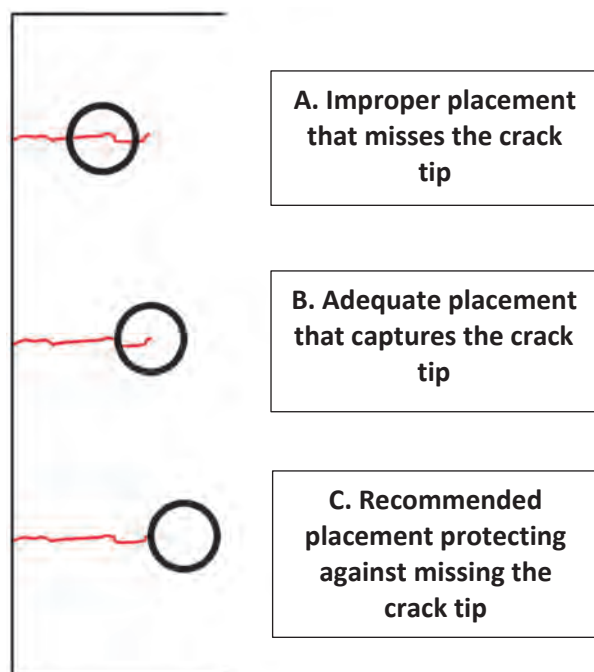
**Figure 3-4. Improper and Proper Drilled Hole Placements for Crack Arrest**

Correct hole placement, relative to the crack tip, is one of the most important considerations for effectively drilled holes. Consider the examples of hole placement illustrated in Figure 3-4, as first proposed by Fisher et al. (1980). The top example, A, shows a case where the crack tip is entirely missed by the drilled hole and the crack tip is allowed to continue growing. The second, B, depicts an acceptably placed hole because it adequately captures the crack tip. The third scenario, C, is the recommended placement. The hole is drilled such that the edge of the annular cutter just intercepts the crack tip. This approach is recommended because it better safeguards against the possibility of missing the tip. Even if the hole is inadvertently drilled slightly ahead of the crack tip, the crack will only be able to grow until it intercepts the hole and then will become arrested. However, it is not necessarily recommended that the hole be purposefully drilled away from the crack tip as if to anticipate arrest. All efforts should be made to locate the crack tip and place the cutter such that it intercepts the tip. Once the hole has been drilled, a couple of simple checks can be done to determine the hole placement, as follows:

- If the removed core splits in half, then the crack tip has been missed and the hole placement corresponds with scenario A in Figure 3-4. The crack tip should be relocated using MT or PT and then another hole drilled, or grinding should be performed to remove it.
- If the crack can be seen on one edge of the hole in the drilled plate, but not on the opposite side, then the tip has been adequately removed (see Figure 3-9). The crack may also appear on one side of the removed core, in which case the hole placement corresponds with scenario B in Figure 3-4.
- If the crack can be observed on one edge of the drilled plate, but not on the opposite side, and also cannot be observed anywhere in the removed core, then the hole placement corresponds with scenario C in Figure 3-4.

2. Position the magnetic-based drill as seen in scenario C of Figure 3-4. *Caution: Tie off the mag-based drill to the girder using sturdy clamps and chain/rope. In the event of power loss, this will help prevent injury or damage to equipment.*

1. Inspect the area carefully using NDT methods such as PT or MT to identify any cracks that may exist.
2. If a crack is identified in Step 1, position the magnetic-based drill as seen in scenario C of Figure 3-4. If a crack is not located, position the drill such that the annular cutter is horizontally centered at the weld toe termination, as seen in Figure 4-25. The holes can be drilled slightly above the weld toe, as shown in Figure 4-25, or with the edge of the hole touching or slightly intercepting the weld toe. Drill the holes. *Note: Carbide tip annular cutters should be used when the cut penetrates welds or heat-affected zones. This is*

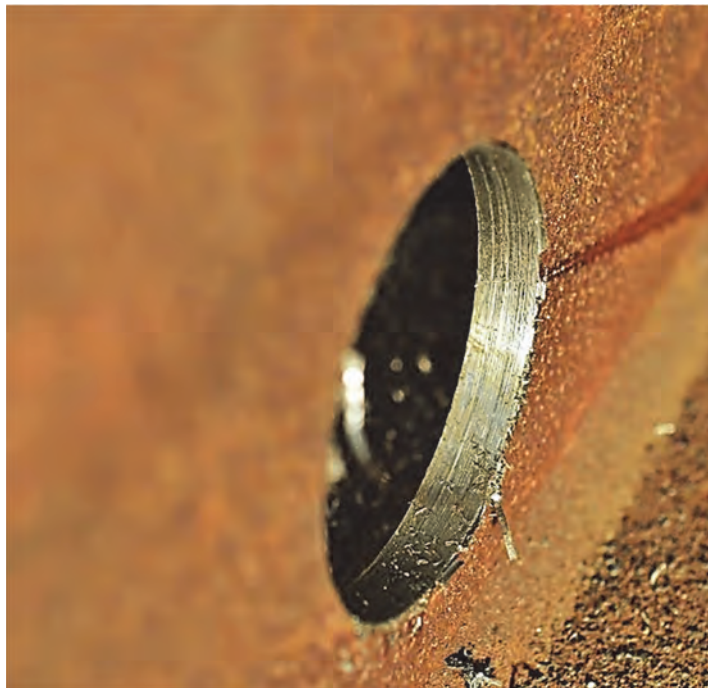
**Figure 3-6. Drilled Hole Showing Rough Edges and Burrs**

Another important consideration is the edge condition of the hole. The edge condition of the hole may very well impact the fatigue life of the repair or retrofit more than the diameter of the hole. Even the quality of the drill bit used can have an effect on the fatigue life. Brown et al. (2007) found that holes drilled with dull bits often resulted in a fatigue life similar to punched holes, or about Category C. They reference other research which reportedly has shown that these differences can drop the fatigue resistance of the hole to as low as Category D. Figure 3-6 shows an example of the edge conditions following drilling and before sanding. The cutting process naturally leaves rough edges and burrs that can generate stress concentrations that over time can become initiation sites for fatigue cracks. A recommended sanding procedure includes using an 80 to 100 grit flap wheel with an angle grinder around the outer edges of the hole on both sides of the plate. Then the inside of the hole should be sanded using an 80 to 100 grit flap wheel with a die grinder. The result is a smooth-to-the-touch surface free of burrs and rough and gouged edges while being careful not to burnish the surface, as discussed for painting in Section 3.2. Also, sometimes when drilling begins, the magnetic base may shift as the annular cutter digs into the plate. This can happen when the magnetic connection to the plate is insufficient due to a number of possible reasons, such as excessive moisture, oil, or corrosion; plate curvature; or on very thin plates. When this happens, gouges can result that are capable of initiating

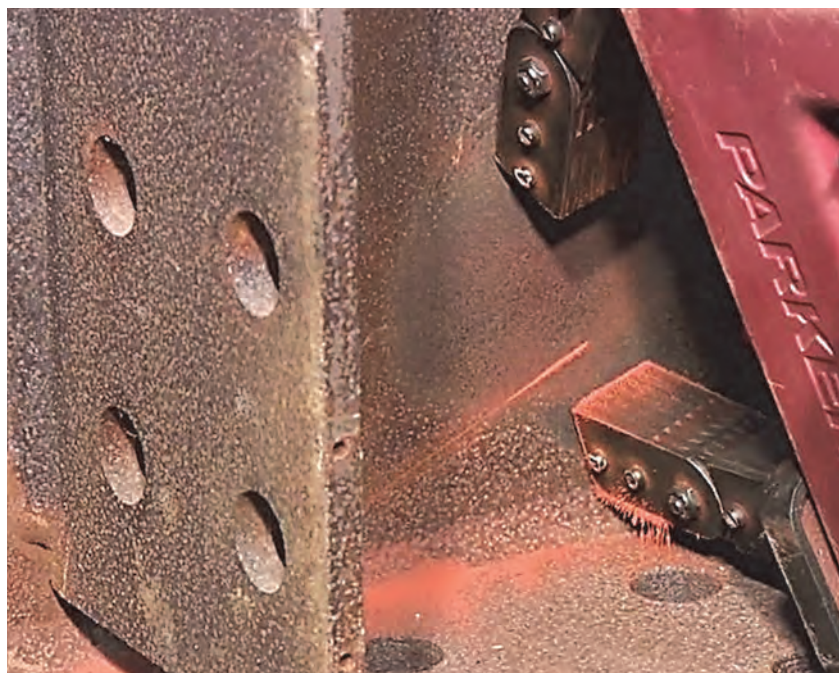
Figure 3-7. Magnetic Particle Test Performed Before Drilling Crack Arrest Hole in Order to Locate the Crack Tip

1. Locate the crack tip using enhanced inspection techniques, such as MT or PT. Figure 3-7 shows an MT inspection being performed where the crack is highlighted by the red magnetic particle dust. Inspect both sides of the plate to ensure the tip is not missed.

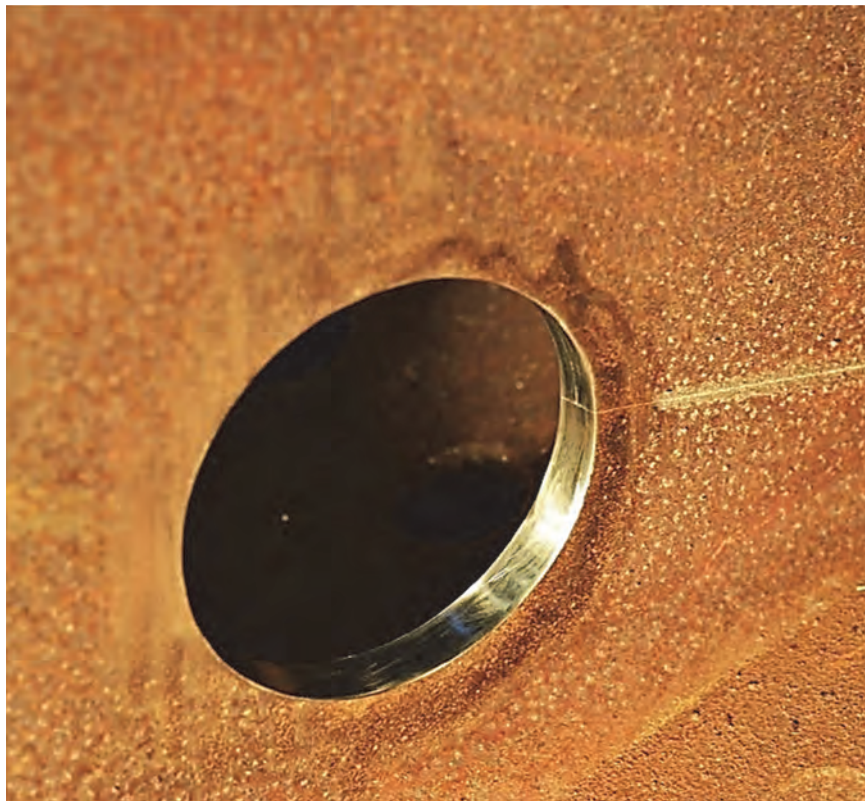
**Figure 3-9. Example of Finished Crack Arrest Hole Prior to Painting**

5. Following removal of the core, reinspect the edge of the drilled hole using MT or PT to ensure the crack tip does not remain.
6. Sand the edges of the drilled hole using an 80 to 100 grit flap wheel with an angle grinder on the exterior edges and an 80 to 100 grit flap wheel with a die grinder on the interior edges. An example of a polished drilled hole is shown in Figure 3-9.

4. *If a high-strength bolt is not installed:* Sand the edges of the drilled hole using an 80 to 100 grit flap wheel with angle grinder on the exterior edges and an 80 to 100 grit flap wheel with die grinder on the interior edges. An example of a polished drilled hole is shown in Figure 3-9.

5. Follow up with grinding to improve the hole edge conditions:
  - a. Drilled hole: Sand the edges of the drilled hole using an 80 to 100 grit flap wheel with angle grinder on the exterior edges and an 80 to 100 grit flap wheel with die grinder on the interior edges. An example of a polished drilled hole is shown in Figure 3-9.

7. *If a high-strength bolt is not installed:* Sand the edges of the drilled hole using an 80 to 100 grit flap wheel with angle grinder on the exterior edges and an 80 to 100 grit flap wheel with die grinder on the interior edges. An example of a polished drilled hole is shown in Figure 3-9.

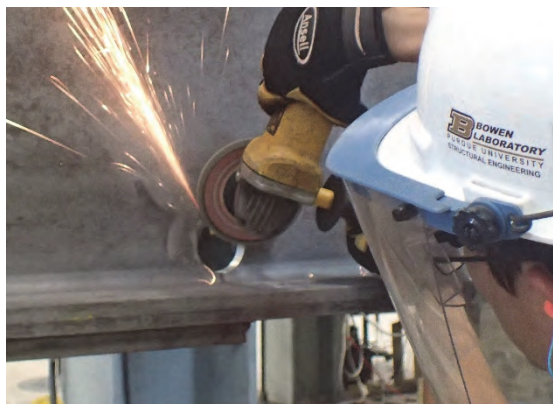
There are two main types of handheld grinders, angle and die. Grinding wheels for the angle grinder typically come in either 4.5- or 9-inch diameters and a wide range of types and grits. Also called a disc grinder, the angle grinder can also be used to quickly cut steel when using a cutting wheel. An example of an angle grinder is shown in Figure 3-10 paired with a flap wheel for sanding. A typical die grinder is shown in Figure 3-11 fitted with a rotary burr bit for rough grinding. The die grinder typically uses much smaller abrasive wheels and cutting wheels than the angle grinder, as well as carbide rotary burrs, allowing for access to smaller spaces. The angle grinder, although more difficult to get into tight spaces, has the advantage of faster material removal.

**Figure 3-10. Typical Angle Grinder with Flap Wheel**      **Figure 3-11. Typical Die Grinder with Burr Bit**

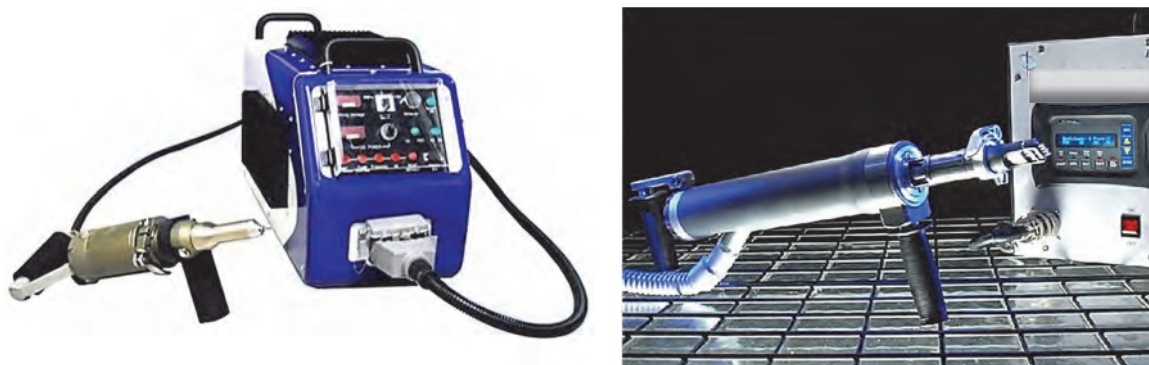
Figure 3-15. Examples of UIT Tools

The primary difference between these two forms of post-weld impact treatment is in the equipment itself. The UIT equipment impacts at extreme rates of 20 to 27 kHz, whereas the peening hammer impacts at only 100 to 200 Hz. The extreme impact rate of UIT affords faster application and minimized areas of missed treatment. UIT is far more precise with computerized, automated controls providing reproducible results. The UIT tools include a handheld tool connected to a generator unit or central unit where controls and monitoring are housed (see Figure 3-15). The equipment is designed to be ergonomic, minimizing vibration discomfort, noise, and worker fatigue for the operator.

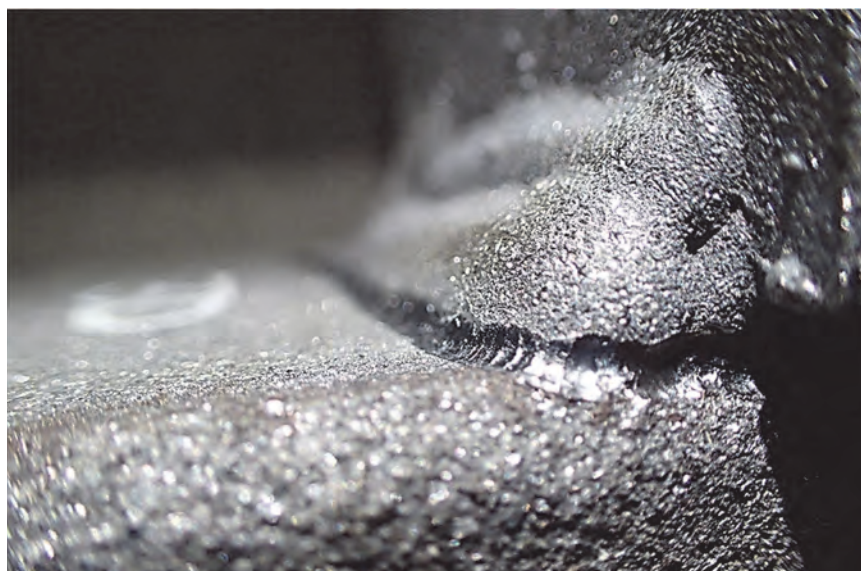
**Figure 3-17. Appearance of Properly Treated Weld Toe Using UNP Method**

7. Inspect the groove, looking for a uniform, shiny appearance, such as that shown in Figure 3-17. A  $\frac{3}{32}$ -inch welding rod or a peening needle can also be lightly dragged through the groove. A well-formed groove will allow the rod/needle to slide without catching. If gaps in treatment are located, repeat treatment in those areas and inspect again.

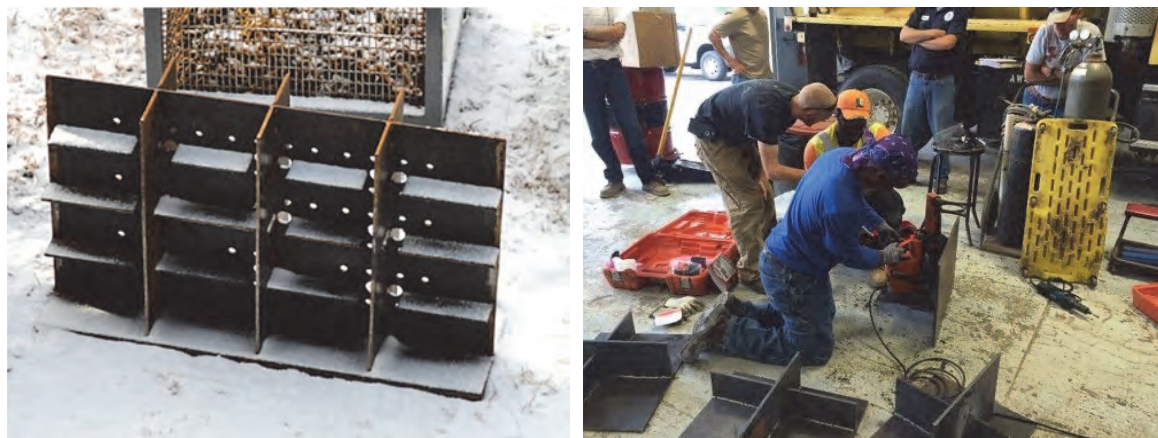
**Figure 3-19. (Left) Example of Used Mockup, (Right) Performance Testing of a Contractor Prior to Implementation of a Repair Project**

Experience has shown that even the most experienced contractors and maintenance crews can underestimate the challenges of executing repairs on steel bridges. Unfortunately, in some cases it is not until they actually begin work that those challenges surface. This type of situation can cause costly delays for the owner and the contractor, or worse, actually cause damage to the structure. Figure 3-19 shows an example of a used mockup specimen (left) and ironworkers performing repairs as part of a performance test (right). This type of testing can be successfully included in rehabilitation contracts where the scope of work requires the fabrication of mockups and satisfactory completion of the test before work can begin on the bridge. The performance test provides two primary functions, (1) to ensure the work can be completed as intended by the contractor, and (2) to establish the level of quality that is expected on the project to all parties. Typically, mockups can be fabricated for only a few thousand dollars, depending on the complexity of the detail. The fidelity of the mockup to the actual detail is very important. Size, quality, condition, and geometry should be replicated as much as possible. Economy is achieved by duplicating the detail like shown in Figure 3-19, without compromising authenticity. Difficult-to-access areas, such as corners of intersecting plates and connection elements should not be overlooked because often it is these details that make the actual repair or retrofit challenging and where the real benefit of the mockup will be gained.

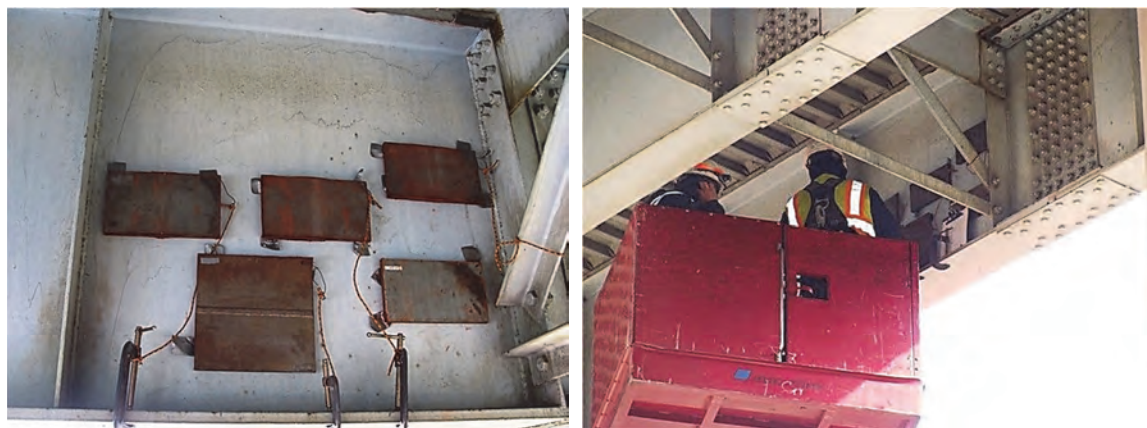
**Figure 3-20. (Left) Welded Steel Test Specimen Hung on a Bridge, (Right) Performance Testing of an Inspector Prior to Beginning NDT on Bridge Welds**

NDT inspection relies on trained inspectors who follow established procedures and correctly interpret the test results. High variability in nondestructive test results has been shown to occur among certified inspectors where variances in thoroughness, care with which NDT procedures are followed, and interpretation of results differed. Washer et al. (2014a) conducted performance testing of ASNT Level II and III certified UT and MT inspectors to establish inspector qualifications prior to inspection work beginning on the Sherman-Minton Bridge over the Ohio River near Louisville, KY. Before inspecting the tied arch structure, inspectors were first evaluated in a performance test program. The welded-steel specimens used for performance testing were fabricated plates with known flaws of various sizes. Figure 3-20 shows similar test specimens hung on a bridge (left) and an inspector completing a performance test (right).

Installing the test specimens on the bridge helps to make the test authentic, ensuring ambient factors present in actual inspection are also at play during testing (e.g., wind, temperature, access, bucket sway, lighting). A sample of the test results is provided in Figure 3-21 (Washer et al., 2014a). The horizontal axis is the actual flaw length and the vertical axis is the measured flaw length as reported by each inspector. The diagonal line passing through the plot represents the correct flaw length and the solid circles are the average measured lengths. The results of the performance tests identified inspectors whose performance was substandard and provided quantitative measures of

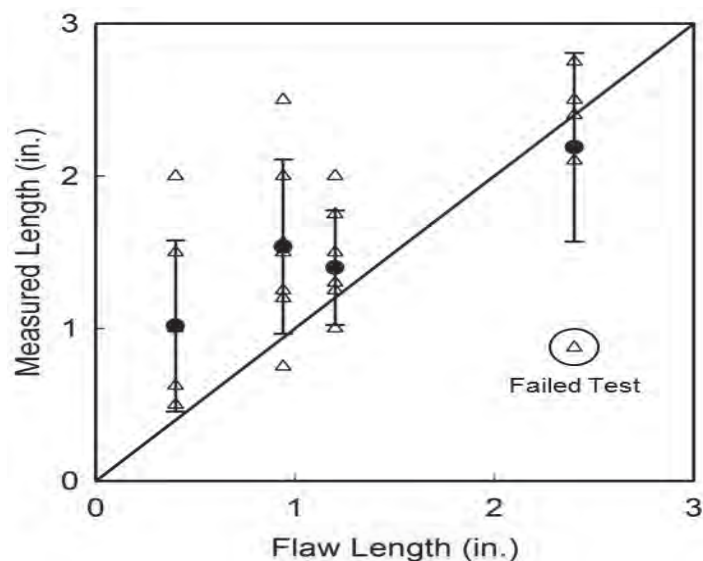
Figure 3-21. Sample of UT Performance Testing Results (Washer et al., 2014a)

the variations in the NDT results (Washer et al., 2014a). The variations can be seen in the plot where it shows that scatter among inspectors was as much as the defect length, meaning that some inspectors were over or underestimating crack sizes by as much or more than 100 percent. At the same time, a few inspectors were able to report very accurate results.

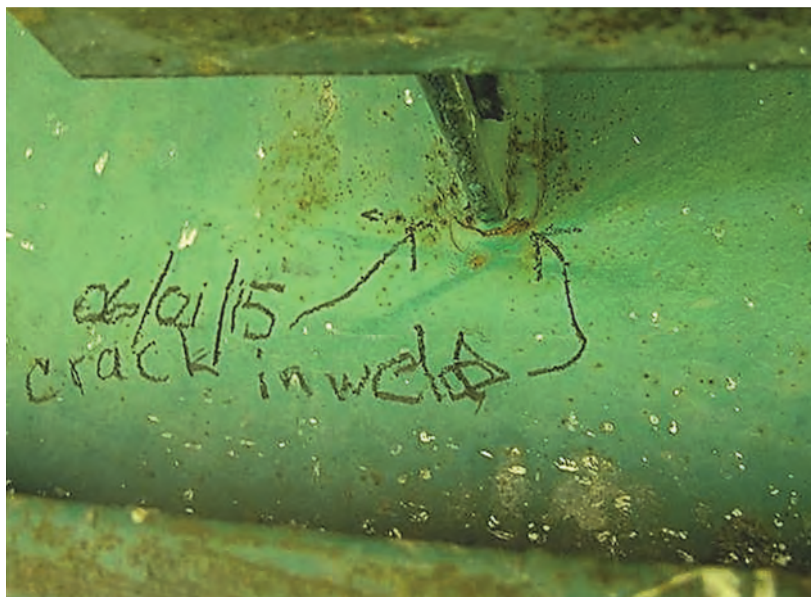
Figure 3-22. Distortion-Induced Fatigue Crack Growing out of the Throat of the Weld

A simple “two-hole” retrofit for distortion-induced fatigue cracking on twin, 6-girder interstate bridges was evaluated using a prototype. The superstructure of the bridge included 30 skewed spans made up of six 48-inch-deep, continuous plate girders with a fully composite reinforced concrete deck. Bridge inspectors discovered distortion-induced fatigue cracks that initiated at the bottom of several transverse connection plates and grew into the web plates. This prompted a more thorough arms-length inspection of the bridge resulting in 30 locations identified with fatigue cracks grown into the web plate and hundreds more locations that appeared to have some distortion-induced cracking at the weld termination (as seen in Figure 3-22) that had not yet grown out into the web plate. The unique aspect of this distortion-induced fatigue cracking was that it was occurring despite the relatively large 5-inch web gap, which can also be seen in Figure 3-22. Most often, distortion-induced cracking occurs where there are much smaller web gaps; however, larger web gaps can also crack if sufficient displacement occurs and particularly when weld quality is lacking.

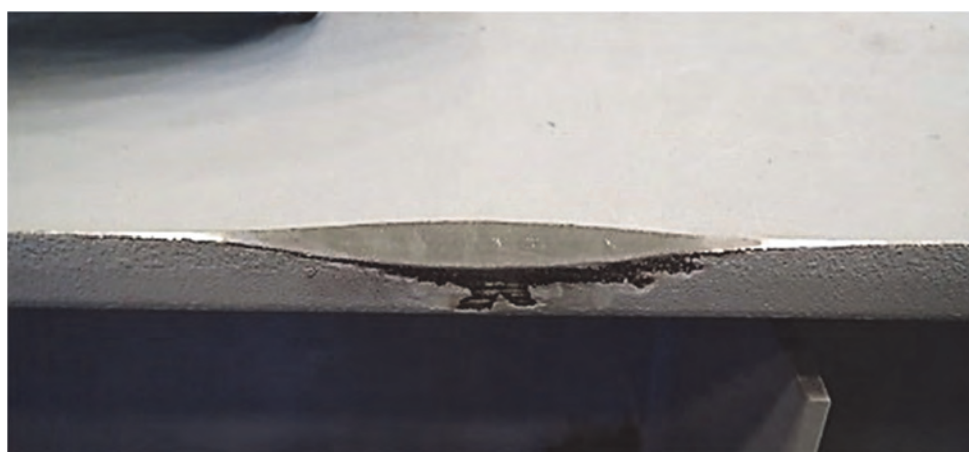
Figure 4-17. Example of Edge Flaw Removed with 5:1 Fairing Ratio, Shown Prior to Repainting

3. Perform rough grinding to remove the bulk of the material using 40 to 60 grit flap wheels while being careful to follow the tapered markings.
4. Complete the fine grit grinding step using 80 to 100 grit flap wheels. Figure 4-17 shows an example of a 5:1 taper following the removal of an edge gouge on a flange. Notice the smooth and gradual surface of the repair.

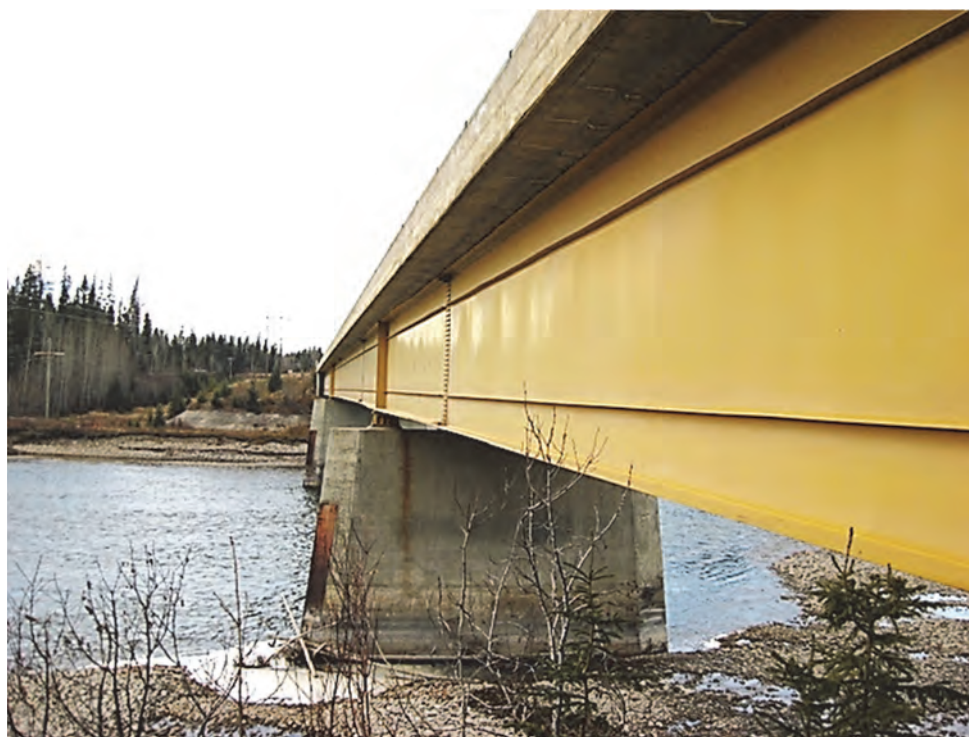
**Figure 4-20. Example of Longitudinal Stiffeners Located in Tension and Compression Zones**

Longitudinal stiffener plates are typically placed in compression zones in order to stiffen the web plates against bend-buckling out of plane. The purely compression regions of a bridge generally are not a concern for fatigue cracking because even though fatigue cracks can initiate at weld toes in a compression zone, they will not propagate beyond the tensile residual stress of the weld toe. Outside the tensile stresses of the weld toe, the compressive live-load stresses will not advance the crack further and it dies off. However, longitudinal stiffeners are often continued into stress reversal zones that are subject to tensile stresses. In some cases, they have also been used as architectural features, such as that shown in Figure 4-20 where they are subjected to full tensile dead load stress and live-load stress ranges. In such cases, the weld terminations, as well as the butt weld splice locations, can become prone to fatigue cracks. These regions of the stiffener plate can also be prone to constraint-induced fracture where poor groove weld quality at the butt splices or insufficiently sized web gap regions at intersections with transverse stiffener plates has caused brittle fracture. Performing the retrofits discussed in Section 6.2 will address both fatigue and fracture concerns for details intersecting transverse plates, and performing the retrofits discussed in Section 6.3 will address both fatigue and fracture concerns for the groove-welded butt splice details. Retrofits presented in this section apply to weld terminations of both longitudinal stiffeners and gusset plates and may not remove the risk of constraint-induced fracture. Rather, the following retrofits are intended for fatigue only.

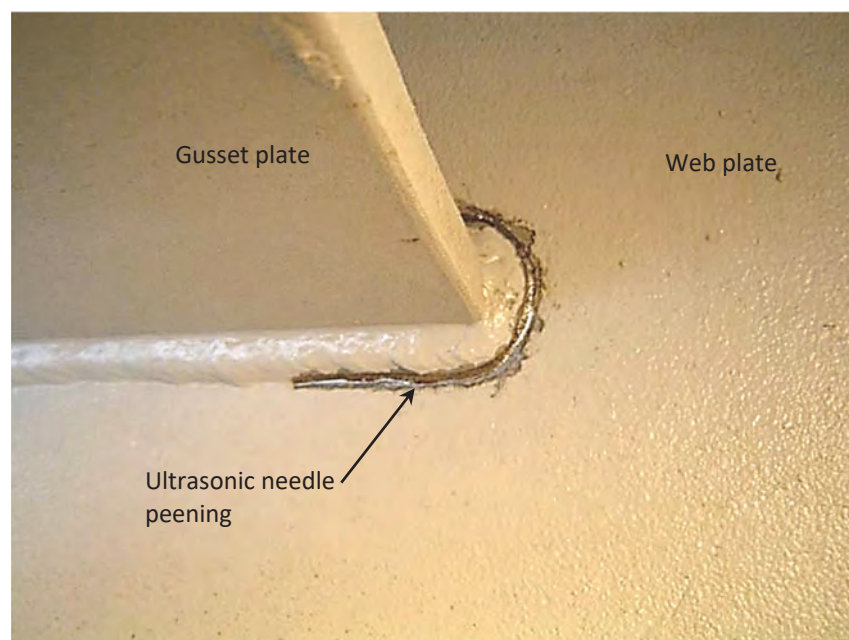
**Figure 4-23. Weld Toe Peening at Gusset Plate Termination (Photograph courtesy of Iowa DOT)**

Weld toe treatment is described in detail in Section 3.5. Refer to that section for a complete description of weld toe grinding for removing existing cracks, as necessary, and for applying post-weld peening treatment. Peening should be applied to the last 2 to 3 inches of the gusset or longitudinal stiffener plate weld, following the weld toe in contact with the web plate. If the weld wraps around the end, ensure that the peening treatment follows the weld toe around and continues for 2 to 3 inches along the underside of the plate, as seen in Figure 4-23. It is not clear from

this figure whether or not the paint coating was removed prior to peening. This is an important step to ensure quality peening treatment. Tool access between the attachment plate and adjacent flange plate should also be considered before choosing this retrofit approach.

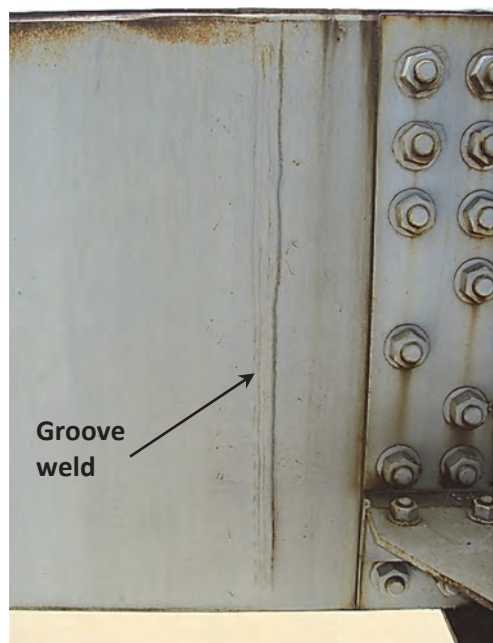
Figure 4-30. Transverse Groove Weld with Reinforcement Left in Place (Category C)

If the weld reinforcement is left in place, such as that shown in Figure 4-30 the fatigue resistance is reduced by the additional stress concentration at the weld toes. Thus, transverse groove welds with the reinforcement not removed, with or without the correct thickness or width transition slope, are Category C. This is relatively good fatigue resistance, and it is not often that cracks will develop at Category C fatigue details on typical highway bridges. However, cracks have been found propagating out of this type of detail, particularly on older steel bridges from the interstate era of the 1950s to 1960s when the fatigue limit state was never considered in the original design. Cracks

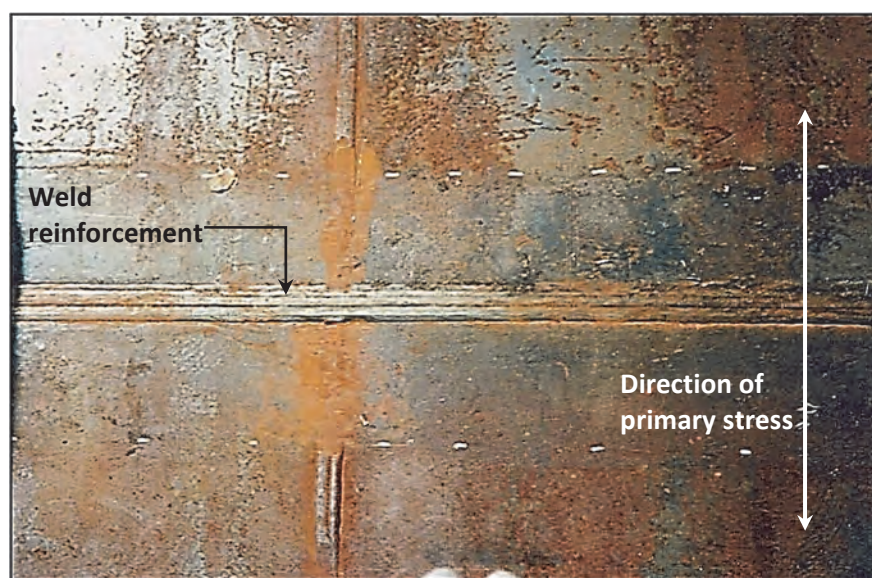
Figure 4-31. Category C Transverse Groove Weld

Once the internal soundness of a transverse groove weld has been determined by NDT, one of the most efficient ways to improve fatigue resistance from Category C to Category B is to grind off the weld reinforcement. Figure 4-31 shows a typical transverse groove weld in a flange plate. The weld reinforcement has been left in place. The weld toe creates a stress concentration that reduces fatigue resistance and is the most likely point of crack initiation. By removing the weld reinforcement, the weld toe is also removed, which reduces the stress concentration and improves the fatigue strength of the detail. To perform this retrofit, first establish the soundness of the weld using UT or PAUT. Next, follow the surface grinding techniques discussed in Section 3.4, being careful to remove the entire weld

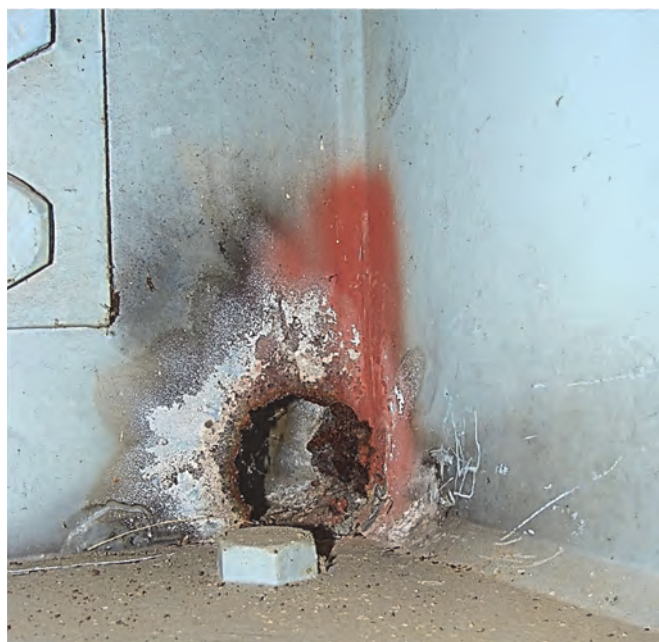
**Figure 4-34. Poor Quality Flame-Cut Hole That is Prone to Fatigue and Fracture**

Using thermal cutting makes sense for some retrofit applications, but it is important that the hole not be left in conditions anything like seen in Figure 4-34. Further, plasma cutting is strongly encouraged over traditional oxy-acetylene thermal cutting whenever possible. Drilling the hole is also highly recommended whenever possible and will produce a much higher quality edge finish with minimal sanding at the edges. If a thermal cut is used to make a weld access hole or a retrofit hole, it is recommended that a carbide rotary burr bit and die grinder be used to remove the hardened and brittle martensite layer at the burned edge, grinding down to bright metal and removing gouges. Additional grinding and sanding are recommended following the burr bit, as listed below. This will not only

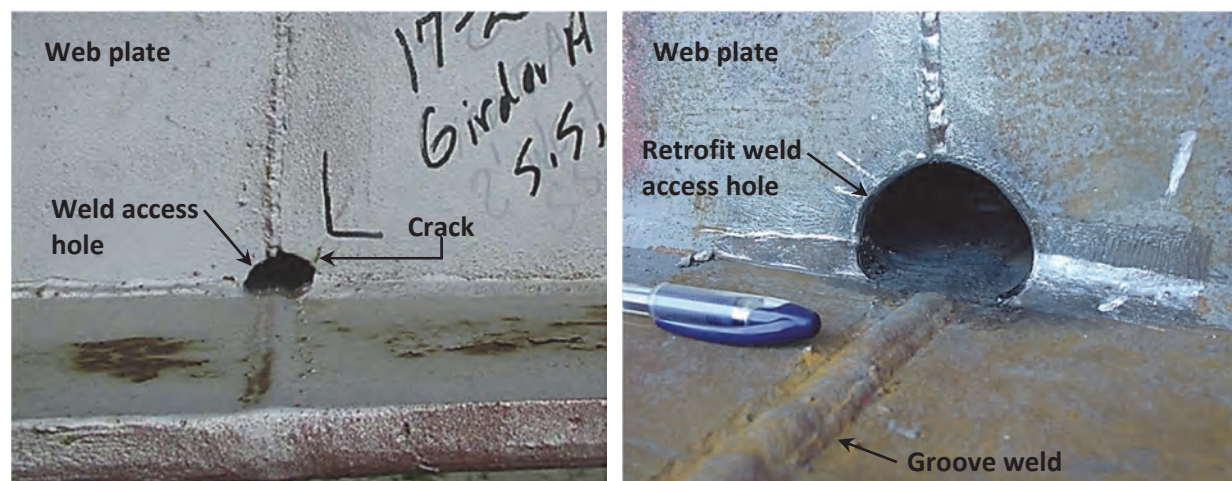
**Figure 4-35. Repair of a Cracked Weld Access Hole Showing before (Left) and after (Right) (Photographs courtesy of Kansas DOT)**

remove discontinuities at the edge of the hole related to the roughness of the cut but also any microflaws that may have formed in the brittle layer during cooling. Figure 4-35 shows a before and after repair of a cracked weld access hole. Notice the increased and improved radius, smooth and polished edges, and gradual transitions into the flange plate. This particular repair also included peening treatment around the edge of the hole and at the termination of the flange-to-web welds to further improve fatigue resistance. Grinding the transverse groove weld smooth would have likely resulted in an overall Category B fatigue detail. Leaving the weld reinforcement in place made this a Category C detail. See Section 4.6 for retrofit techniques for transverse groove welds.

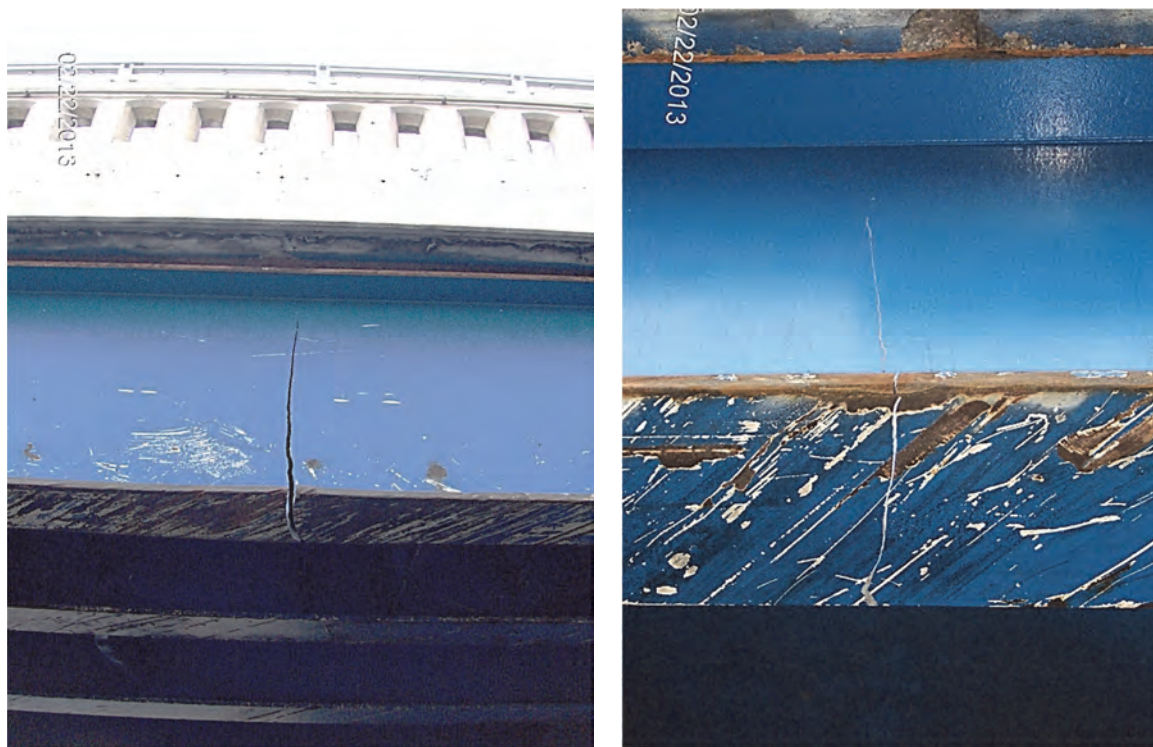
**Figure 4-47. Fractures on the Same Girder Resulting from a Single Impact Event**

This same phenomenon has also been observed outside of the laboratory. One example is the Virginia Avenue Bridge over the I-65/I-70 northbound lanes near downtown Indianapolis. In 2013, the fascia girder was impacted by the boom of an aerial lift being hauled on a flatbed trailer. The non-composite girder instantly fractured at two locations, one on either side of the point of impact, just beyond the adjacent cross-frames. The fractures are shown in Figure 4-47. The fractures both initiated at locations of *previous* impacts in the hardened, cold-worked zones where small cracks existed. Fortunately, the fractures both arrested in the web plate just inches from the top flange, keeping the nearly 40-foot girder section from falling into traffic. For bridges like the Virginia Avenue Bridge that span over interstate traffic and are frequently impacted, proper inspection and maintenance following an impact event can be very difficult. Often the impacts are not reported and are challenging to distinguish from past impacts documented

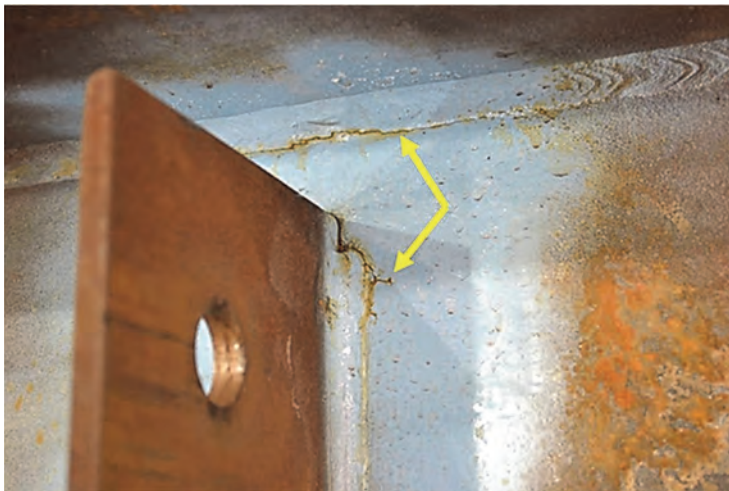
Figure 5-3. Example of Web Gap Cracking Resulting from Distortion

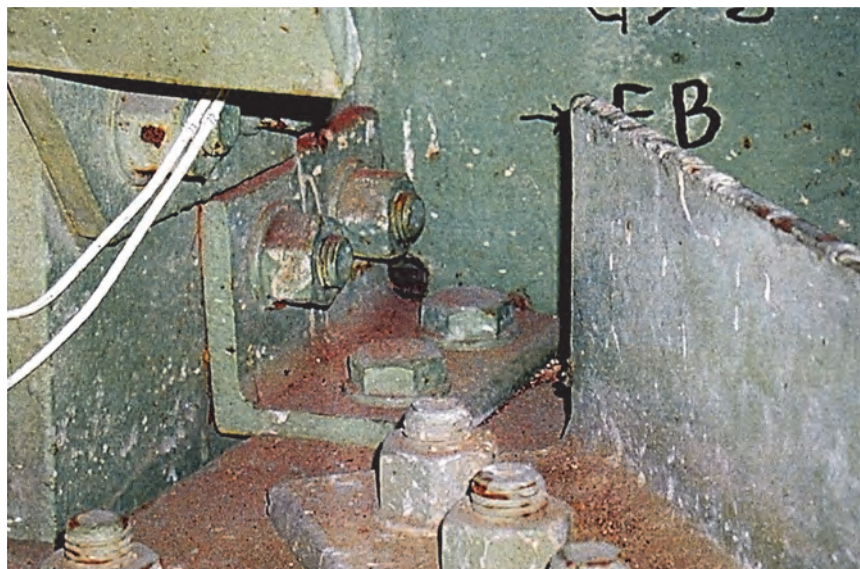
**Figure 5-6. Insufficiently Stiff Splice Angle Shown Installed on Gusset–Connection Plate Web Gap**

When properly designed and installed, a bolted splice retrofit can be very effective in minimizing distortion stresses in the web gap region. However, when the stiffening elements are not sufficiently rigid, the retrofit will be ineffective. An example of this, shown in Figure 5-6 was investigated by Connor and Fisher (2006). The angle was a 3 in.  $\times$  3 in.  $\times$   $\frac{3}{8}$  in. angle attached with two bolts per leg and was not capable of providing enough rigidity between the gusset plate and transverse connection plate to prevent the high web gap cyclic stresses. Conceptually, this can be seen when comparing the scale of the stiffening angle to that of the adjacent lateral bracing element and floorbeam connection. Not only would this not mitigate the distortion fatigue, but likely the stiffening angle would begin to fatigue as well.
