# MAINTENANCE GUIDELINES FOR STEEL BRIDGES

Addressing Fatigue Cracking and Details  
at Risk of Constraint-Induced Fracture

G14.1-2021

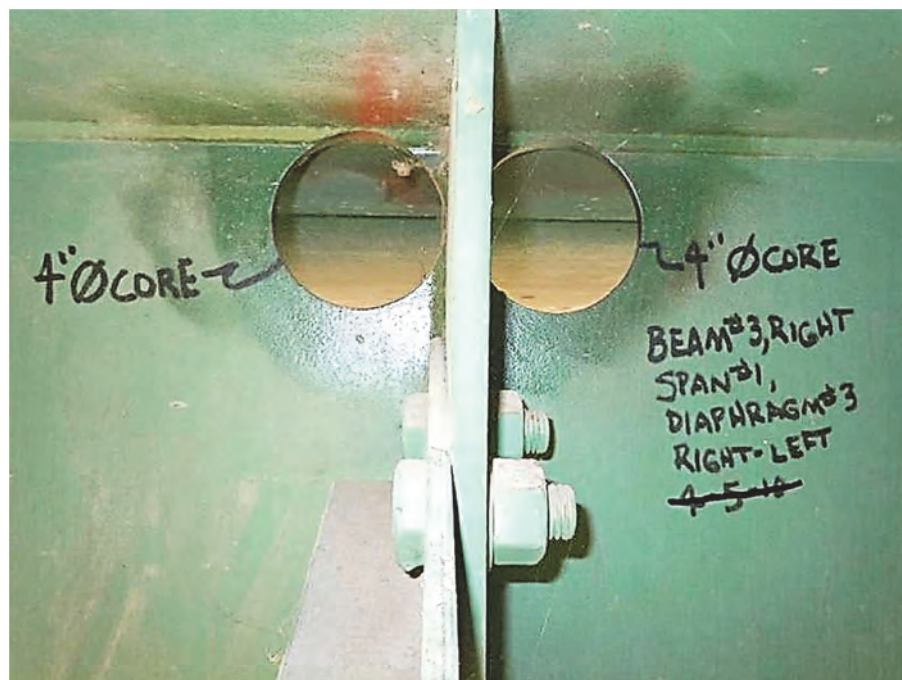
**Figure 5-11. Large-Hole Retrofit—Note Interception of Horizontal and Vertical Weld Toes (Photograph courtesy of Iowa DOT)**

This retrofit should be installed using the techniques discussed in Section 3.3. The drilled holes are recommended to be at least 3 to 4 inches in diameter and each hole should intersect the horizontal and transverse welds approximately  $\frac{1}{8}$  inch. If a hole misses either of the welds, use a die grinder and carbide rotary burr bit to grind from the inside of the drilled hole toward the missed weld until the hole is extended sufficiently to intercept it. Maintain a round and gradual profile as best as possible. In the case that there is an existing crack at the detail, the hole should be drilled to either completely remove the crack, or if the crack is too long to be completely removed, the hole should be drilled such that it removes the crack tip. See Figure 3-4 for recommendations on hole placement. This may require that the drilled hole be placed such that the horizontal flange-to-web weld is missed. If this is the case, it is recommended that grinding or an additional hole be used to ensure the horizontal weld toe is intercepted to isolate the web plate from crack propagation.

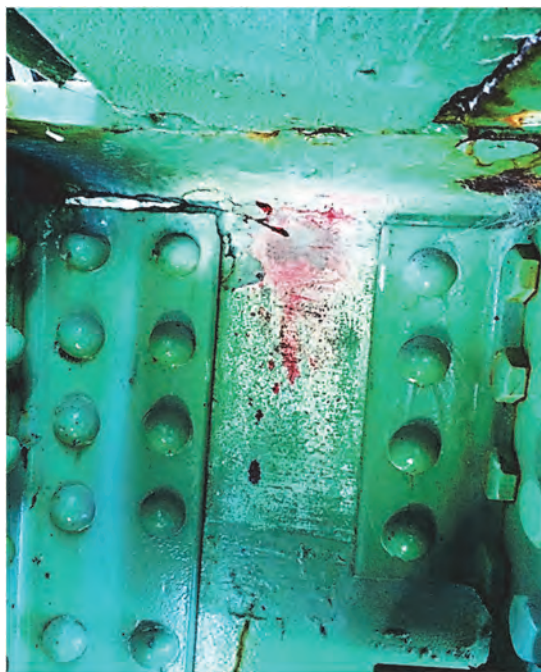
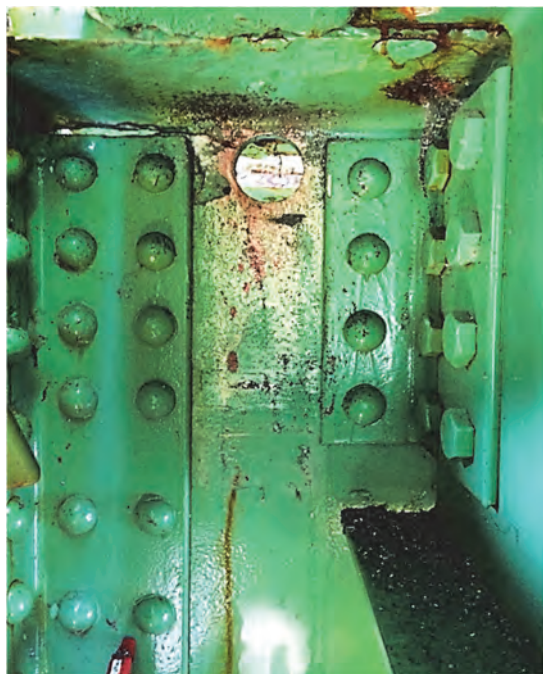
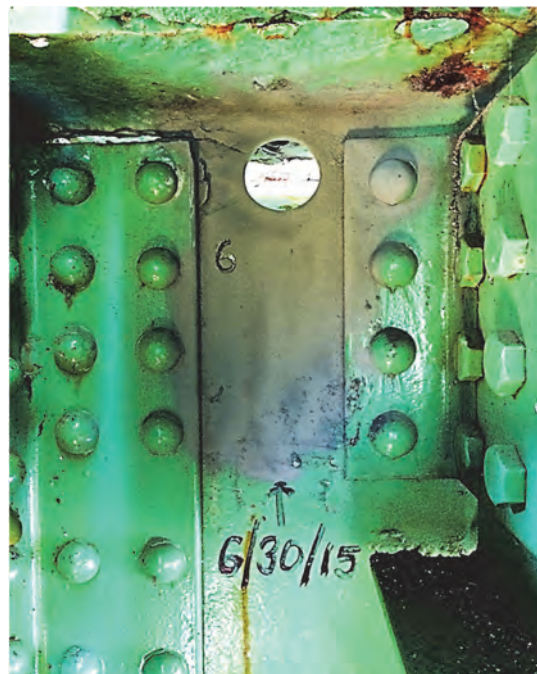
Figure 5-17. Floorbeam Web Gap Crack

Figure 5-18. Results of PT Revealing Extent of Crack

**Figure 5-19. Drilled Hole Prior to Sanding Edges**

**Figure 5-20. Finished Repair with Zinc-Rich Paint**

The simplest and most economical repair is a large drilled hole for crack arrest. The reader is referred to Section 5.1.2.1 on use of drilled holes for repair and retrofit of web gap regions for transverse connection plates. An example of this repair method is shown in Figure 5-17 through Figure 5-20. These images are from the SR 119 through-truss bridge in Indiana. The end floorbeams of the simple span truss were experiencing distortion-induced fatigue cracks in the web gap region between the floorbeam top flanges and the connection angles which tied the floorbeam to the truss gusset plate. Figure 5-17 shows one of the cracks with corrosion staining. Notice how the crack initiates inside the web gap at the end of the floorbeam and extends parallel to the direction of the floorbeam primary stress (perpendicular to flow of traffic). This is an important attribute of distortion-induced fatigue that is driven by secondary stresses not normally accounted for in the design. It is also important to realize that the cracking was only manifest on the end floorbeams, where the global shear incompatibility between the floor system and the very stiff truss would be the greatest. Figure 5-18 shows the crack enhanced with dye penetrant, which was used to reveal the crack tip before drilling the hole. Figure 5-19 shows the completion of the drilled hole, prior to finishing sanding to clean up the edges for improved fatigue resistance. A 2 1/2-inch diameter hole was drilled, which when combined with the length of the crack will provide improved compliance at the detail and further relieve the secondary stresses while blunting the crack tip. Figure 5-20 shows the final step of the repair with the application of zinc-rich paint to protect against corrosion on the exposed steel. Refer to Section 3.2 for guidelines and tips for drilling effective crack arrest holes.

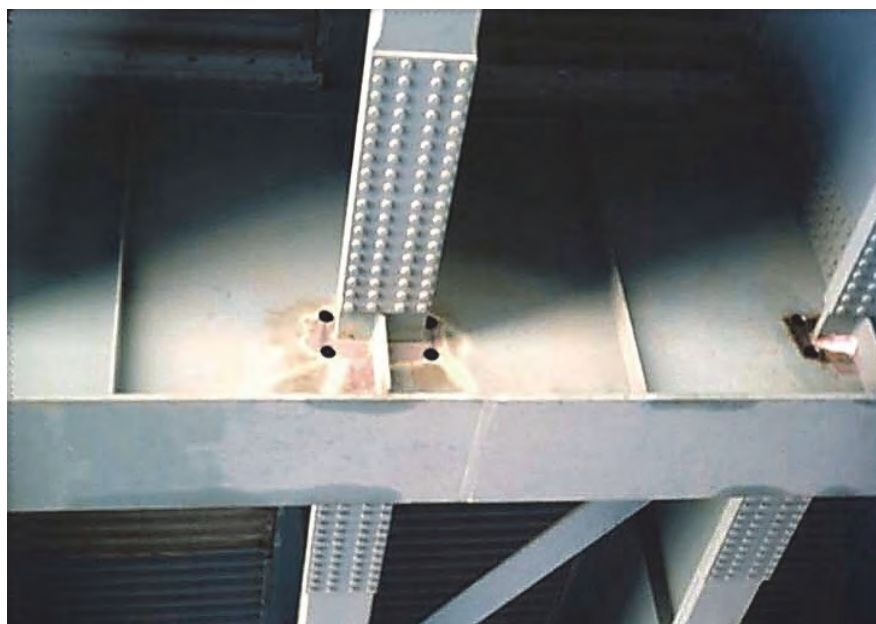
Figure 5-38. Completed Dog-Bone Retrofit on a Web Penetration Detail

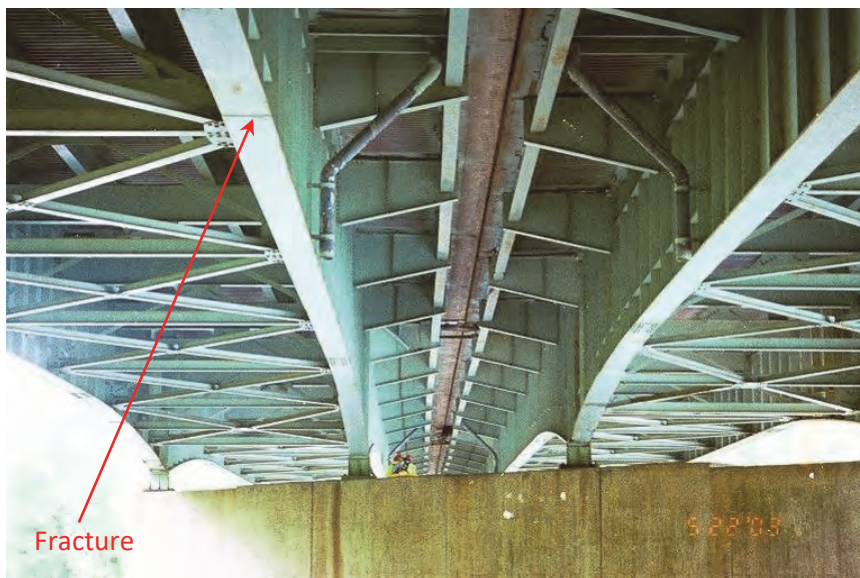
Figure 6-1. U.S. 422 Bridge Fracture Discovered in 2003 During Retrofitting

The best-known case study for CIF is the Hoan Bridge in Milwaukee, WI, which carries I-794 over the Milwaukee River. This case study is discussed more in Section 6.1. Other bridges have also had similar fractures originate at CIF-prone details, such as the Shenango River Bridge and the U.S. 422 Bridge over the Schuylkill River. Interestingly, the U.S. 422 Bridge fracture was discovered while retrofits to its lateral gusset plates were being performed in 2003. Figure 6-1 shows the fracture in the tension flange of the fracture-critical girder. The fracture severed the tension flange and traveled 9 inches into the web before arresting at discontinuities in the web plate (Kaufmann et al., 2004). Figure 6-2 shows the inside and outside vantage points of the fracture, revealing the ductile yielding of the web plate indicated by the yield lines in the paint and the separation of the tension flange. The deflection of the fracture-critical girder was so slight that it went unnoticed by motorists for an unknown amount of time.

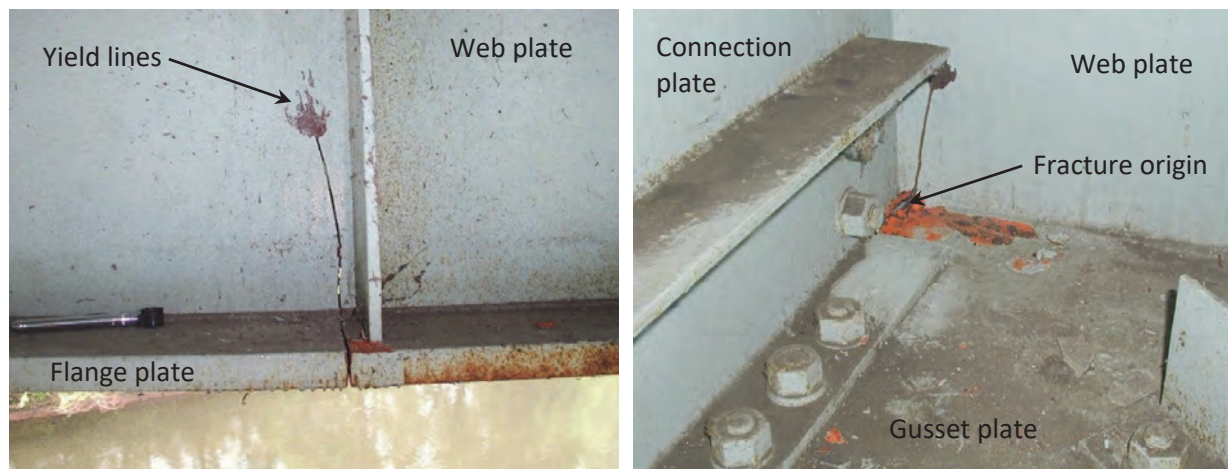
Figure 6-2. U.S. 422 Bridge Fracture That Arrested in the Web

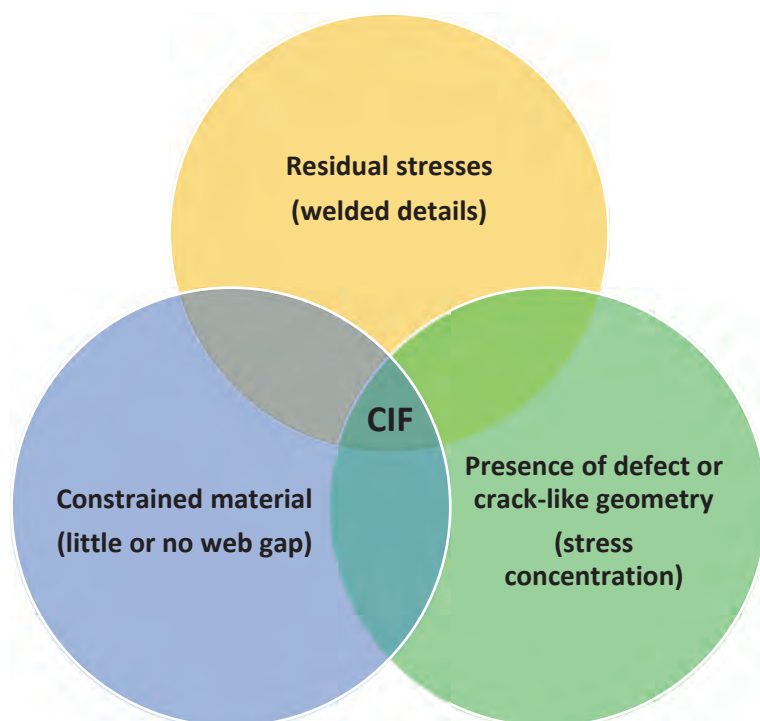
Figure 6-3. Defining Characteristics of CIF-Prone Details

There are three contributing elements to constraint-induced fracture, characteristic of all CIF-prone details, which when any one of the elements is missing, the likelihood of constraint-induced fracture drops dramatically. Figure 6-3 illustrates these elements, conceptually showing that the risk of CIF exists at the intersection of the three elements.

1. There needs to be a localized area of stress concentration that intensifies the dead and live load stress level. The presence of defects within the weld, as well as certain geometry of the connection can both act as discontinuities that interrupt stress flow and cause concentrations.
2. The joint must be highly constrained, resulting in a three-dimensional state of stress that prevents plastic flow, as would occur in a simple uniaxial stress state.
3. There must be an elevated level of tensile residual stresses locked into the local area. While the dominating contributor is residual stresses from welding, other factors contribute to a lesser degree, such as dead load and erection stress. As is well documented, residual stresses due to welding can easily reach the yield strength of the base metal.

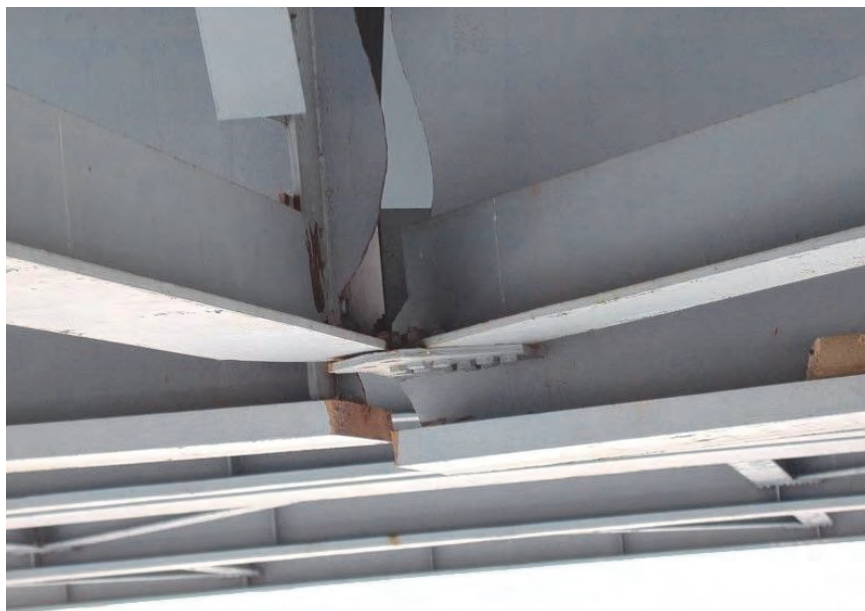
Figure 6-6. Hoan Bridge Fracture Showing the Gusset Detail of the Interior Girder

CIF-prone details located at gusset (or shelf) plate details are often also referred to as “Hoan Details” in practice. This stems from a fracture of all three girders on one of the south approach spans of the Hoan Bridge in Milwaukee, Wisconsin, on December 13, 2000. The approach spans for the steel tied arch bridge are continuous plate girder construction with CIF-prone details at the lateral gusset plates. There are three girders in the cross section. Following the fracture, the northbound span sagged about 4 feet, but incredibly did not collapse, though two of the three girders completely fractured and significant cracking was observed in the web of the third. Detailed analysis indicated that brittle fractures developed at the intersection of the shelf plate and transverse connection plate without any detectable fatigue crack extension or ductile tearing at the crack origin (Fisher et al., 2001). The photograph in Figure 6-6 was taken shortly after the discovery of the fracture and shows the interior girder CIF-prone detail. The brittle nature of the fracture is evident from the lack of yield lines in the paint and the straight, sawcut-like appearance of the fracture surface. Figure 6-7 shows the Hoan detail removed from the bridge for evaluation with the characteristic intersecting welds and crack-like geometry rendered by the lack of weld between the gusset plate and the transverse connection plate. Although this crack-like geometry increases risk of CIF, brittle fracture can still initiate at a CIF-prone detail that has a weld connecting the gusset plate to the transverse plate. This was the case for the U.S. 422 Bridge fracture discussed previously.

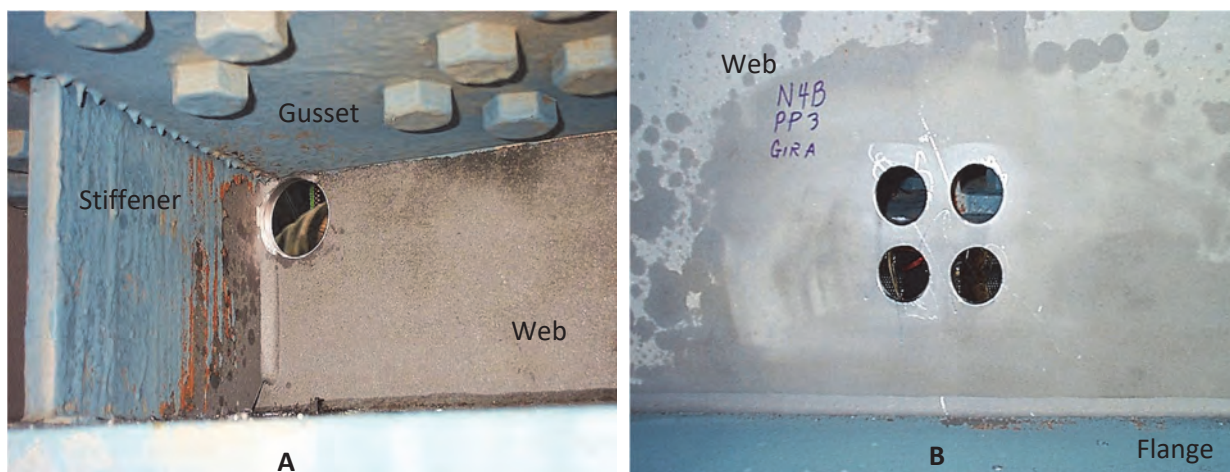
Notice in photograph (A) that the transverse stiffener weld toe has been drilled out. Photograph (B) shows the entire retrofit from the opposite side of the web plate, revealing the four holes that surround the CIF-prone detail.

**Figure 6-13. Web Isolation Holes Retrofit on the Hoan Bridge (A) beneath the Gusset, (B) Opposite Side of Gusset (Photographs courtesy of Phil Fish)**

2. Drill the hole. *Caution: Tie off the mag-based drill to the girder using sturdy clamps and chain/rope. In the event of power loss, this will help prevent injury or damage to equipment. Note: Carbide-tip annular cutters are recommended when the cut penetrates welds or heat-affected zones due to the increased hardness of the material.*
3. Inspect the hole placement to confirm that it intercepts the vertical weld at least  $\frac{1}{8}$  inch. If the hole misses the vertical weld toe, use a carbide rotary burr bit with a die grinder to widen the hole toward the vertical weld toe. Grind until the weld toe has been sufficiently disconnected and there is no longer a continuous path for a fracture to bypass the isolation hole. Figure 6-13 shows this retrofit on the Hoan Bridge.

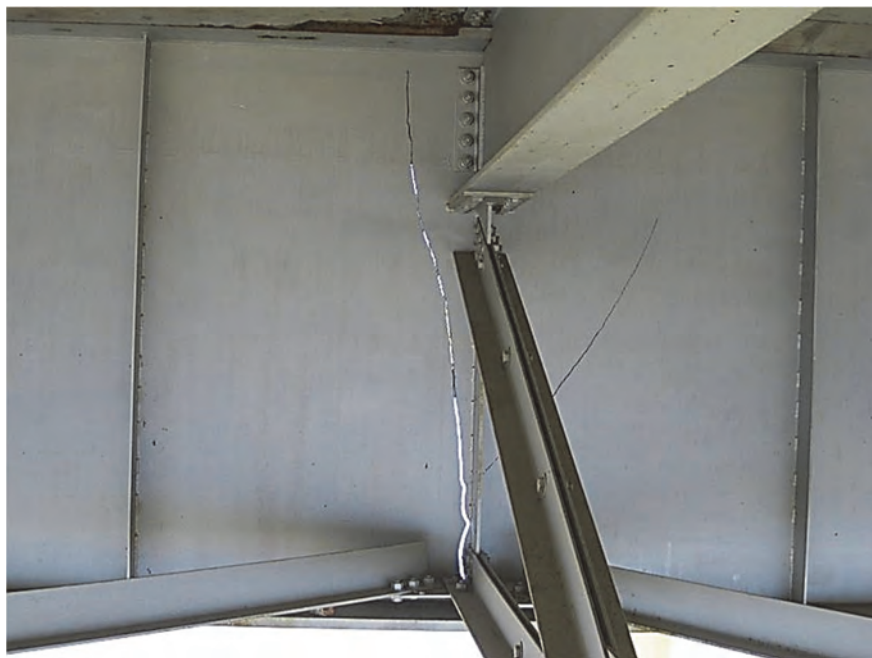
**Figure 6-14. Diefenbaker Bridge Fracture Originated at CIF-Prone Detail**

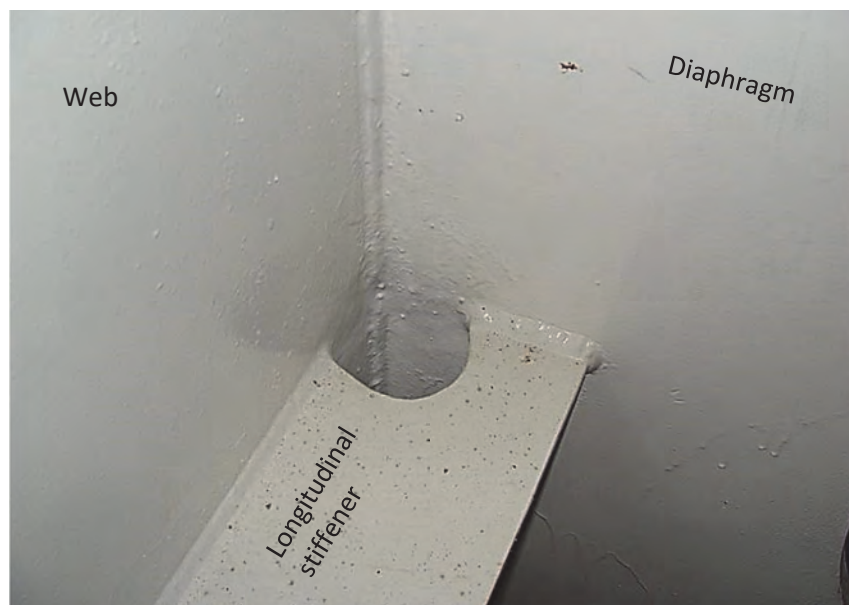
**Figure 6-19. Hoan Bridge Longitudinal Stiffener CIF Retrofit**

Since this detail and the gusset detail discussed in Section 6.1 are very similar, it is recommended to consult Section 6.1.2 for additional guidance on retrofit approaches for the longitudinal stiffener CIF-prone detail. This includes the isolation holes and ball end mill retrofit methods. The remainder of this section will provide additional discussion and an example of the stiffener coping retrofit that cuts back the longitudinal stiffener from the transverse stiffener/connection plate. The cope detail for the longitudinal stiffener can be performed in the same fashion as shown in Section 6.1.2.1, where coring and grinding are used to create the cope at the corner of the intersecting plates. An example of this is shown in Figure 6-19, taken from the Hoan Bridge inside the tie girder span.

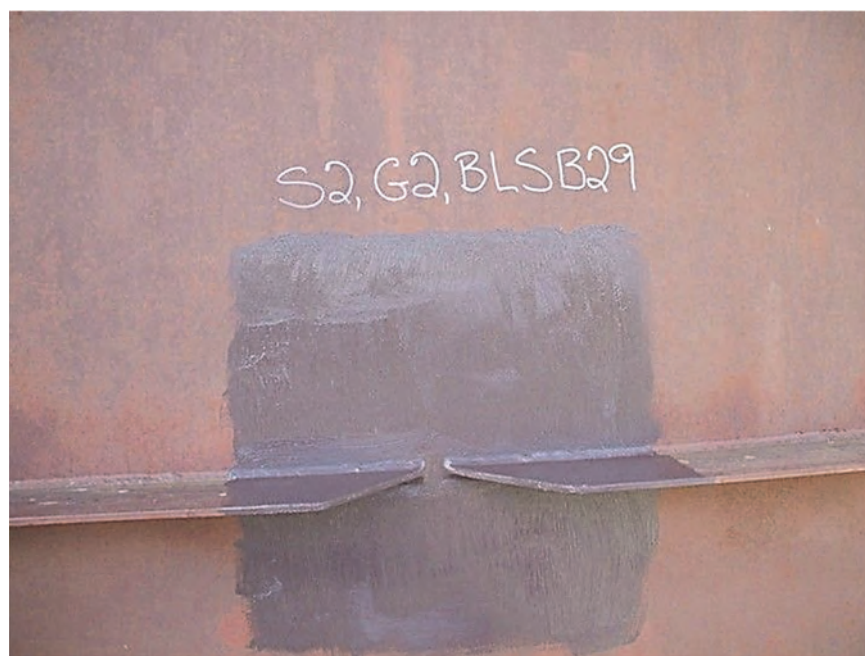
Figure 6-25. Alternate Version of the Longitudinal Stiffener Core Retrofit with the Stiffener Plates Cut Back in Addition to the Drilled Hole

There are several varieties of this retrofit that have been implemented by DOTs throughout the country. Some remove more of the longitudinal plate than others, which will not make the retrofit more successful at its primary objective, fracture isolation, but may provide a particular aesthetic look that the owner prefers. The method that is presented here is a method that is relatively feasible to implement (i.e., minimal labor and skill involved) while providing effective and low-maintenance performance. Figure 6-24 shows the longitudinal stiffener core retrofit as described in the following procedure. An example of one implemented by a DOT is shown in Figure 6-25. Notice that the main difference between the two is that the stiffener plate in Figure 6-25 was cut back from the drilled hole at a taper. Due to the tapered cut, the original drilled hole in the stiffener is no longer visible in this version of the retrofit.

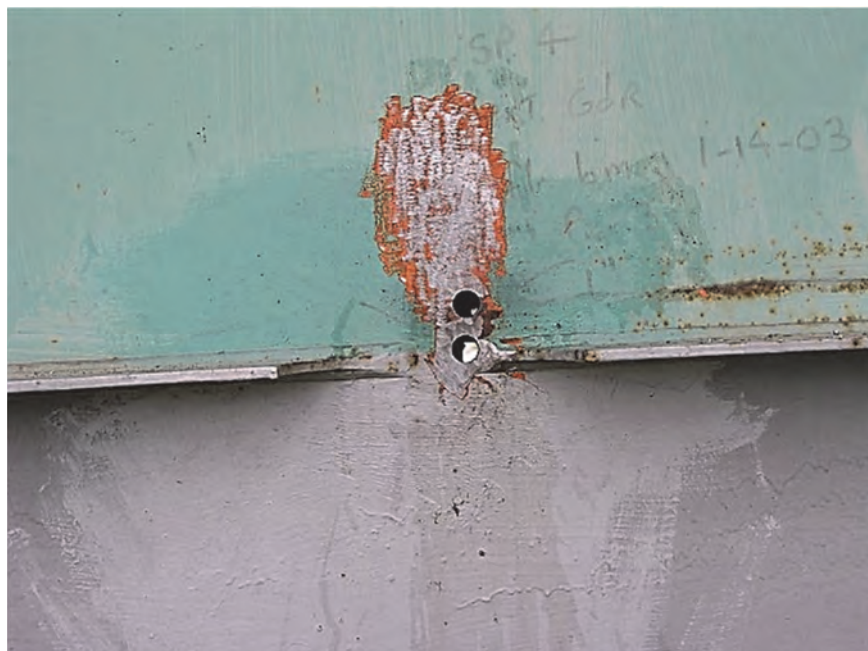
**Figure 6-26. Longitudinal Stiffener Core Retrofit Showing Drilled Holes in the Web Plate for Crack Arrest (Photograph courtesy of Kansas DOT)**

Another example of this retrofit is shown in Figure 6-26. This case shows a very gradual transition radius that was installed (most likely by flame cutting and grinding) in an effort to improve fatigue resistance of the weld termination in the newly formed web gap. Notice that there are also two holes drilled in the web plate, as well. These were installed to blunt existing crack tips in the web plate. Final touches for the retrofit would include smoothing out the grinding marks seen in the web plate, cleaning, and painting to prevent corrosion.

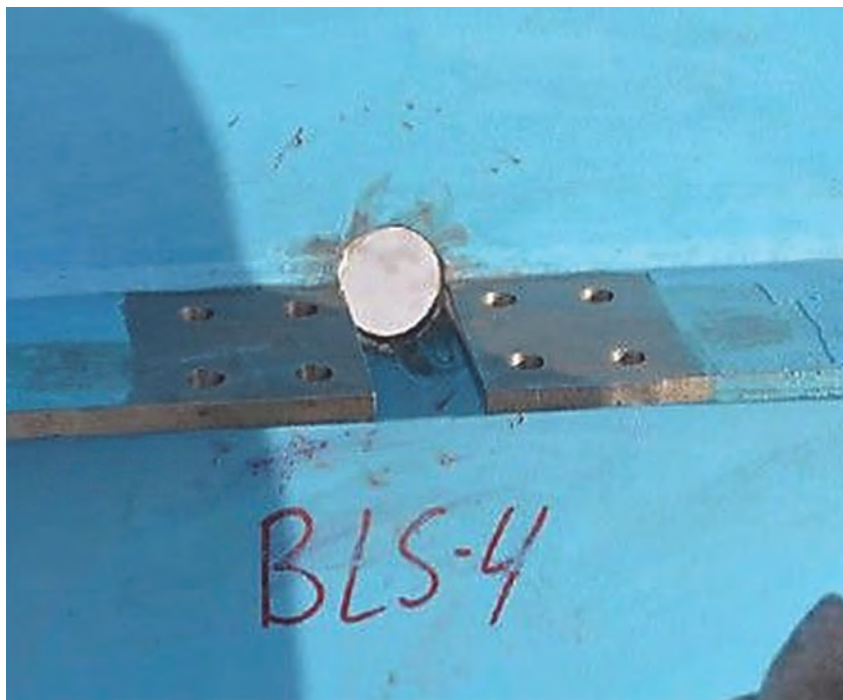
Figure 6-29. Finished Retrofit with Drilled Holes for Optional Bolted Splice

6. Once the hole is drilled, use a cutting wheel on an angle grinder, portable band saw, or a reciprocating saw to cut in from the outside edge of the stiffener, intersecting the cut lines in the stiffener made by the annular cutter in Step 5. Figure 6-28 shows this step using a portable band saw.
7. Next, sand the edges of the drilled hole and exposed web plate using an 80 to 100 grit flap wheel with angle grinder on the exterior edges and an 80 to 100 grit flap wheel with die grinder on the interior edges. Sand until the surfaces are smooth and free of cutting marks and gouges. If it is desired to restore the section of the stiffener plate, a bolted splice may be used, as seen being prepared in Figure 6-29.

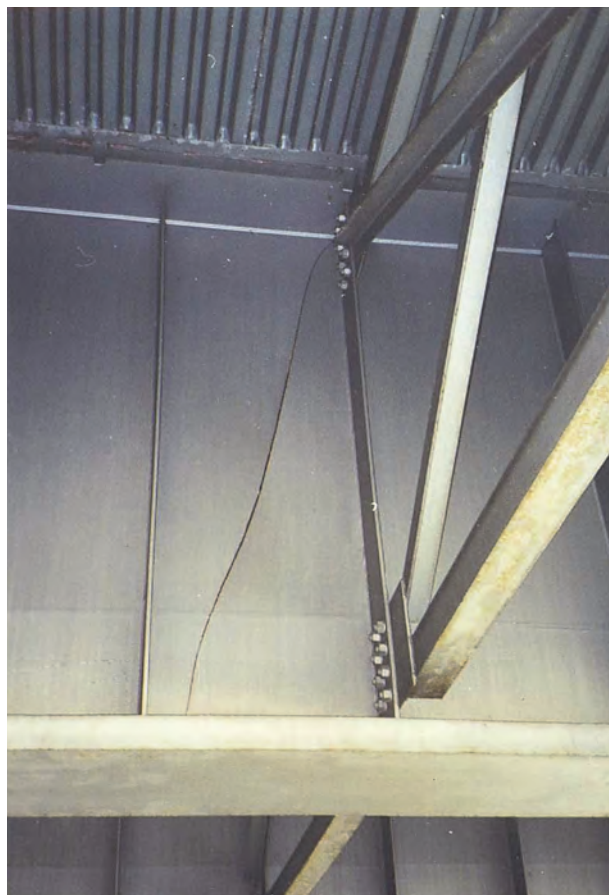
**Figure 6-32. Fracture Initiated at Stiffener in Negative Moment Region (Photograph courtesy of Y. Edward Zhou)**

Several cases of brittle fracture initiating at the top of a bearing stiffener (or sometimes from connection plates) in a negative moment region of continuous spans have been observed. Figure 6-32 shows one such example from a bridge carrying I-495. This type of fracture, however, is much less common and there may be a number of undocumented cases. The actual cause of the fracture, meaning the characteristics that make one detail more prone than another, has not been well quantified by research or field studies. It is believed that some contributing factors are those that would contribute to a triaxial stress state at a subsurface microscopic flaw, such as the thickness of the stiffener element, the size of the longitudinal and vertical welds, the quality of the welds, and the size of the web gap. It is worth noting that no such fracture is known to have occurred when the stiffener/connection plate or bearing stiffener was welded to the flange.

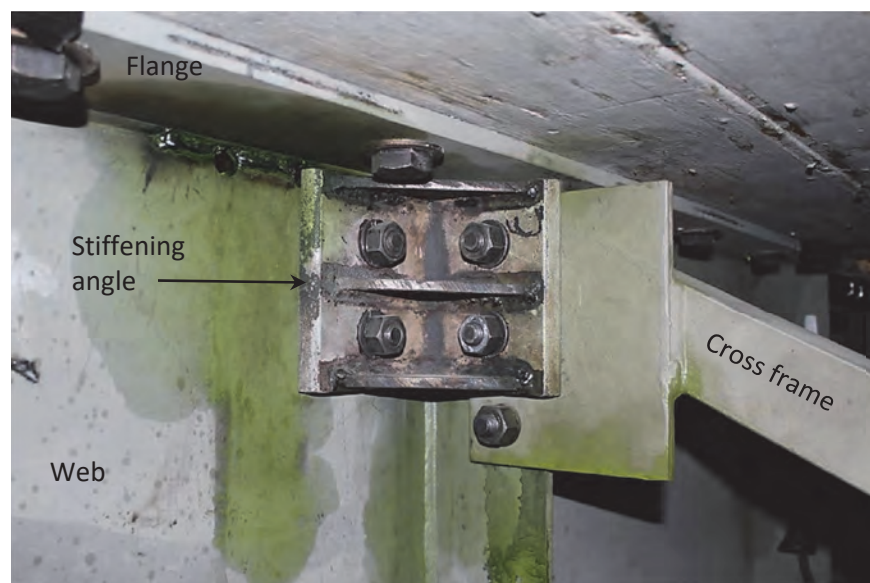
**Figure 7-2. Stiffened-Angles-with-Plate Retrofit (Taken From Bennet Et Al., 2014)**

Nuances between different applications of the doubler plate–angle retrofit exist, such as the structural shapes used (i.e., WTs, angles, plates), the sizes of the fasteners (i.e.,  $\frac{3}{4}$ -inch,  $\frac{7}{8}$ -inch, or 1-inch diameter), and the thickness/stiffness of the shapes and plates as well. All of these factors affect the overall stiffness of the finished retrofit, which is the most critical performance criterion. If the connection is not sufficiently stiff, it will not correct the problem. (Section 5.1.2 discusses detailed recommendations for stiffening retrofits.) However, even with very stiff components like those seen in Figure 7-2, the doubler plate–angle type retrofit does not provide a positive

The doubler plate–angle type retrofit has the potential to work well in some applications when meticulously designed and installed. Bennett et al. (2014) found some positive results with highly stiffened angles and backer plates (see Figure 7-2). However, they also concluded that it was not as effective at mitigating crack initiation and propagation at the flange-to-web welds as connecting the stiffening component directly to the flange. This is because, as mentioned above, the loads are still transferred through the web into the flange. Although the cost benefit of this type of retrofit is that the deck does not require excavation at top web gaps, a cost drawback is that it needs very stiff structural components with a reasonable susceptibility to aggravating the web gap demands in cases of moderate to low-quality fit-up.
