HOT-DIP GALVANIZED STEEL USE IN BRIDGE CONSTRUCTION

**Tom Langill
Technical Director
American Galvanizers
Association**

This paper will address technical issues with the use of hot-dip galvanized steel in bridge construction. Some key technical issues that will be addressed are the slip factor of hot-dip galvanized, painted, and metallized coatings in slip critical connections as well as the potential for cracking in bridge components during and after the hot-dip galvanizing process. Hot-dip galvanized coatings are used in small to medium sized bridges but are limited by the size of the zinc bath to coating small to medium sized structural beams. Both hot-dip galvanizing and zinc metallizing can produce coating of zinc metal and can be in contact with no corrosion interactions. Large beams that cannot be hot-dip galvanized because of their size can be thermal spray metallized while the smaller pieces can be hot-dip galvanized. When hot-dip galvanizing in the zinc bath at a temperature of 850 F, the expansion and contraction of different sized parts in steel assemblies could produce significant stresses in the steel sometimes resulting in distortion. Suggestions to avoid the poten

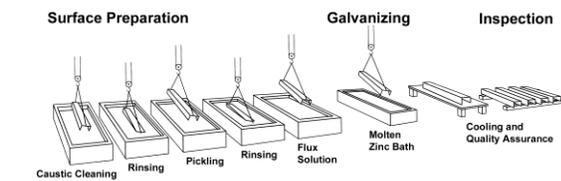
Figure 1. Galvanizing Process Schematic

Unlike paint coatings that form an adhesive bond with the underlying steel, galvanized coatings develop a metallurgical bond through the formation of a series of iron-zinc alloy layers. However, in order for these intermetallic layers to form properly, the steel must be prepared and processed in a specific sequence. The galvanizing process consists of three basic steps, namely surface preparation, galvanizing and inspection. Each of these steps, as discussed in the following, is important in obtaining quality galvanized coatings. The layout of a typical hot dip galvanizing line is shown in Figure 1.

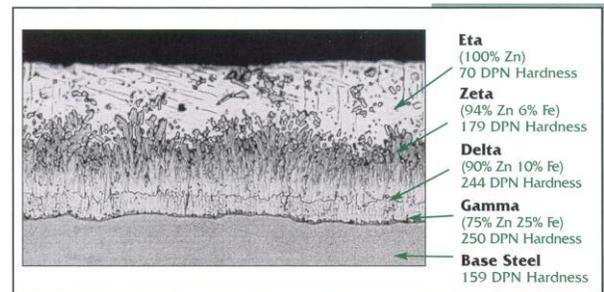
Figure 2. Typical Galvanized Coating Micrograph

The coating consists of a very thin gamma layer next to the steel substrate, a blocky delta layer and columnar growth of zeta crystals. These iron-zinc intermetallic layers are covered by a layer of pure zinc eta layer that remains on the surface as the article is withdrawn from the molten zinc bath.

During the galvanizing process, a series of alloy layers form as a result of the metallurgical reaction between the molten zinc and the steel. The formation of these layers is influenced by a number of factors including the chemistry of the steel, the immersion time in the zinc bath and the bath temperature, the surface roughness of the base steel, and the rate of withdrawal of the article from the zinc bath. The cross section of a typical galvanized coating developed on steel with low silicon content (< 0.03%) is shown in Figure 2.

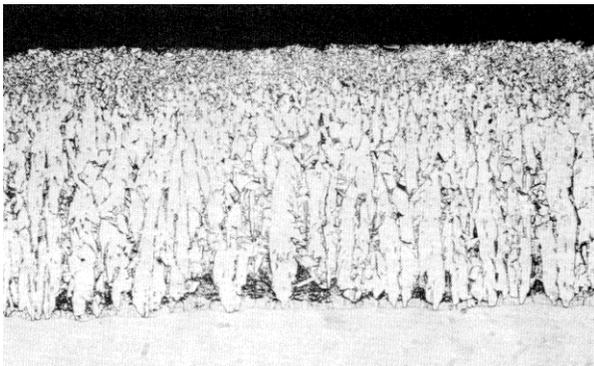
Figure 3. Reactive Steel Micrograph

This coating would have a dull gray surface appearance. Similarly, when galvanized steels are heated (annealed) at temperatures above about 430-450°C, the growth of the zeta phase is accelerated which can result in the complete disappearance of the eta layer at the surface. This appearance is very common in larger beams as the

Galvanized coatings sometimes consist entirely of enlarged zeta crystals, due to the reactive nature of the steel where the silicon content of the steel to be galvanized causes the zeta alloy layer to grow constantly during the immersion of the steel in the galvanizing bath. Also, the zeta crystals have grown to the surface of the coating and have consumed the outer pure zinc layer as seen in Figure 3.

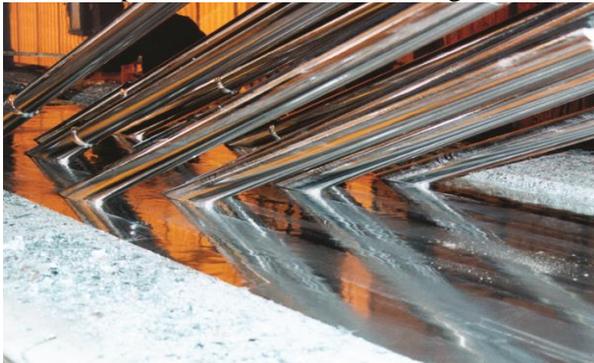
Figure 4. Shiny Galvanized Coating

Variations in the thickness and appearance of galvanized coatings highlight one of the most significant problems faced by galvanizers when processing steels of uncertain origin and/or unknown chemistry, see Figures 4 and 5. While bright coatings are the preferred outcome when galvanizing, if reactive steels are galvanized the coating will usually be quite thick and grey in appearance. These variations become particularly obvious when different steels, some of which may be reactive, are mixed in the same galvanizing batch. Since the galvanizer cannot normally control the morphology of the finished coating on reactive steels, the appearance cannot be accurately predicted but this has no effect on the corrosion protection of the zinc coating.

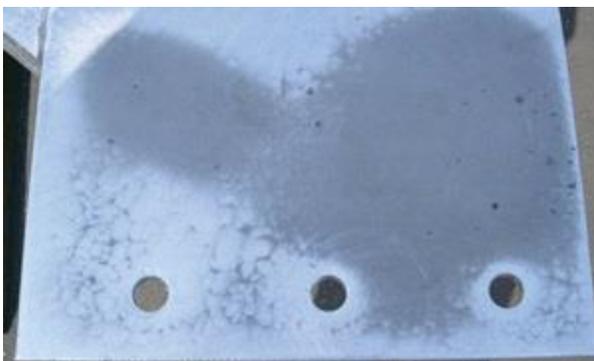
Figure 5. Dull Galvanized Coating

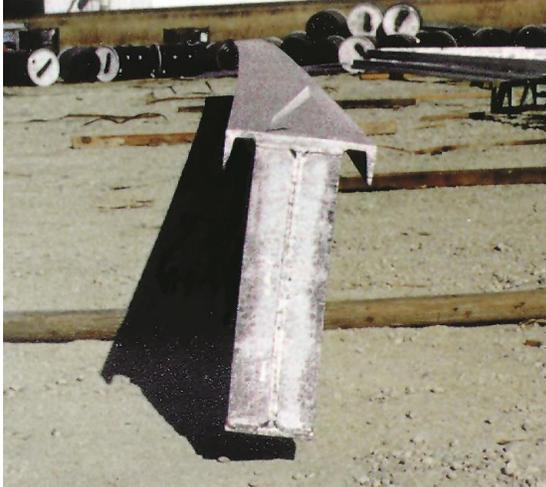
Figure 6. Distorted Asymmetric Beam

Another design issue that can result in distortion is the asymmetrical assembly of steel pieces into a part to be galvanized, as in Figure 6. The design of the part in the picture includes a top flange from channel material, but has no corresponding bottom flange to make the design symmetric. This allows

the buildup of stress during the thermal expansion of the part in the galvanizing kettle to be relieved by distorting the entire piece from one end to the other, following the most likely rolling direction of the steel used for the web portion of this part.

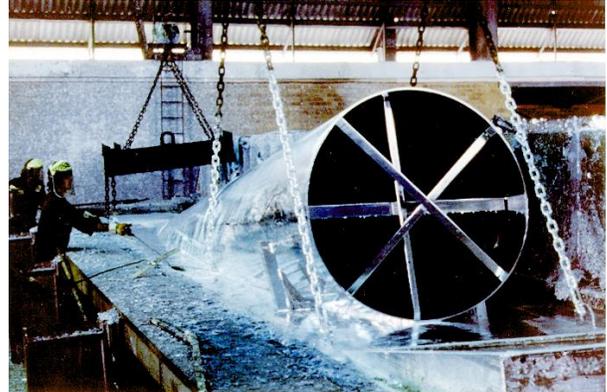
Figure 7. Temporary Bracing for Thin Walled Tube

The high temperature induces a softening in the sheet steel and performs a stress relief of the mechanical stresses induced during the cold bending of the sheet. This stress relief can start a distortion of the part's shape in the galvanizing kettle. A temporary or permanent brace may be added to the design to prevent this distortion from occurring. The thin walled poles pictured in Figure 7 have a permanent brace welded to their wider end to prevent distortion of the walls of the pole during galvanizing. Some designs require an asymmetric look and need thin materials to fit the assembly of the part in its final application. The galvanizer should review any asymmetric design with his customer before attempting to galvanize the part. The earlier in the process of design the galvanizer can consult on the final design details, the less likely they will be to end up with a part that cannot be used after.

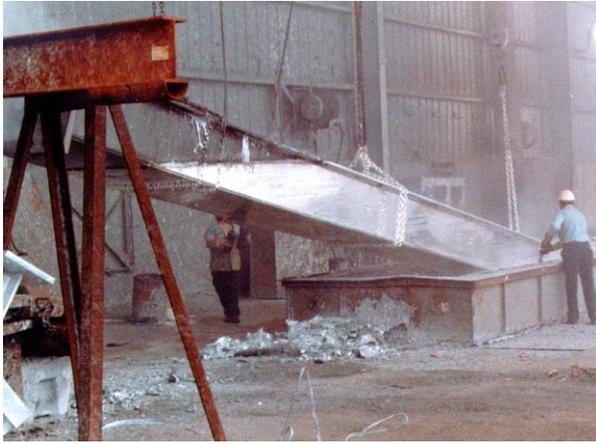
Figure 8. Progressively Dipped Beam

When an item is too large for total immersion in the kettle of molten zinc but more than half of the item will fit into the kettle, it may be progressively dipped, sometimes referred to as "double-dipped."

When the need for progressive dipping is anticipated, adequate venting must be provided at both ends of the structure. When an article of small mass or asymmetric design is progressive-dipped, there may be a change of shape and/or movement from the centerline of the article. The thermal changes in the part are significant when a section of the part is immersed in the zinc metal and a section of the piece is outside the zinc bath. The thermal gradients in the part can cause warpage and distortion in the piece to be progressively dipped.

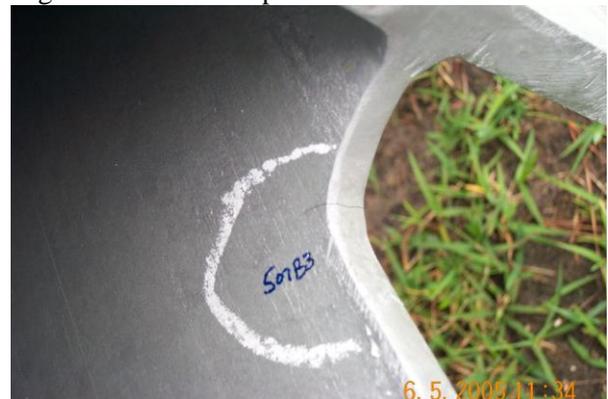
Figure 9. Cope Crack in Beam

This whole process is known as liquid metal embrittlement (LME), but it does not mean that the steel parts are embrittled. The only embrittlement that occurs is the area around the weld and the HAZ where the small cracks can form. This same process has occurred many times with cope cut beams, where the cope area becomes the highly stressed region that attracts more stresses and can experience cracking at the 90 degree bend of the cope.

What is really tough about the cope cracking issue is it does not happen all of the time, but only occasionally when the conditions are just right. An example of the size of the cope cracks is pictured in Figure 9. For cope cracking the frequency of occurrence is about 10%. This makes it very difficult to predict and to prevent. During the mid-1990's, ILZRO did a very thorough study (5) of the causes behind cope cracking. The principal conclusion of the study was that making a certain steel beam susceptible to this type of cracking required a number of contributing factors. There
