Fitting in with Historic Architecture Yale Music Library Addition

By Geoff Conway, P.E.

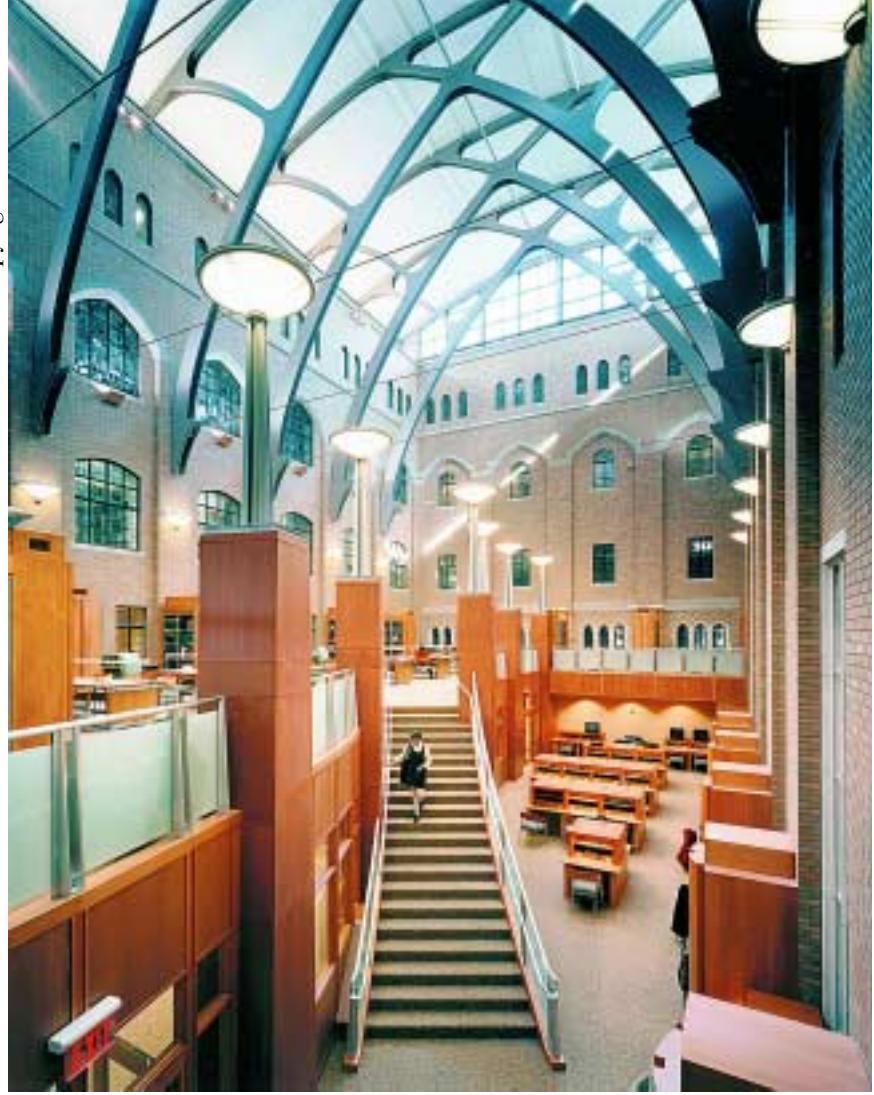
The architectural focal point for the new addition is the roof structure, which was deisgned to resemble the gothic window and arch shapes seen throughout the existing building. The six, 10-ton exposed arch/trusses, which span the 53' court-yard, utilize bottom chords made up of tapered and curved plates.

The architectural/structural focal point for the new addition is the roof structure. Six, 10-ton exposed steel arch/trusses, not a conventional type or category of truss, span the 53' courtyard. Much time and effort went in to selecting their final shape and design and addressing complex constructability issues. The bottom chords of the arch/trusses are constructed of tapered and curved plates (varying in width from 24" at the base to 12" at the top) welded together to make a wide flange shape oriented on its side. The top chords and web members are made of curved W-shapes also oriented on their sides. The shape of the trusses resembles the gothic window and arch shapes seen throughout the existing building. The steel roof trusses were fabricated in Canada, while AISC-member Berlin Steel fabricated the remainder of the structural steel, along with providing the erection and detailing.

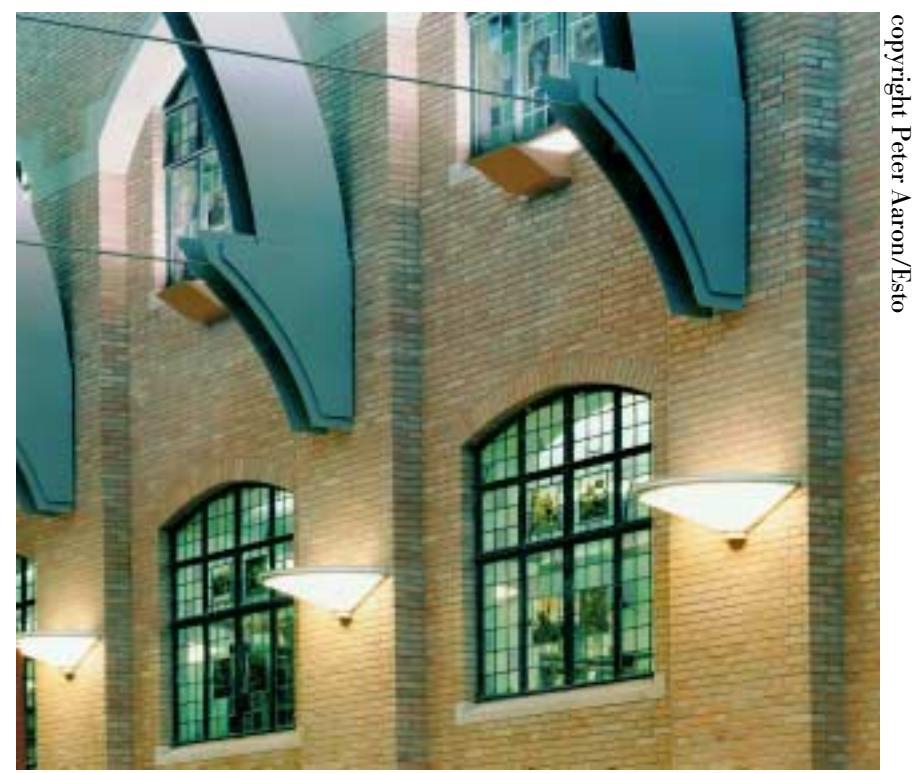
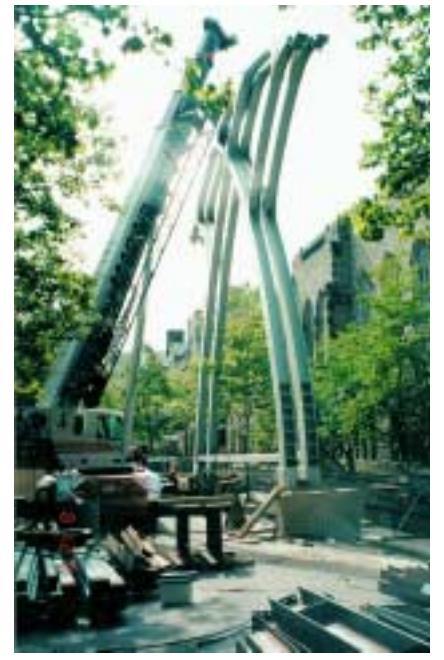
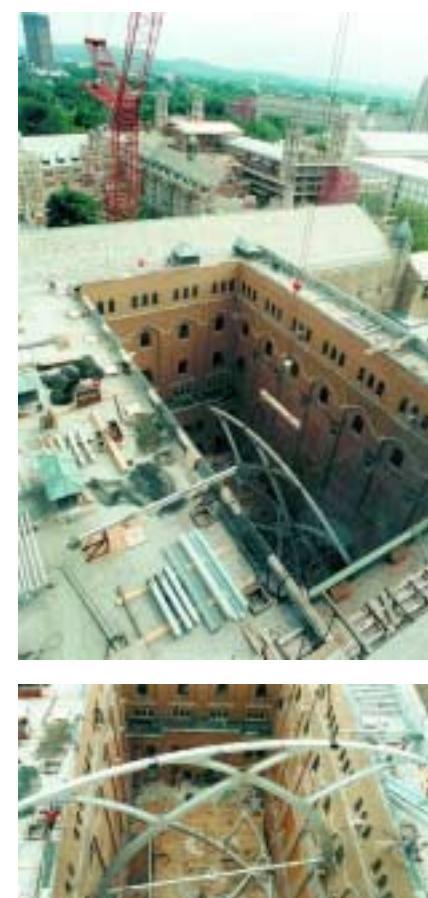
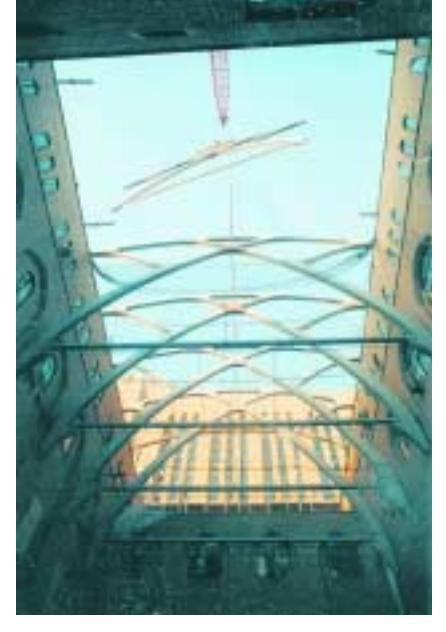
Erection of the roof trusses was a challenge due to the confined space. Truss sub-assemblies were lifted into the courtyard floor for final assembly. Then, the trusses were hoisted into their final position using a large 300ton crawler crane positioned in the street. The crane operator was required to lift the trusses "blind" with only inches of clearance on each side of the existing courtyard.

Erection of the roof trusses was also a challenge due to the confined space. Truss sub-assemblies were lifted into the courtyard floor for final assembly. Then, the trusses were hoisted into their final position using a large 300-ton crawler crane positioned in the street. The crane operator was required to lift the trusses "blind" with only inches of clearance on each side of the existing courtyard. In addition to the new structure in the courtyard, the existing building was also renovated. New mechanical shafts and an elevator shaft were added. Areas of existing floors were reinforced for compact file storage. Cover plating existing steel girders and adding new steel beams accomplished this.
