# **RAISING**the **ROOF**

Helmut Cerovsek, P.E. and Chris Rust

A steel roof-raising renovation saved time and money for the Allen County War Memorial Coliseum in Fort Wayne, IN.

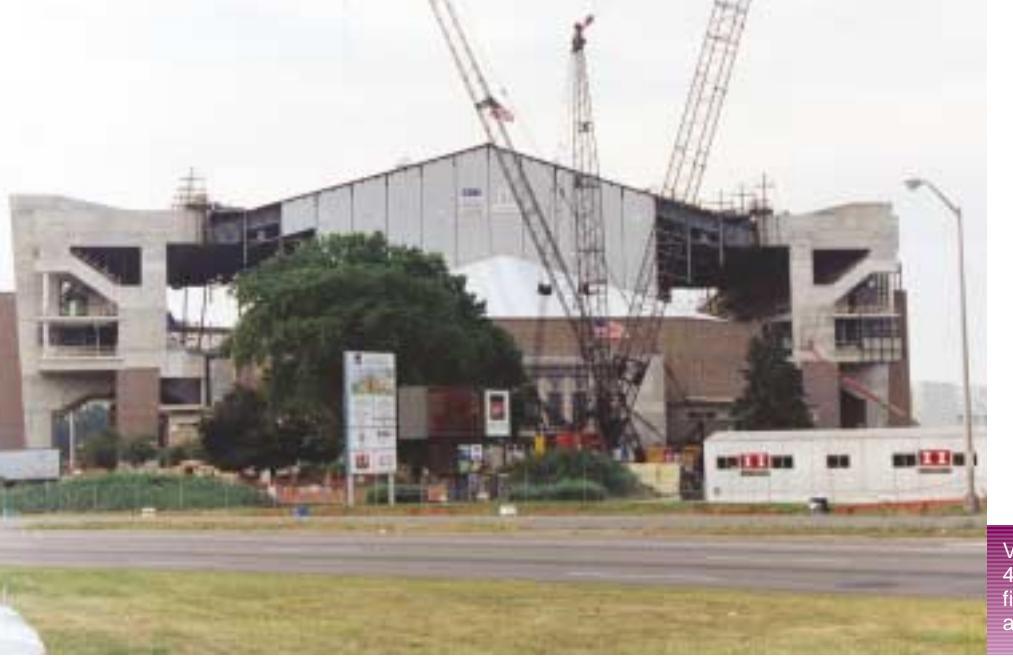
View of coliseum at the new raised height of 41'-10" above the previous position. The final elevation of the peak is roughly 120' above grade.

Aug. 2, 2002 the entire 1,200-ton structure was lifted 41'-10" higher to its new resting position, connected to the 16 new concrete cantilevers that reach out and grab the roof. The lift took just under five hours to complete and it went up without a hitch. The ability to reinforce and reutilize the existing steel structure resulted in a major cost saving when compared with the possible construction of an entire new roof system. The owner remained in operation during the renovation, resulting in \$3 million of revenue that otherwise would have been lost if the facility had been closed throughout construction.  $\star$
