# Progressive Collapse Basics

by R. Shankar Nair, Ph.D., P. E., S. E.

A rational look at today's building codes, with an eye on blast-resistant design.

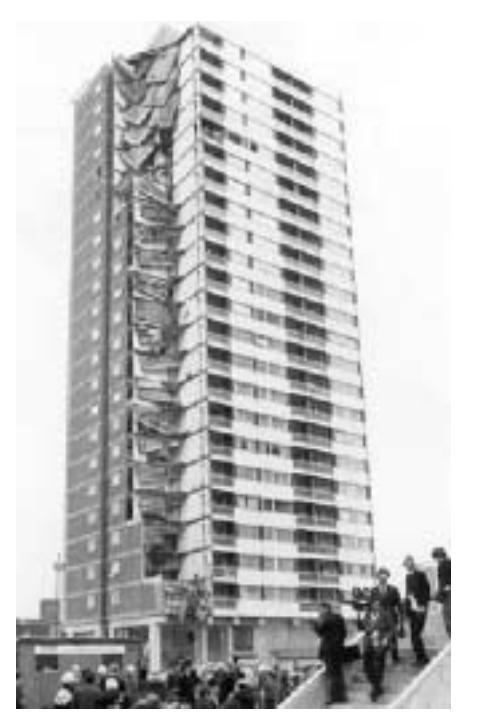
Ronan Point building after the May 1968 collapse.

n May 16, 1968, Ivy Hodge, a tenant on the 18th floor of the 22-story Ronan Point apartment tower in Newham, east London, struck a match in her kitchen. The match set off a gas explosion that knocked out load-bearing precast concrete panels near the corner of the building. The loss of support at the 18th floor caused the floors above to collapse.

The impact of these collapsing floors set off a chain reaction of collapses all the way to the ground. The corner bay of the building collapsed from top to bottom. Mrs. Hodge survived but four others died.

Greater redundancy would have been difficult to build into the type of structure employed in the Ronan Point tower. Improved local resistance, in the form of greater strength of the precast concrete wall panels that blew out, precipitating the collapse, would not have helped; the panels would have blown out regardless of their strength.

Better interconnection of structural components is the key for this structure. Stronger and more positive connections between the wall panels and the floors, with less reliance on friction due to weight to hold everything together, is likely to have greatly reduced the scale of the collapse of the Ronan Point building.
