Capital View

An expansion project within a stone's throw of the U.S. Capitol adds a little more steel to a notoriously concrete town.

MODERN STEEL CONSTRUCTION JULY 2007

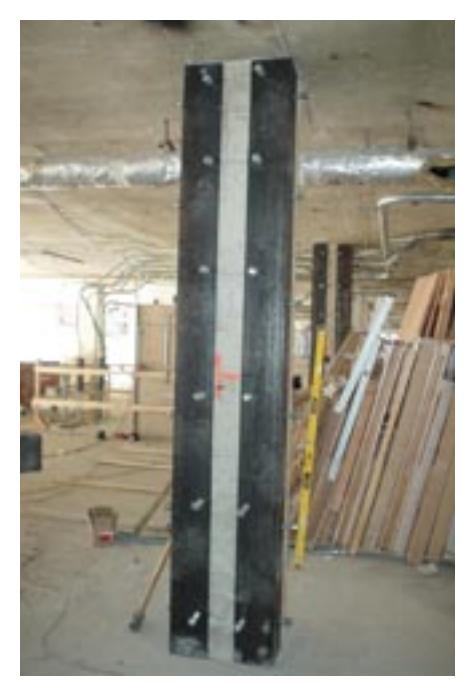
Steel angles with shear studs were attached to some existing concrete columns for reinforcement. A new concrete shell will encase these assemblies.

They were set in place with high-strength Hilti epoxy anchors with the closure piece field-welded and epoxy-bolted. Epoxy was injected into any existing gaps between the back of the angle and the front face of the column. The angles were placed about 1 in. below the underside of the slab, and a nonshrink grout was dry-packed into the void.

Steel jacketing, concrete enlargement, and complete column replacement were methods used to increase the capacity of existing concrete columns. The steel jacketing methods used epoxy anchors and epoxy injection systems to bond either steel plate and/or steel angles to the existing columns, with head and base angle "seats" to transfer the additional accumulated load through to the newly modified columns and foundations.

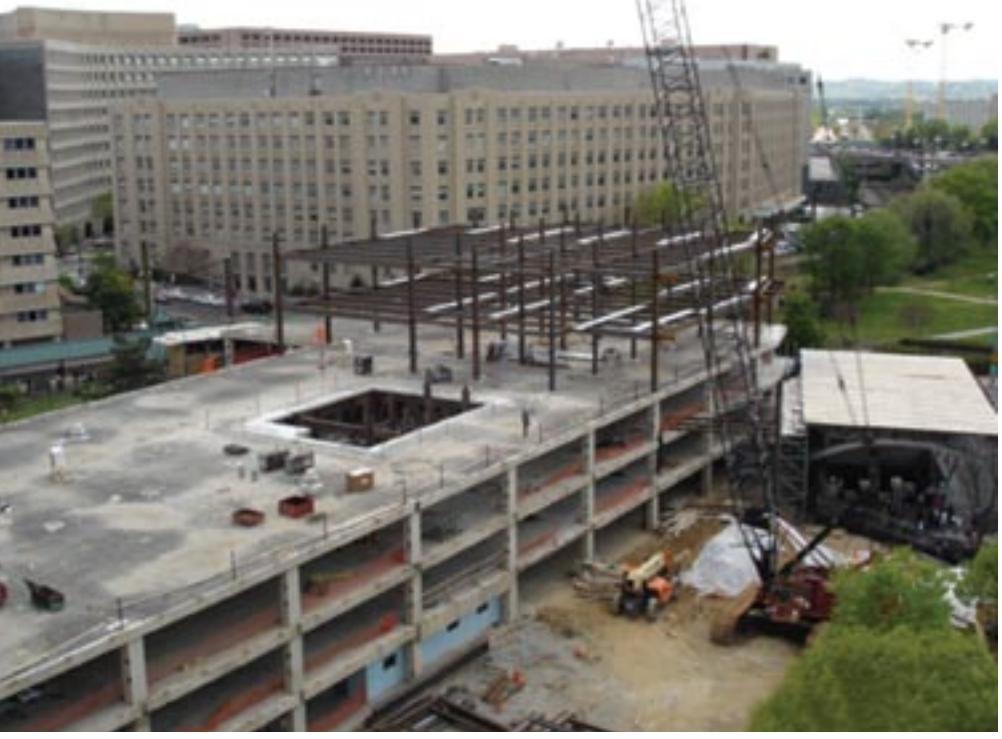
Seven floors of steel-framed offices were added atop this three-story concrete structure from the 1970s.

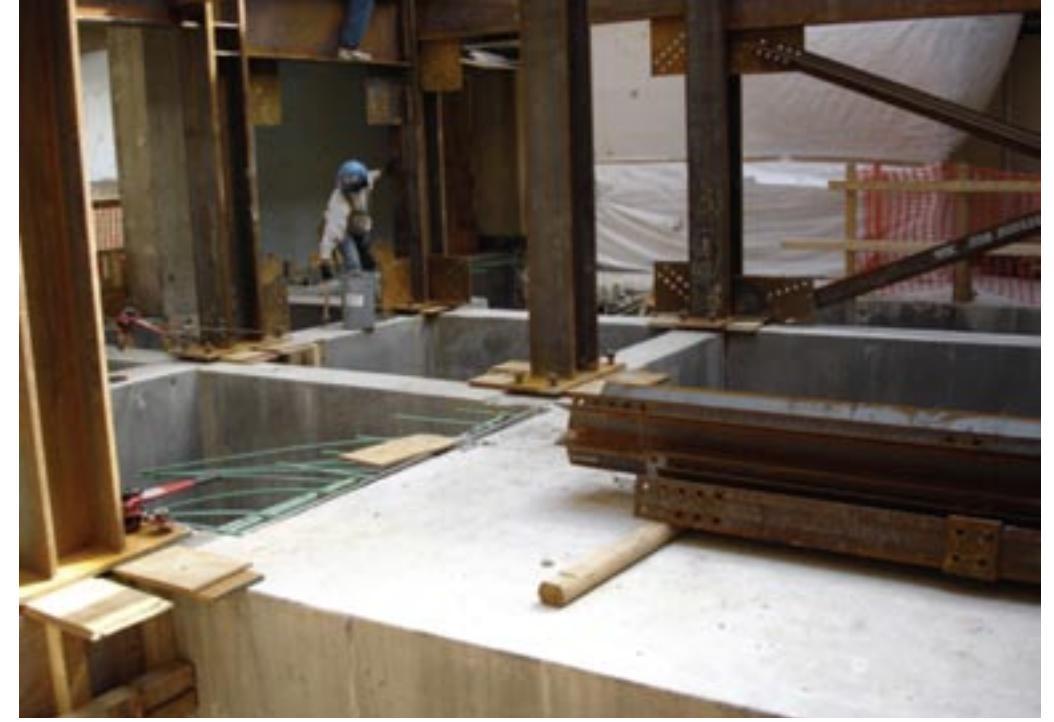
The new elevator bank's pit walls function as girders carrying new structural steel columns and lateral bracing.

The new elevator bank pit system required the pit wall extensions to be girders carrying new structural steel columns, and the steel K and X wind bracing to be placed from above through the existing three story building. These girders were supported by new hand-dug caissons and tied to existing caissons, which, as excavation commenced, were found not to be of the size, location, or geometry called for by the original documents.
