Steel Bridge

New Spans Over Two Oregon Rivers

DECEMBER 2010 MODERN STEEL CONSTRUCTION

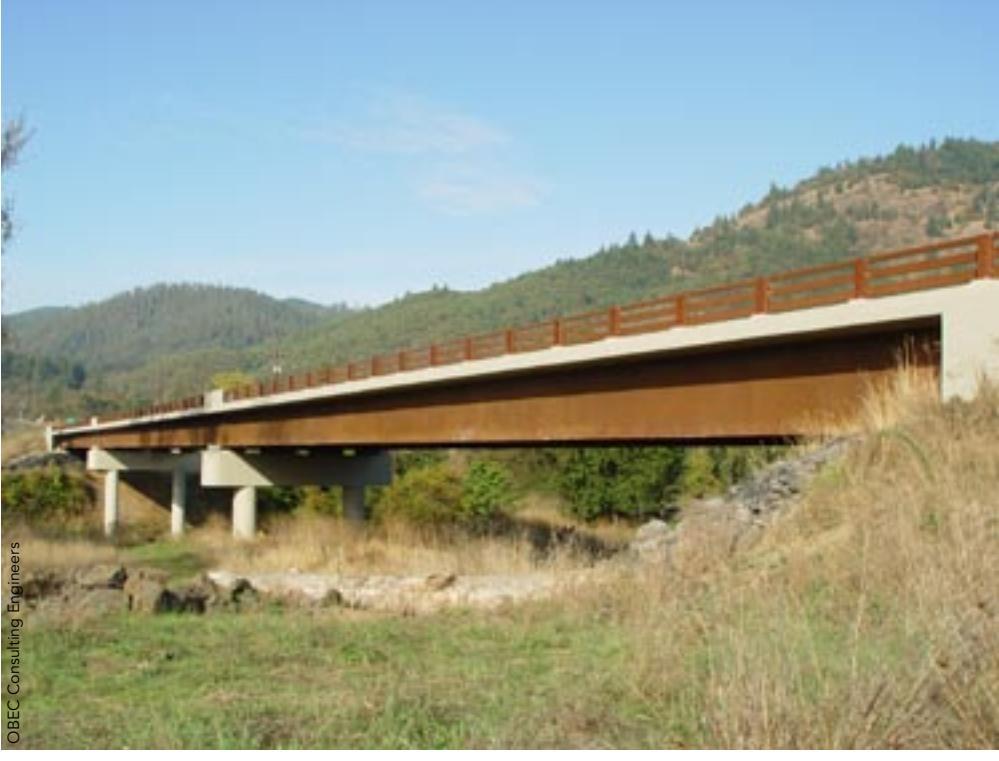
- The new 588-ft-long South Umpqua River (Pruner Road) Bridge uses four weathering structural steel girders spaced 12 ft apart.
- The new South Umpqua River (Pruner Road) Bridge features aesthetic treatments including a brown powder-coating on the steel top railings.

The new Pruner Road Bridge is a 588-ft-long threespan bridge composed of four weathering structural steel plate girder lines. The unbalanced spans of 200 ft, 218 ft, and 170 ft were chosen to avoid the existing footings of the old bridge. In order to find the most efficient use of steel, the designer analyzed several girder configurations. The final girder spacing is 12 ft—well within the ODOT guidelines of 11 ft to 14 ft for spans longer than 140 ft. The four lines of weathering steel girders, conforming to ASTM Specification A709 Grade 50W, are 80 in. deep.

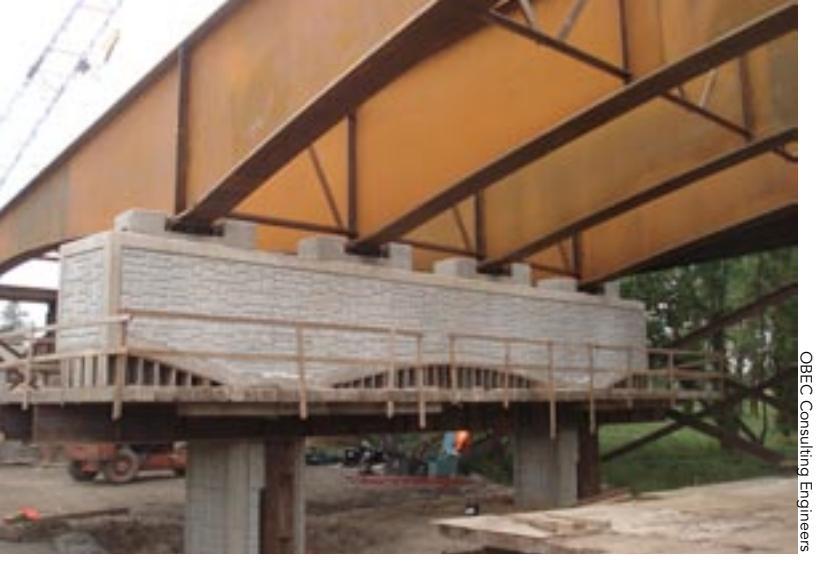
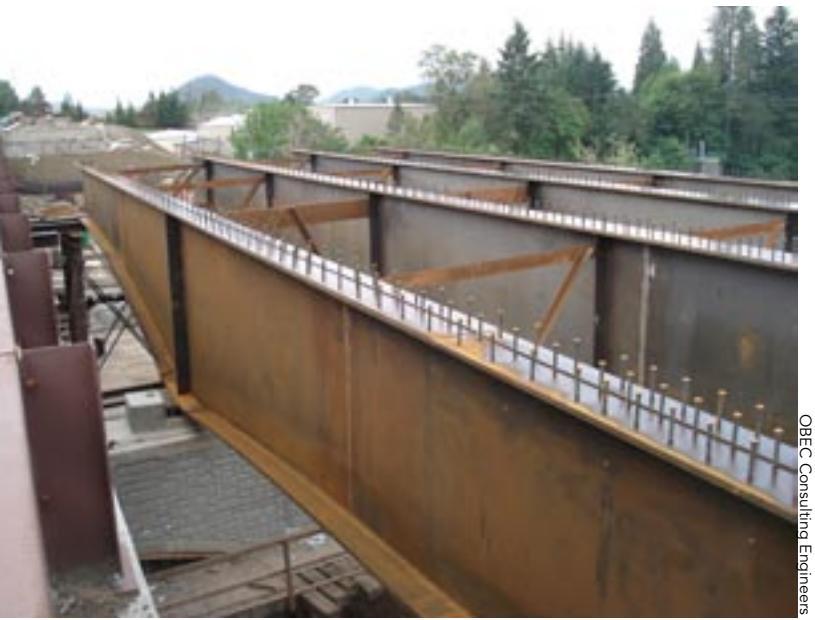
- Douglas County and the Oregon Department of Transportation considered concrete and steel alternatives for the permanent North Umpqua River (Brown) Bridge, but ultimately chose the structural steel option. To increase the structure's aesthetics, OBEC Consulting Engineers designed the bridge to utilize haunched steel girders at its interior piers.
- This artist's rendering was used during preliminary design to demonstrate what the final North Umpqua River (Brown) Bridge would look like.

To give the new highly-visible North Umpqua River (Brown) Bridge more visual appeal, the structure features haunched weathering structural steel girders and an ashlar stone architectural treatment at the interior pier. In addition, all visible concrete surfaces are stained with three different colors.

Because of the North Umpqua River Bridge's high visibility, the county wished to add aesthetic features. Haunched girders and arched interior piers give the new bridge an attractive appearance, while all visible concrete surfaces are stained with three different colors and incorporate an ashlar stone appearance.

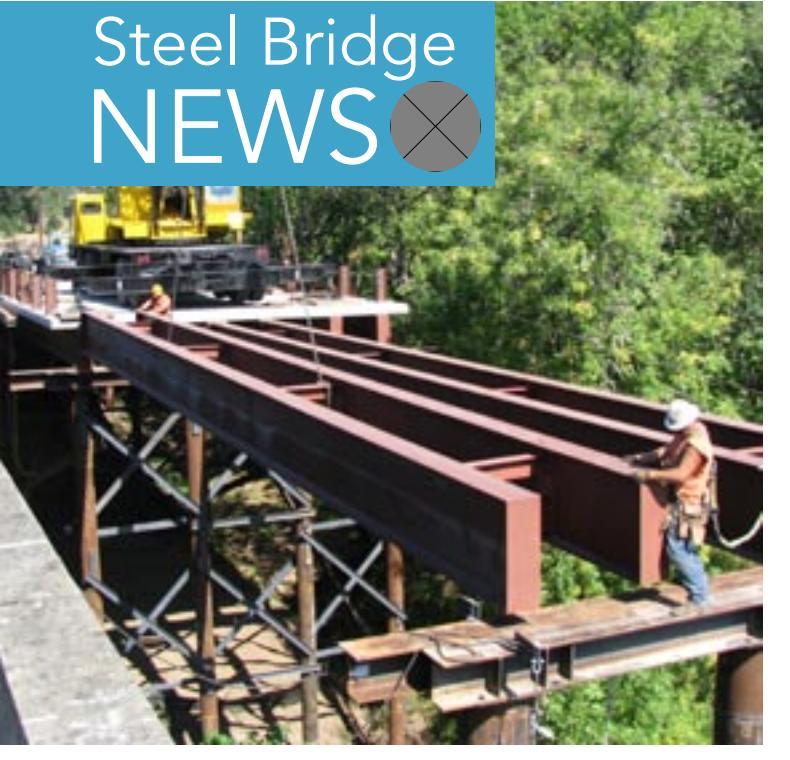
The North Umpqua River detour bridge being constructed adjacent to the existing bridge. The steel girders for the 120-ft main span were salvaged and modified from a local bridge replacement.

The temporary detour bridge was designed as a 12-span structural steel bridge with 40- to 60-ft-long approach spans and one 125-ft-long main span. During the design phase of the detour bridge, the county provided several ideas to promote the concept of sustainability. The main steel girder spans of the detour bridge were salvaged and modified from an earlier local bridge replacement, and several approach spans incorporated salvaged beams from the county's bridge maintenance yard stockpile, saving the county from having to purchase new beams. The design included locally fabricated precast concrete deck panels and steel bridge rail, all of which are planned to be disassembled and used at different sites after the permanent bridge has been constructed.

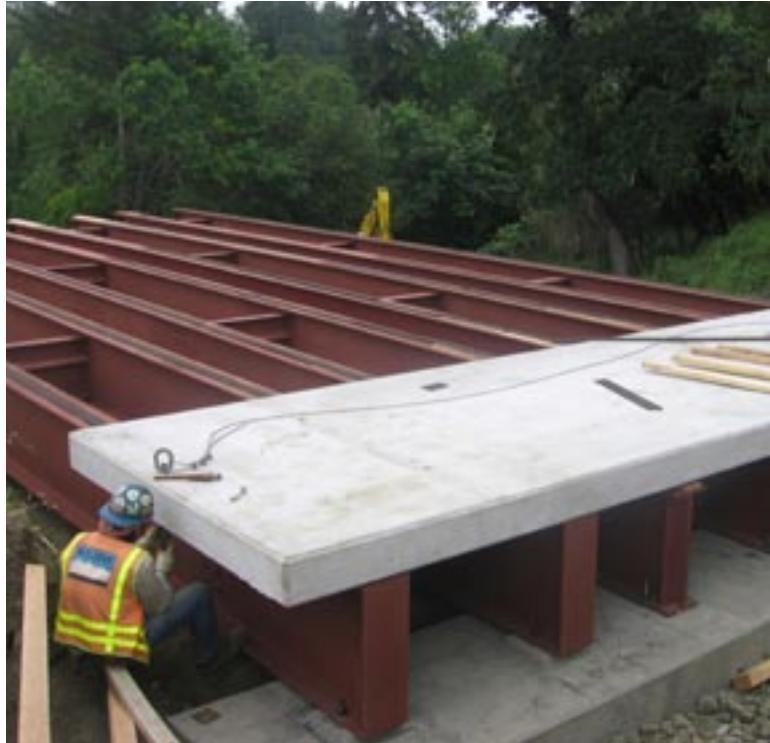
Workers install the precast concrete panels that make up the deck of the temporary North Umpqua River detour bridge. Douglas County plans to reuse the deck panels and steel bridge rail at different sites after the permanent bridge is complete.

of the deck panels and steel girders from the temporary bridge on future bridge replacement projects. The salvaged structural elements can be easily stockpiled and take up much less room in the county storage yard than concrete girders. With the lighter overall weight, they also are more easily handled by smaller equipment, which frees up the county to deploy them more rapidly, especially in the event of an emergency repair. The steel elements in particular represent a built-in cost savings that will help the county make the most of limited resources because the engineering details can be easily transferred to another site.
