CASE STUDIES OF COMPLEX GIRDER ERECTION

SUMMARY

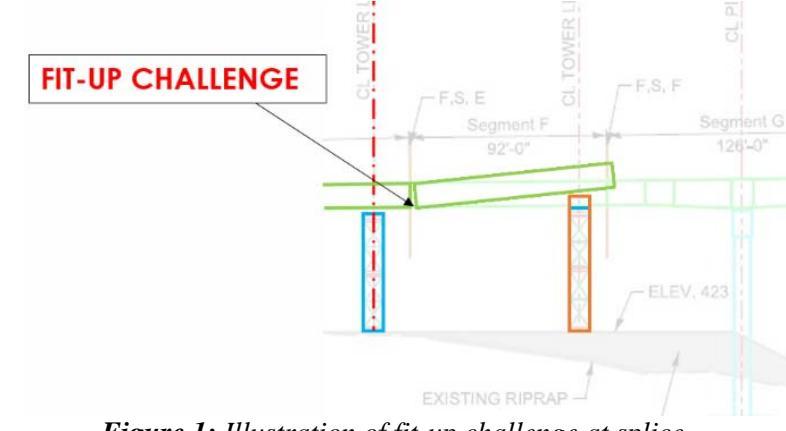
Figure 1: Illustration of fit-up challenge at splice plate if shoring tower on the right is too high.

For the four approach spans leading up to the canal (two on each side), the contractor elected to use shoring towers to reduce the effective span length and use "conventional" erection methods. The challenge associated with the shoring towers was to accurately set the top elevation of the tower in order to accommodate both making the splices and then the deflection at the time of release. If the towers were too tall challenges would occur at the splice plates due to improper alignment of the webs. Figure 1 below illustrates how a shoring tower that is too high relative to the trailing tower would create a challenge for making the web splices. A top elevation that is too low, simply creates a scenario where the next support could be "too high"

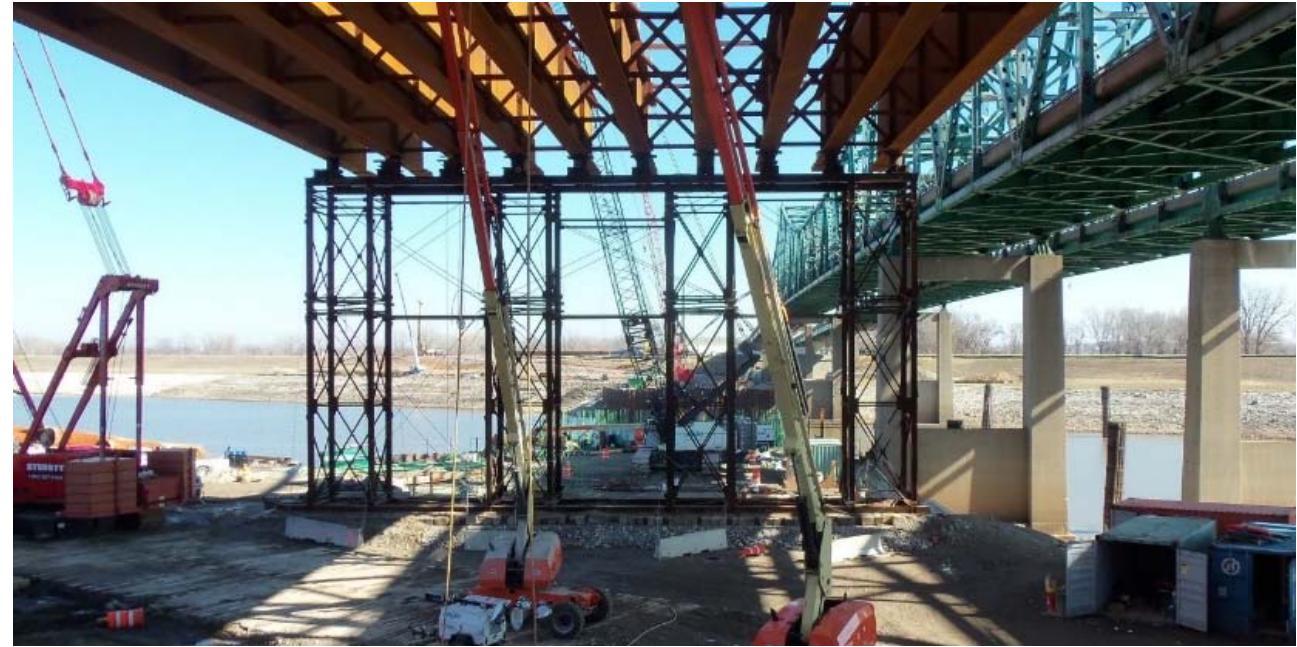
Figure 2: Shoring tower used for girder erection for approach spans on I-270 over the Chain of Rocks.

Release of the shoring towers was also a challenge due to the magnitude of girder deflections. In the spans adjacent to the main span, up to 21 inches of deflection had to be accounted for at the time of tower release. This required bolsters and special jacking details to facilitate lowering of the structure to release the tower. Figure 2 provides an illustration of the shoring towers used on the project.

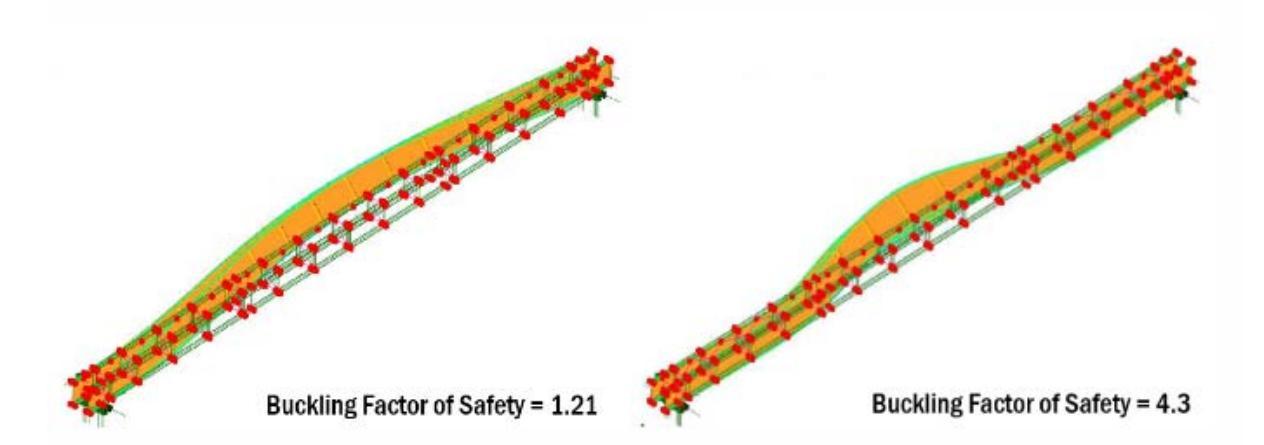
Figure 3 (below): Two girder buckling analysis showing the improved performance when the top lateral bracing was installed.

In order to meet the limitations on closing the navigation channel to marine traffic, the contractor decided to pre-assemble the main span girder segments on a barge near the shore. The cross section was composed of 10 girder lines and the pre-assembled main span section consisted of 3 segments fully spliced together with a total length of 370 feet. The decision was made to lift two sections, each four girders wide (with a weight of 1.6 million pounds) and a center section which would only be two girder segments wide. The two girder segment had to be analyzed for global buckling during the strand jacking lift. LUSAS finite element software was used to assess the stability of this section in this scenario. The initial factor of safety against buckling was found to be only 1.21 which the team was not comfortable with. Top lateral bracing was added which modified the buckling shape and increased the factor of safety to 4.3 (See Figure 3).

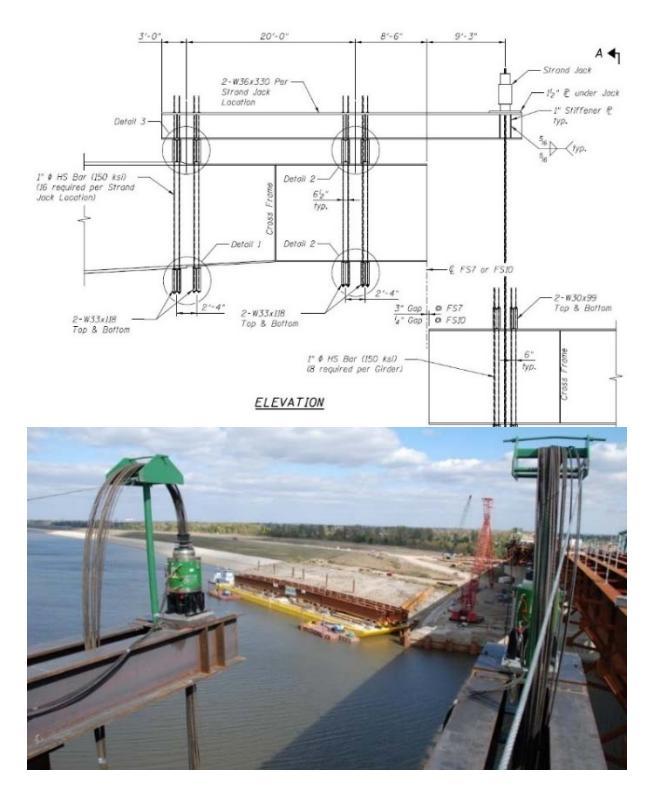
Figure 4: (Upper) Plan details showing strongback jacking beam and (lower) Strand jacks ready to lift the segments below.

The strand jacking operation itself was to be conducted from the top of the previously erected girders on either side of the navigation channel. Strongback jacking beams were erected on each side as shown in figure 4 below. When erecting drop-in segments, it is important to check the length of the opening between the upper girders against the overall length of the pre-assembled girder below. Girder deflection and rotation along with chamfered web ends can contribute to conflicts if this is not taken into consideration.

Figure 4 illustrates plan details and a photo of the strand jacking assembly. High strength (270 ksi) post-tensioning strands were used to lift the girders from the barge nearly 60 feet below and make the connections at each end of the previously erected girders. Each strand lift took only one day and all Coast Guard requirements were met.

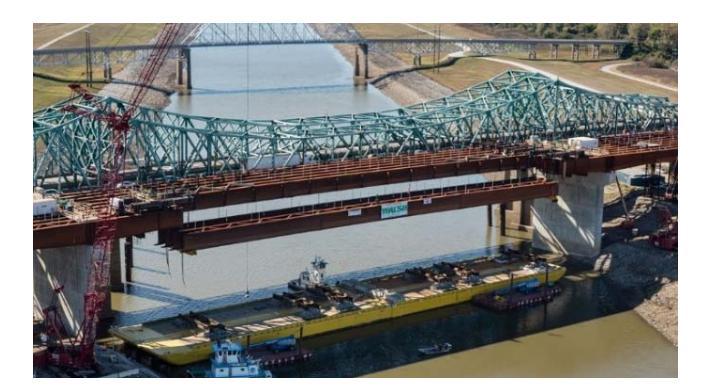
Figure 5: Strand Jacking of the last 4 girder system to complete the girder erection for I-270 over the Chain of Rocks.

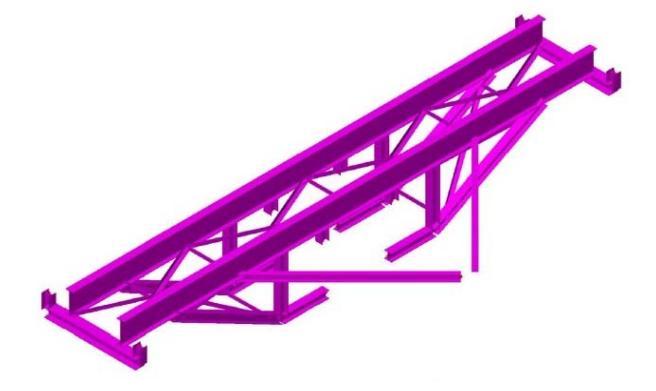
Figure 6: Finite Element model of pier bracket.

Pier brackets were designed to be assembled on barges below and placed over the top of the pier in a single crane pick. The pier brackets created additional support locations for the girder, away from the bearing, to stabilize the girders during erection. Figure 6 on the following page illustrates the finite element model of the pier bracket used for this bracket.

In order to assess the structural adequacy of the pier brackets, a load criteria had to be developed. Quartering wind loads, girder erection forces, contractor work platforms and construction tolerance eccentricities were all considered while determining structural demands on the pier bracket. Due to the fact that the bracket essentially "sits" on top of the pier, it was very important to ensure the support conditions in the finite element model matched up with the structural behavior that would be expected in the field. Because the first girder would be erected as a single segment, pipe braces were used to achieve temporary stability while also providing resistance for a variety of different wind loading conditions.

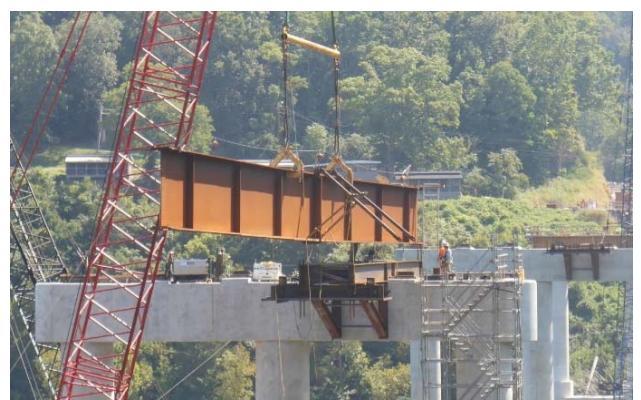
Figure 7: *Photo showing girder installation with the pier bracket in place.*

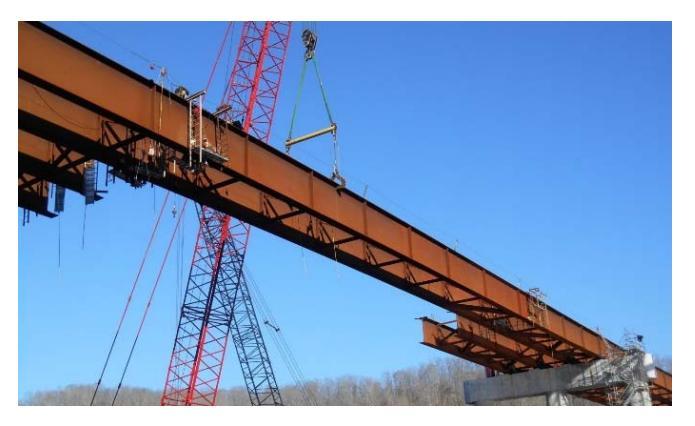
Figure 8: Erection of the first two girder segments of span.

After erecting all of the pier segments at piers 2 and 3, the midspan segments were pre-assembled on a barge below. The 200' midspan segments (in tandem), were lifted via two cranes and spliced to the previously erected pier segments. During this operation, it was important to specify when the supports at the pier brackets must be released and the bolsters removed. This step had to happen so that the pier brackets did not take substantial load when the recently erected girders deflect in the new configuration. After span 3 was erected, a pier bracket was relocated to pier 4. The process was then to be repeated at pier 4, with the midspan segments of span 4 being dropped in. The structural behavior was different in this situation as continuity had an impact on the girder deflections and rotations. The first tandem of midspan segments in span 4 were erected by connecting the upward deflected "high" splice first (near span 3) and then lowering the other end into place to connect to the girders on pier 4.

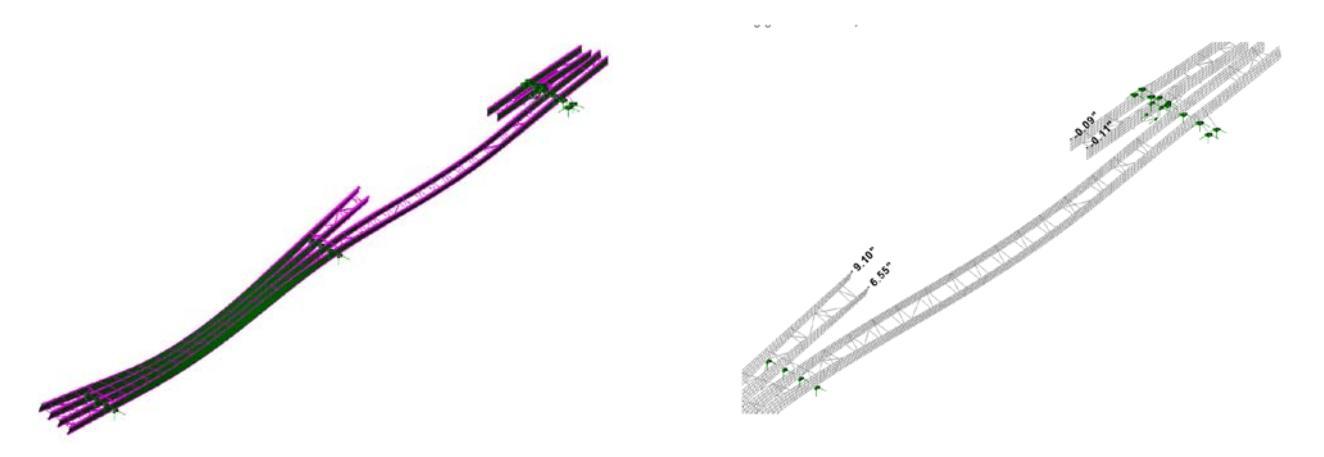
Figure 9: (*Left*) *Amplified deflected shape showing span 3 and two girders of span 4 erected.* (*Right*) *Deflections (inches) at the ends of the previously erected segments prior to placement of the girders in span 4.*

After the first pair of span 4 midspan girders were erected, the second pair would have to be installed while accommodating the deflections of the previously erected segments. Figure 9 illustrates the deflected shape of the girder system prior to the second pair of span 4 girder segments being erected. For this step, the splices had to be made in a specific order, with reductions in crane load occurring after each splice was made in order to facilitate fit-up. After the splices adjacent to pier 3 were made, the crane near pier 3 released its load to allow the crane near pier 4 to control the location of the other end of the girder.

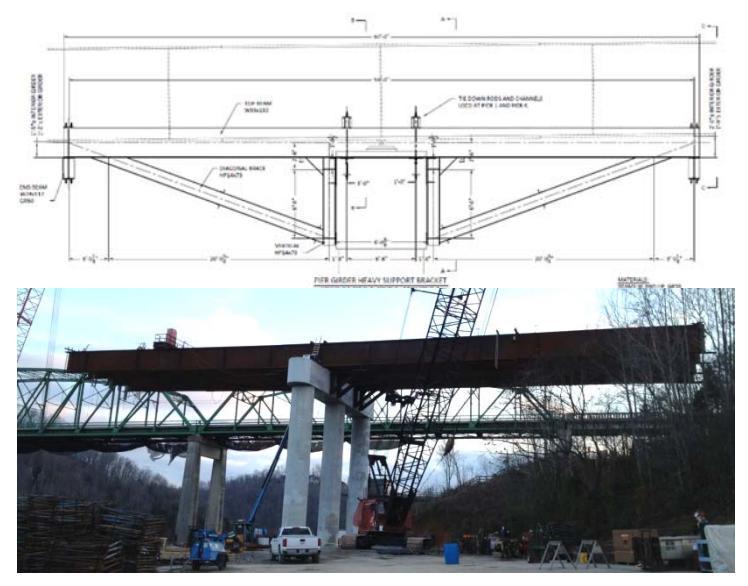
Figure 10: (*Top*) Plan details showing the anchorage to the pier cap. (Bottom) Unbalanced girder configuration at pier 1.

During construction, it was determined that the pier bracket at pier 1 would have to support an unbalanced load in order to meet the schedule. The design and details of the pier bracket were retrofitted to be able to handle the unbalanced load scenario. Tie-downs were anchored into the pier in order to support the uplift that would occur when a segment was spliced to one end of the pier segments. Figure 10 shows the anchorage detail for the pier bracket and a photo of the unbalanced condition.

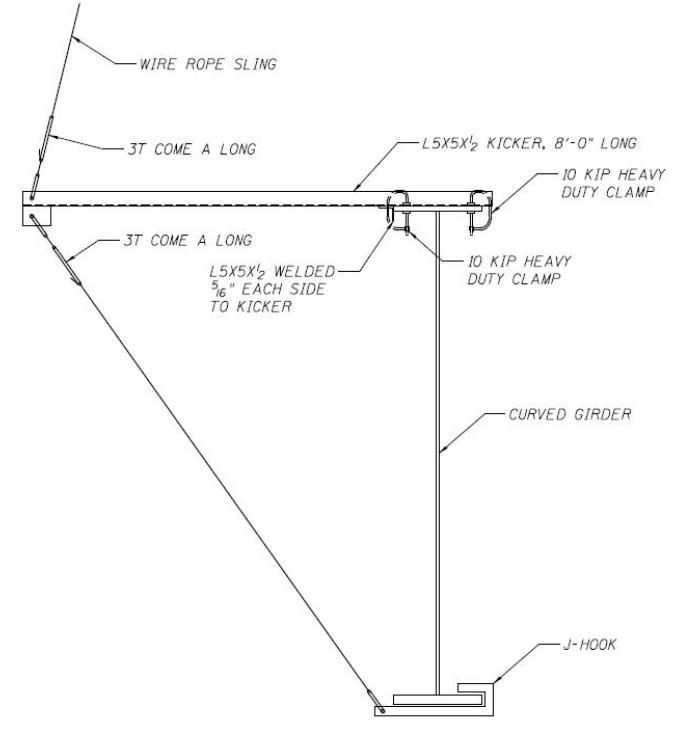
Figure 11 (Below): Details of rigging adjustment detail used to maintain girder plumbness during the pick.

After all 6 girder lines were erected to the first splice, the next girder segment would extend from the shoring tower to the pier. The contractor was not going to modify the length of the spreader beam for each girder segment, so some "roll" was going to have to be accommodated in each pick. It was decided to use a spreader beam that was shorter than the ideal length such that the "roll" during the pick would always be inward. A rigging adjustment detail was developed to allow the ironworkers to apply a restoring moment to the girder that would create a "plumb" girder and facilitate making the splices. Figure 11 shows the plan detail of the rigging adjustment detail, and figure 12 shows a photo of its use in the field.

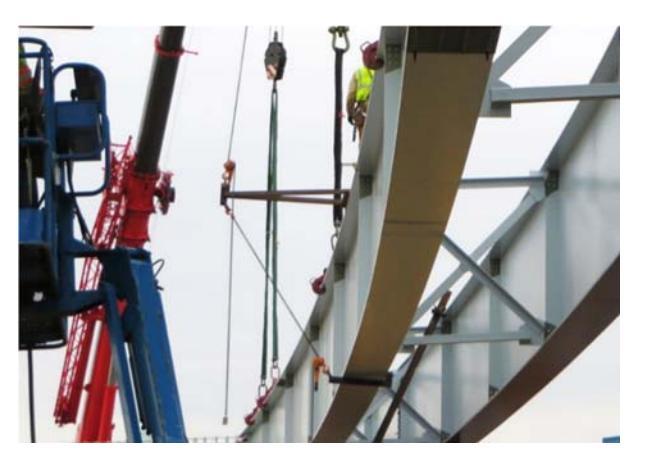
Figure 12: *Photo of the rigging adjustment detail in the field*

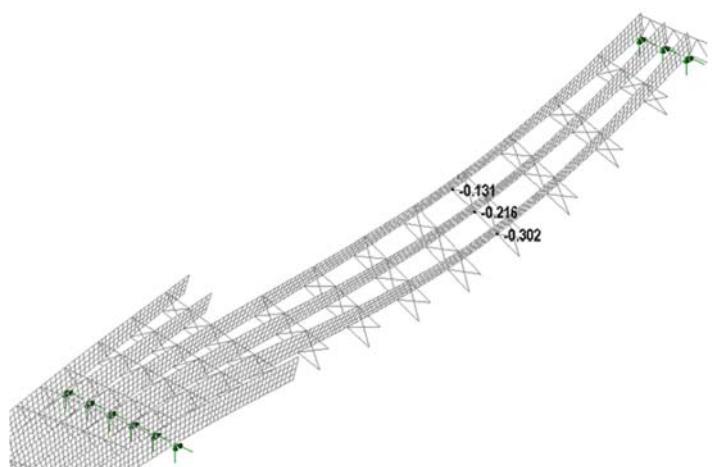
Figure 13: *Finite element model of the deflected shape with girder lines 3, 4 and 5 erected. Deflections are shown in feet.*

Another factor to consider when erecting curved girder structures is the order the girders are erected. Due to staging constraints in one span, the contractor was forced to start with girder 3 and erect toward the outer girders before returning to erect girders 1 and 2 (the inside girders). After girders 3, 4 and 5 were erected, the girder system was "rolling" such that girders 4 and 5 were deflected incrementally more than girder 3 (as to be expected and shown in figure 13). When girder 6 was brought in, cross frame fit-up was difficult as the crane supported girder 6 was not able to fitup properly with the cross frames attached to girder 5 (See figure 14). In order to accommodate the fit-up challenges, the cross frames near the supports, where there is not significant differential deflection, were made first. As stability was achieved via cross frame connections, the crane was able to gradually release load, allowing girder 6 to deflect and the midspan cross frames to be connected.

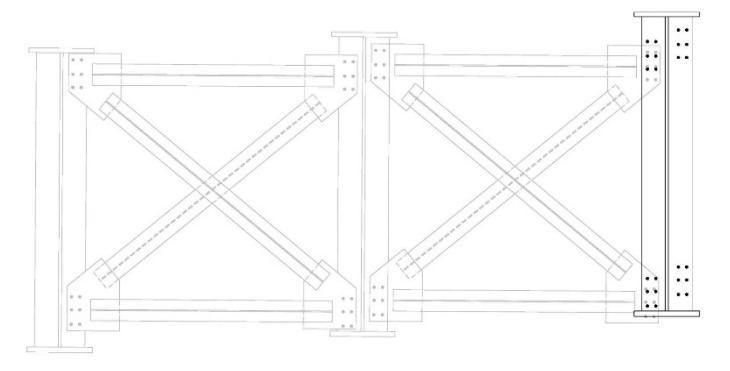
Figure 14: Illustration (drawn to scale) showing the fit-up challenges of the outside girder relative to previously erected inside girders.

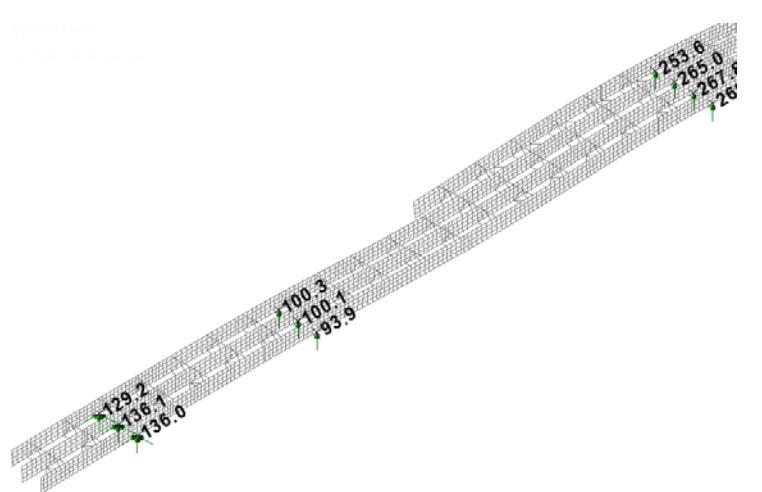
Figure 15: Finite element model showing girder reactions for 3 girder lines erected. The shoring tower is represented by the supports in the middle.

The controlling unbalanced load case is illustrated in Figure 15. This condition would create a "listing" moment of 1,700 kip feet. This unbalanced load condition would result in a 2.2% list which was not acceptable for the 40 foot tall shoring tower. The second order effects of the load would create instabilities and lateral forces that could not practically be resisted on a barge.

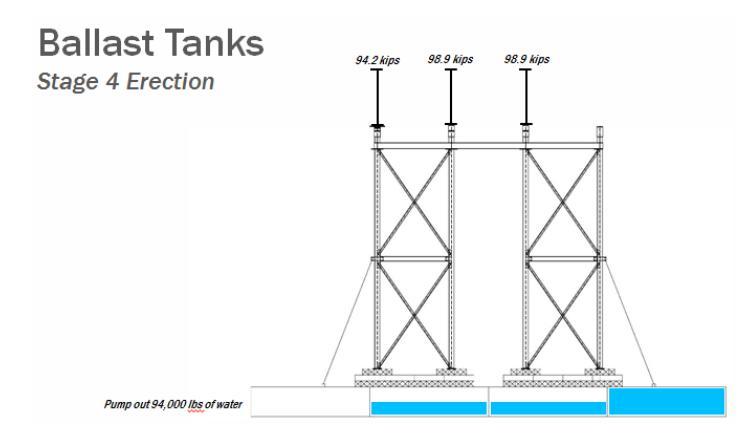
Figure 16: Illustration showing girder reactions and ballast tank configuration at the controlling unbalanced load.

In order to mitigate the listing moment, the contractor was able to use barges with ballast compartments. This would allow for some control of the centroid of the weight within the barge and create the opportunity to provide a resisting moment to the unbalanced load associated with the girder configuration. With the ballast tanks, the barge could remain level throughout the various stages of erection and stability could be maintained. Figure 16 illustrates the load condition

on the girders as well as the ballast configuration in the barges for the critical listing moment in the erection procedure.

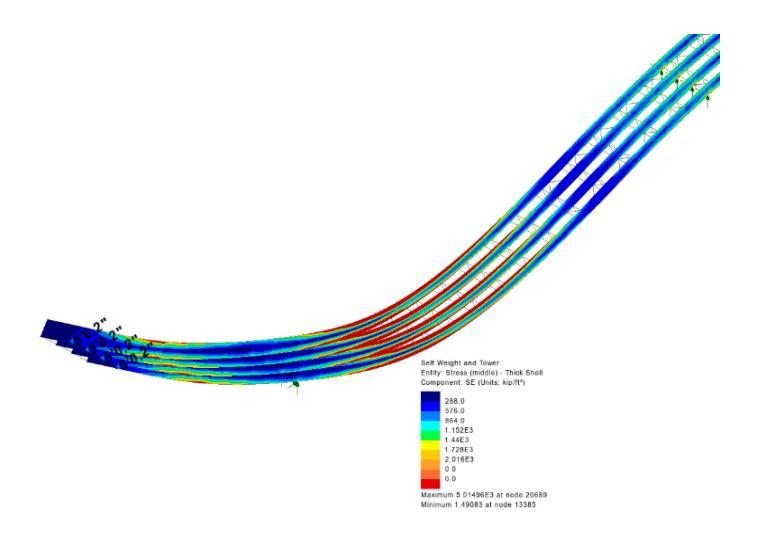
Figure 17: Deflected shape showing contour plots for the girder system at the extreme event limit state associated with flash flooding to submerge the barge

The next extreme event load case was that of a flash flood. The topography in Tennessee is such that the water elevations in these areas can change dramatically with large rainfall events. The total displacement of the sectional barge system was about 750,000 lbs. In order to model this scenario, an applied force of 750 kips in the upward deflection was applied to the girder system at the location of the shoring tower. This would be the force required to "hold" the barges underwater until the water level subsided. For this load case, the upward deflection was over 5', but the girders again remained elastic (See figure 17). This load

case was the controlling extreme event situation and, the girder displacement, coupled with the draft of the barges indicated that it would take a water level rise of almost 8 feet in order for this to occur.

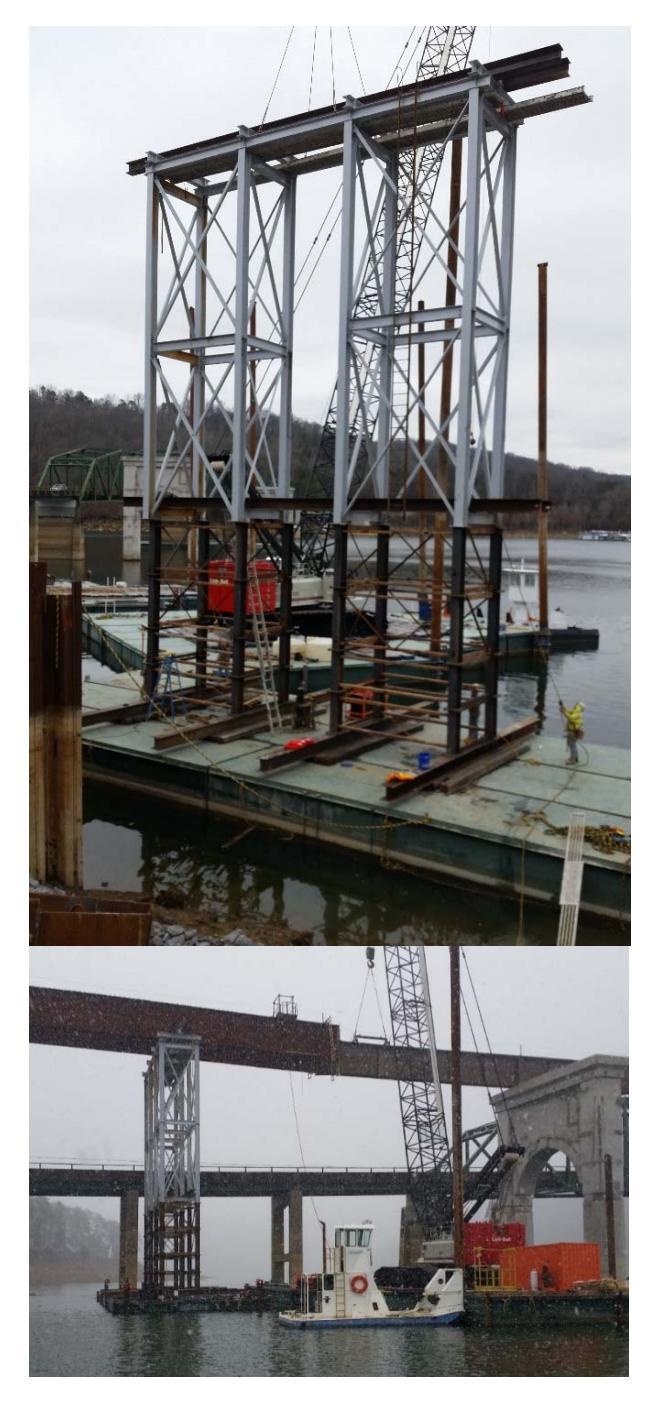
Figure 18: *Photos of barge mounted shoring tower*
