**Structural Engineering Report No. ST-01-3.2**

**COLUMN STIFFENER DETAILING  
AND PANEL ZONE BEHAVIOR OF  
STEEL MOMENT FRAME CONNECTIONS**

**June 2002**

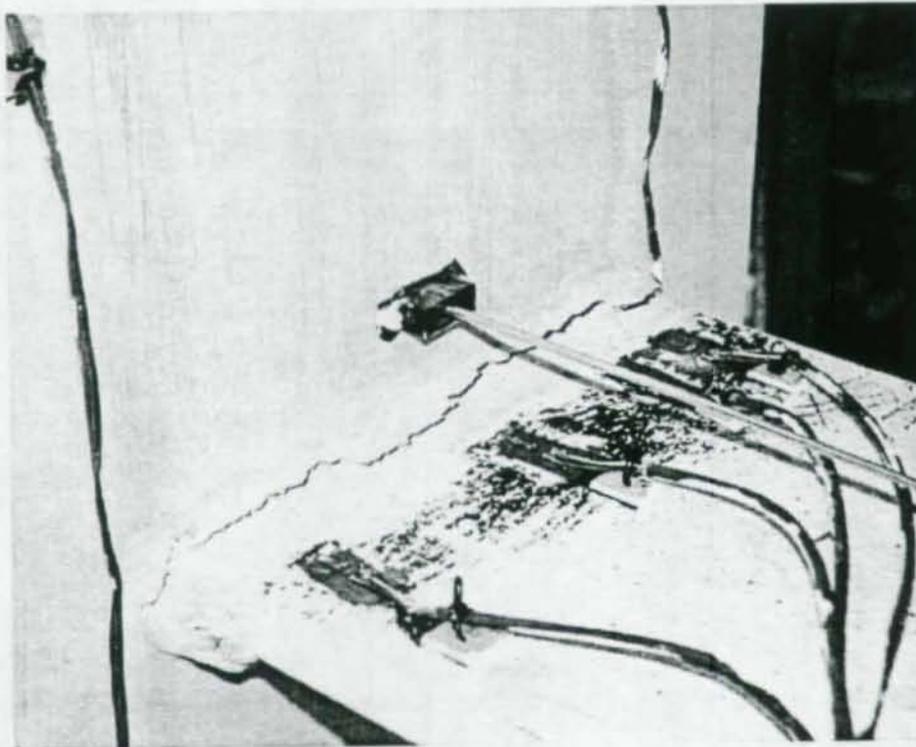
**Figure 5.52:** Fracture of East Top Flange, CR4

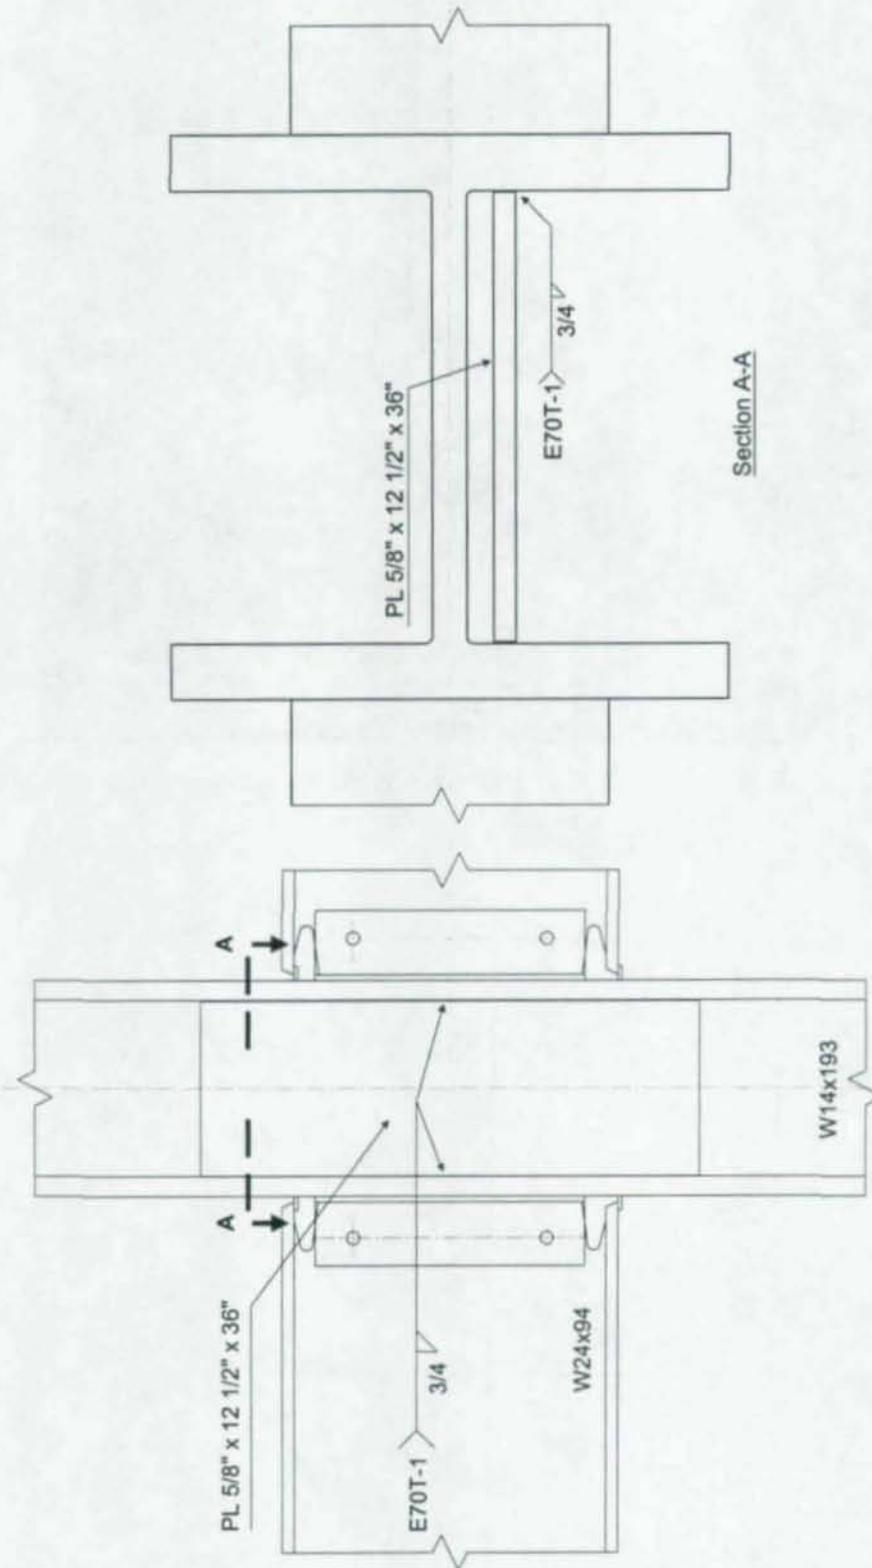
Figure 3.14: Specimen CR2 Fillet-Welded Doubler Plate Details

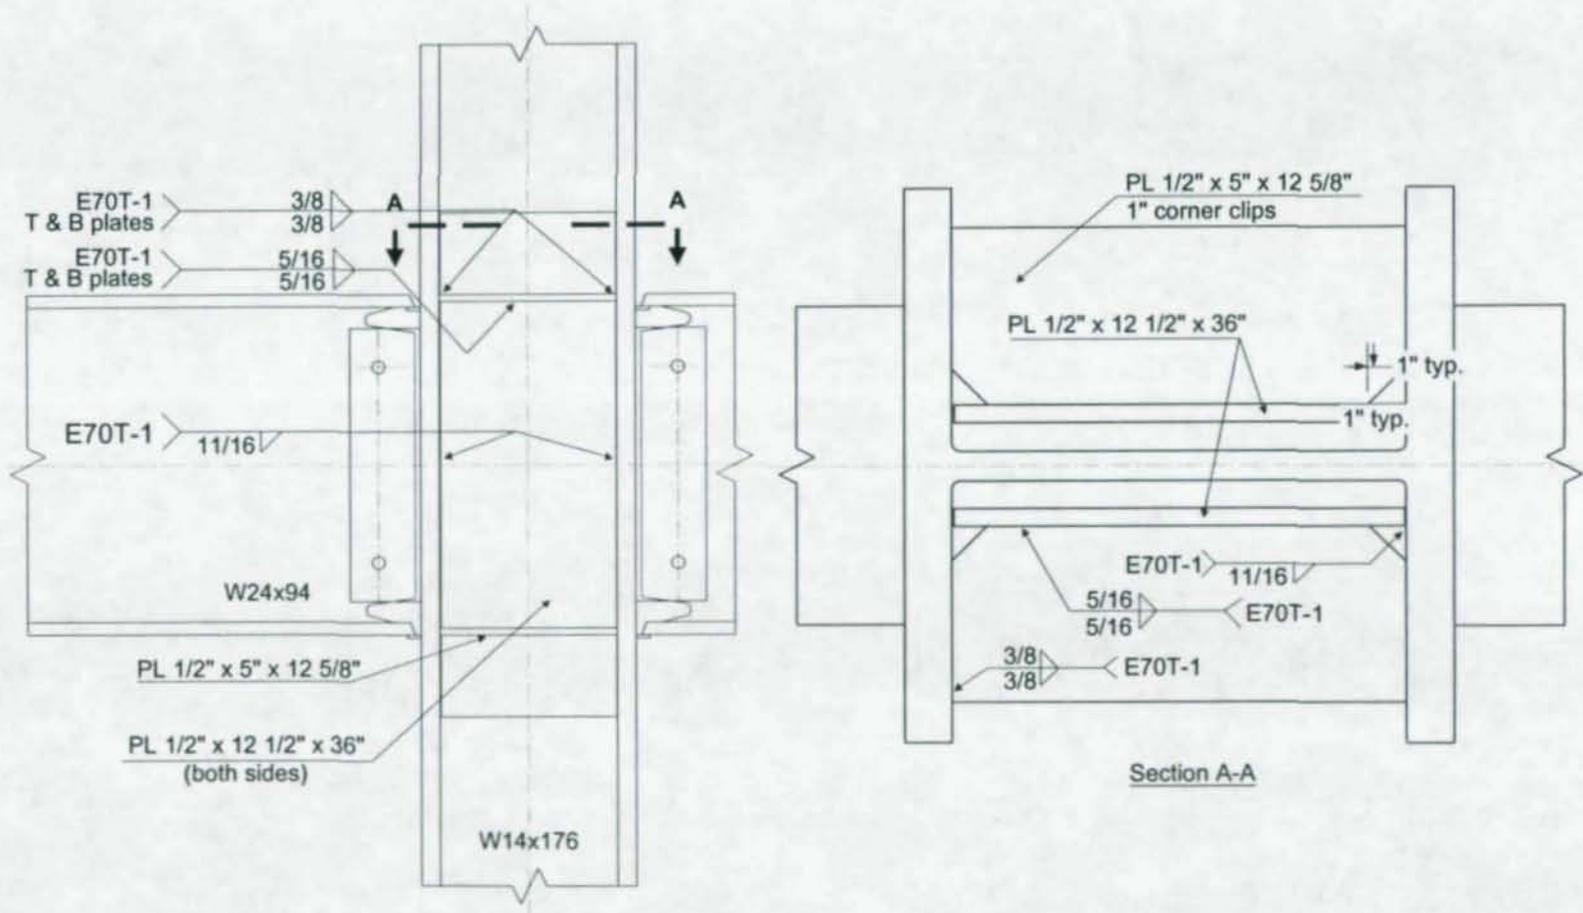
Figure 3.15: Specimen CR3 Stiffening Details

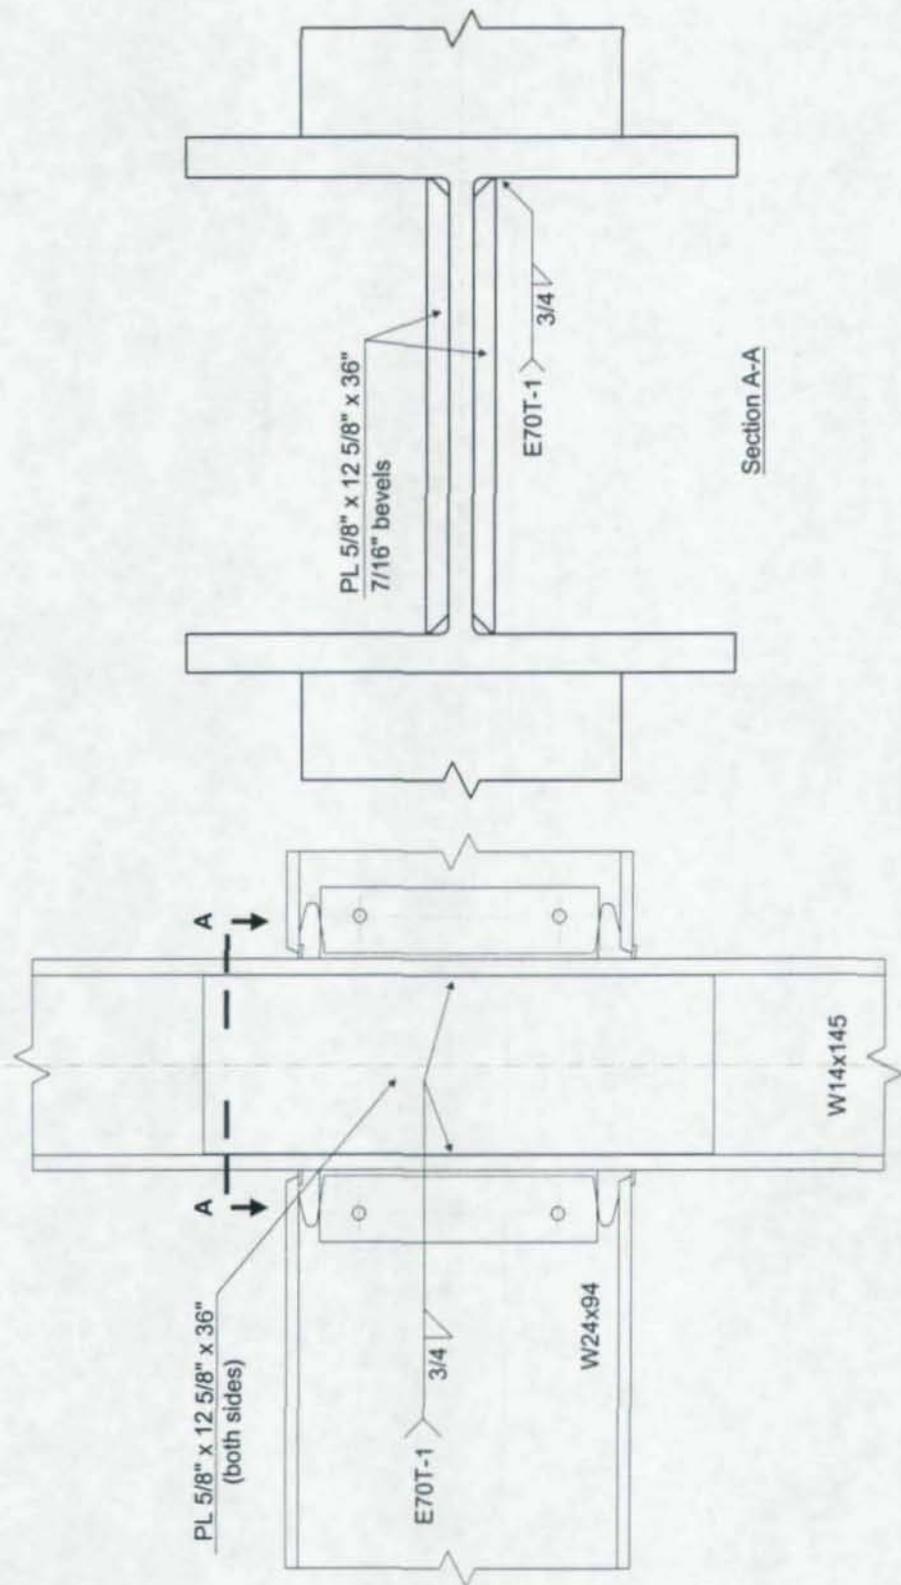
Figure 3.16: Specimen CR5 Fillet-Welded Doubler Plate Details

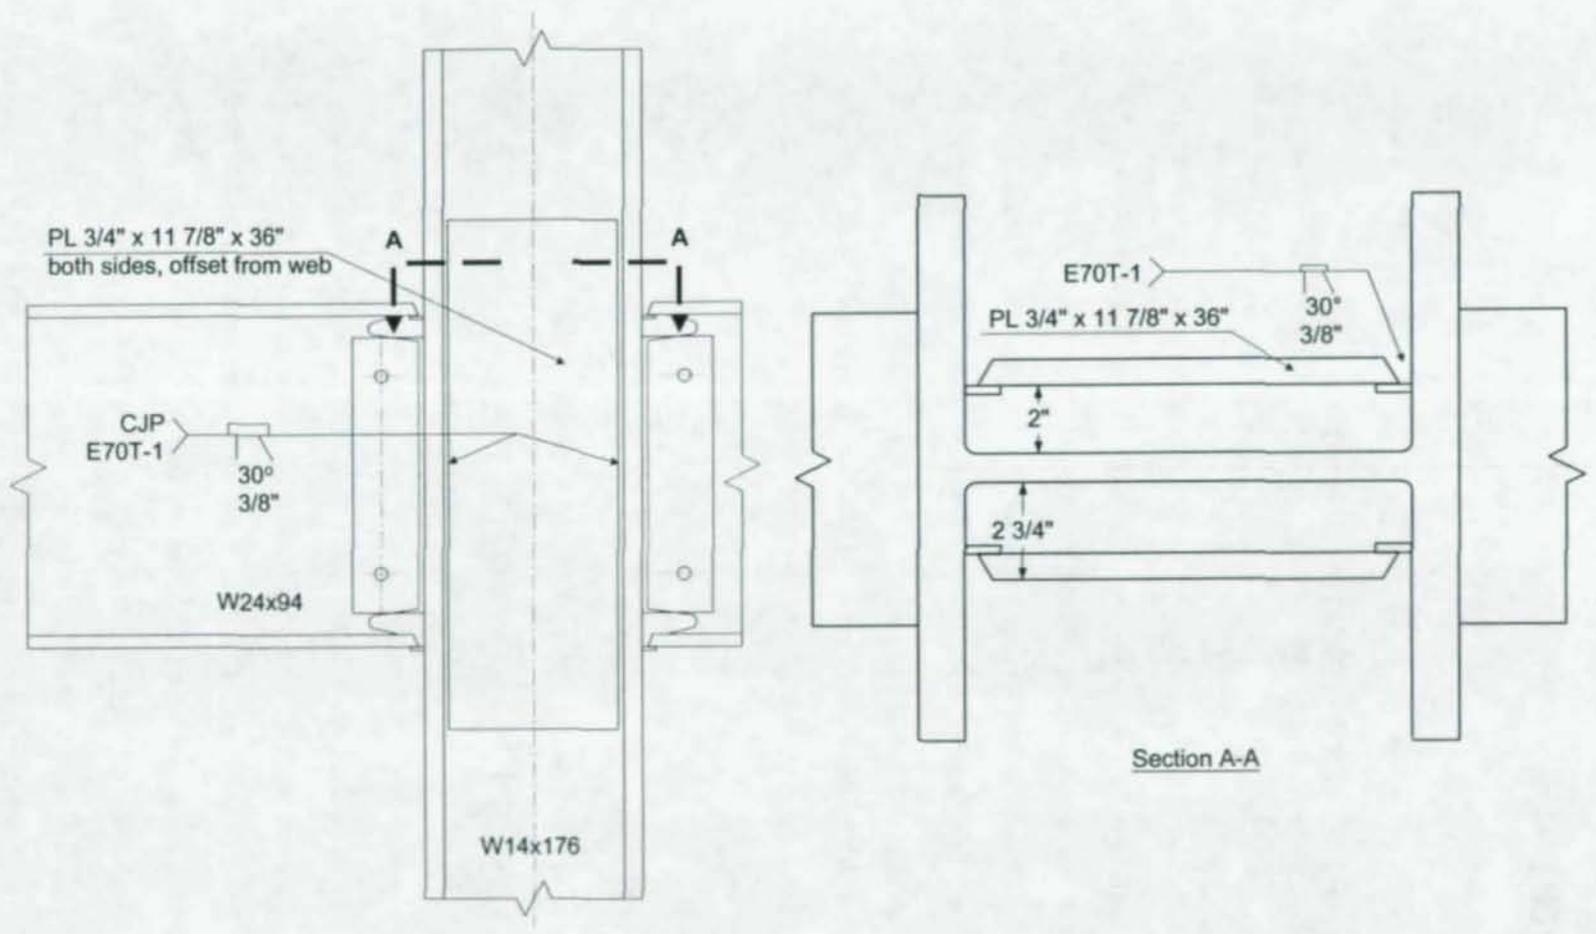
Figure 3.17: Specimen CR4 Offset (Box) Doubler Plate Details

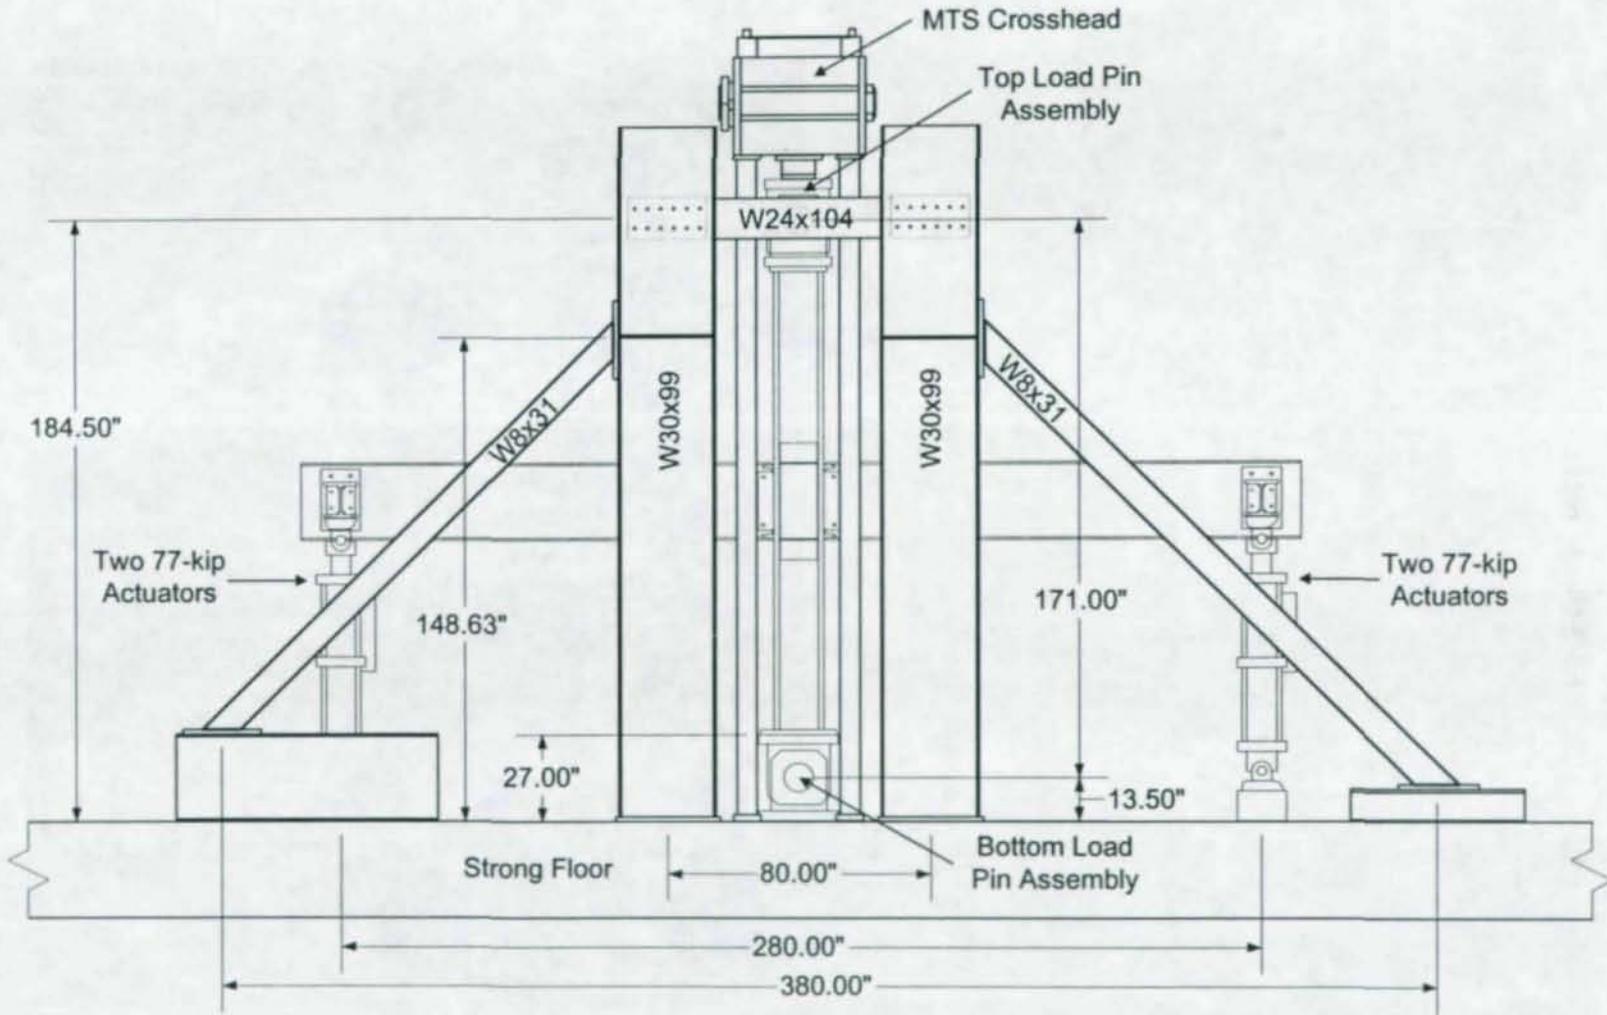
Figure 4.1: Load Frame Elevation With Specimen

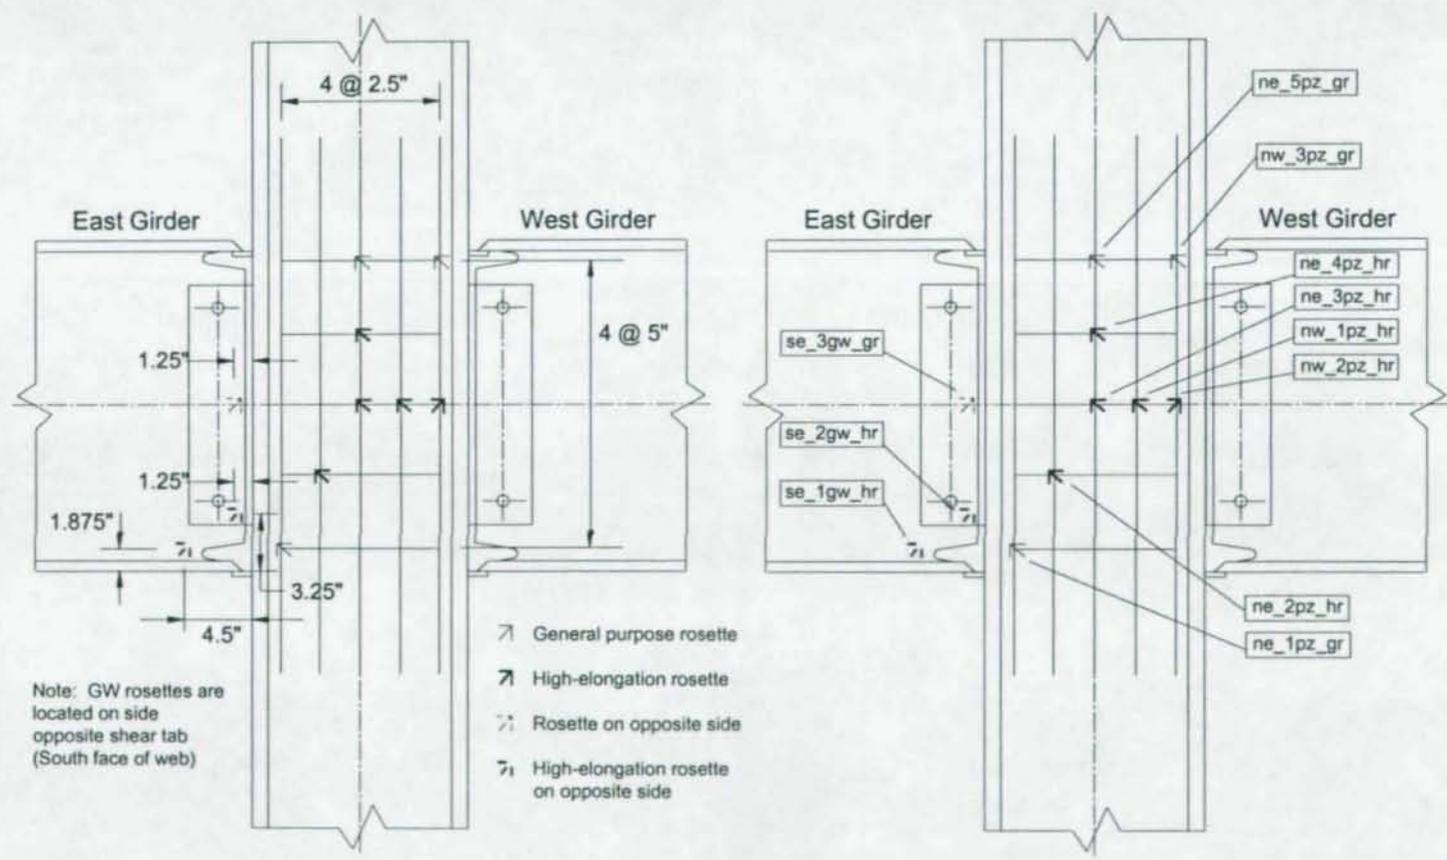
Figure 4.8: Panel Zone and Girder Web Instrumentation for Specimen CR2

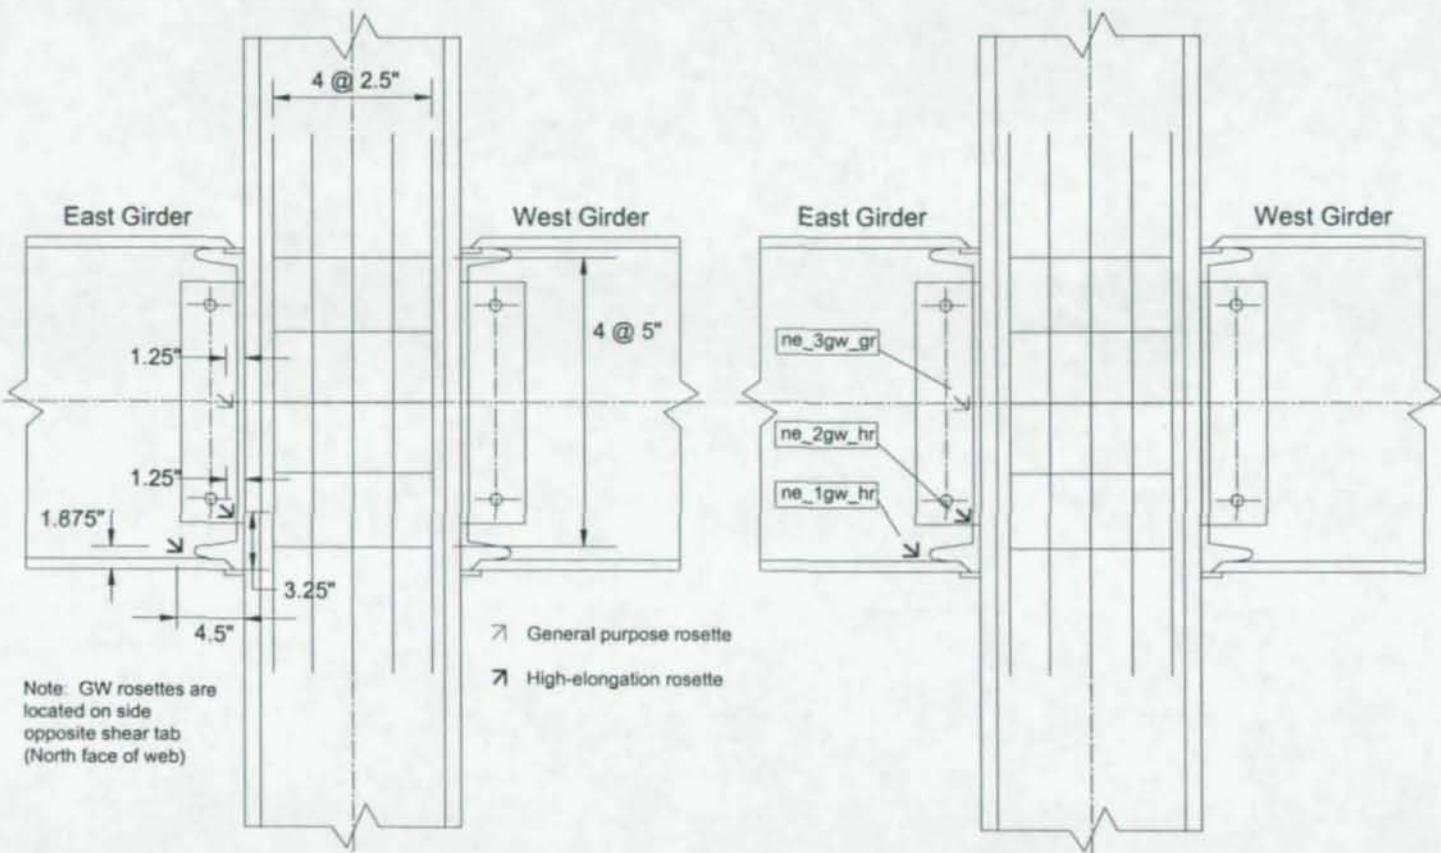
Note: GW rosettes are located on side opposite shear tab (North face of web)

Figure 4.10: Panel Zone and Girder Web Instrumentation for Specimen CR3

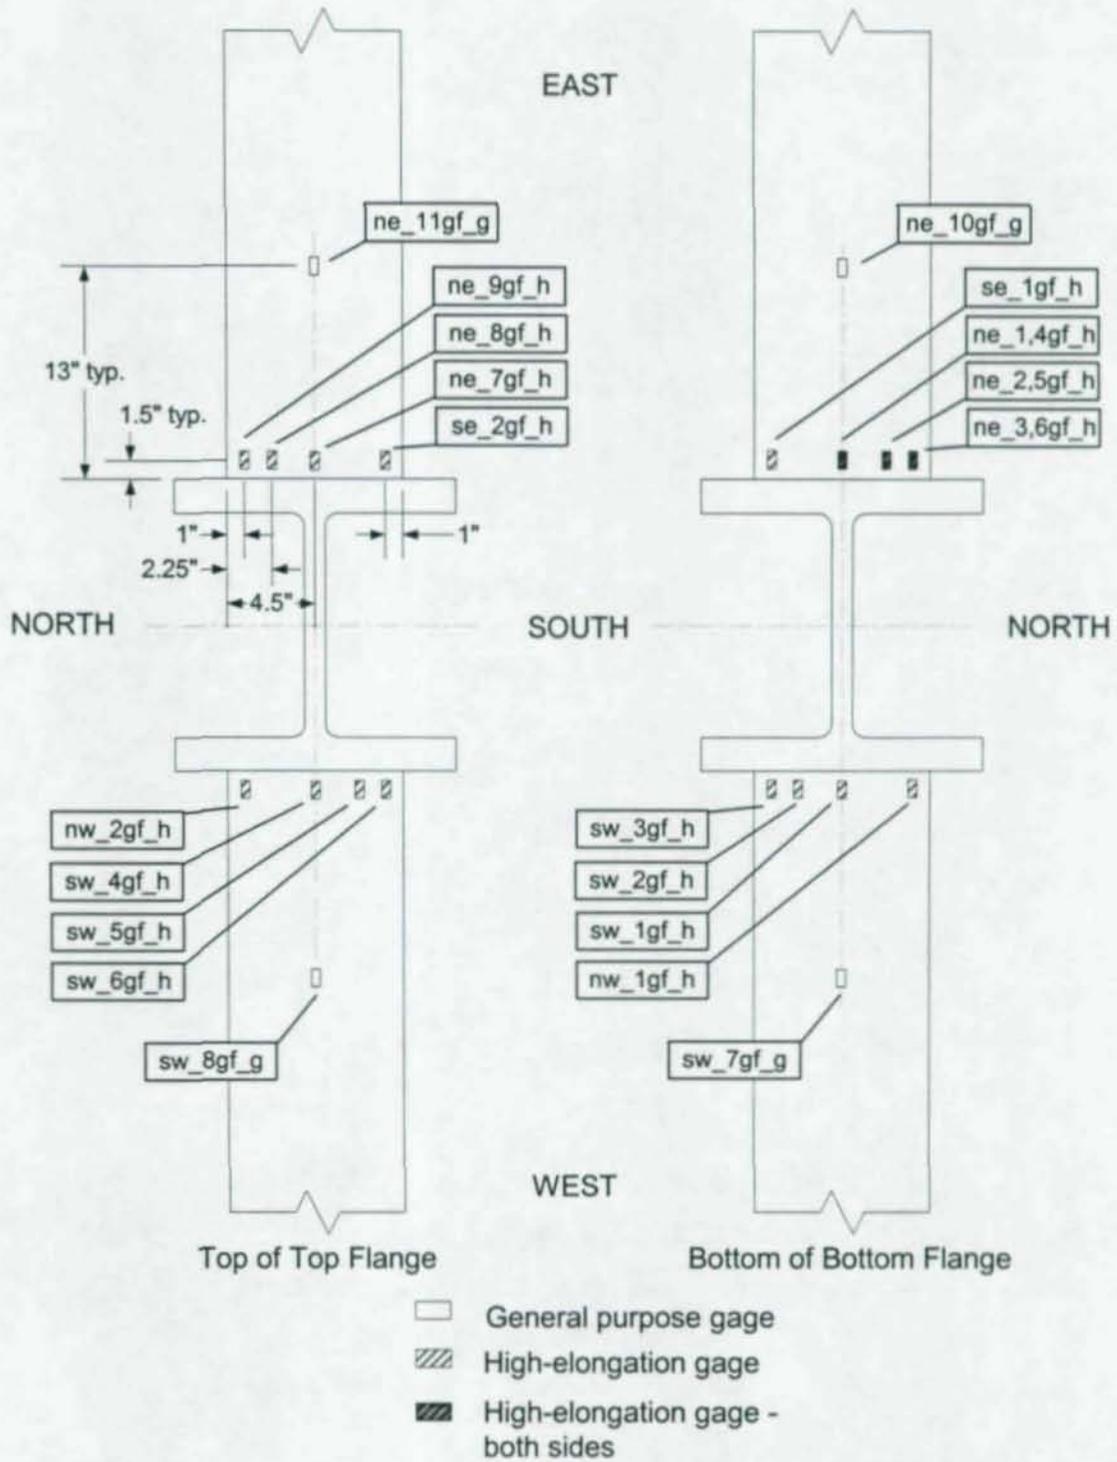
Figure 4.17: Location and Labels of Girder Flange Strain Gages for All Specimens

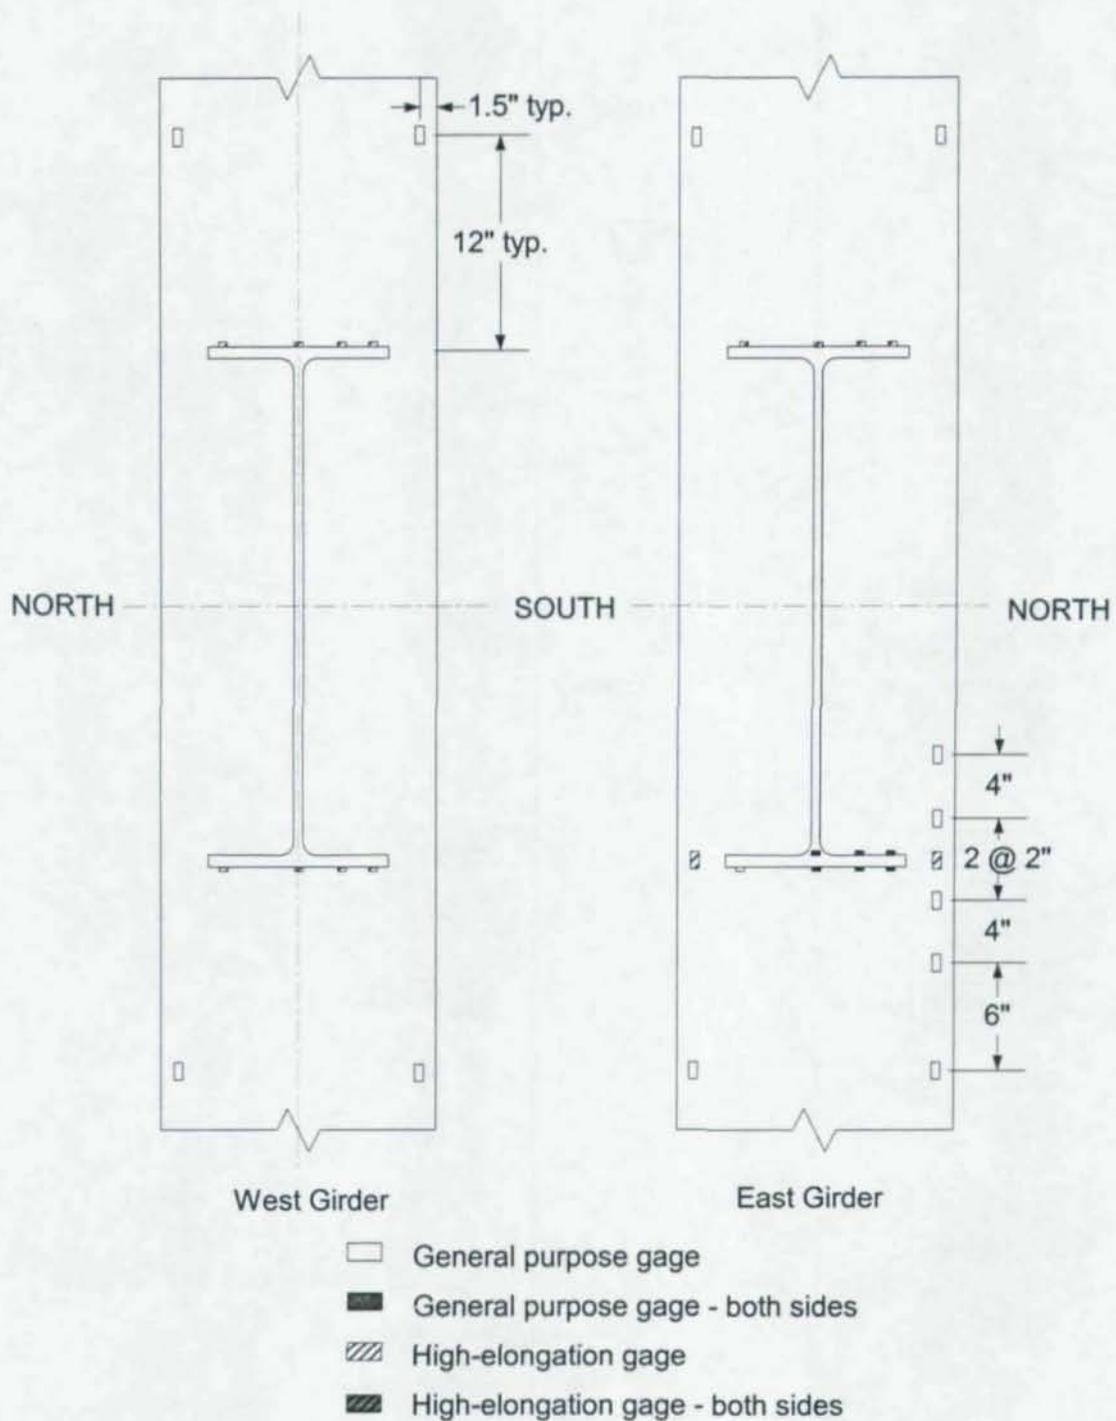
**Figure 4.18:** Location of Column Flange Strain Gages for All Specimens

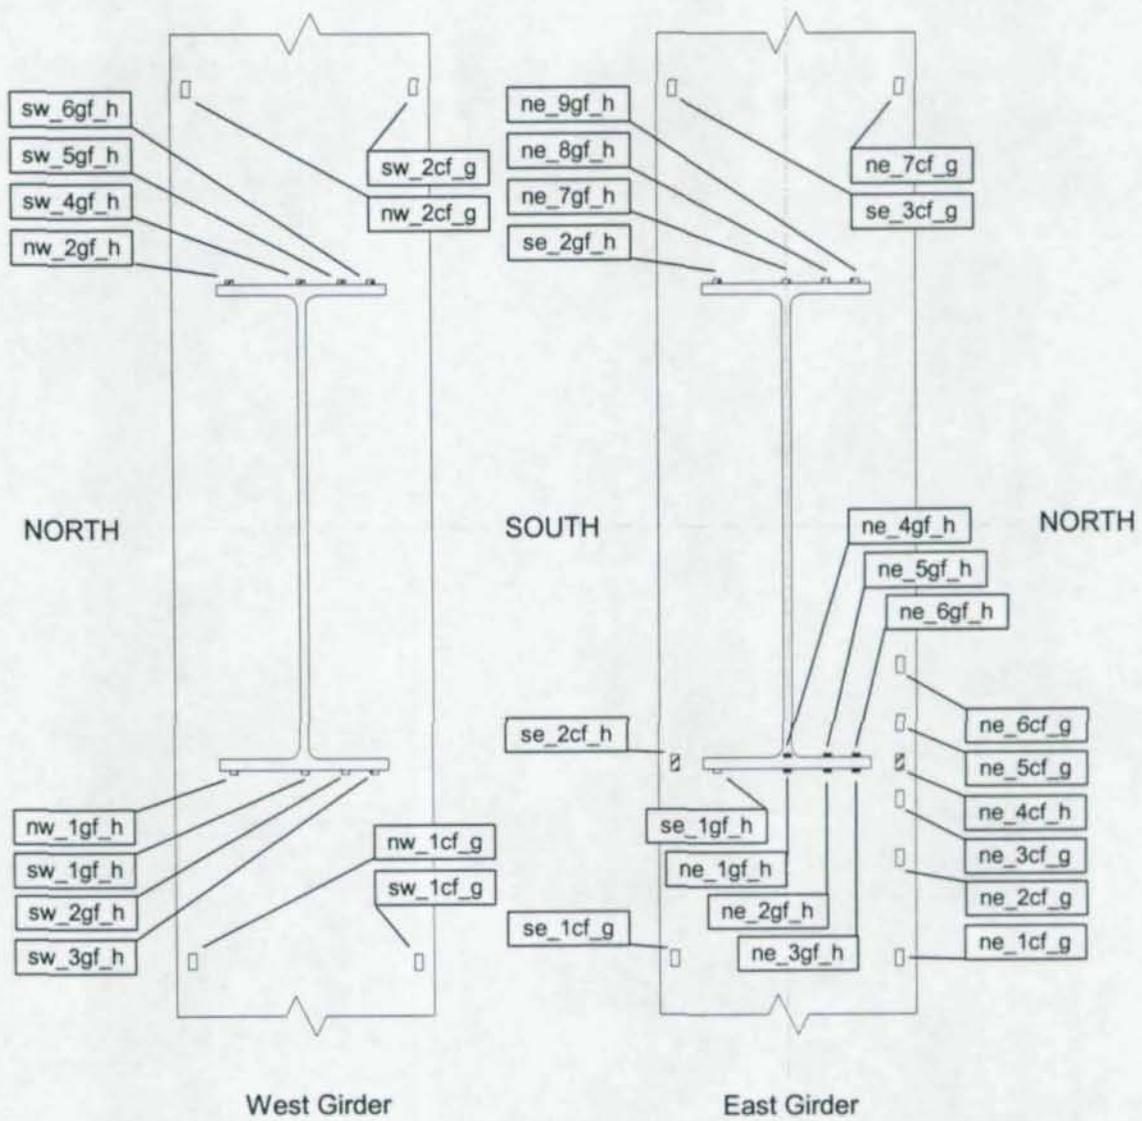
Figure 4.19: Strain Gage Labels for Girder and Column Flanges of All Specimens

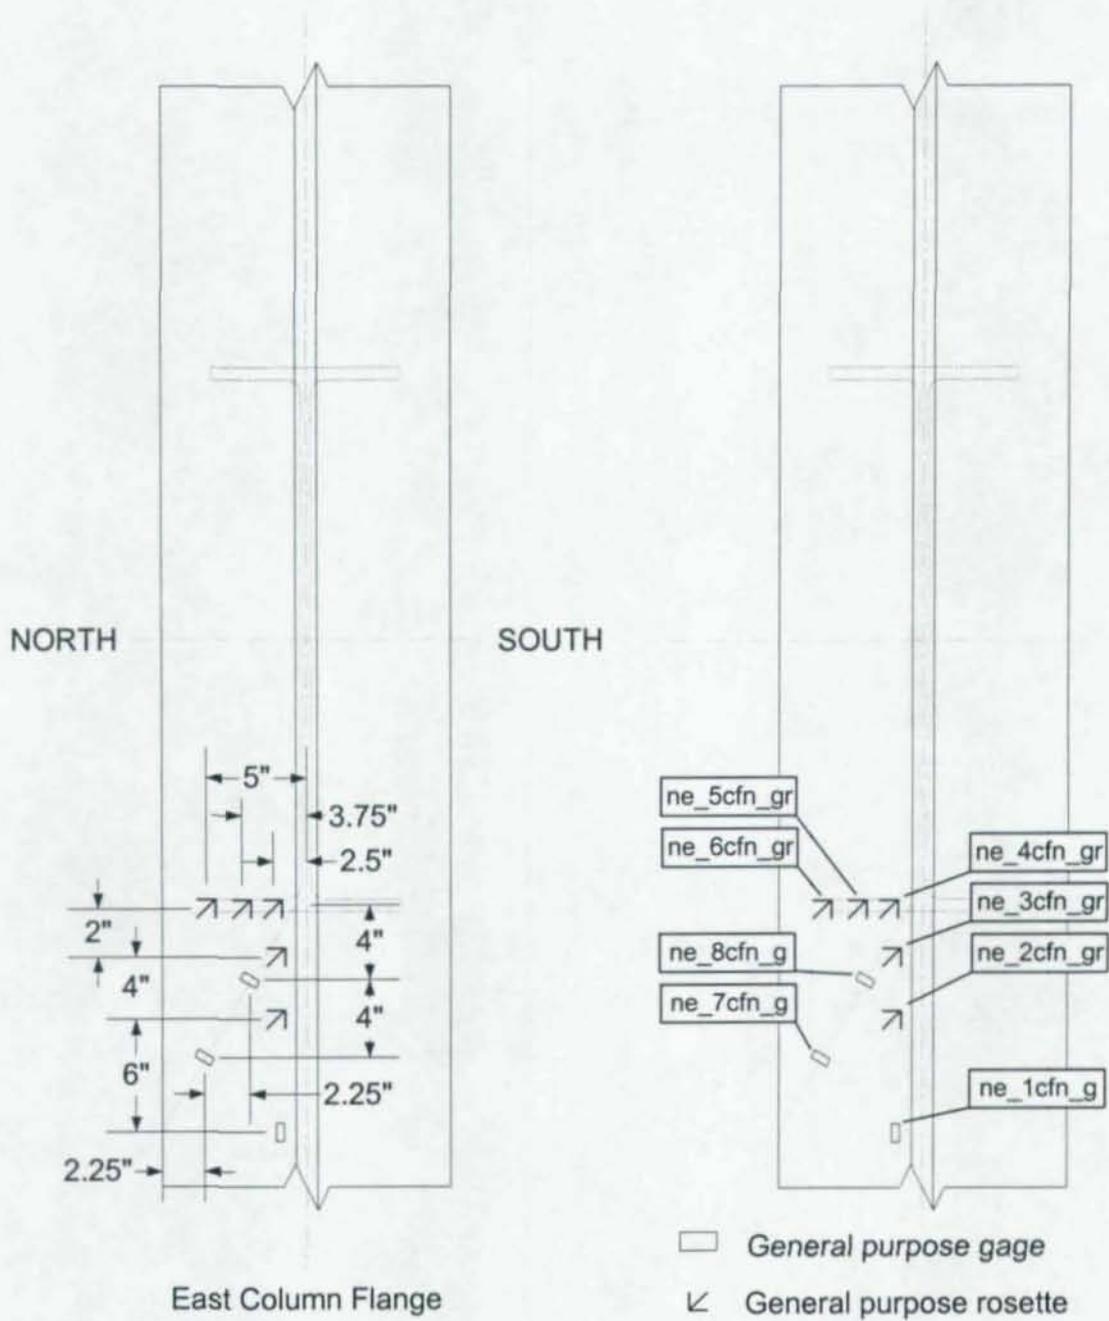
**Figure 4.20:** CFN Group Strain Gages for Specimens CR1, CR2, and CR5

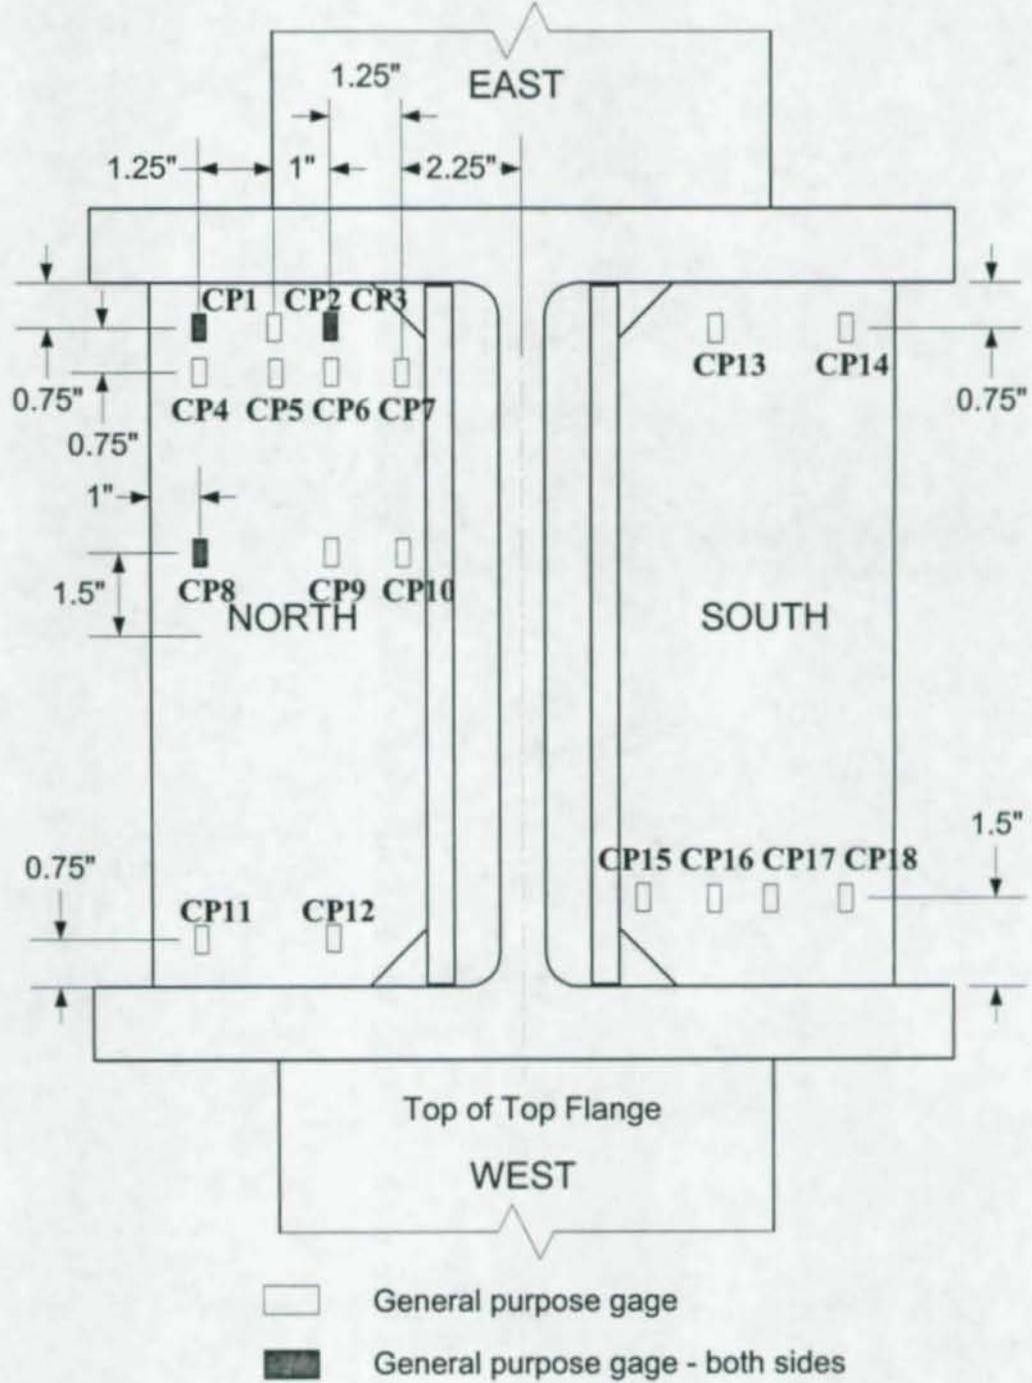
Figure 4.21: Continuity Plate Instrumentation for Specimen CR3

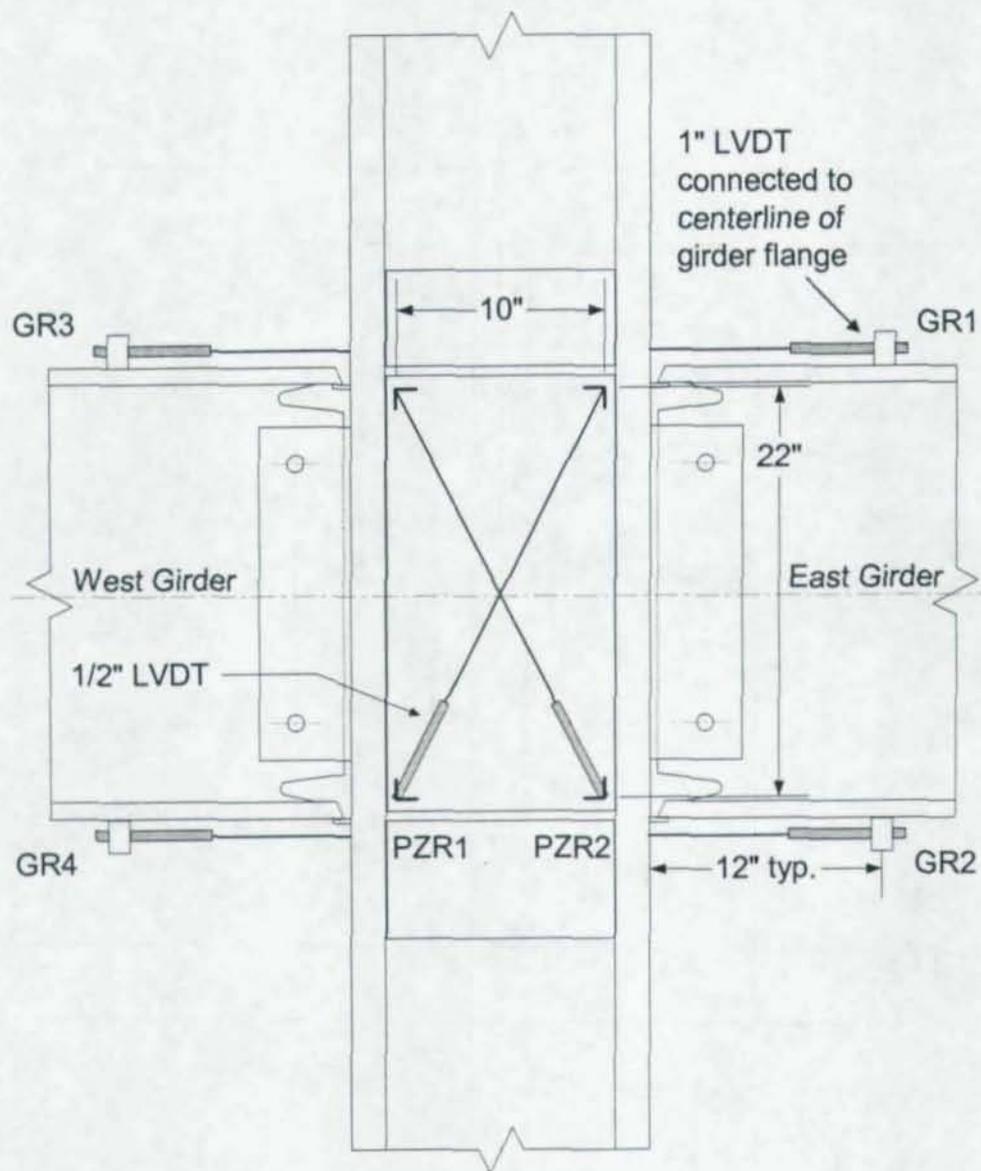
**Figure 4.22:** Girder and Panel Zone LVDT Placement for All Specimens

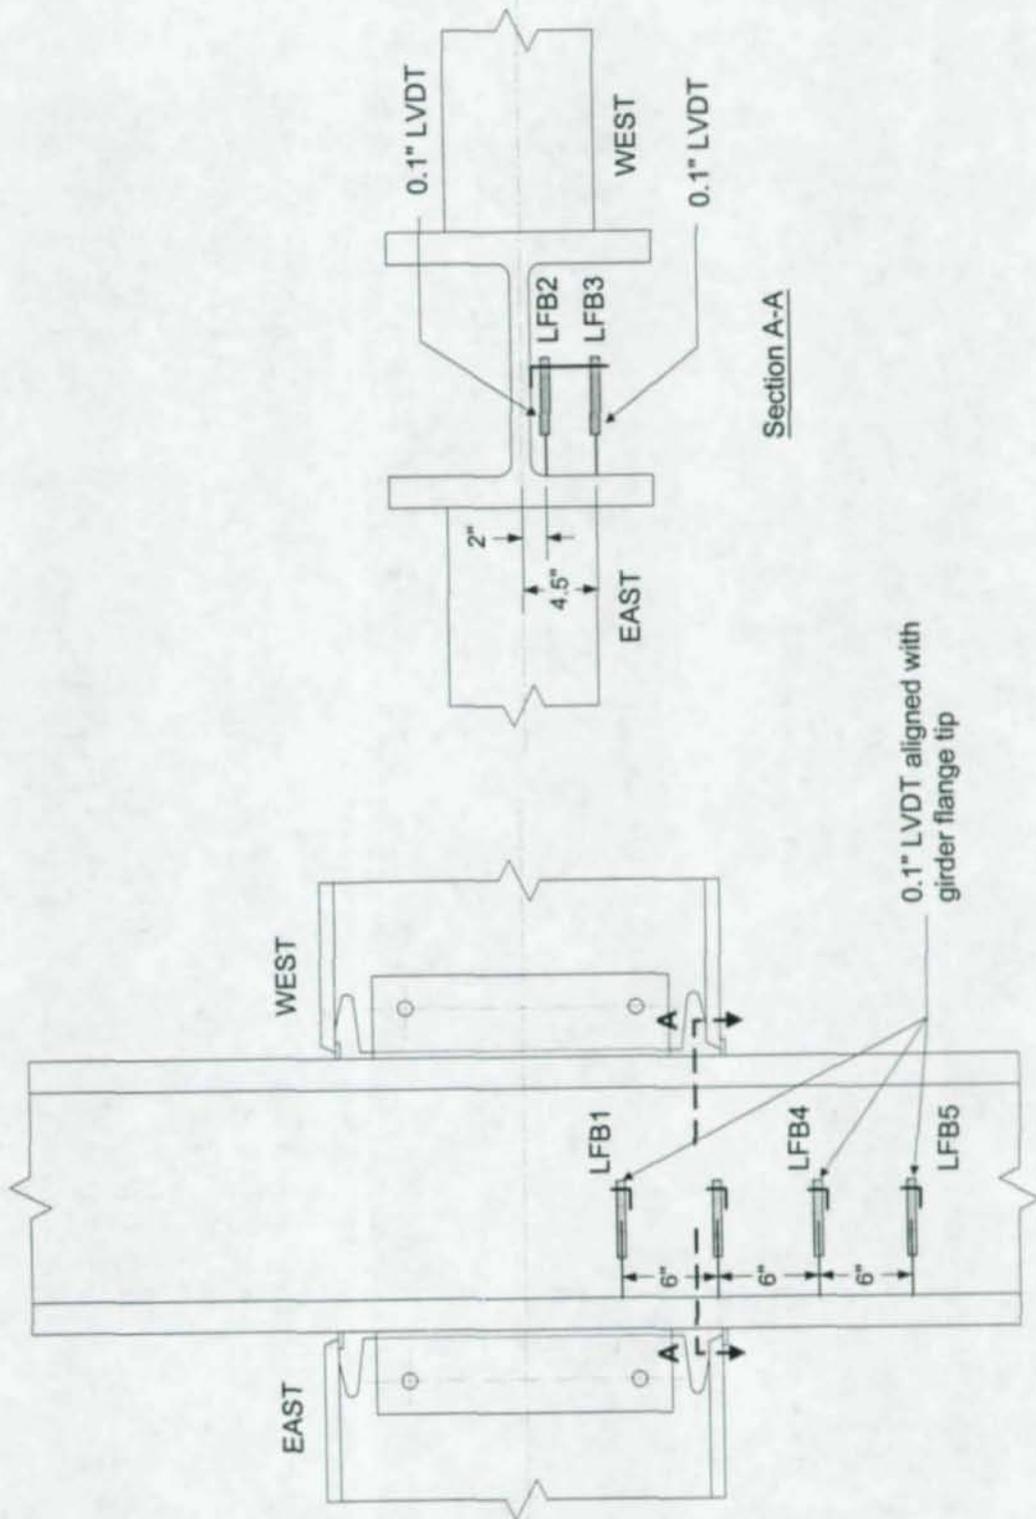
Figure 4.23: Column Flange LVDT Placement for Specimens CR1, CR2, and CR5

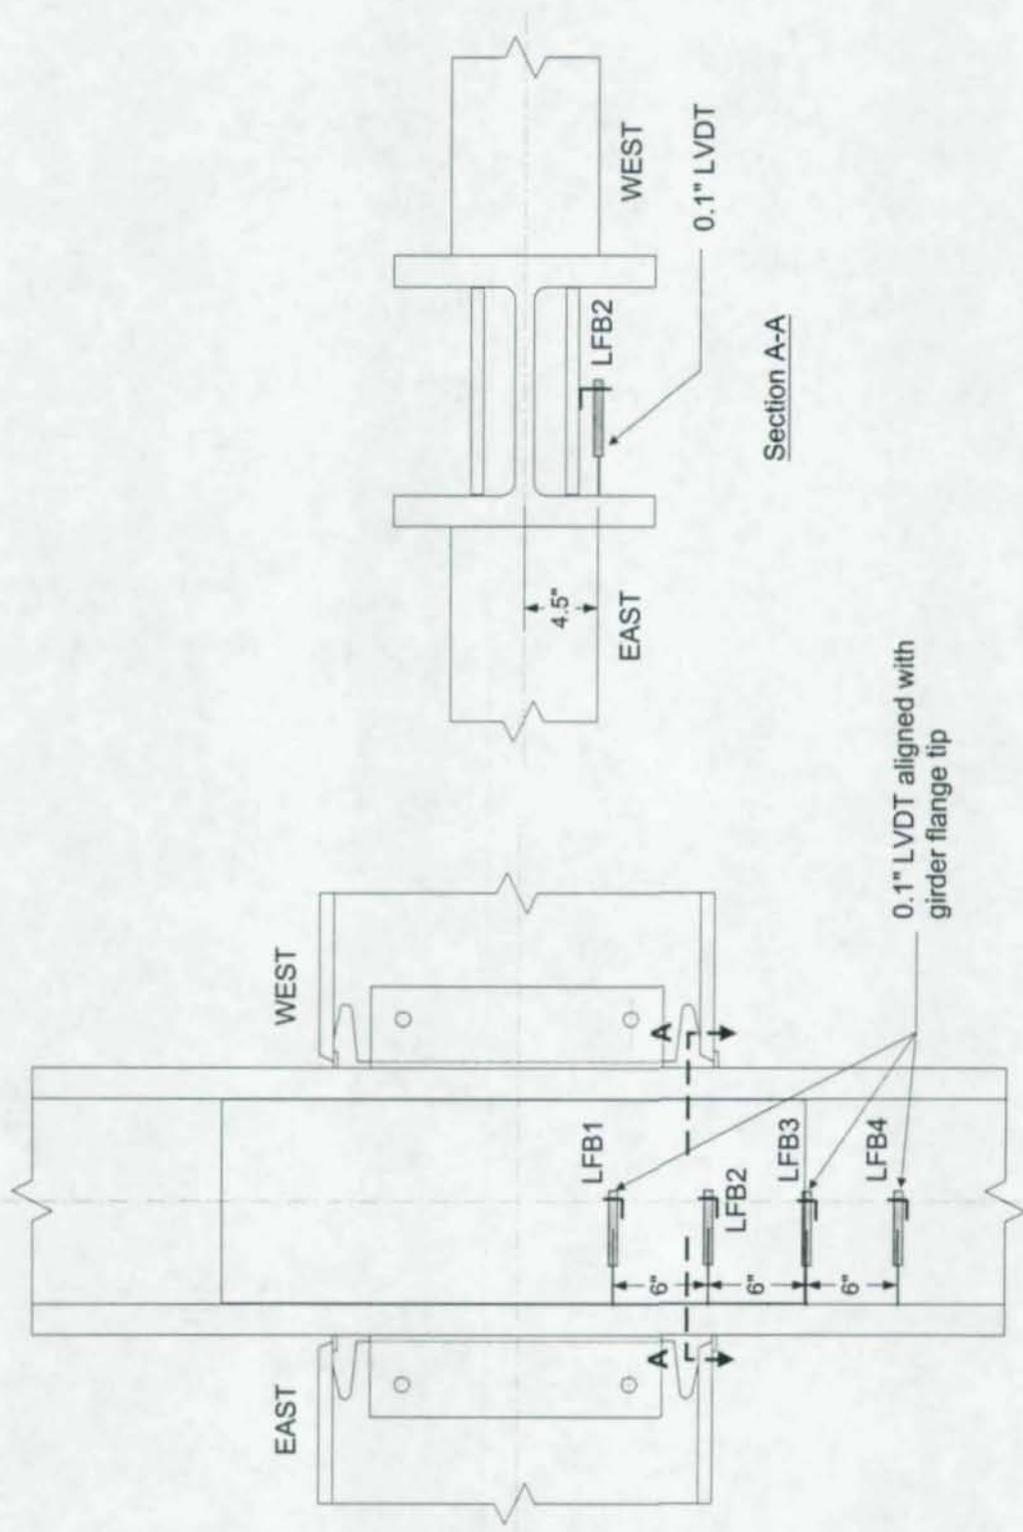
Figure 4.24: Column Flange LVDT Placement for Specimens CR4 and CR4R
