**Structural Engineering Report No. ST-01-3.2**

**COLUMN STIFFENER DETAILING  
AND PANEL ZONE BEHAVIOR OF  
STEEL MOMENT FRAME CONNECTIONS**

**June 2002**

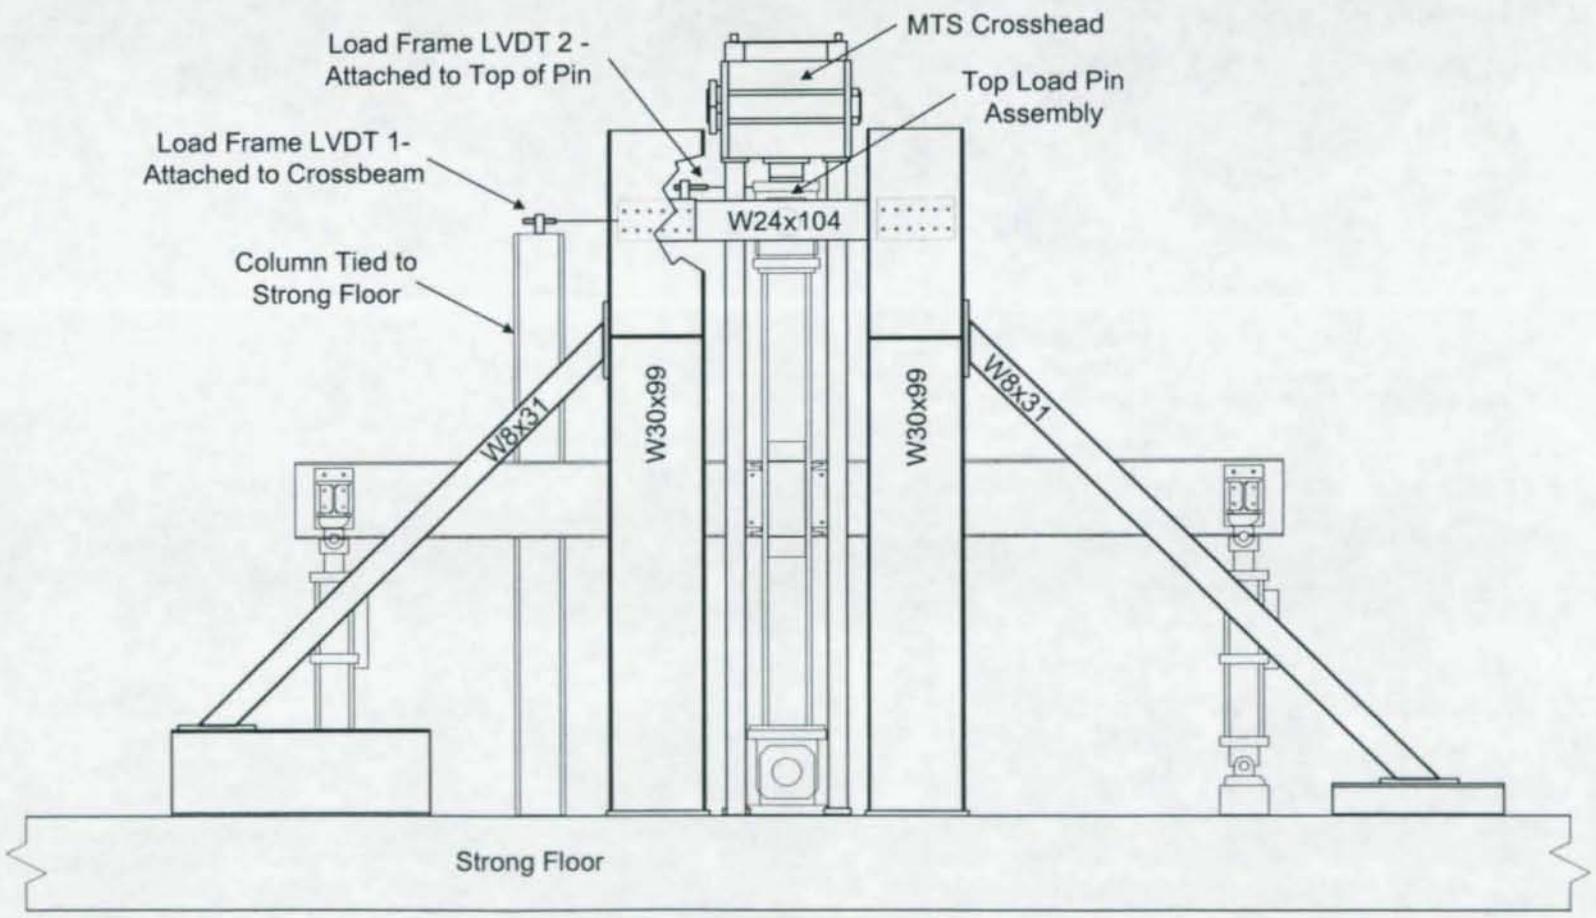
Figure 4.25: Load Frame LVDT Placement

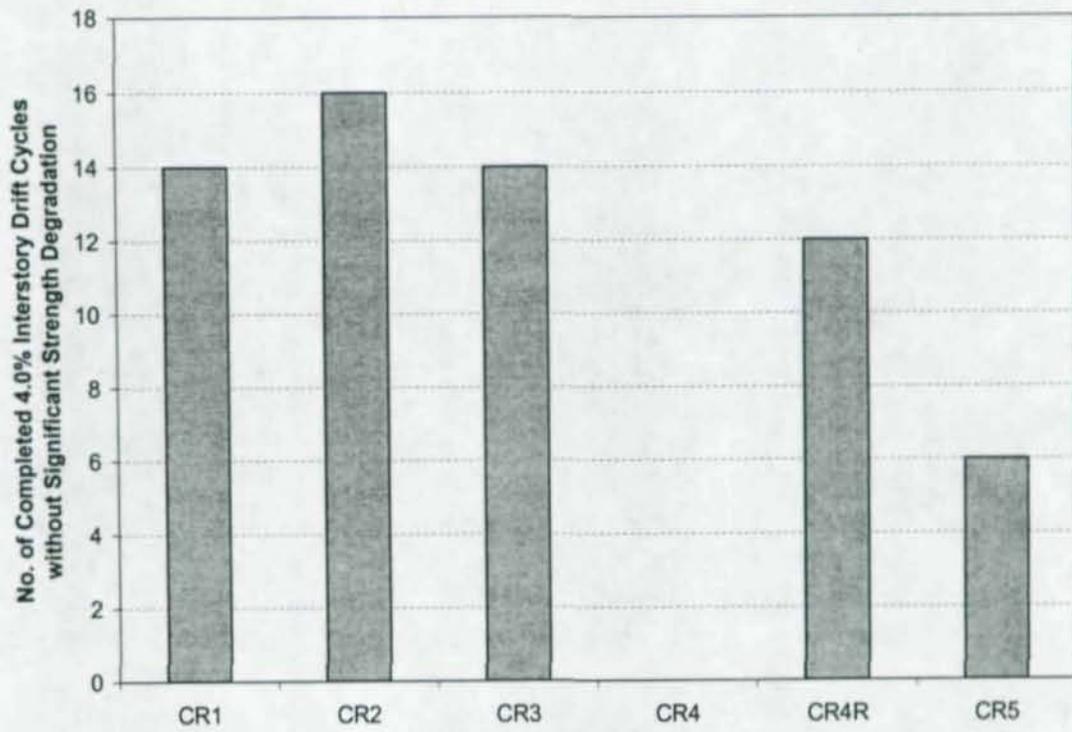
**Figure 5.1:** Number of Completed 4.0% Interstory Drift Cycles without Significant Strength Degradation

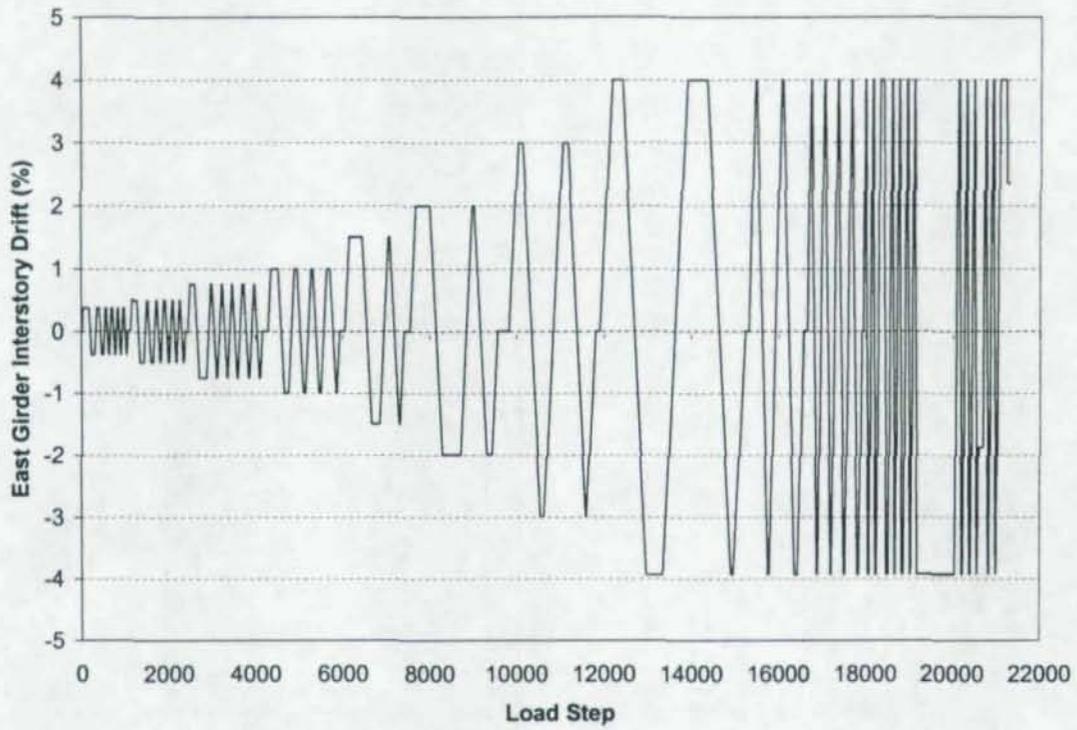
**Figure 5.2:** Displacement History of Specimen CR1

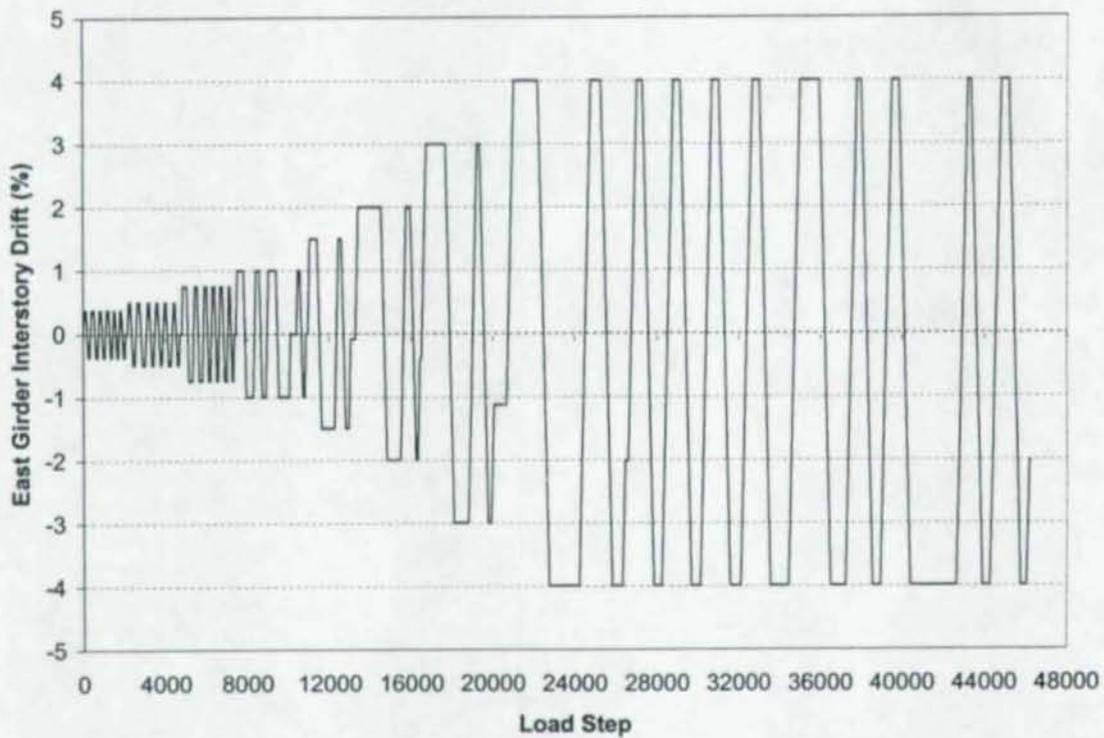
**Figure 5.7:** Displacement History of Specimen CR5

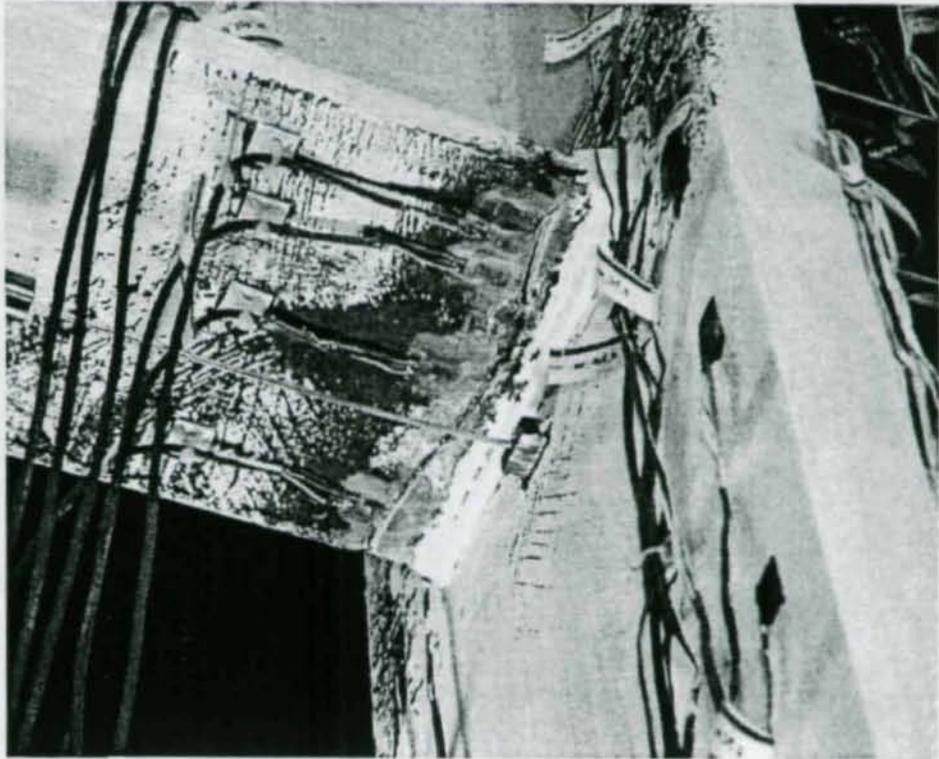
Figure 5.16: Low-Cycle Fatigue Fracture of East Bottom Flange, CR1

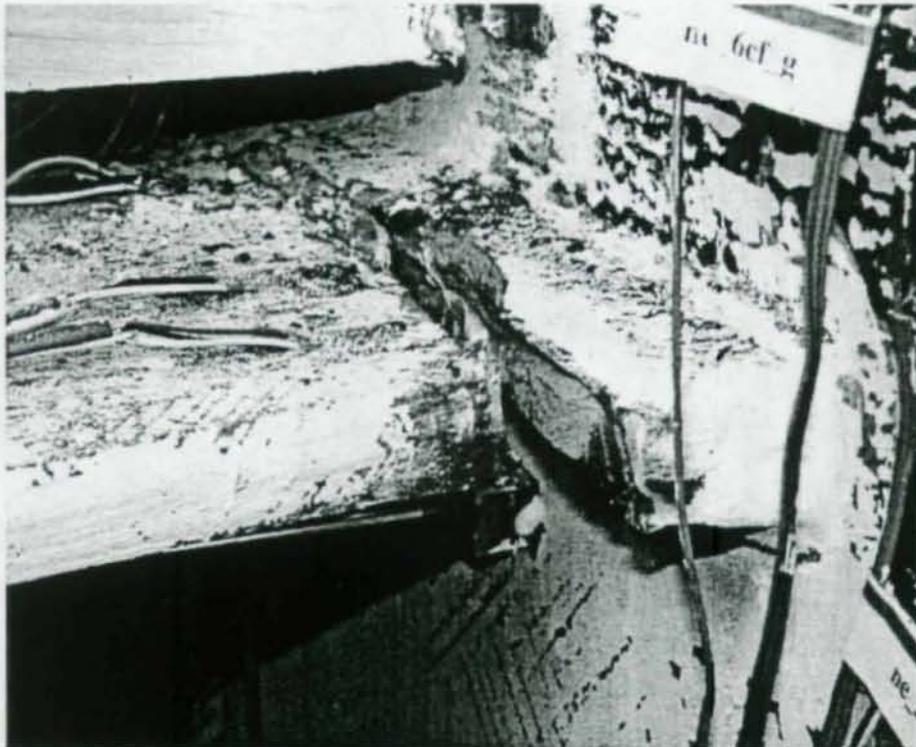
Figure 5.18: East Bottom Flange Fracture Surface After Testing, CR1

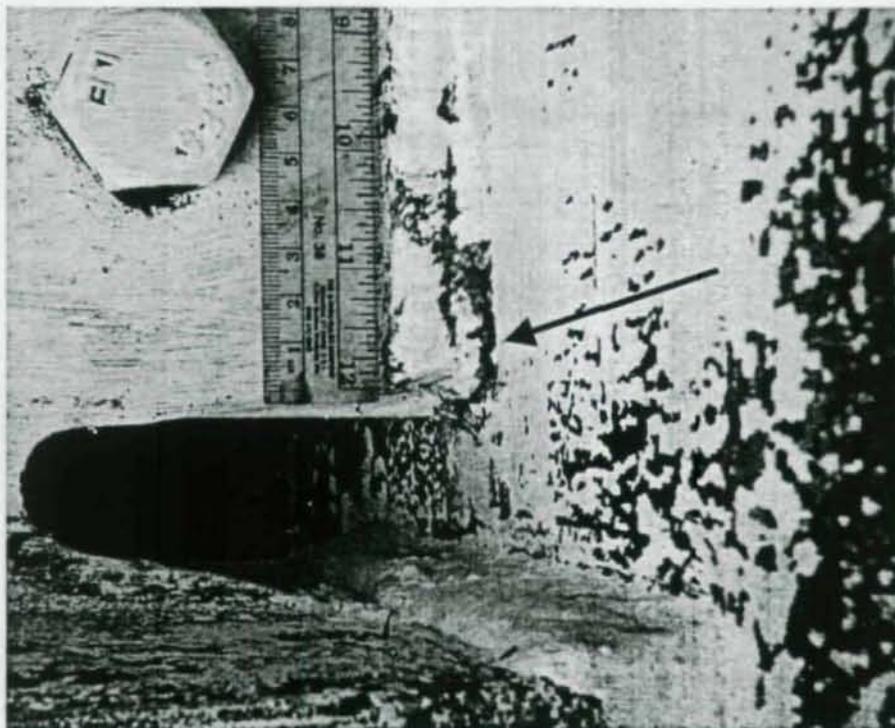
Figure 5.19: Typical Beam Web-to-Column Weld Cracking, CR1

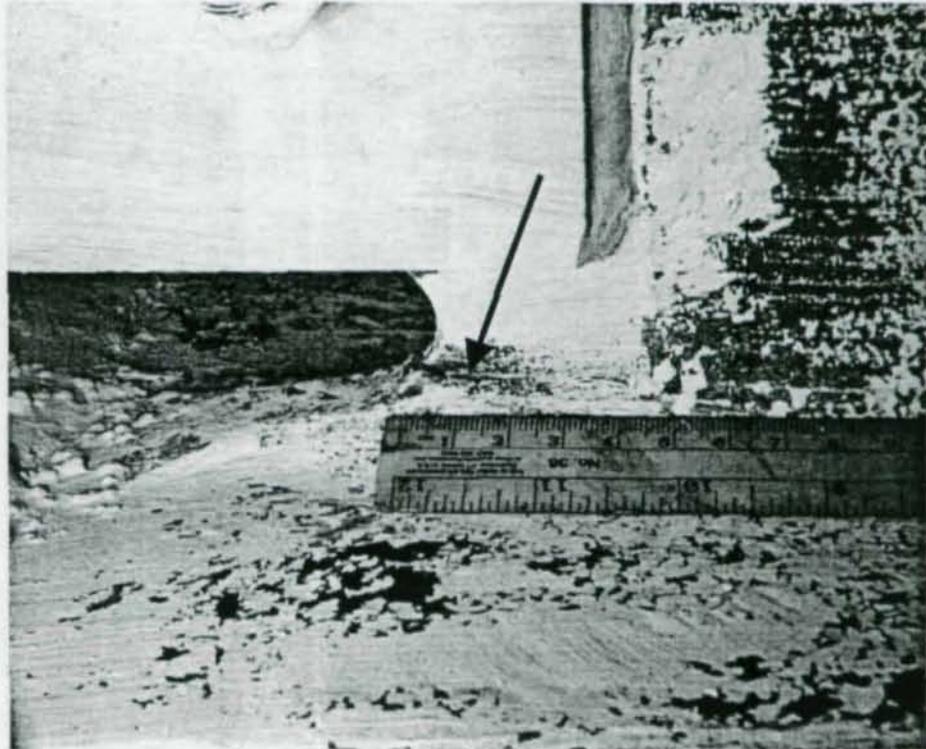
Figure 5.20: Typical Low-Cycle Fatigue Cracking of Access Hole

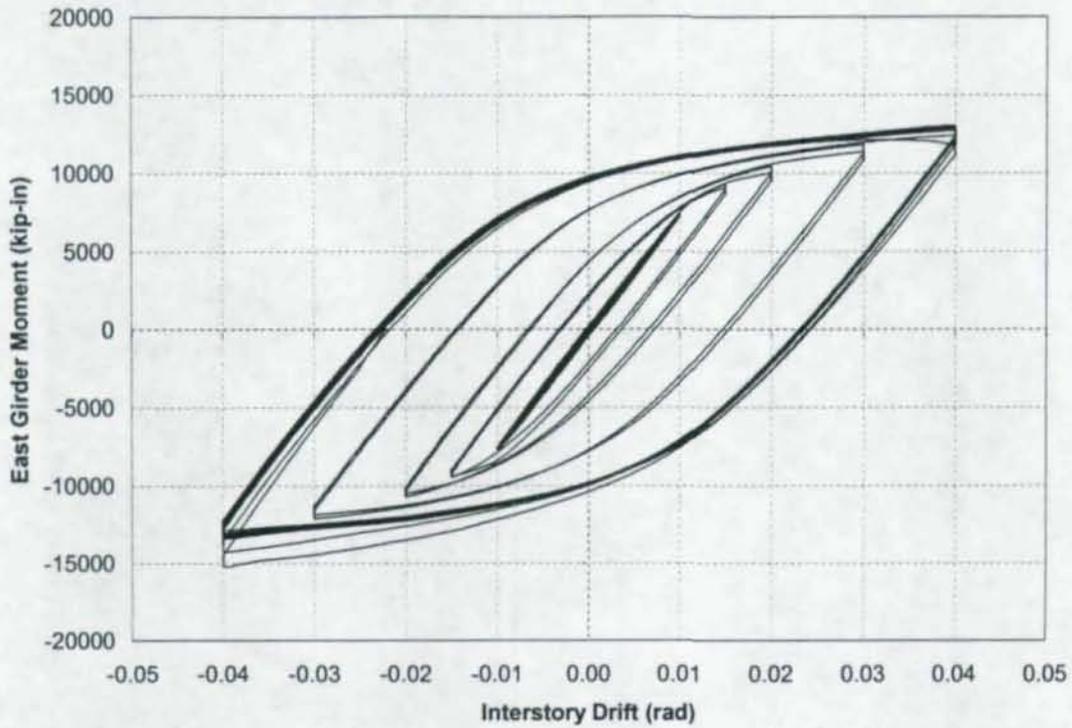
**Figure 5.21:** Moment vs. Interstory Drift for East Girder, CR2

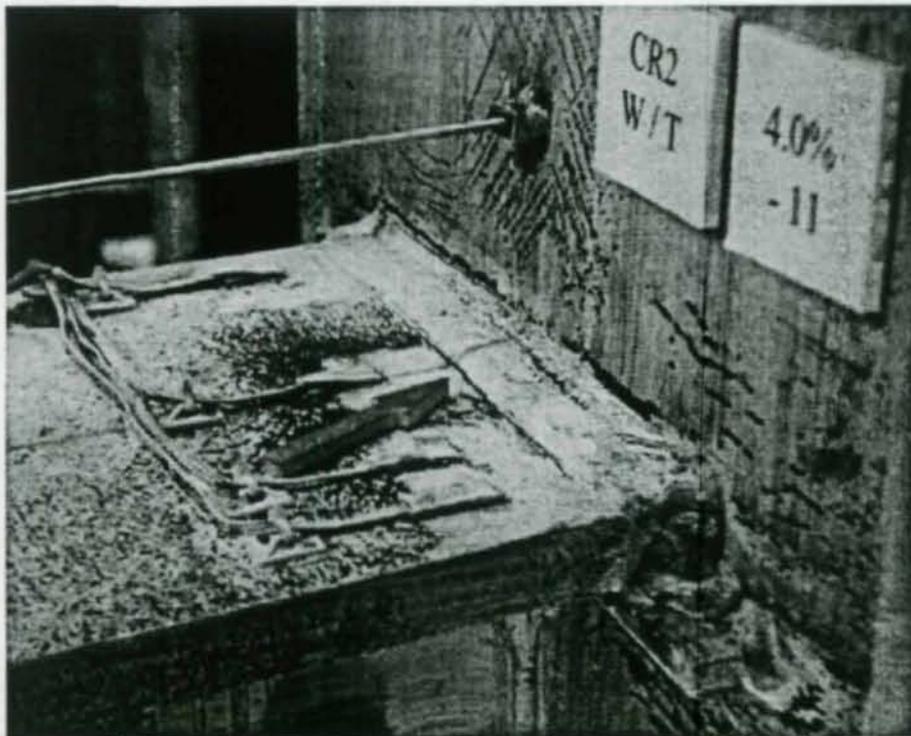
Figure 5.30: Significant Crack Opening in West Top Flange, CR2

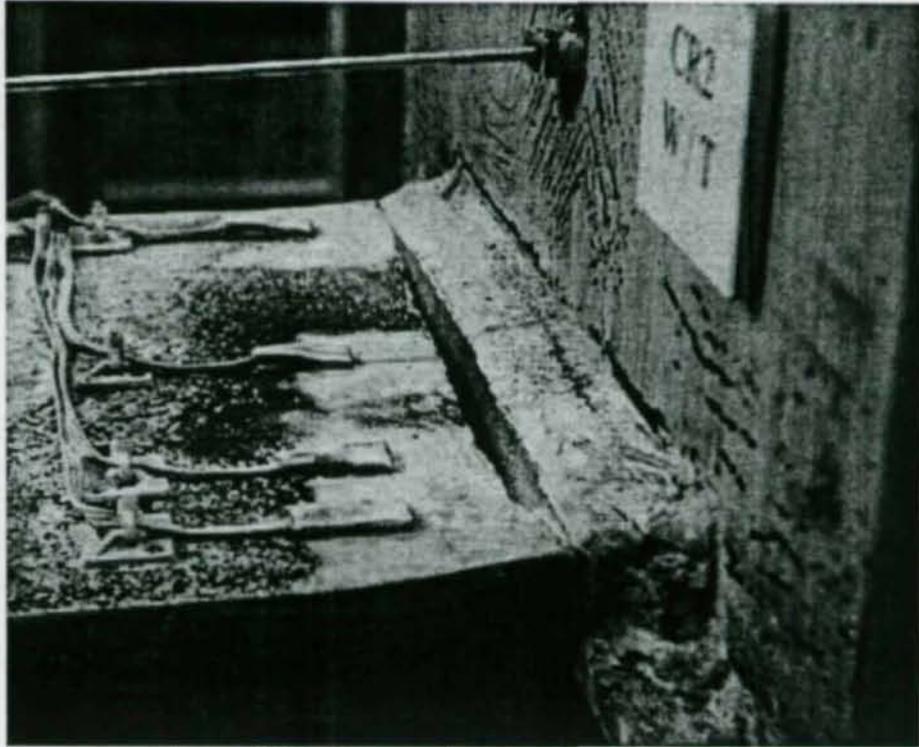
Figure 5.31: Fracture in West Top Flange, CR2

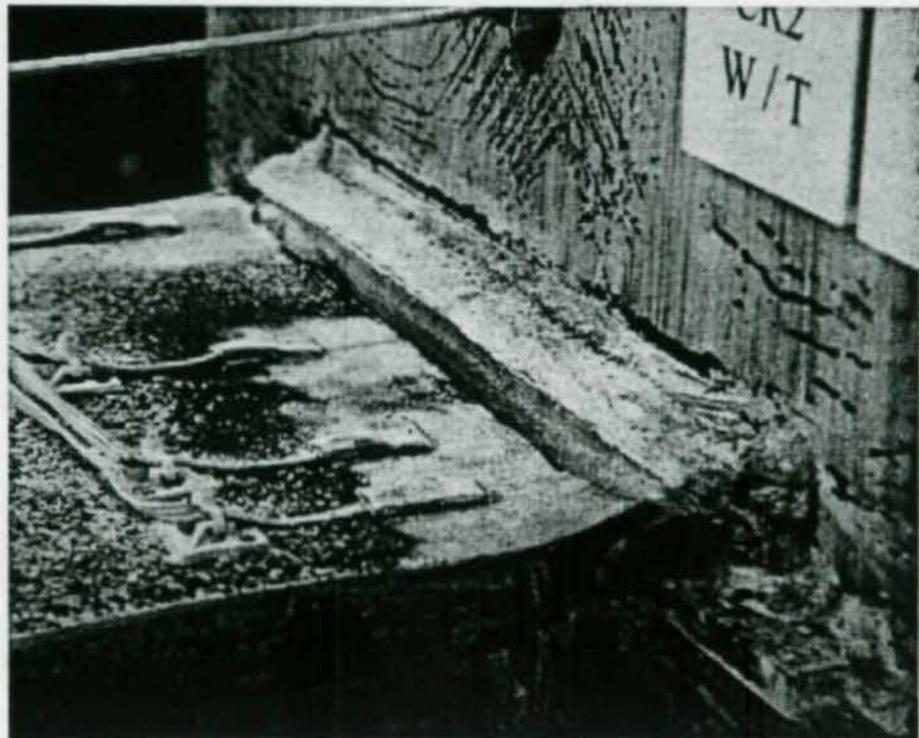
Figure 5.32: Complete Failure of West Top Flange, CR2

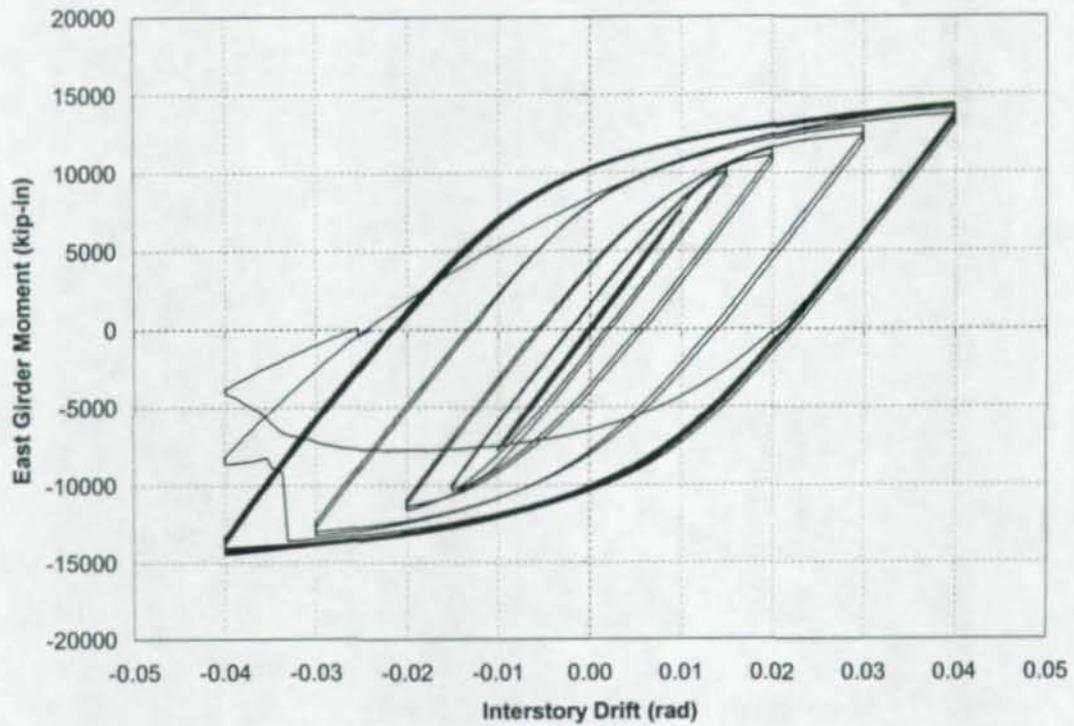
**Figure 5.33:** Moment vs. Interstory Drift for East Girder, CR3

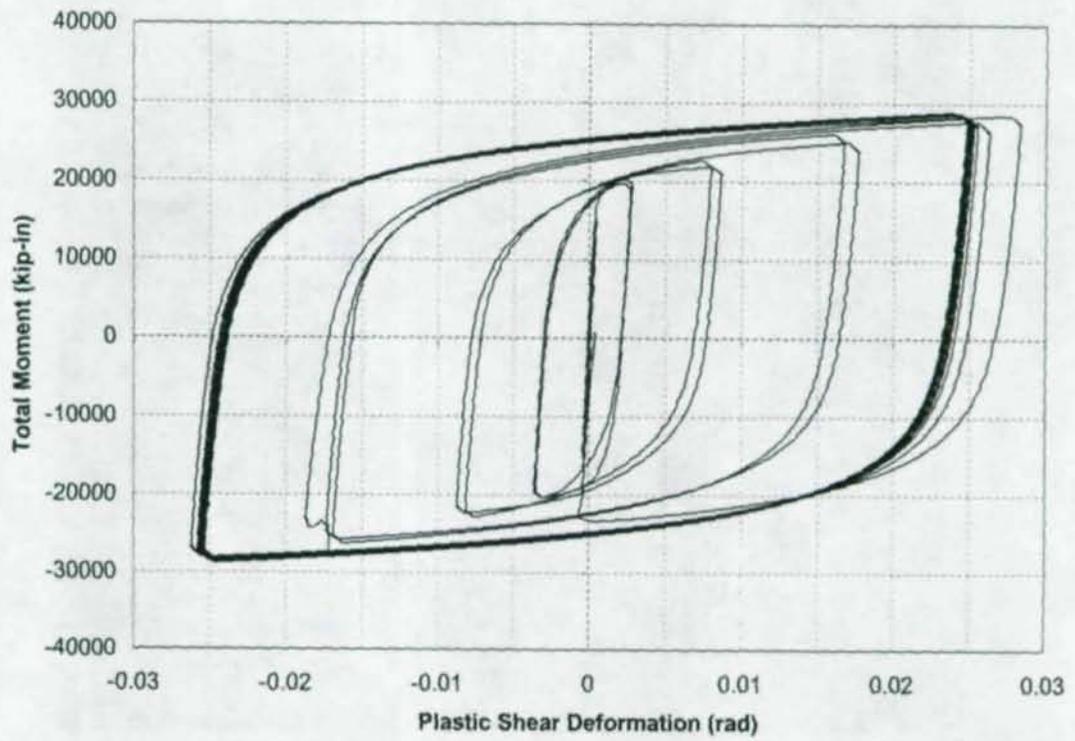
Figure 5.39: Panel Zone Plastic Shear Deformation, CR3

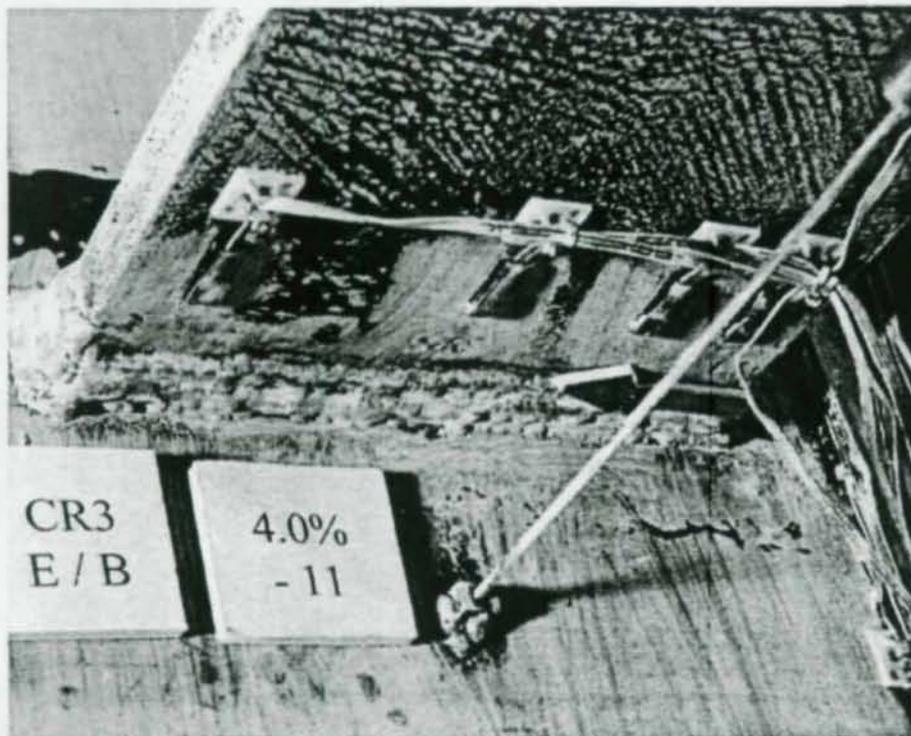
Figure 5.42: Crack Opening in East Bottom Flange, CR3

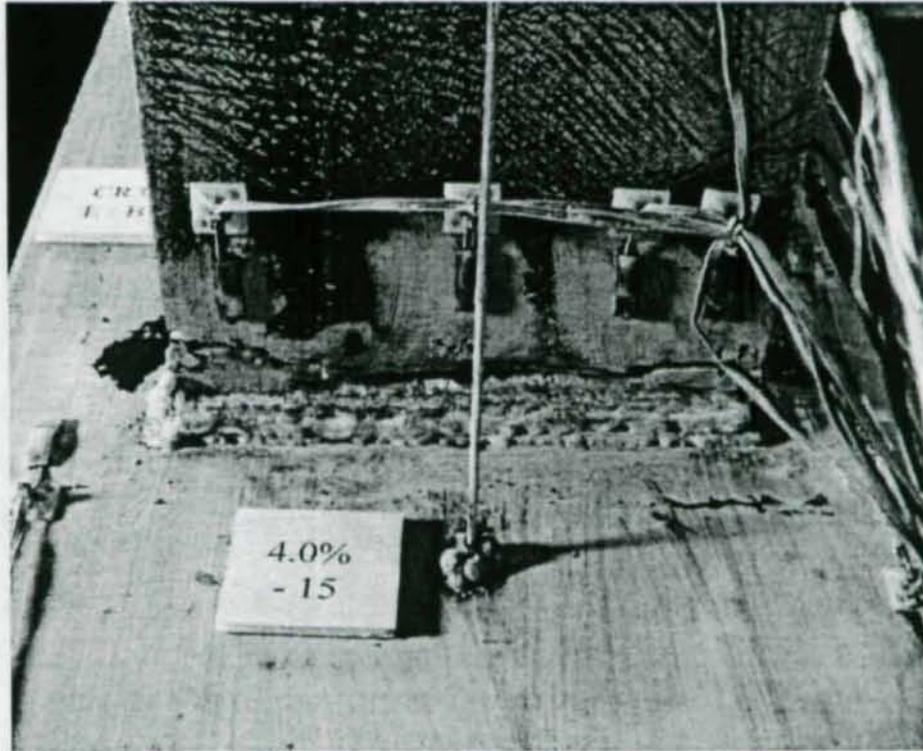
Figure 5.43: Fracture in East Bottom Flange, CR3

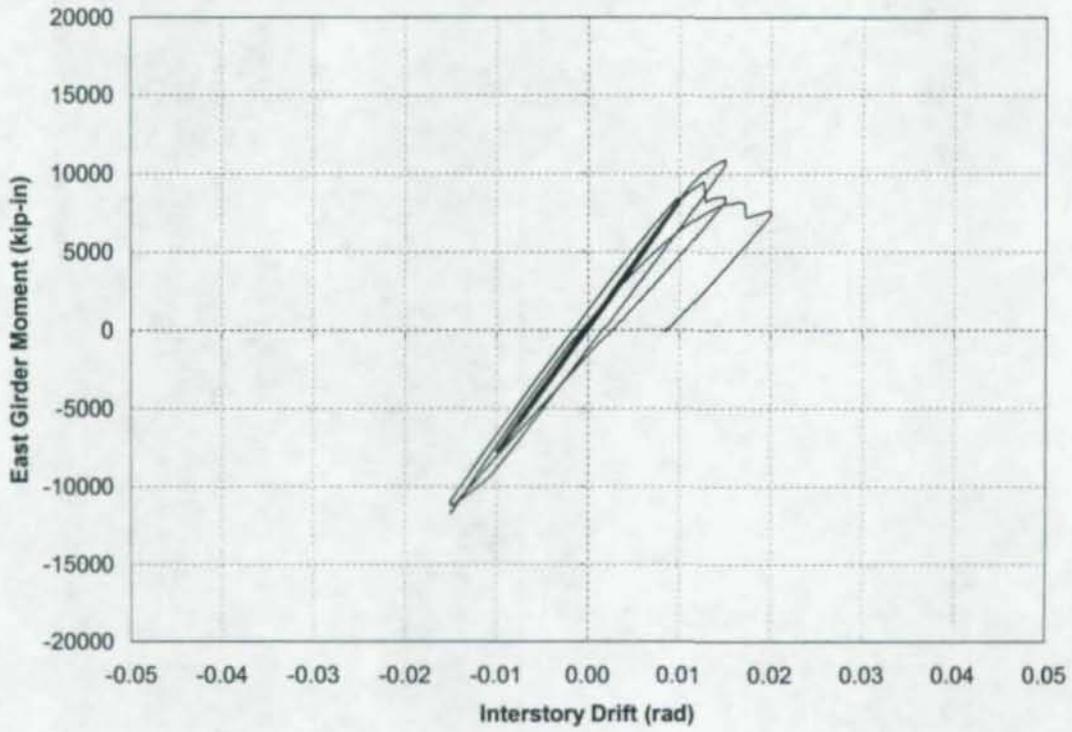
**Figure 5.44: Moment vs. Interstory Drift for East Girder, CR4**

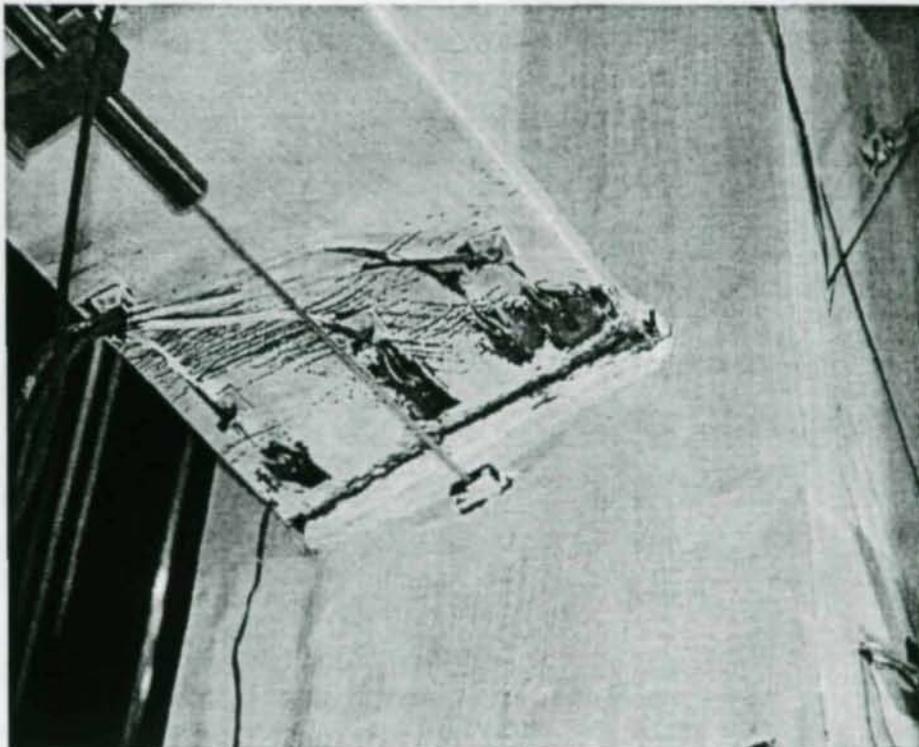
Figure 5.54: Fracture of West Bottom Flange, CR4

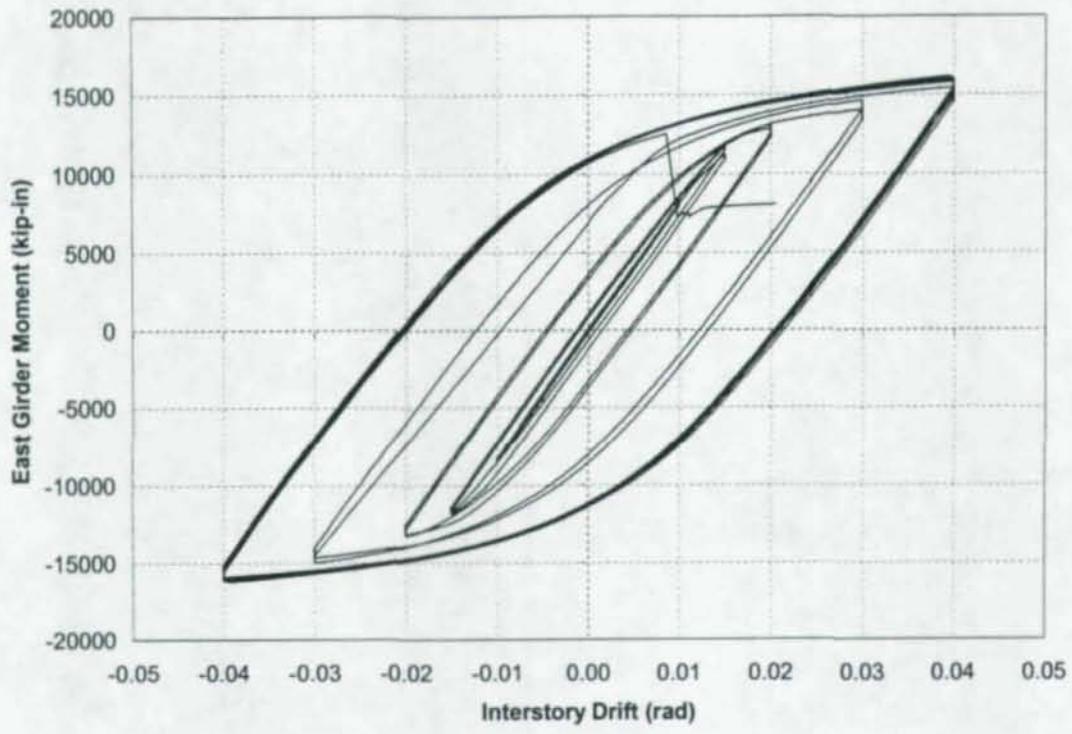
**Figure 5.55:** Moment vs. Interstory Drift for East Girder, CR4R

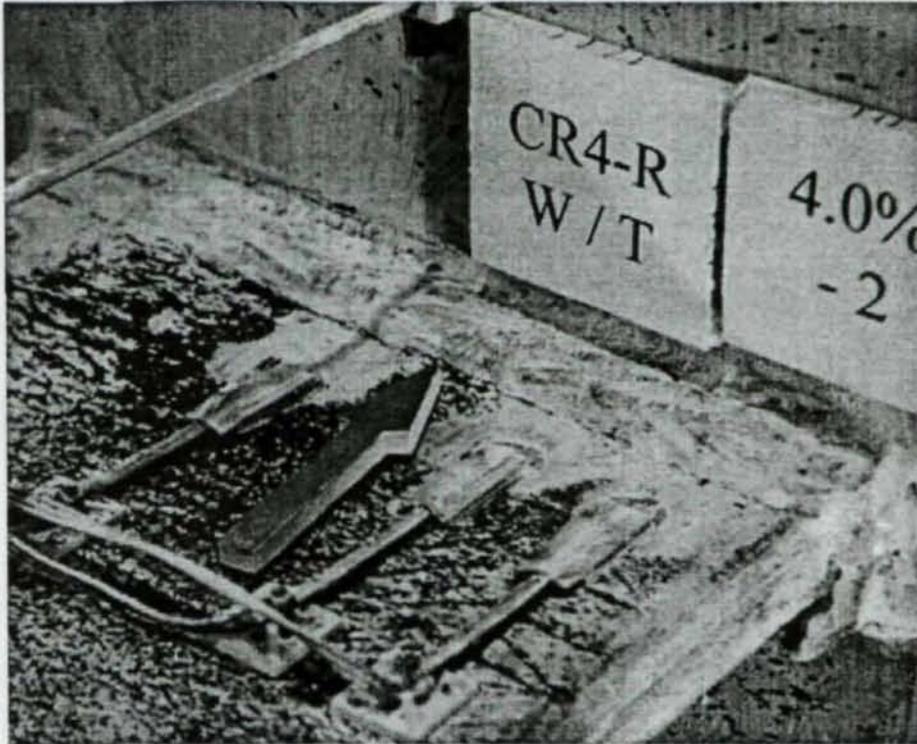
**Figure 5.63:** Through-Width Line Crack on West Girder Top Flange, CR4R

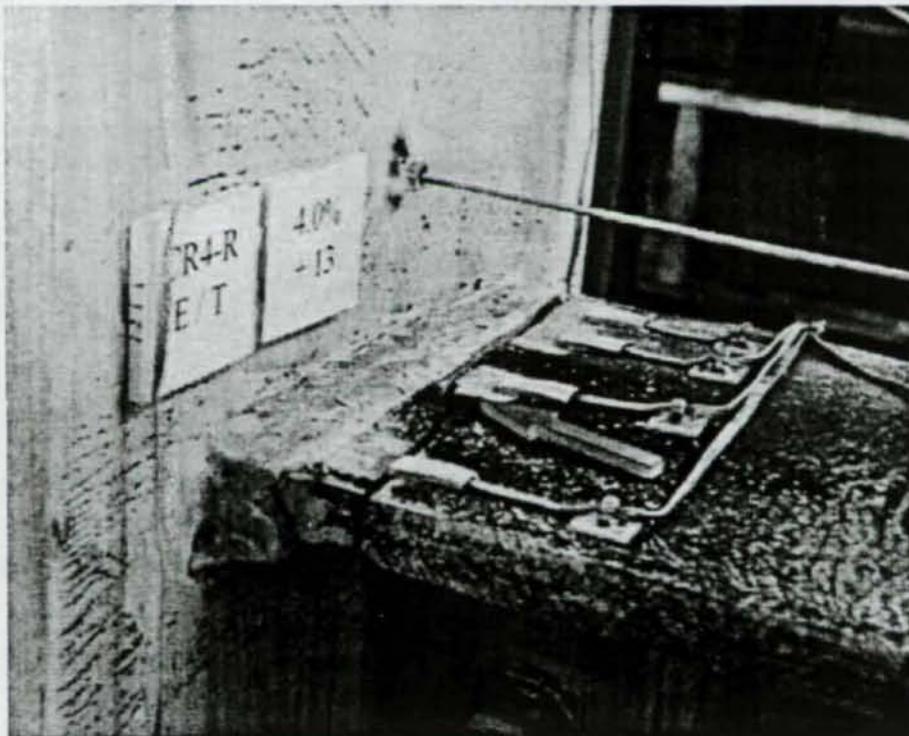
**Figure 5.64:** Fracture of East Girder Top Flange, CR4R

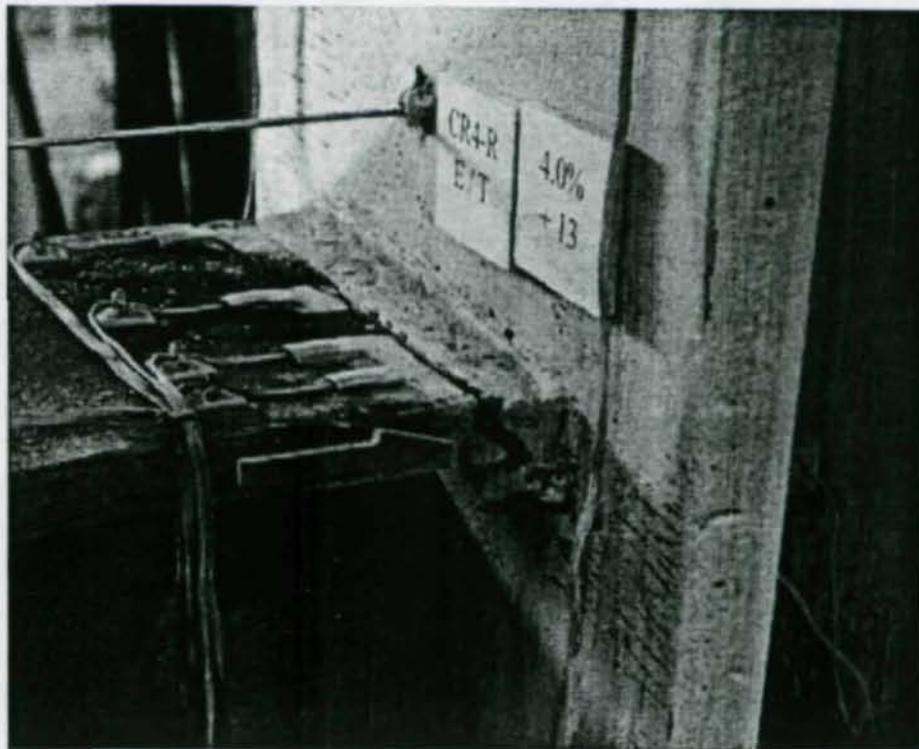
Figure 5.65: Crack following Bevel of the Base Metal at East Girder Top Flange. CR4R

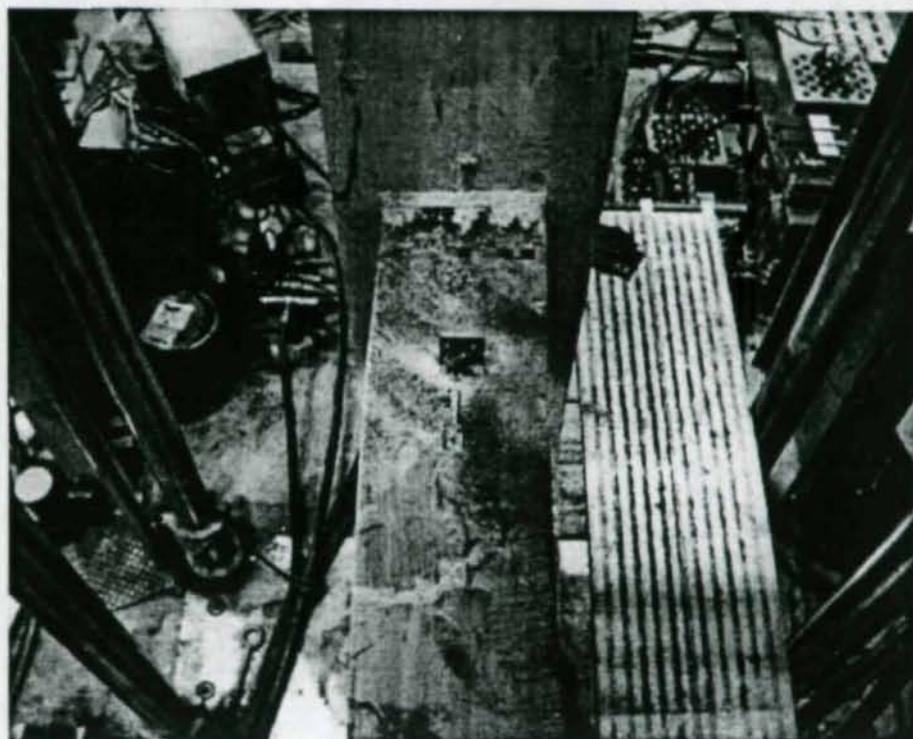
Figure 5.66: Lateral-Torsional Buckling in the West Girder, CR4R

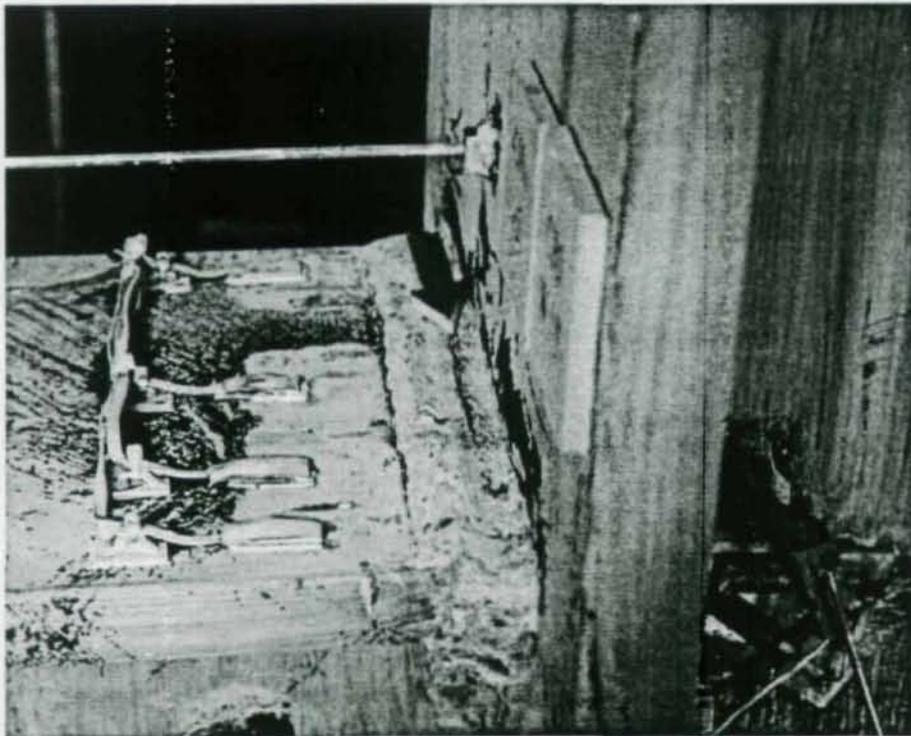
Figure 5.76: Crack Opening in West Girder Top Flange, CR5

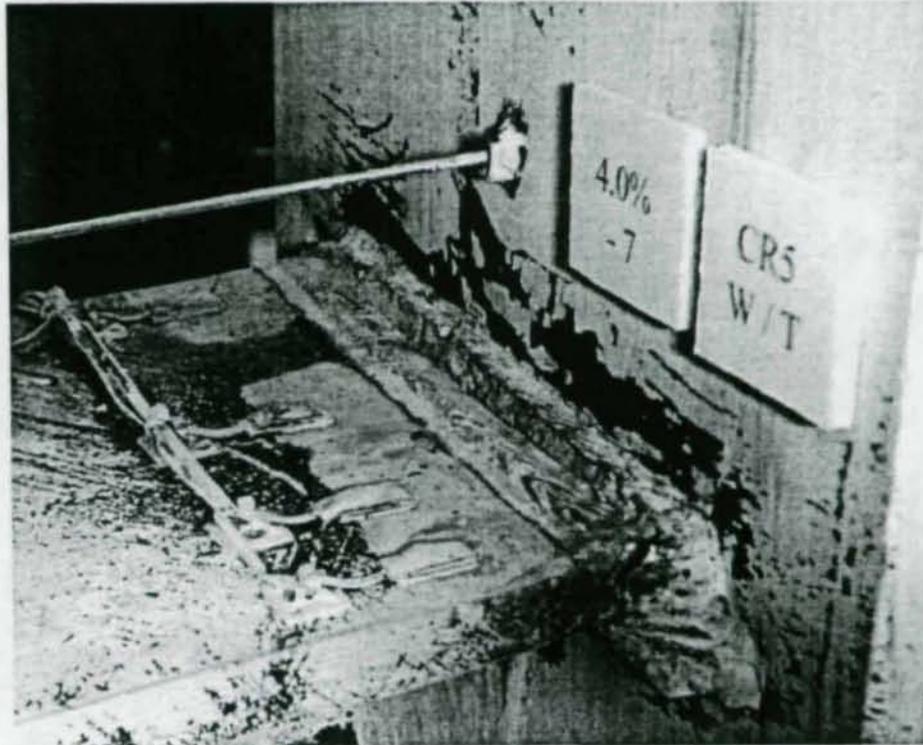
Figure 5.77: Fracture in West Girder Top Flange, CR5

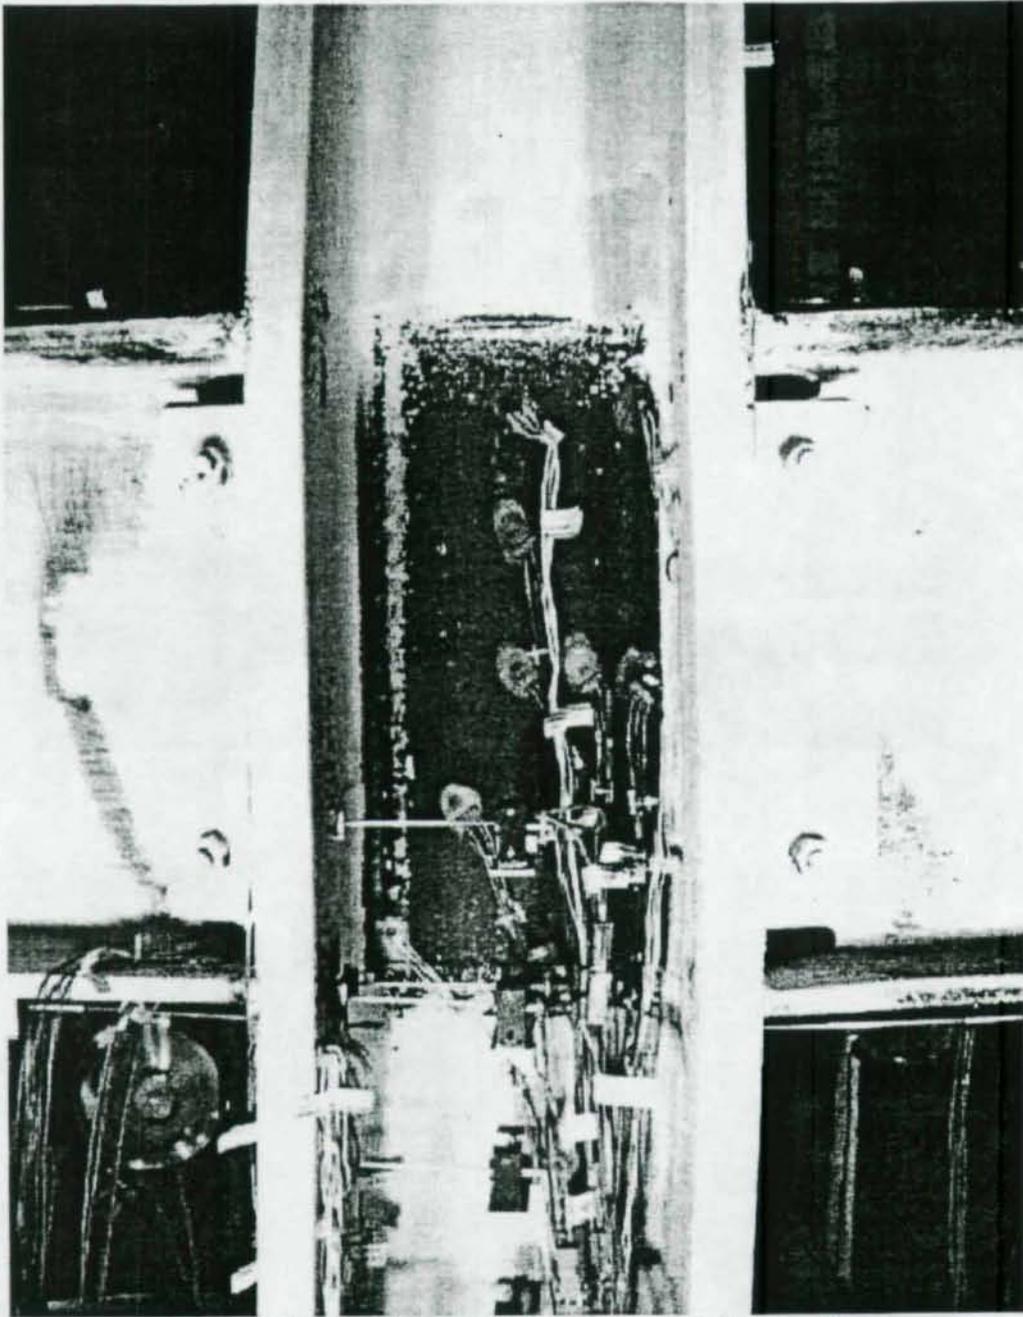
Figure 6.23: Specimen CR1 Panel Zone (Following Test)

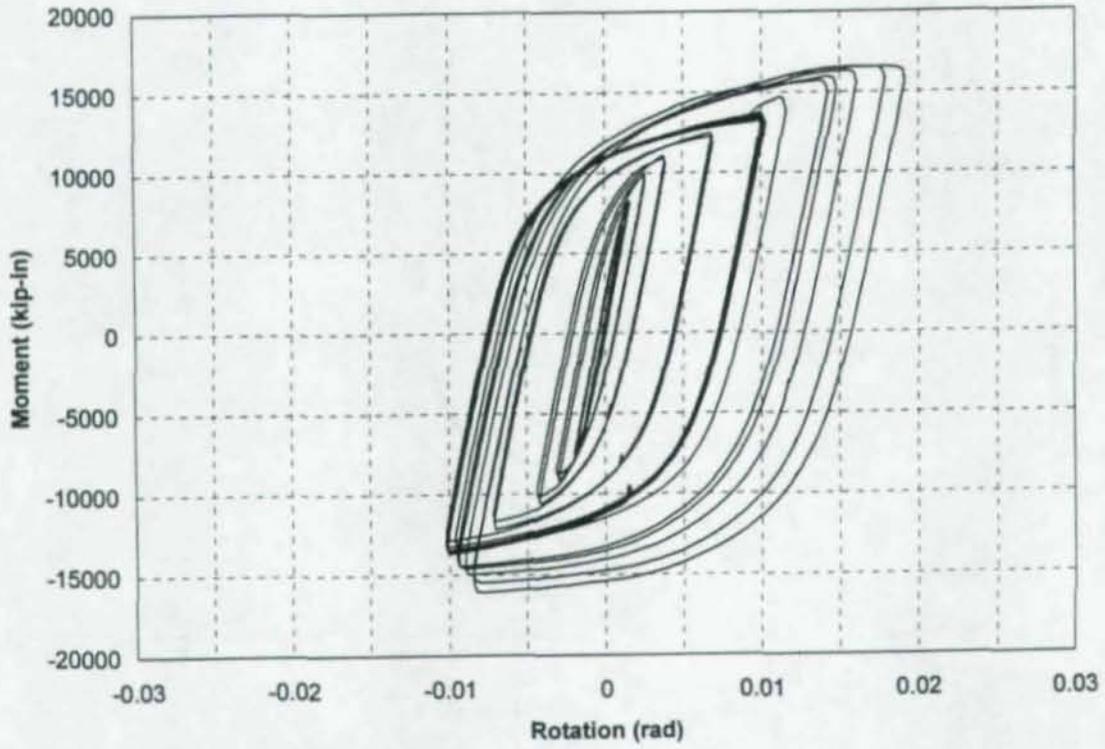
Figure A.27: West Girder Total Rotation, CR1

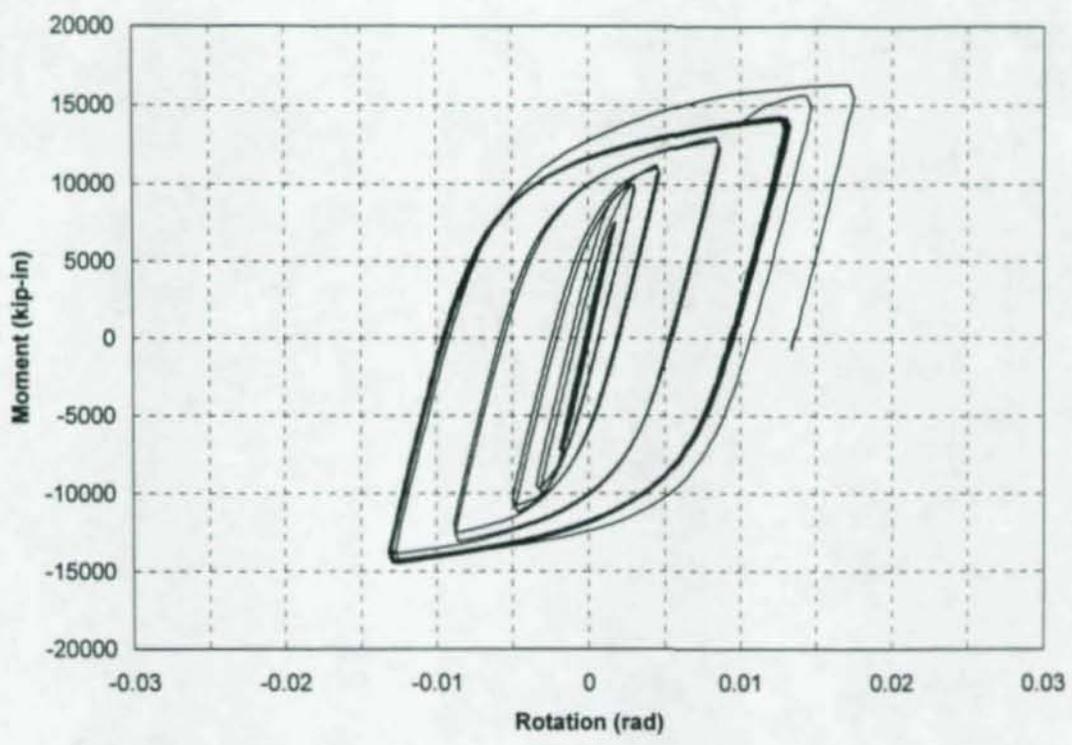
Figure A.31: West Girder Total Rotation, CR3

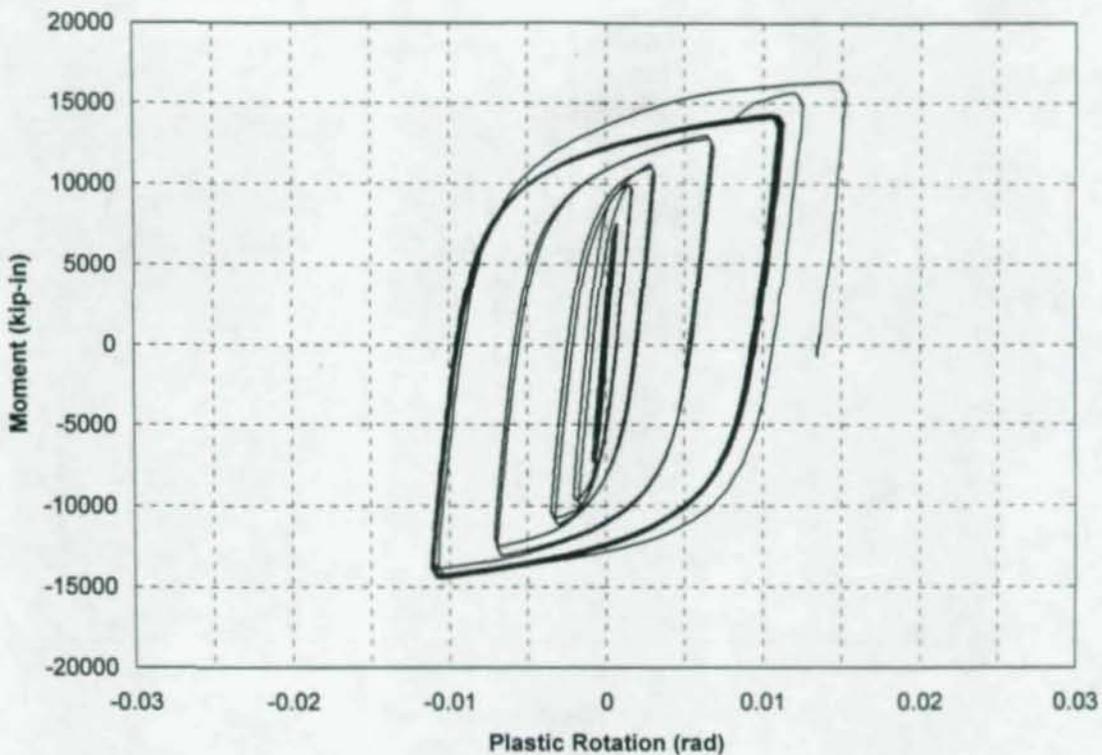
Figure A.62: West Girder Plastic Rotation, CR3
