**Structural Engineering Report No. ST-01-3.2**

**COLUMN STIFFENER DETAILING  
AND PANEL ZONE BEHAVIOR OF  
STEEL MOMENT FRAME CONNECTIONS**

**June 2002**

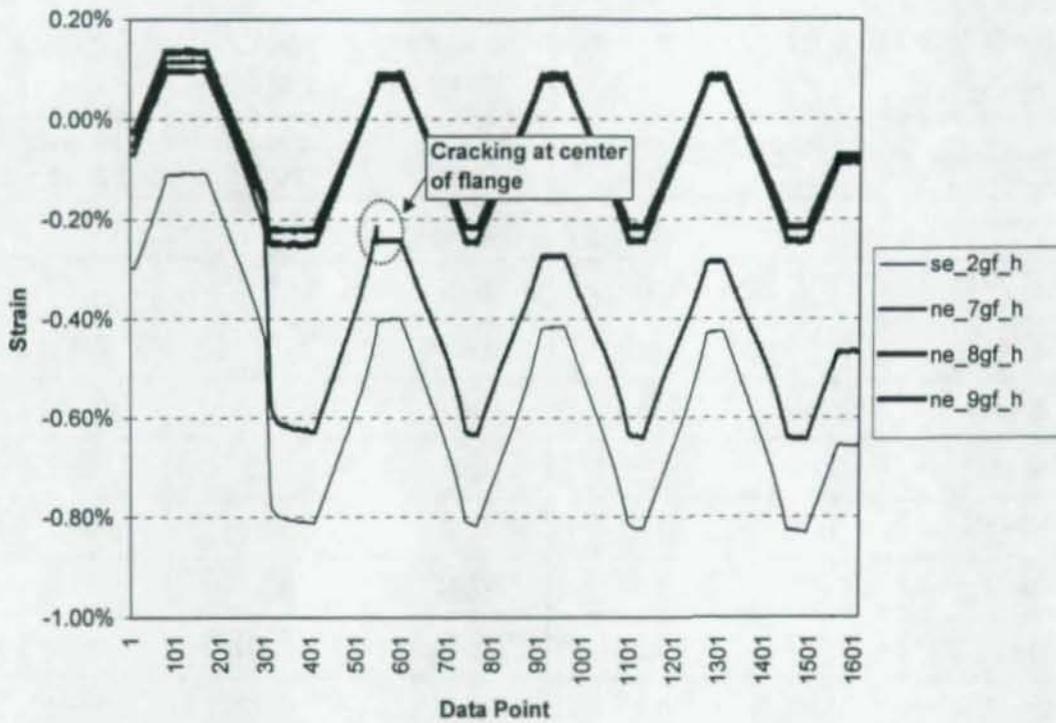
Figure B.1: Strain History of CR4 East Top Flange During 1.0% Drift Cycles

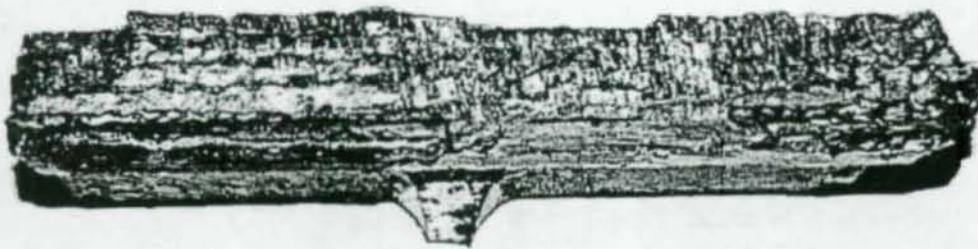
**Figure B.6:** West Top Flange Fracture Surface From Specimen CR4

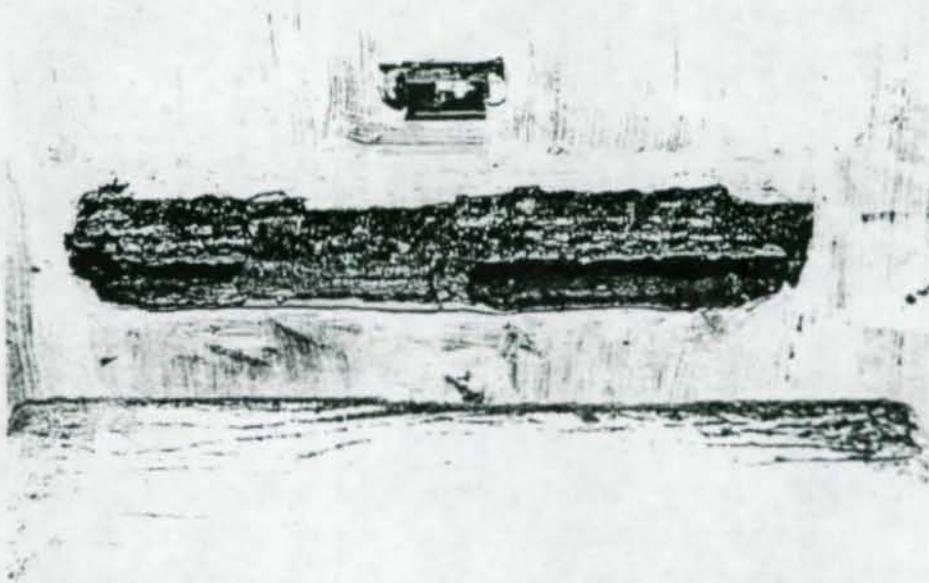
Figure B.7: West Top Flange Fracture Surface at Column Face from Specimen CR4

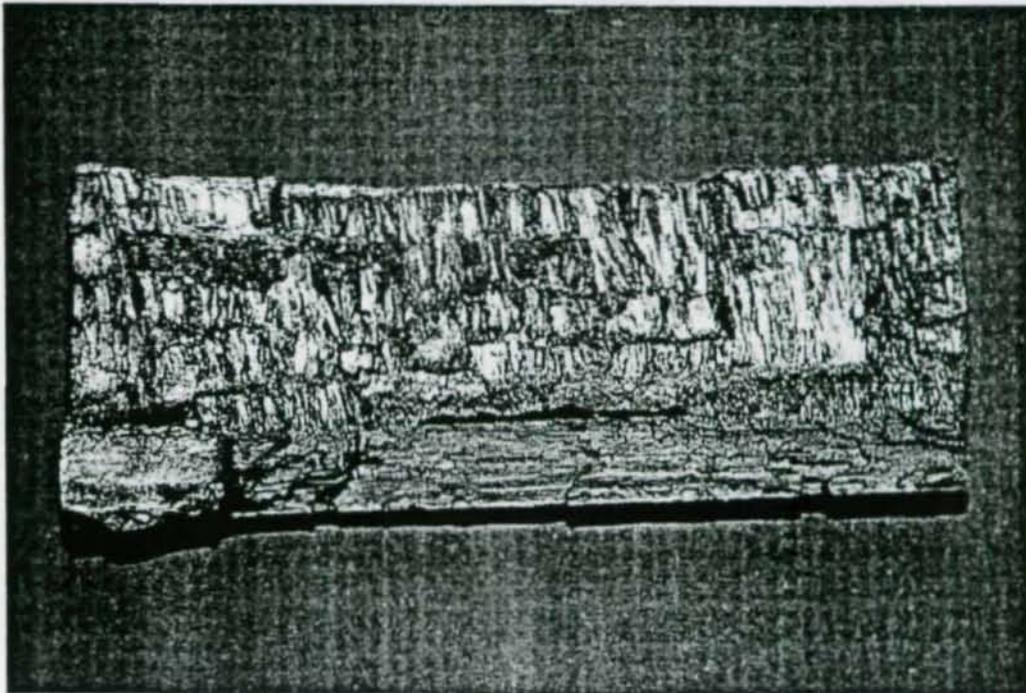
Figure B.8: Close-up View of Specimen CR4 Fracture Surface Features Near Center of Flange

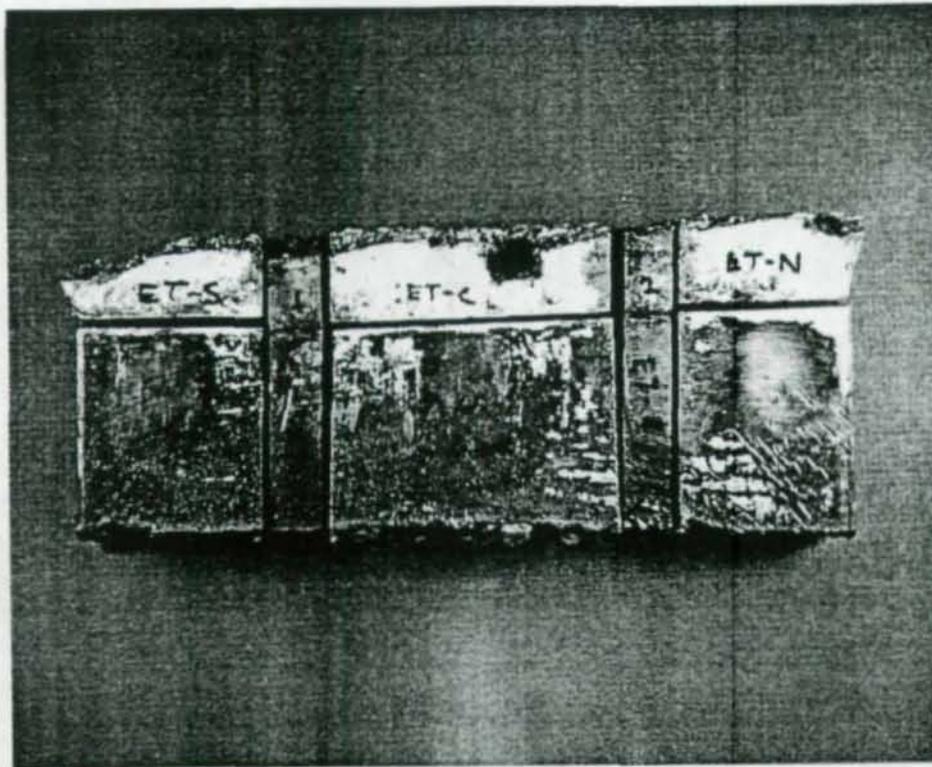
Figure B.9: Typical Sectioning of Fracture Surfaces for Investigation

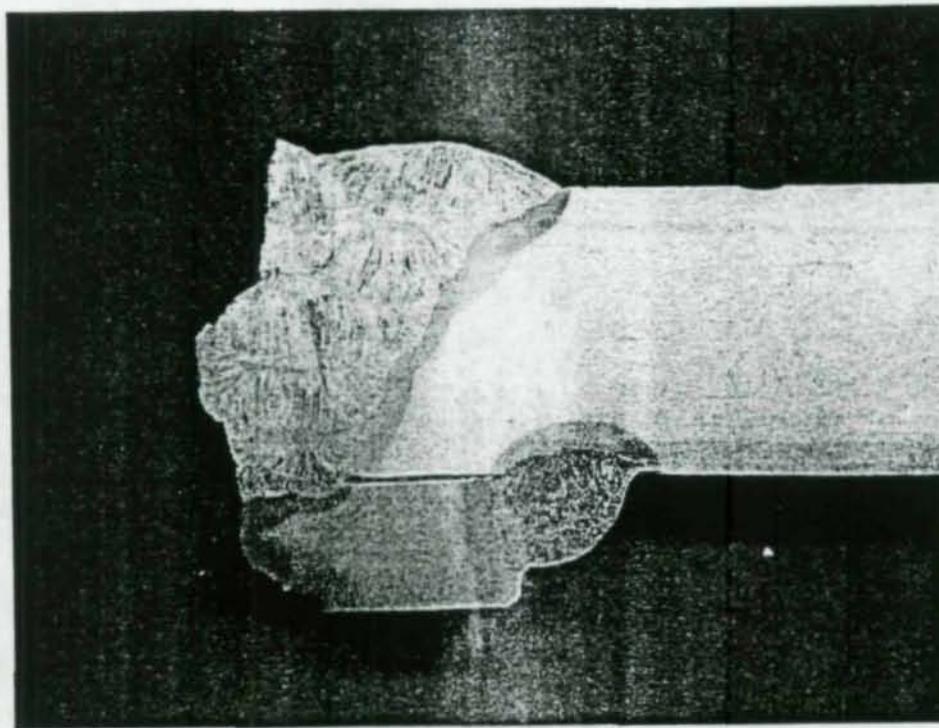
Figure B.10: Fractured Weld Section From East Top Flange of Specimen CR4

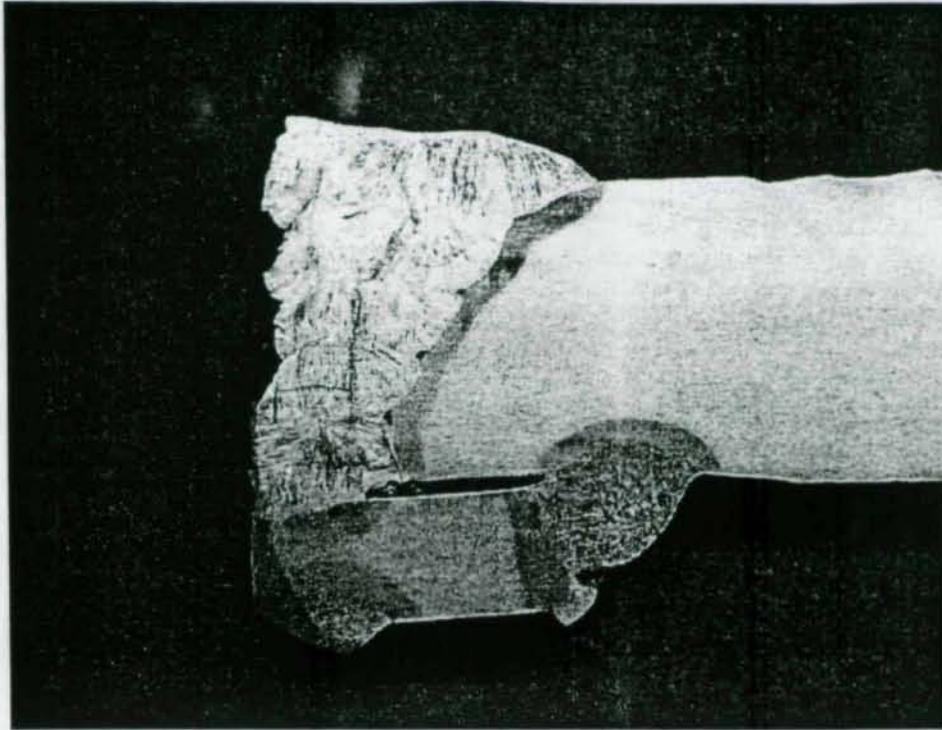
Figure B.11: Fractured Weld Section From West Top Flange of Specimen CR4

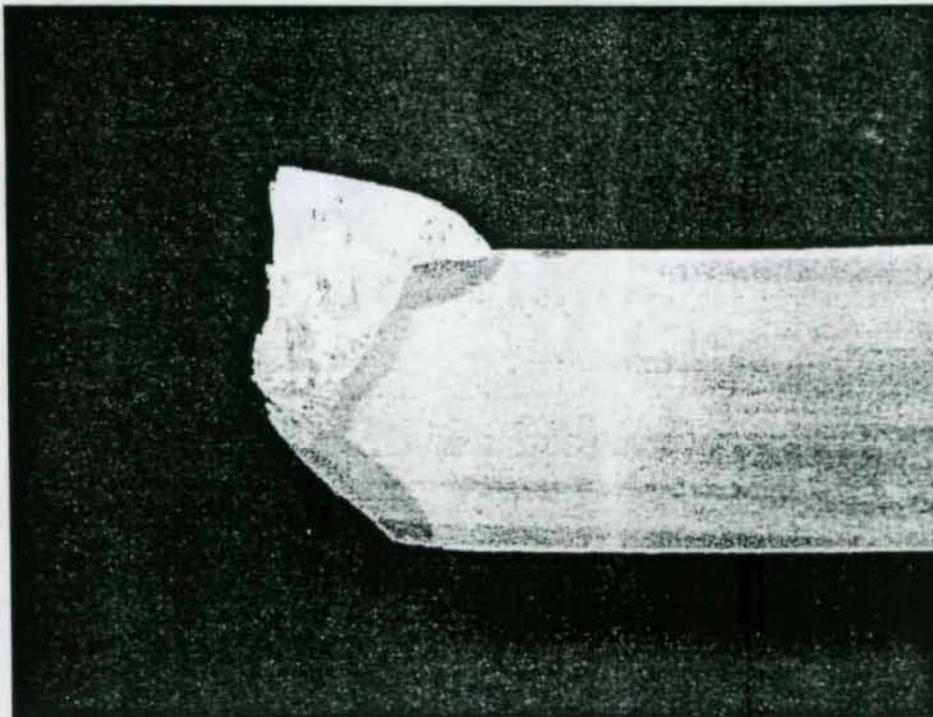
Figure B.12: Fractured Weld Section From West Bottom Flange of Specimen CR4

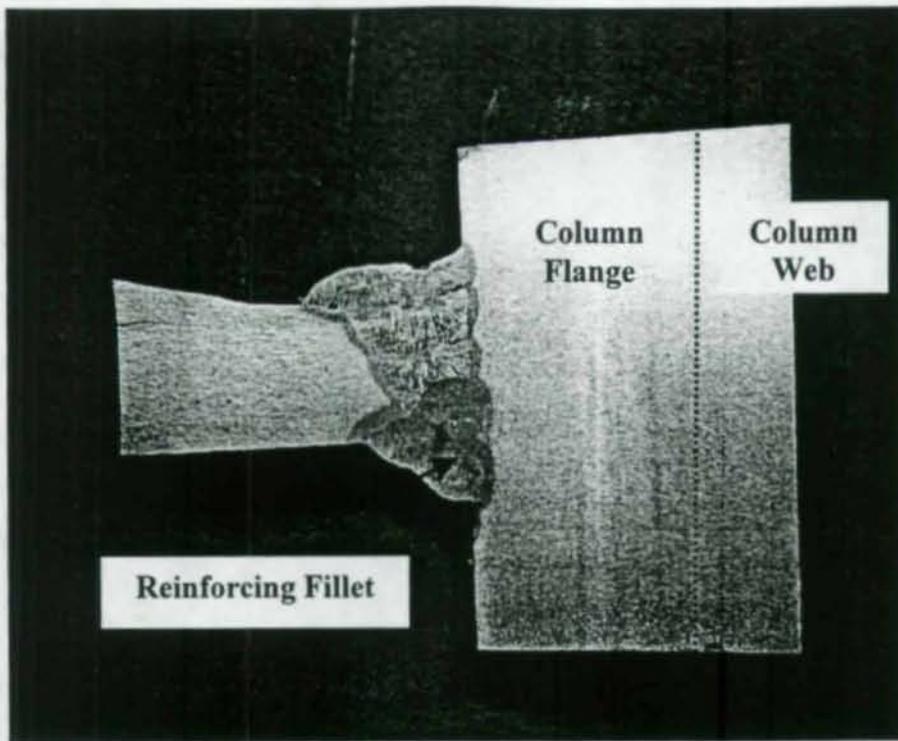
Figure B.13: Weld Section From East Bottom Flange of Specimen CR4

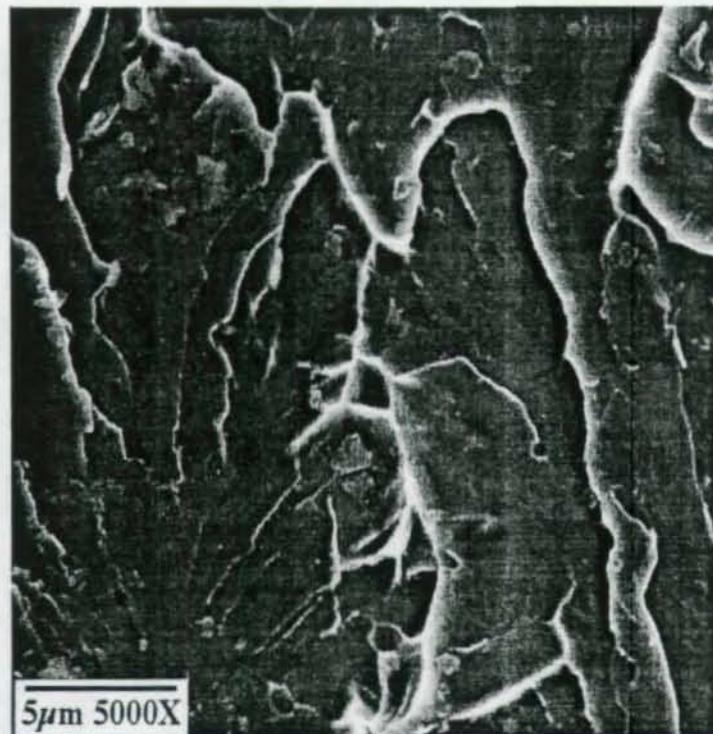
Figure B.18: SEM Photo Showing Cleavage Planes on Fracture Surface of Specimen CR4

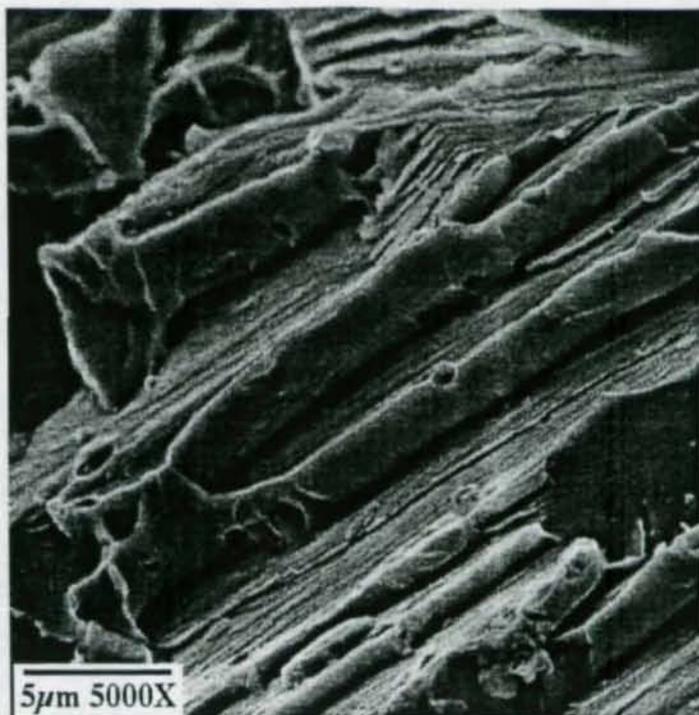
**Figure B.19:** SEM Photo Showing Brittle Cleavage Behavior of Welds of Specimen CR4

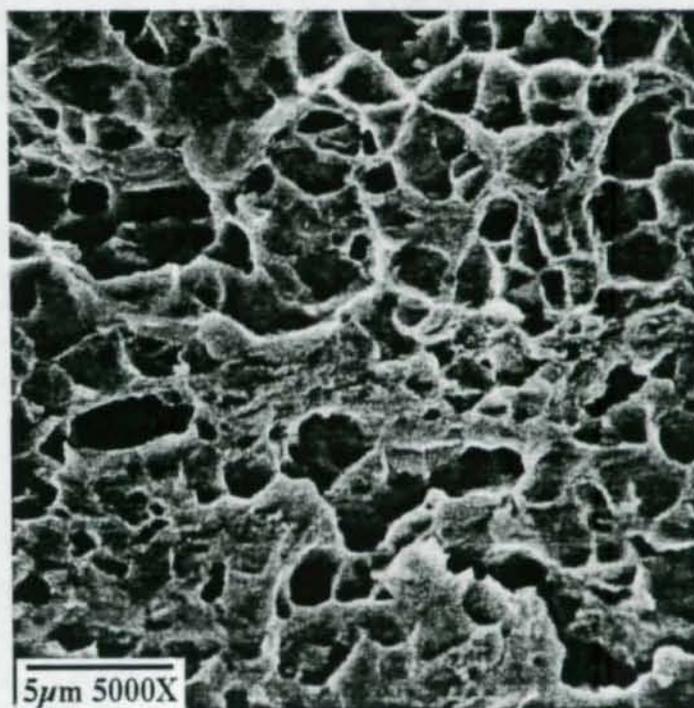
**Figure B.20:** SEM Photo Showing Ductile Fracture of E71T-8 Fillet Welds of Specimen CR4

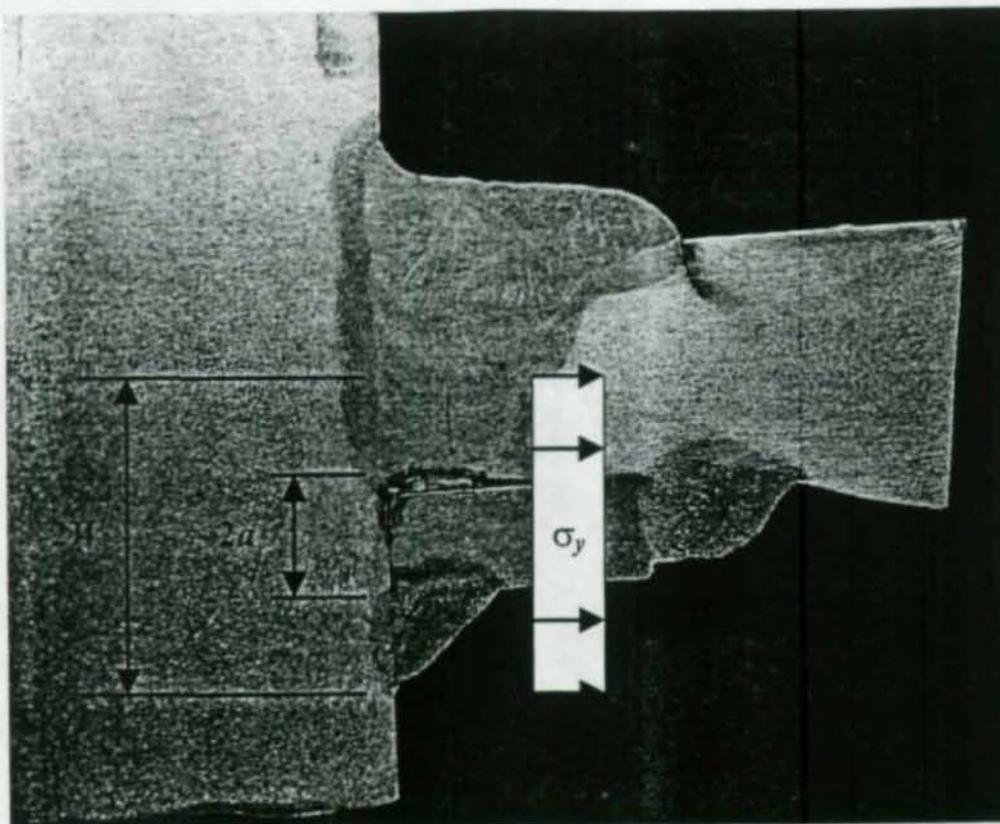
Figure B.21: Illustration of LEFM Application to Backing Bar Notch
