Library Seismic Upgrade

By Keith Robinson, P.E.,
and Debbie Ames

The renovation of the historic Oregon State Library, which included seismic strengthening, upgrading the existing mechanical systems, improving space utilization and providing accessibility improvements, was accomplished without closing the building to normal use.

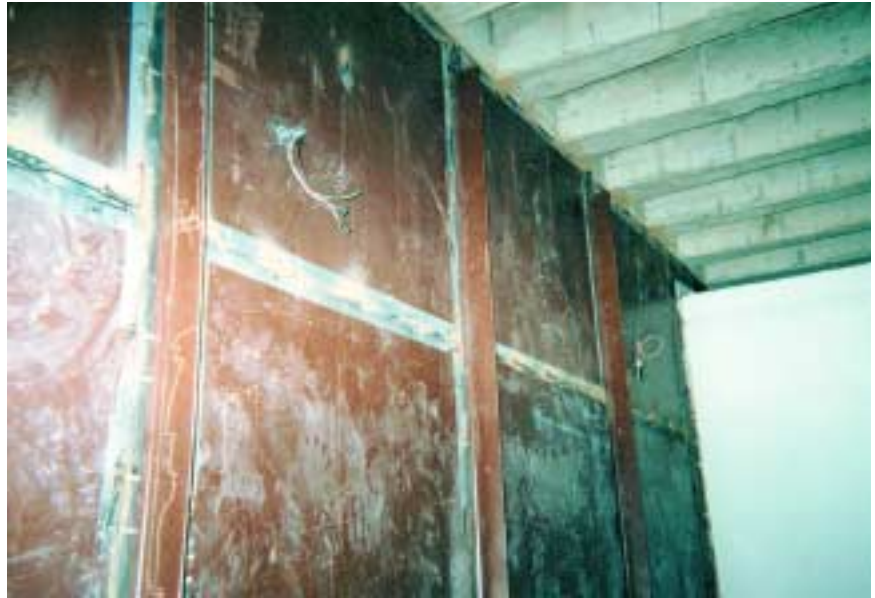
Using steel plates rather than concrete shear walls allowed the design team to overcome many design constraints and was less disruptive to the building's occupants. The owner had no budget to temporarily relocate the library and its many historic volumes; and, the moisture generated by pouring vast amounts of concrete

in the building could harm the historic documents. The use of steel plates solved this problem. It facilitated access and installation in confined spaces, and provided flexibility for architectural space planning. At the request of the contractor, KPFF was able to design the steel plates so they could be installed by hand rather than with machinery. The plates were sized so that two men could carry a plate and install it manually, which eliminated the need for large equipment, lifts, and cranes. The plates were spliced together with structural Tees, which also serve as stiffeners for the plates. To the extent possible, connections were made using bolts rather than welding to minimize the risk of fire from welding in the library. The plate walls are relatively thin in comparison to concrete shear walls.

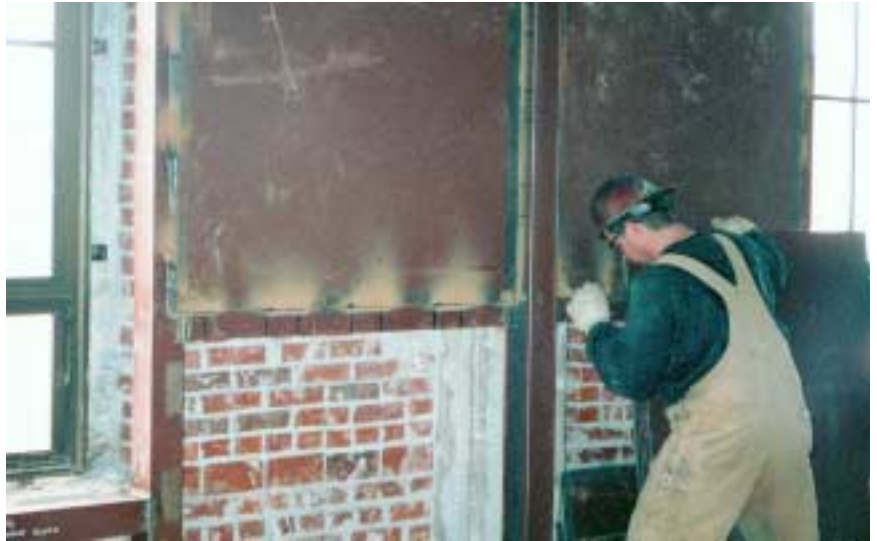
Shown above is the installation of one of the new steel plate shear walls, which were sized so two workers could lift one.
