OHIO STADIUM PRESS BOX

Towers above the Rest

Jack Krebs, P.E., and Ken Shanta, P.E.

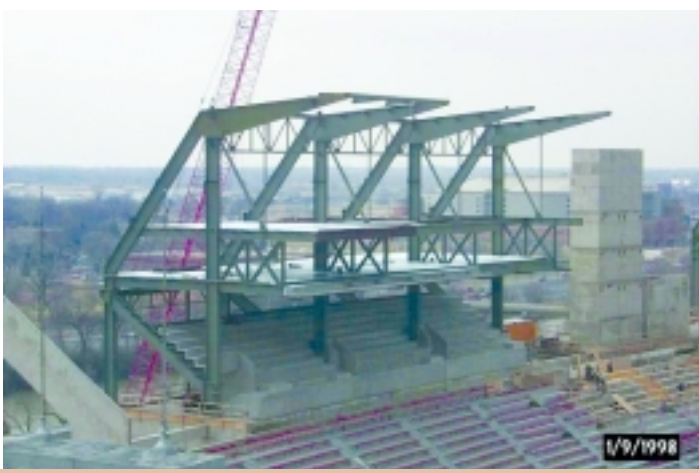
*top: View showing ten of the thirteen frames erected.
bottom: Four southerly frames. Note floor-to-floor truss at suite level.*

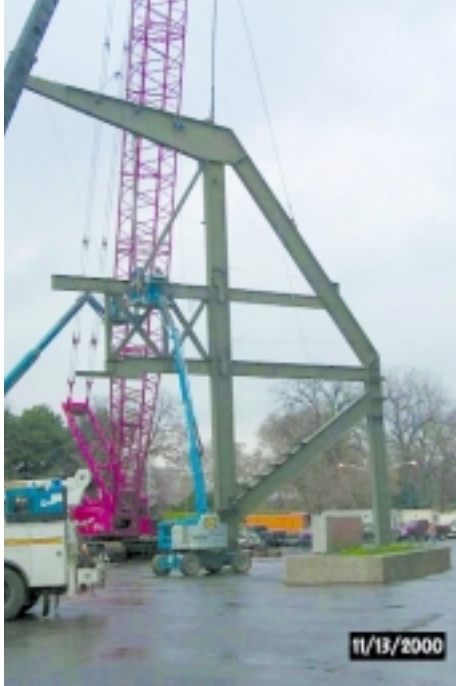
Pre-assembled bent frame being lifted into position.

Adherence to such a restrictive timetable was the responsibility of the both the construction manager, Turner Construction Inc., and the structural steel contractor, Kokosing/P.J. Dick (A Joint Venture). Beginning construction of this type in November is a risky proposition in Columbus because the majority of the work is done in the midst of a cold, often harsh, and highly unpredictable midwestern winter. In order to minimize the weather-induced risks inherent with winter construction, the contractor decided to assemble the entire primary bent, including the frame, cantilevered roof girder, and cantilevered floor-to-floor truss on the ground. Once assembled, the bents were lifted into place with a Mani-

towoc 888 (240) ton crane. Each bent as lifted weighed approximately 30 tons. The remaining steel framing was then infilled between the bents in a conventional manner. The total weight of structural steel used in the pressbox structure was approximately 1,000 tons. A total of 13 bents comprise the main structural framing system. The contractor strategically erected the bents and the associated floor system members in a sequence that provided lateral stability to the adjacent frames. Construction phasing requirements on the project dictated that the erection of the infill floor framing members be delayed to allow for installation of the precast concrete seat decks located below the pressbox structure. The precast tread and riser pieces were lowered via overhead crane between the bents and the lateral bracing system.

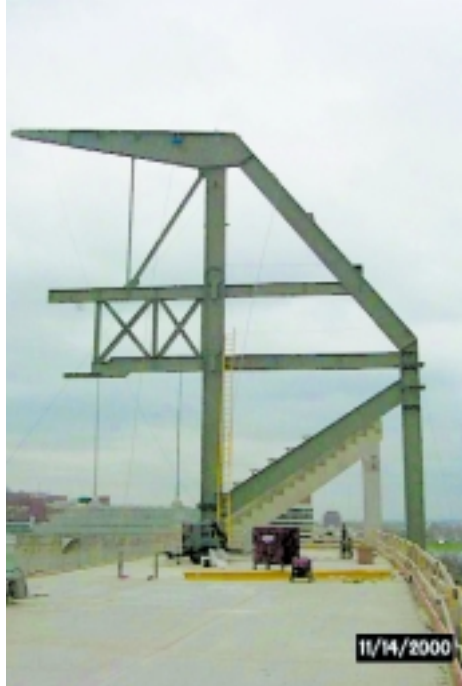
First erected frame on south end.

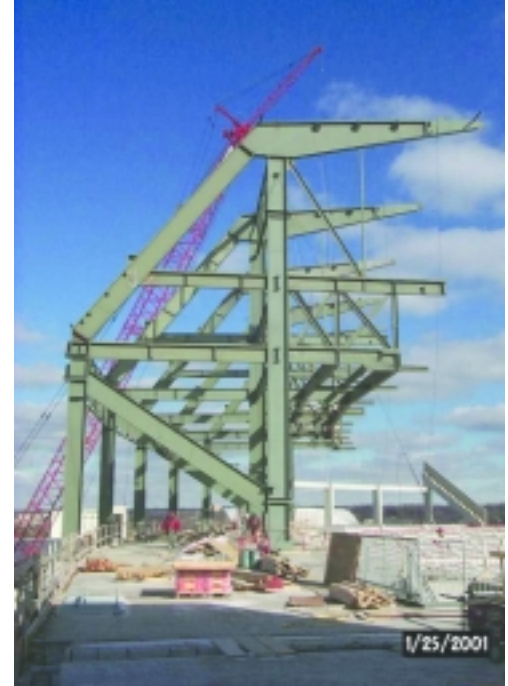
Typical frame as seen from the upper concourse.

The pressbox's primary structural system is a triangular-shaped steel-framed bent. The frame includes Grade 50 built-up 36" deep plate girders with 1½"x15" flanges, and standard W27x84 and W36x135 wide flange sections. A pair of columns supports the bent frame; the column closest to the playing field is a W36x230 member, while a W30x191 was utilized for the rear column. The 36" deep plate girder is the backbone of the frame. It supports a 260 kip tensile load, in addition to a 455 kip-ft end moment at the W30 column. The spliced plate girder connection utilized 38 1"-diameter A490 SC bolts and field welded flanges with partial penetration welds. The frames are located approximately 40' on center. Combinations of bolted and welded connections were utilized. The uniquely designed frame made it possible to support a 34' cantilevered roof, as well as two floor levels that cantilever as much as 25' beyond the front column. The built-up roof plate girder at the connection to the front column is 5'-9" deep, and tapers to 15" at the tip. A 5" thick concrete slab on composite metal deck was utilized as the slab system for all levels. The floor-to-floor cantilevered trusses, made of W24x94 and W27x84 top and bottom chords with W8x31 welded diagonals, are rigidly attached to the front columns with six ¾" diameter A325 SC bolts

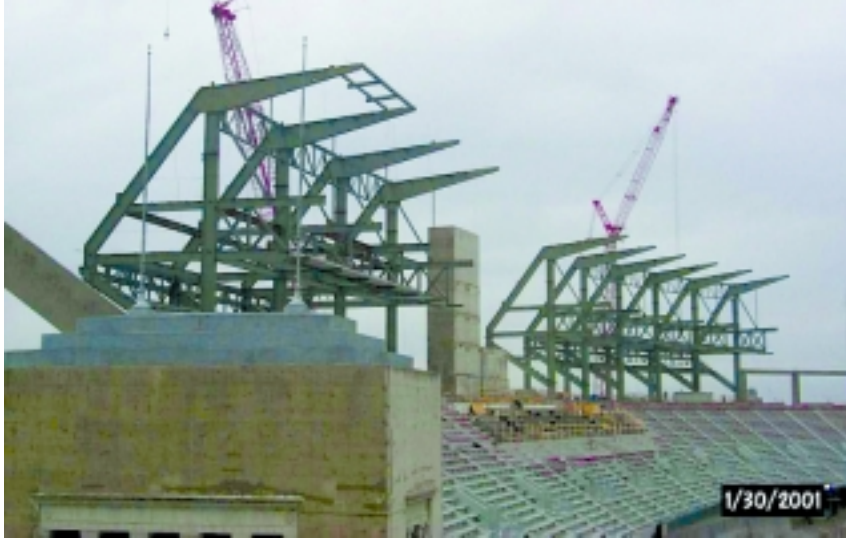
Existing press box demolition delays erection of center frames.

Another construction phasing issue was the removal of the existing pressbox after the 2000 season. This necessitated the delay in erection of several bents within the middle third of the

new structure. The demolition contractor, O'Rourke Demolition, was responsible for coordinating their scope of work with the structural steel contractor to avoid any conflict between the two parties. The volume of space within the new structure is approximately seven times that of the existing pressbox. When completed, the enormous size of the pressbox will certainly provide a dramatic visual impact on players, spectators and the press corps alike.

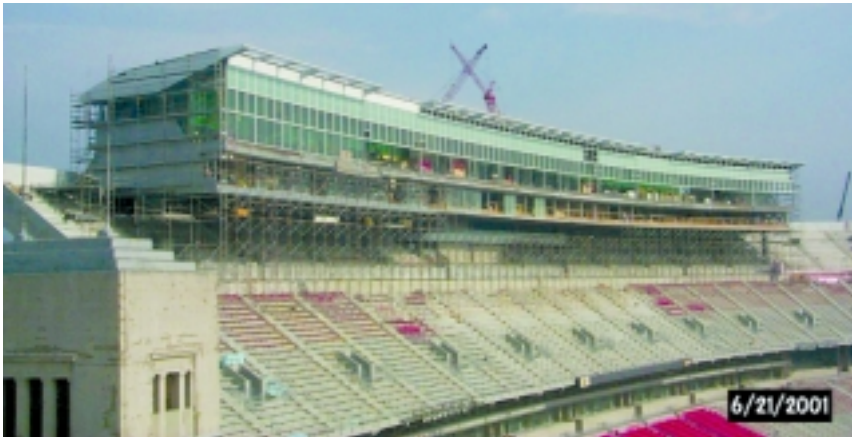
Partially-enclosed press box as viewed from the east.
