merit award
less than \$10M—single-family residence

A Greenwich Playhouse

Greenwich, Connecticut

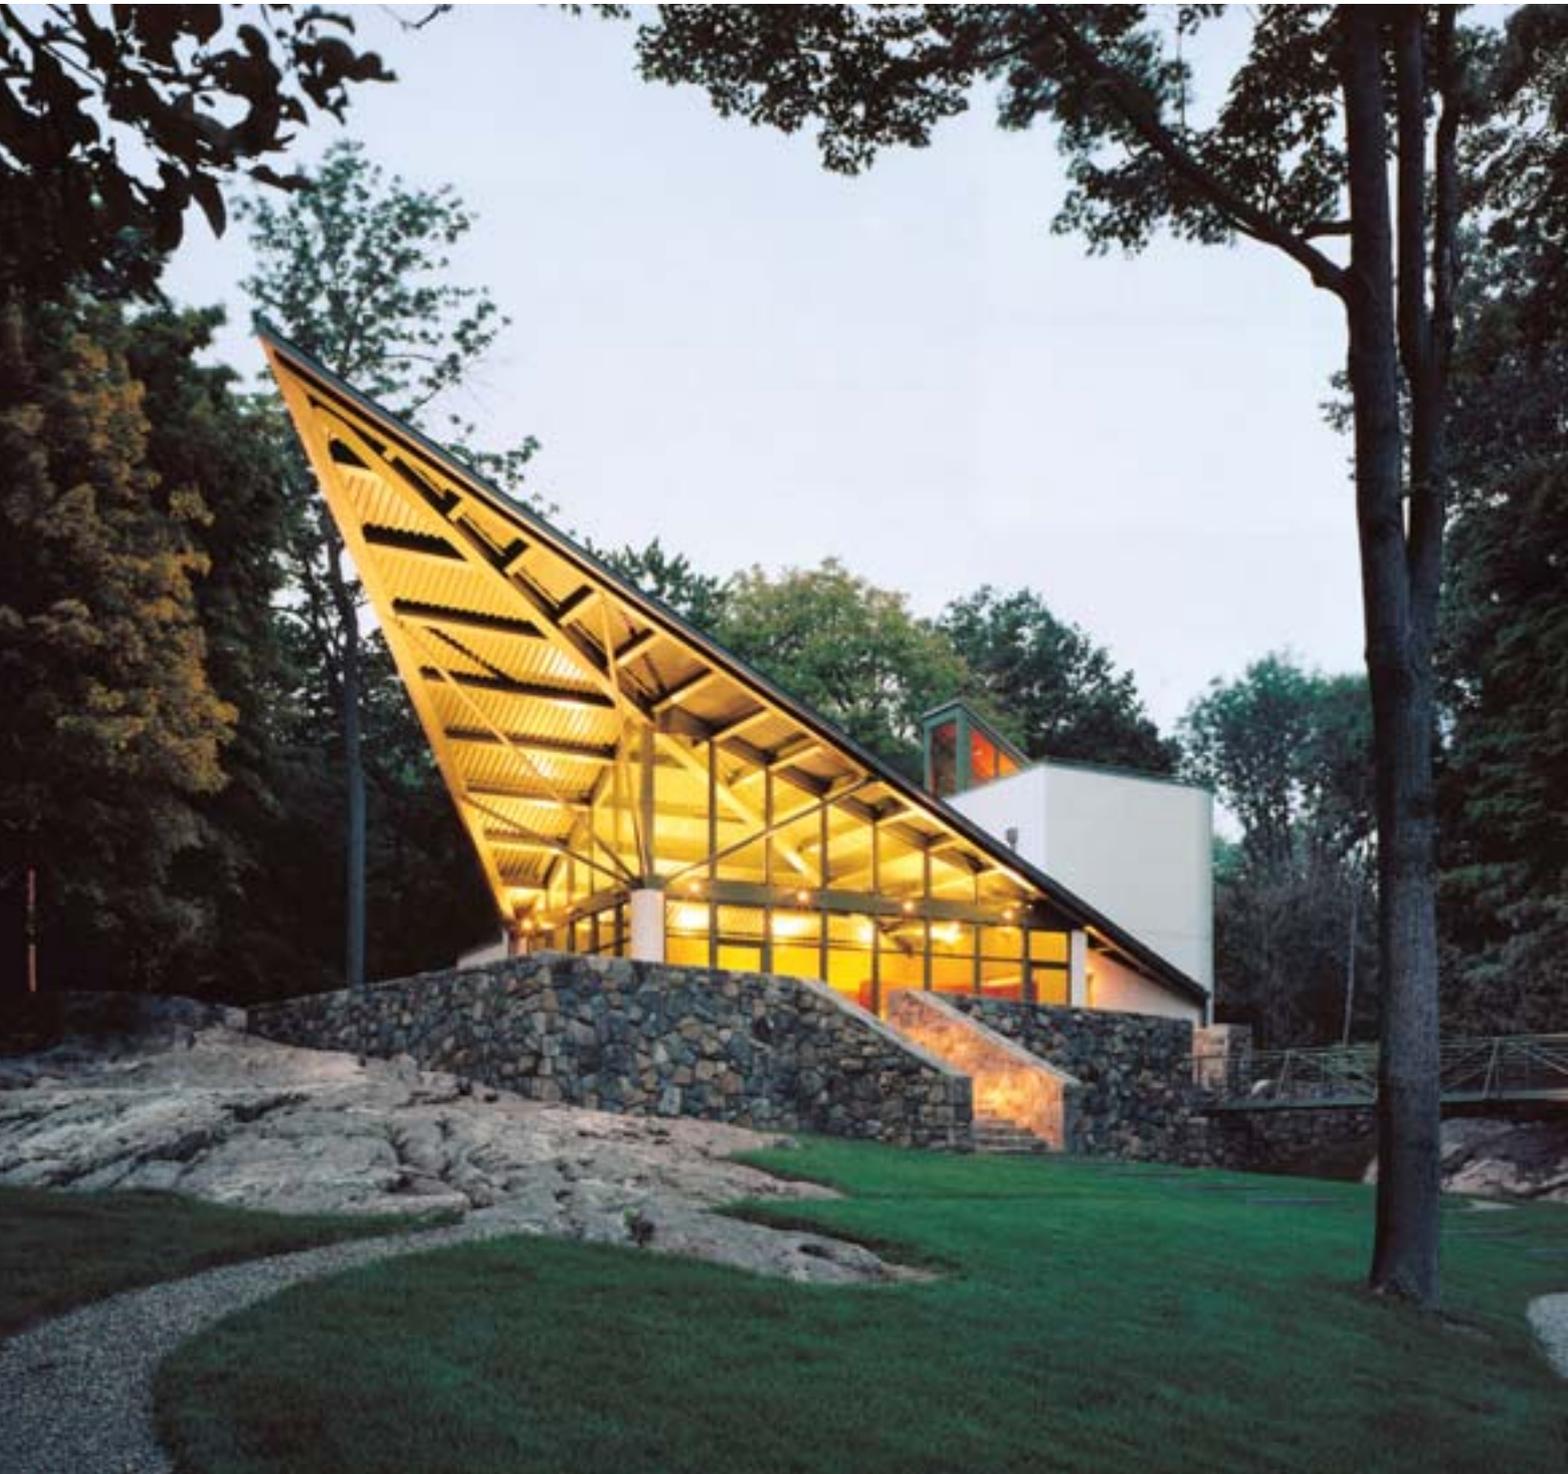
Photograph © David Sandberg/Esto. Austin Patterson Disston Architects

An overhanging steel roof unites the party room with the terrace outside. Its asymmetric form relates the skewed axis of the guesthouse footprint with that of the main house.

Stretching back towards the sky, the roof of the playhouse vaults over its glass walls and seems to keep going. The in-plane shear strength of the metal roof deck was chosen to enable the strength and stiffness of the folded plate geometry of the roof. Mimicking the leaf of a beech tree, the primary roof-framing members spring from the center spine member and cantilever over the glass walls to the roof edge.

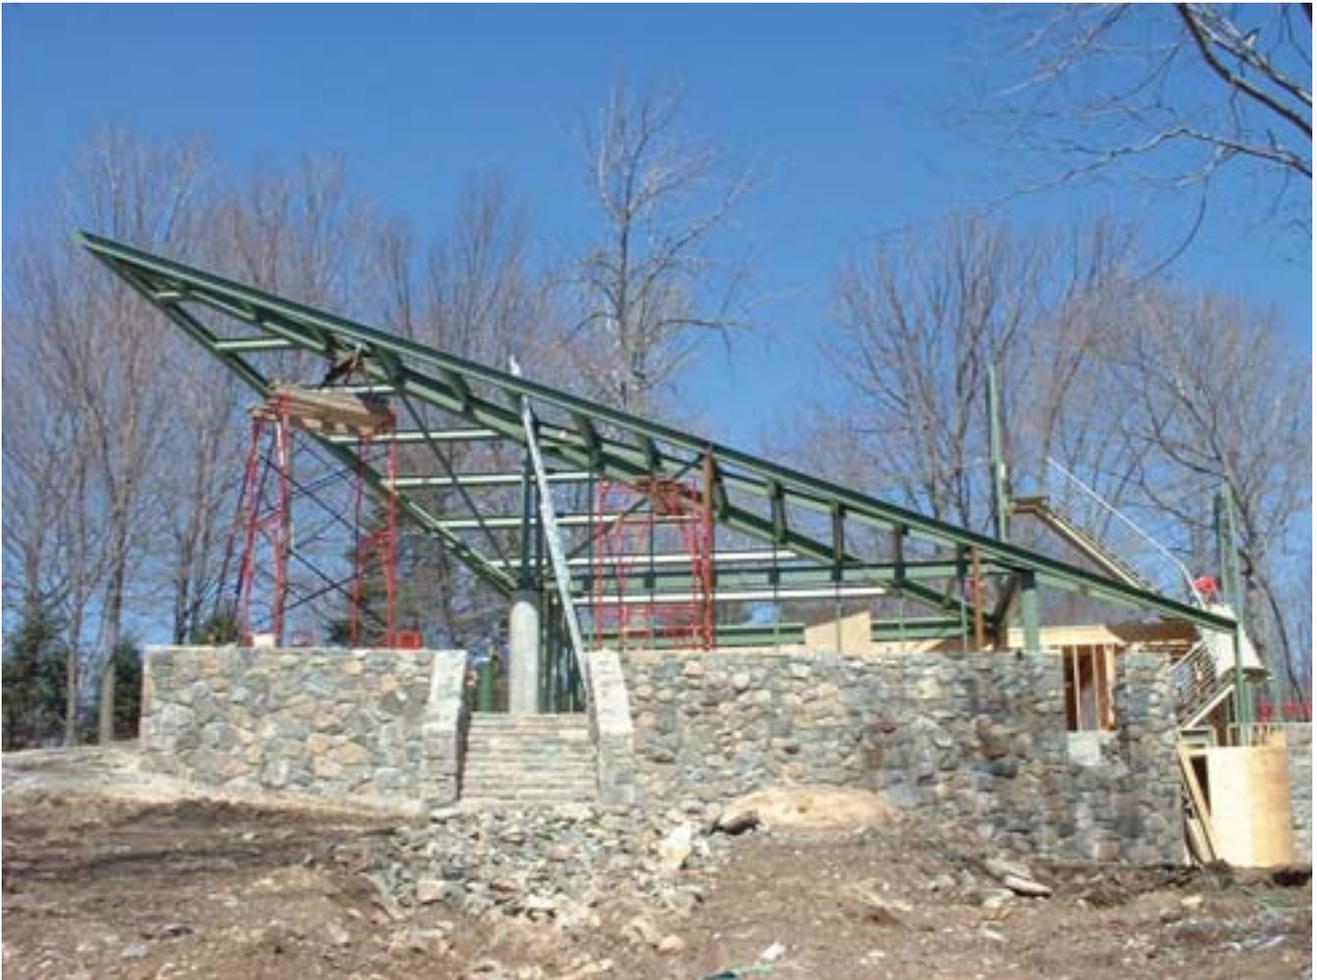
Photograph courtesy Ed Stanley Engineers, Guilford, CT

Most steel connections are exposed and detailed to be continuous. This is

in order to optimize system strength and stiffness while minimizing member sizes. In-plane shear stresses in the metal roof deck were evaluated to verify the required pattern of fasteners necessary to enable folded plate behavior. The roof edges were shored until the metal deck was fastened.

The framing members of the roof and the HSS columns of the glass walls all pierce the weather wall and are exposed at the exterior. This allowed the temperature effects on the framing system's shape due to seasonal temperature fluctuations to be evaluated. Heat tape was used to control condensation on the interior surfaces of the exposed steel during the heating season. Other loads considered are unbalanced roof live loads and eccentric wind loads.

The concealed columns were rolled W10 shapes and the exposed columns in the glass wall were round HSS. The roof beams were rolled W10 shapes with the tapered spine beam cut from a W18.
