Successful Today and
Getting Even Better for Tomorrow

Durable Bridge Coatings

BY ERIC KLINE

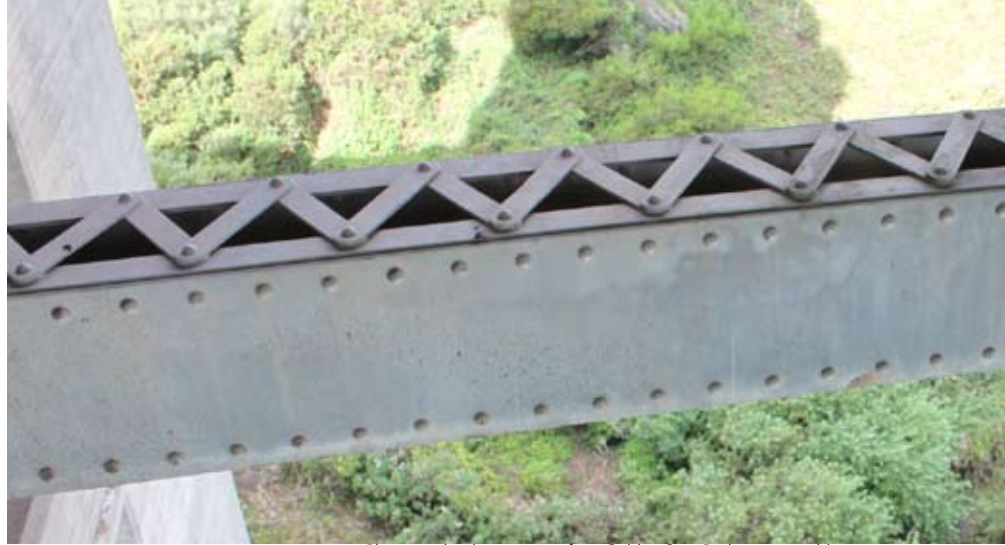
Four decades after being primed with the inorganic zinc-rich paint but never topcoated, these members on the north end of the bridge continue to be in very good condition.

Some areas on the north end of this iconic suspension bridge structure were primed with IOZ, but never topcoated. These areas were recently examined and were in very good condition. According to Dennis Dellarocca, the bridge’s paint

superintendent, there are no plans to disturb the corrosion-free coating that has been in place for more than 44 years.

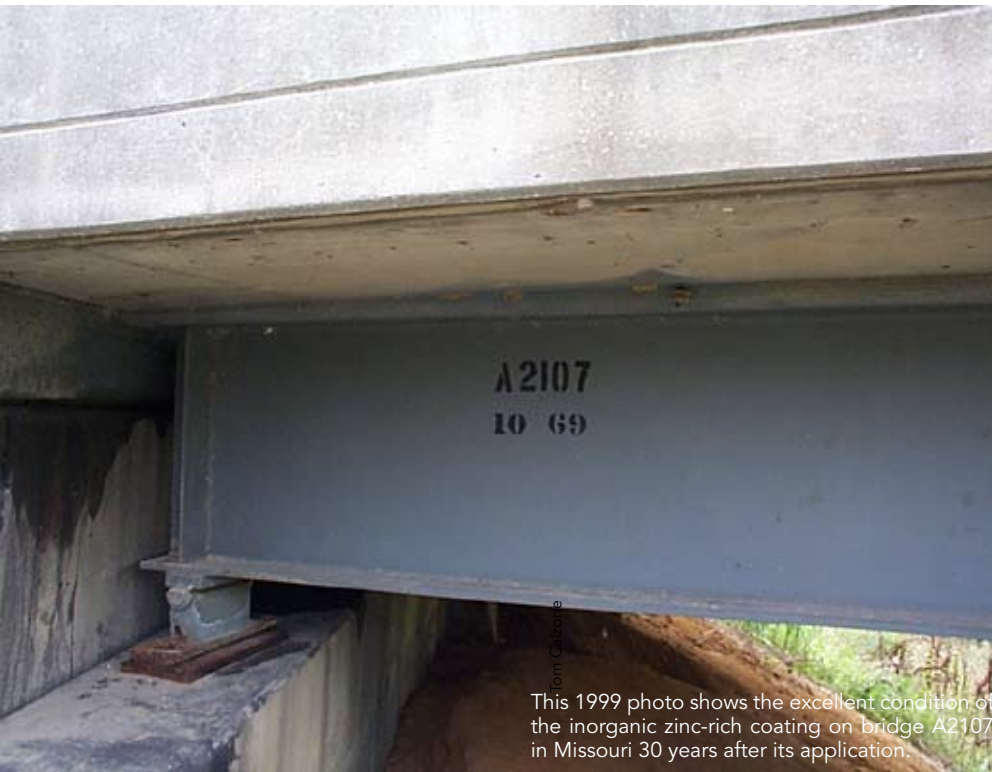
This 1999 photo shows the excellent condition of the inorganic zinc-rich coating on bridge A2107 in Missouri 30 years after its application.

An example of one of the older zinc-coated steel bridges is in Franklin County, Mo. Known as MoDOT Bridge No. A2107, this two-lane, 185-ft-long bridge on Route E crosses Pin Oak Creek. It was painted in October 1969 with an inorganic zinc-rich system; the coating was examined in 1999. At that time the coating condition was very good.

The bridge was overcoated in 2000 with a calcium sulfonate topcoat as part of the state's bridge maintenance program. Having been recently overcoated, the bridge should be well protected for decades to come.
