# The Washington Bridge:

# Steel Arches Across the Harlem River

BY JAMES TALBOTT

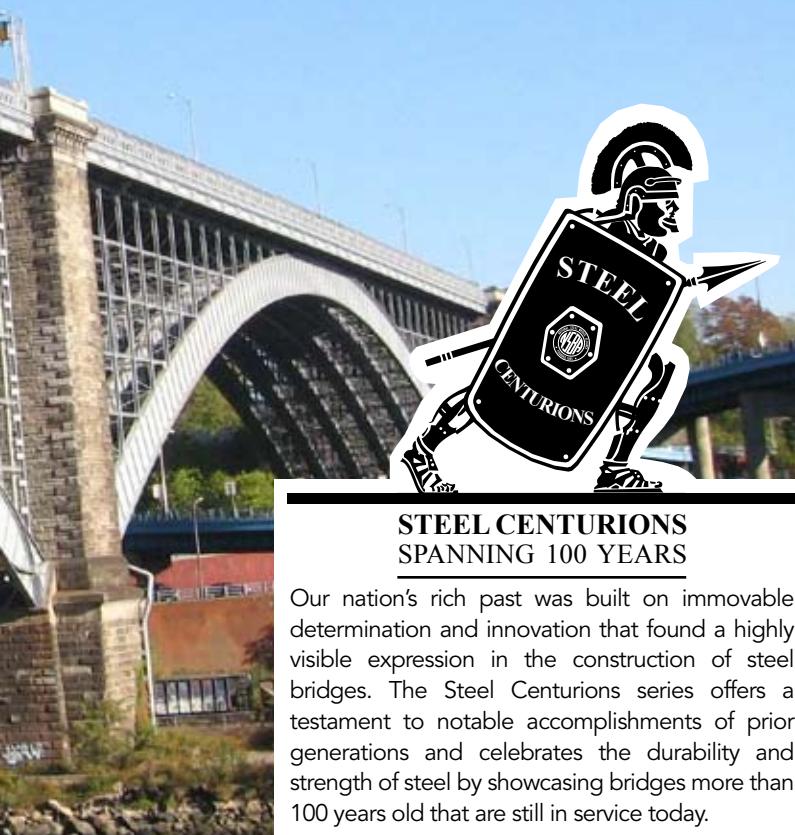
◀ Looking up and across Harlem River Drive from near water level at the Washington Bridge.

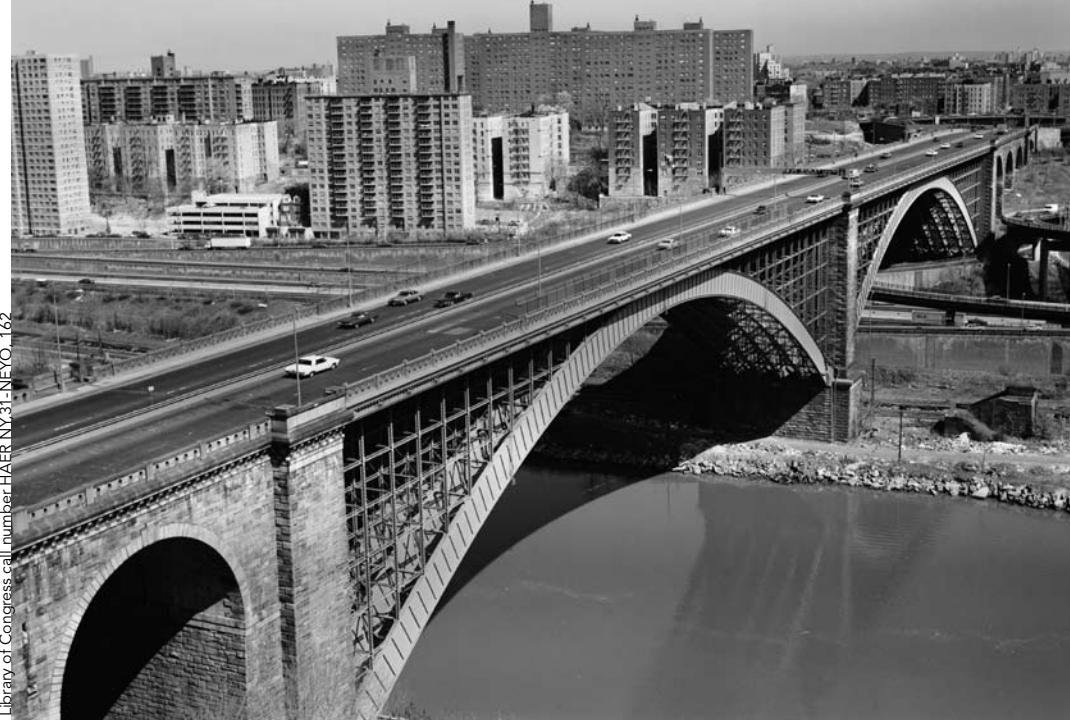
Library of Congress call number HAER NY-31-NEYO 162

▲ The north side of the Washington Bridge with Manhattan in the background circa 1970.
